Inspection Photos

API: 099-06139

Operator: BERRY ENERGY INC

Inspection Date: 1/12/2021

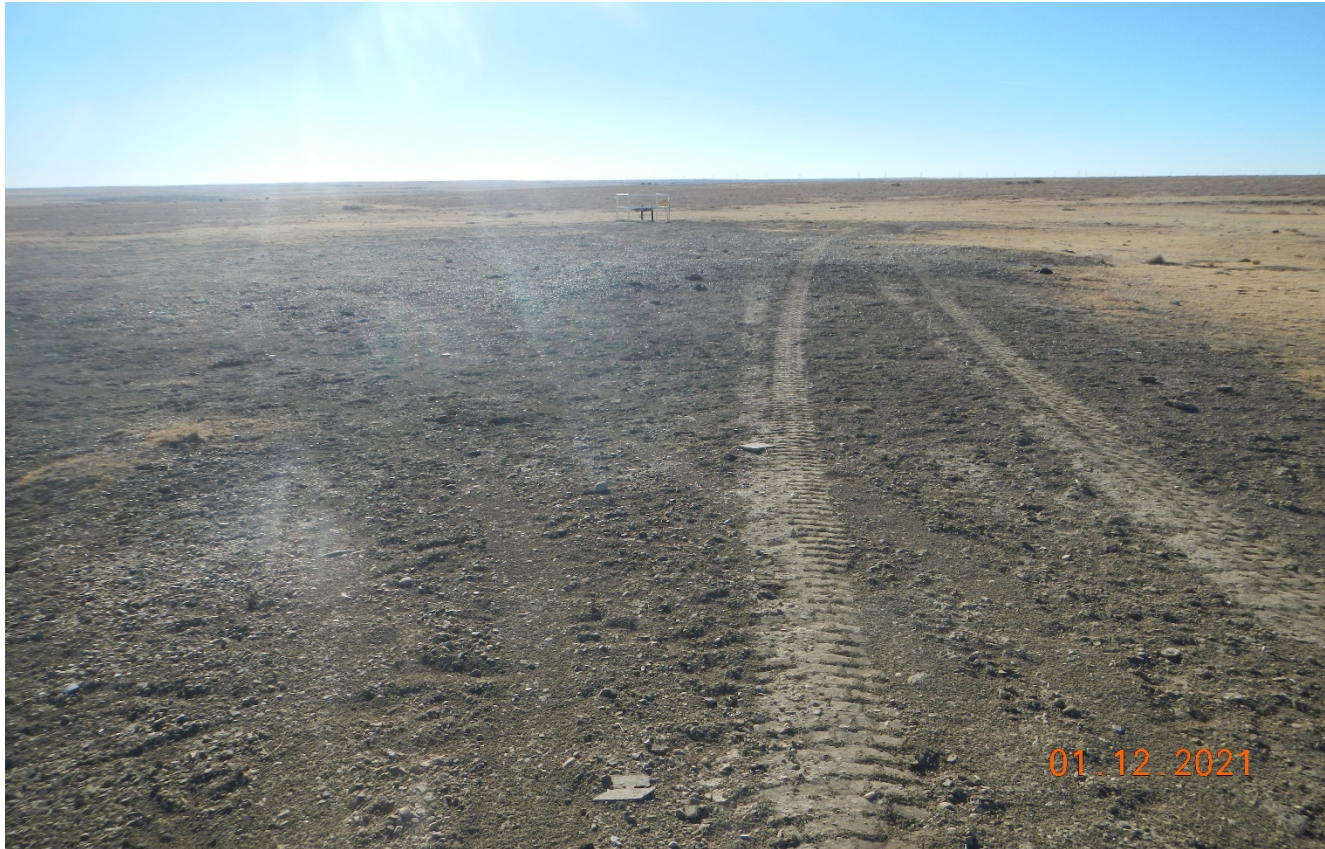
Photo 1. Facing south toward the location. The location is bare of vegetation and has not been reclaimed.

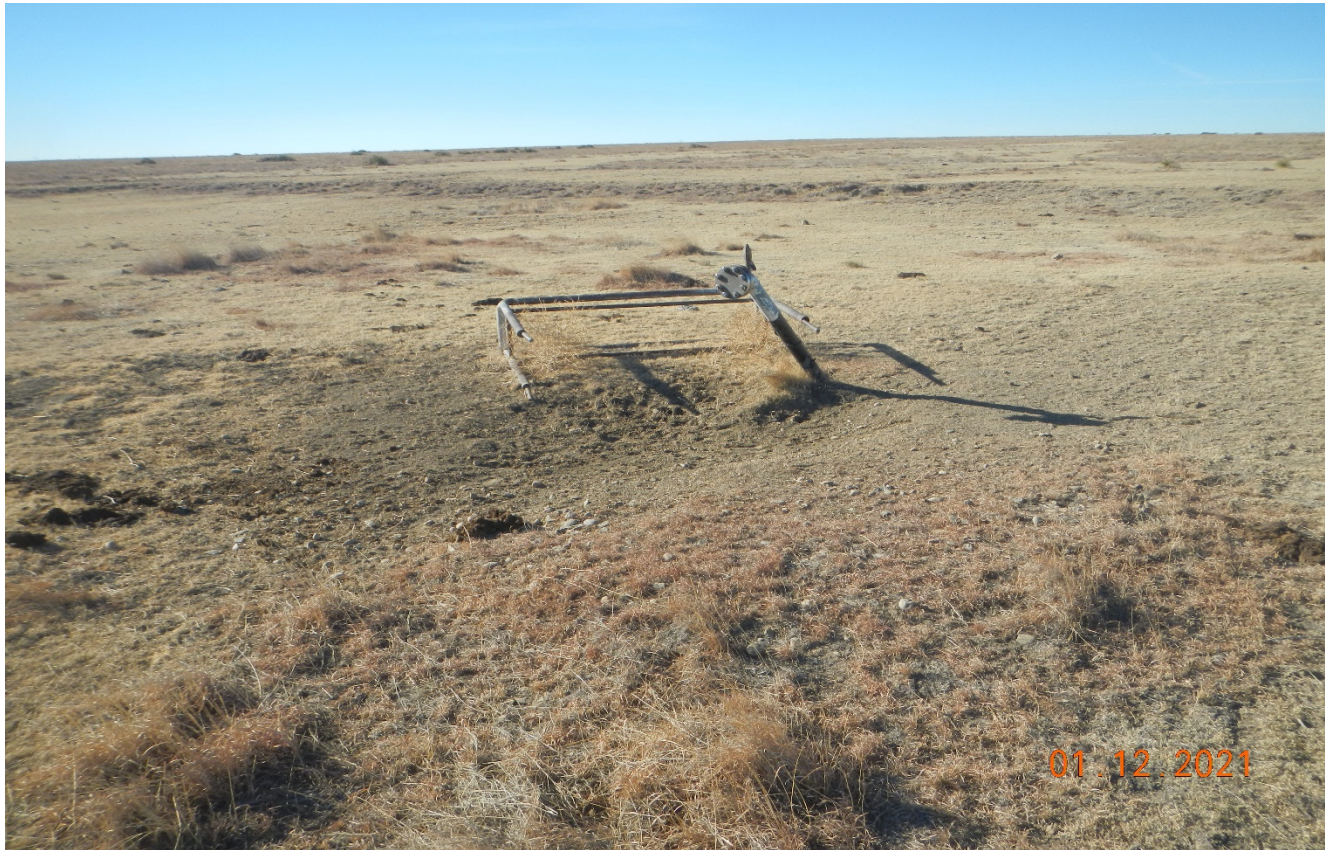
Photo 2. West side of the location. Pipe riser has not been removed.

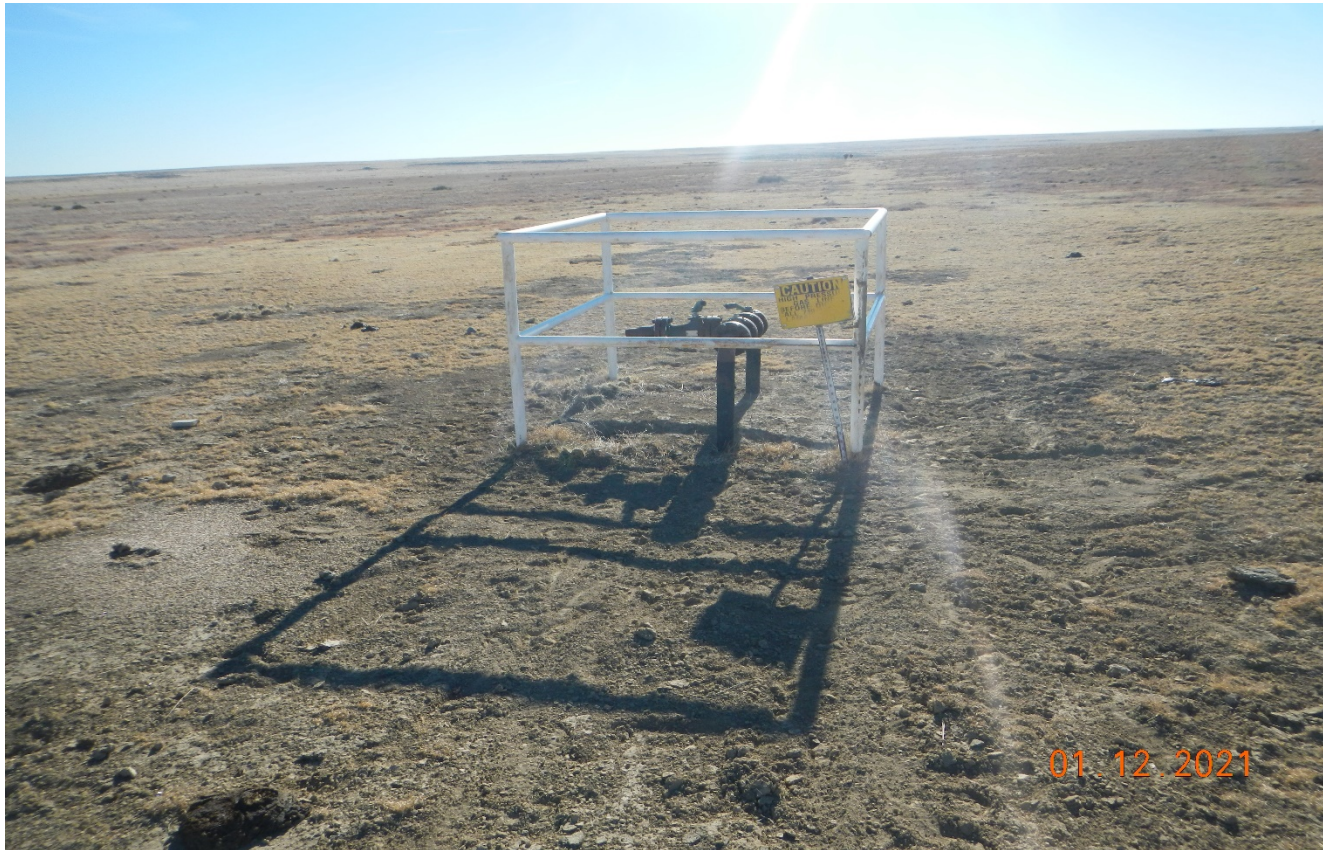
Photo 3. An additional pipe riser has not been removed at the south side of the location.

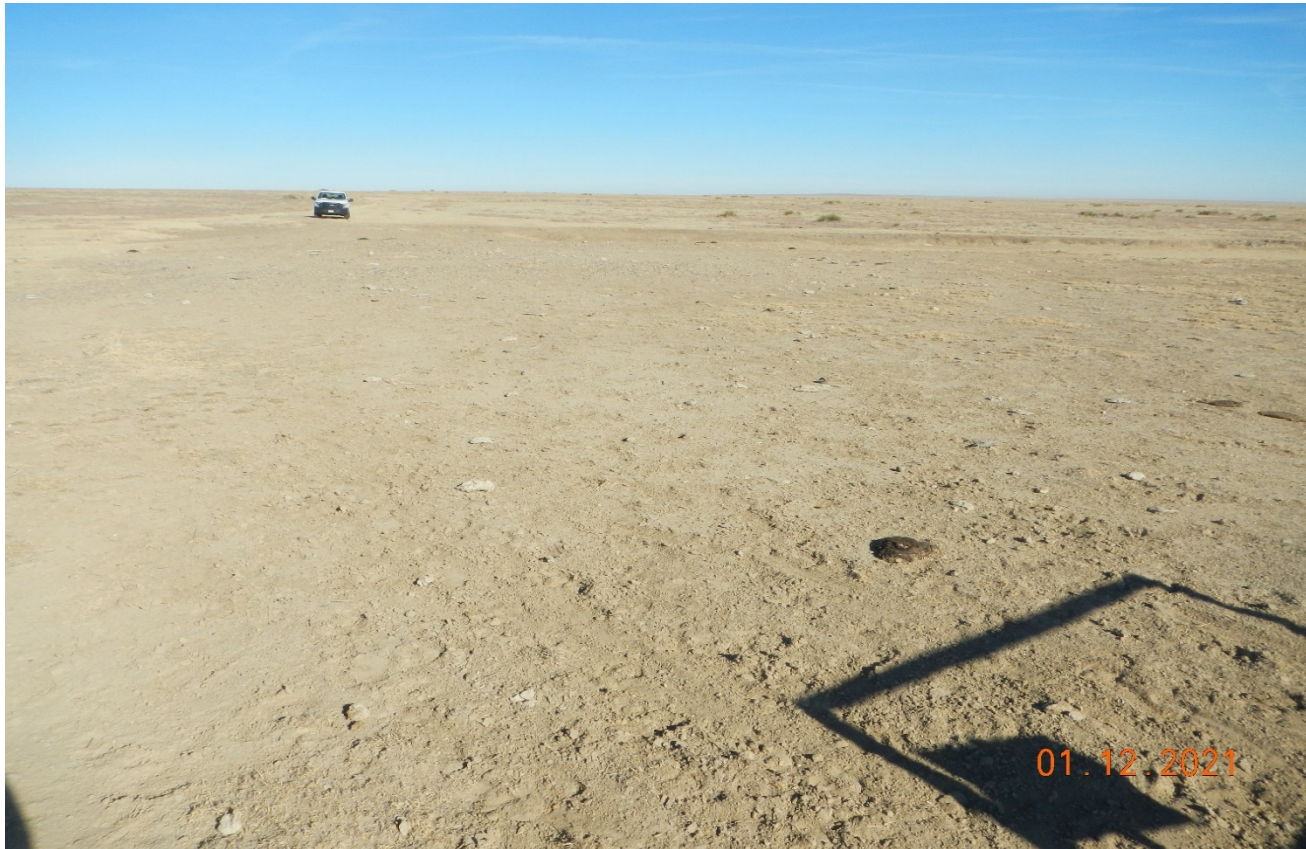
Photo 4. Facing north toward the location. The location is bare of vegetation and has not been reclaimed.

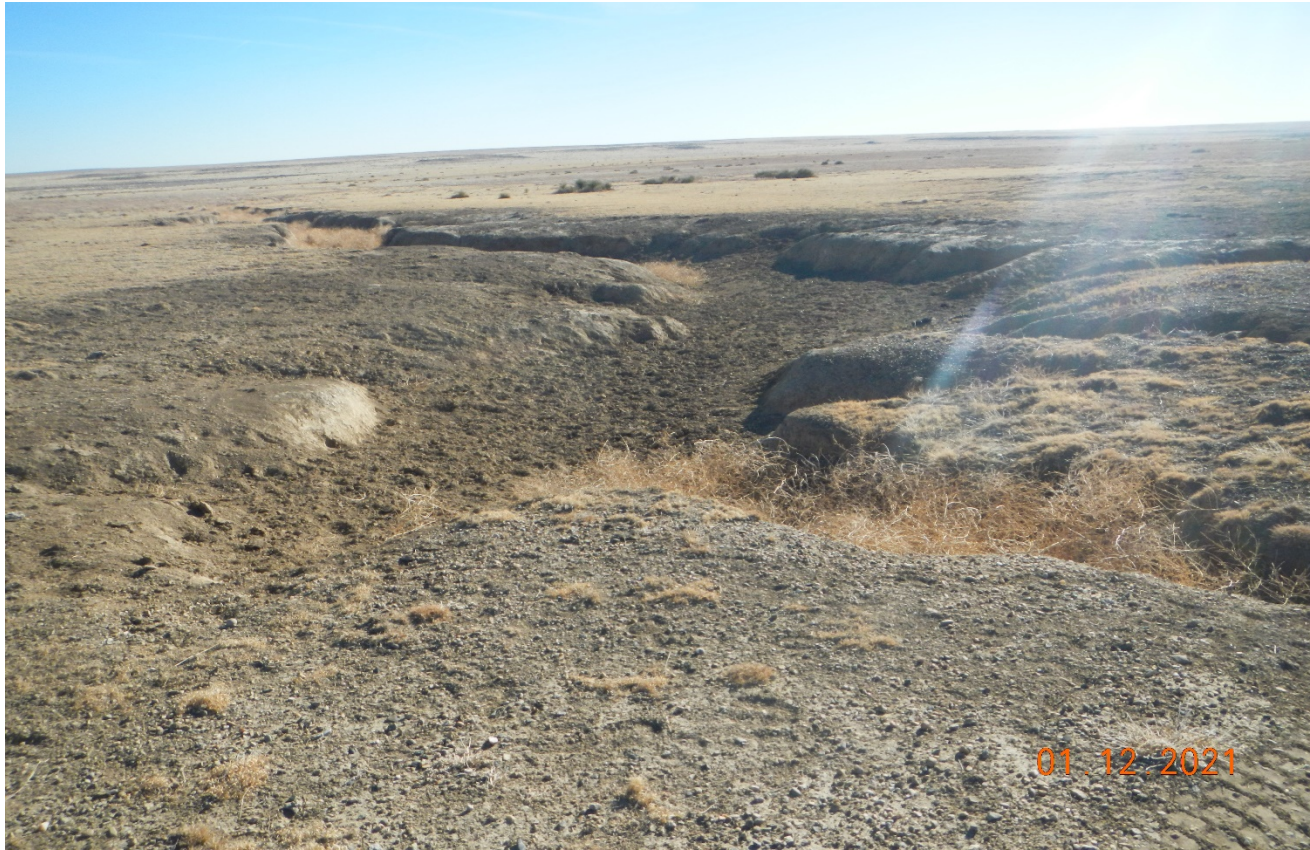
Photo 5. Facing east at the northeast side of the location. This erosion gully extends out into the pasture.
