Inspection Photos

ID: 431431

Operator: STRACHAN EXPLORATION INC

Inspection Date: 1/12/2021

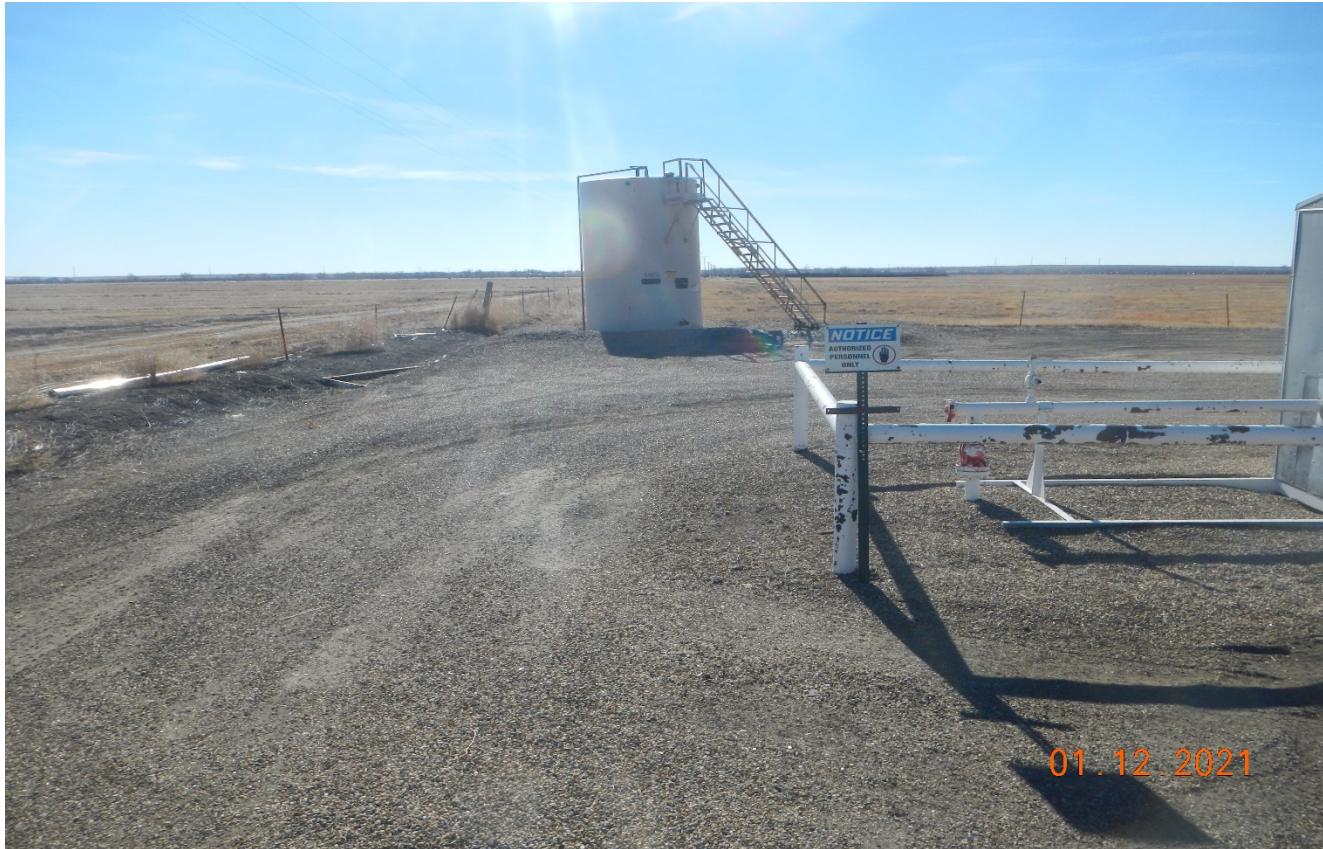
Photo 1. Facing south toward the Prowers Gas Gathering Co Fluid tank. There is no location sign posted per Rule 210.b.

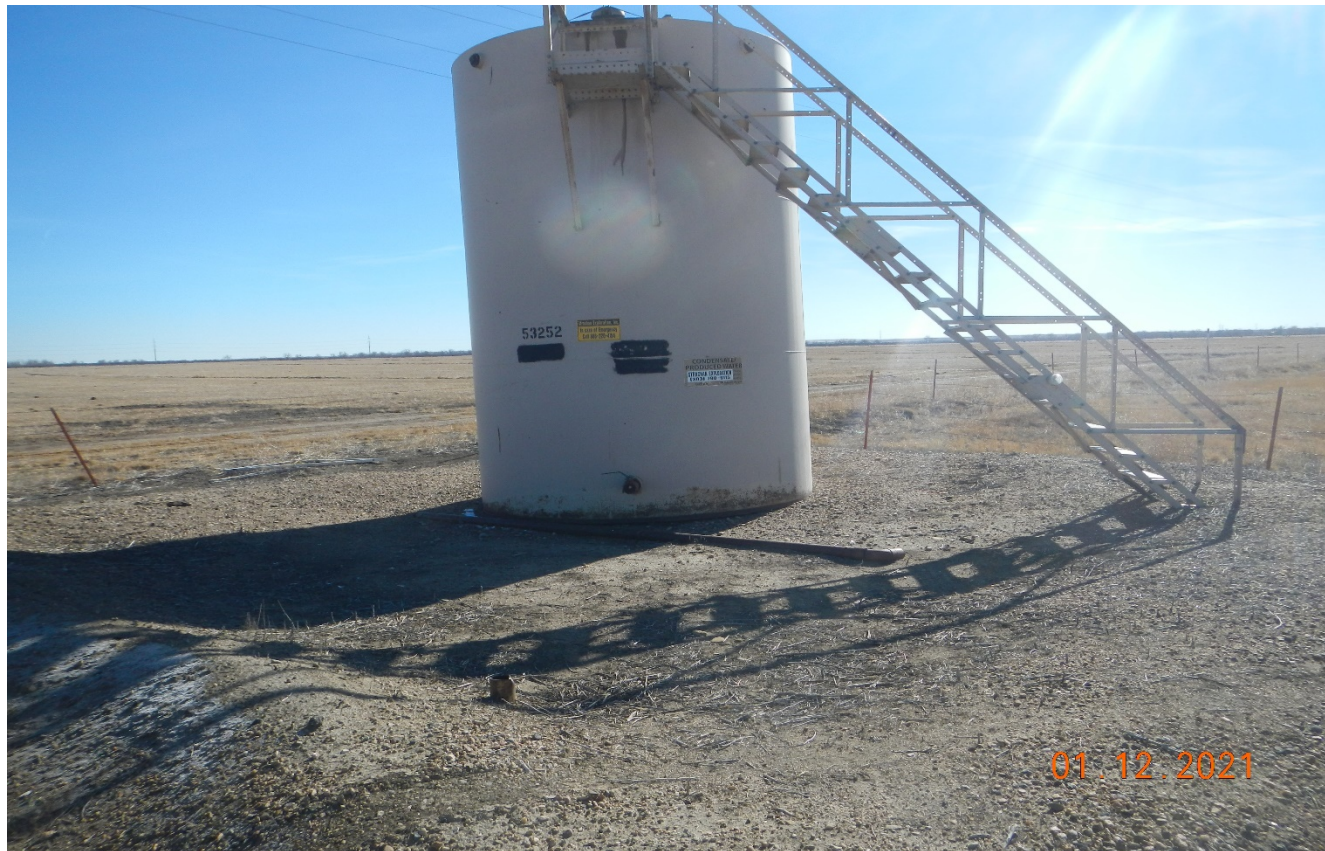
Photo 2. The labeling of the tank is missing information per Rule 210.d.

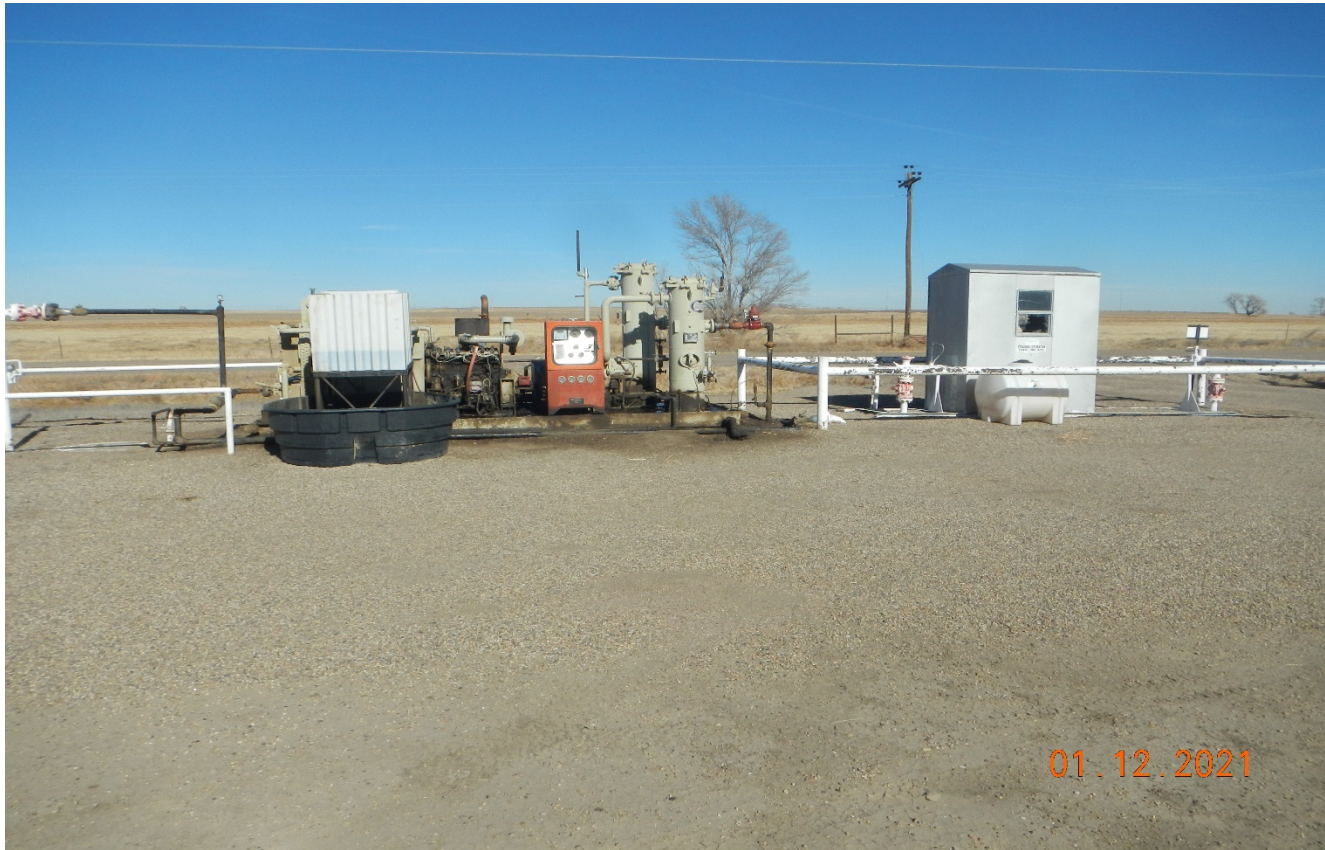
Photo 3. Facing north toward the compressor.

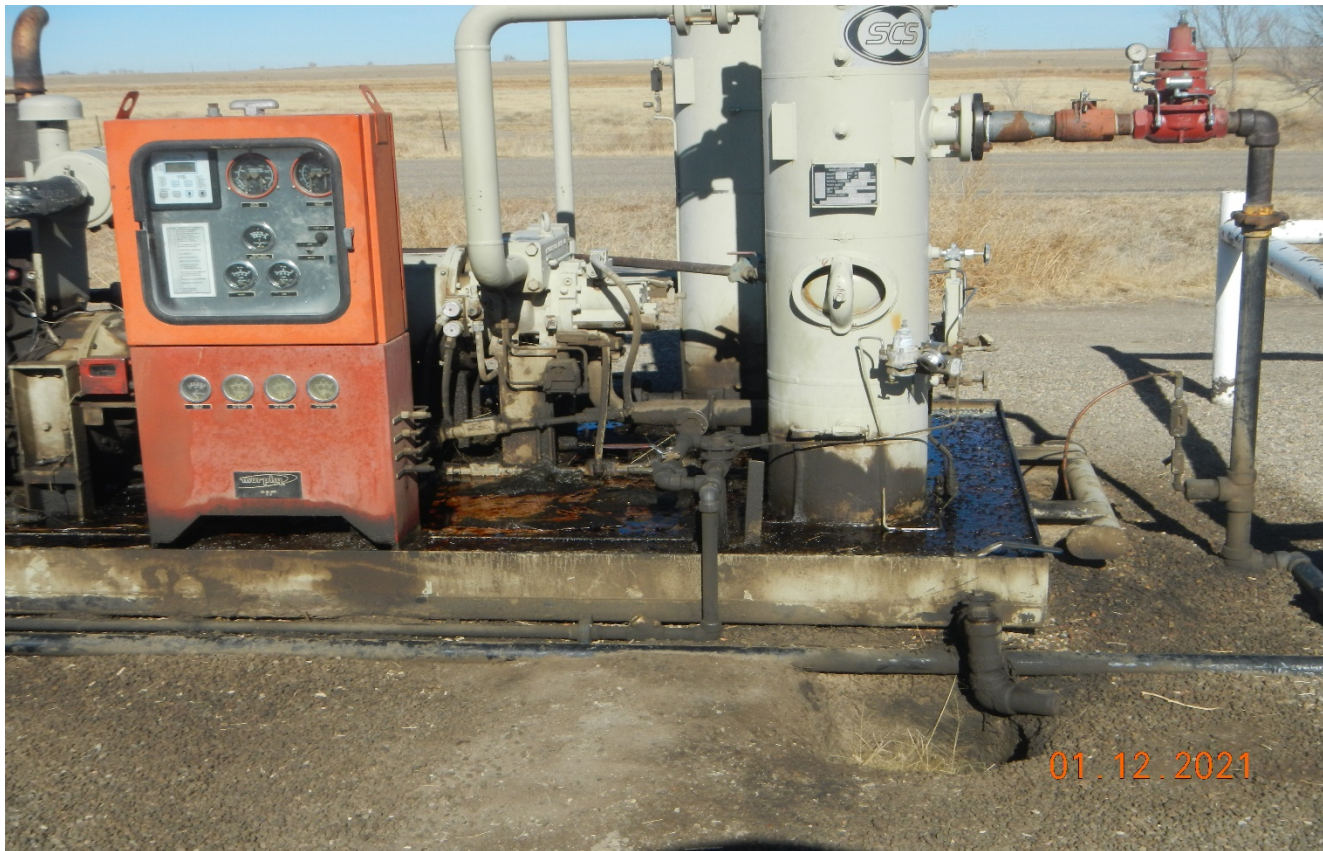
Photo 4. There is oil stained soil around the compressor and on the compressor skid.

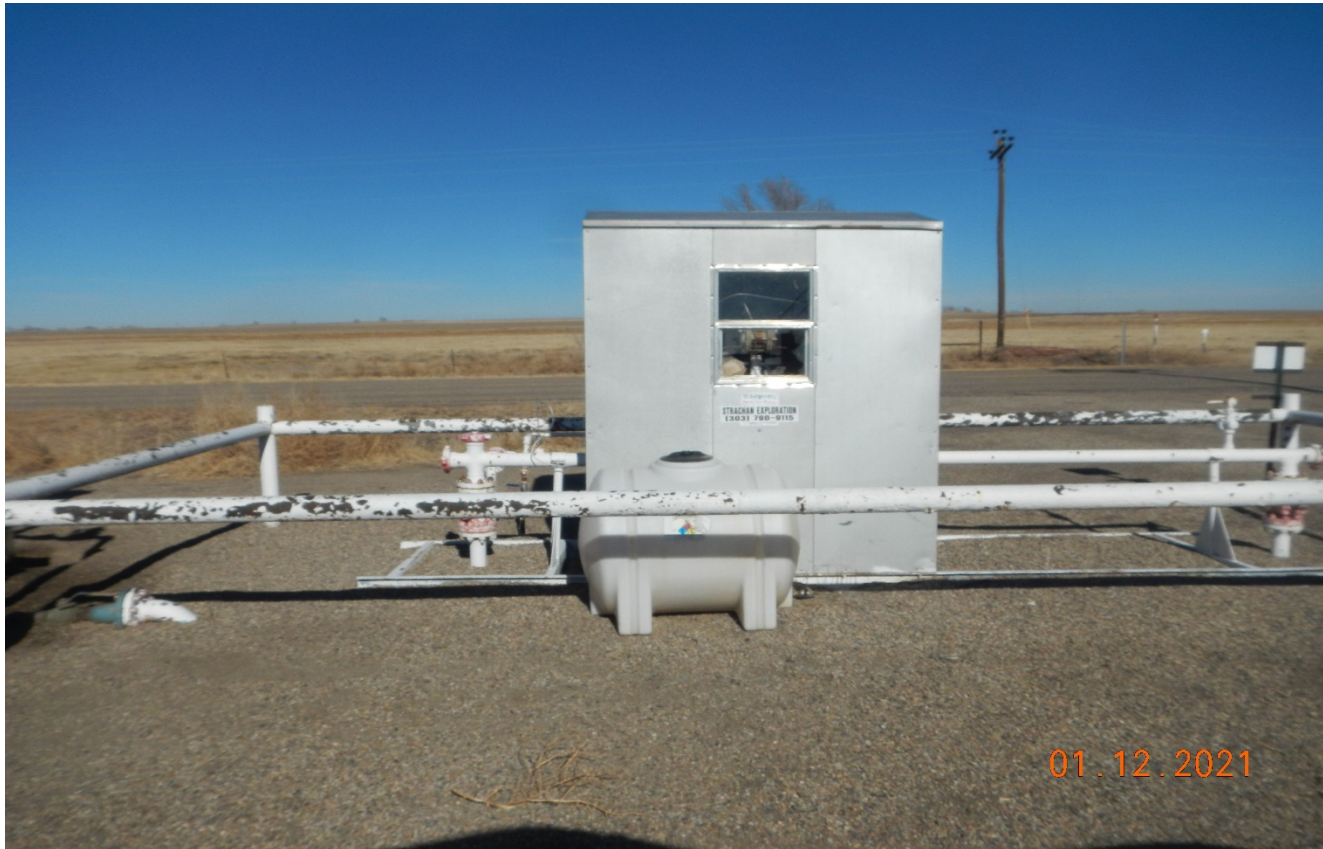
Photo 5. Facing toward meter shed.
