Inspection Photos

API: 099-06215

Operator: BERRY ENERGY INC

Inspection Date: 1/12/2021

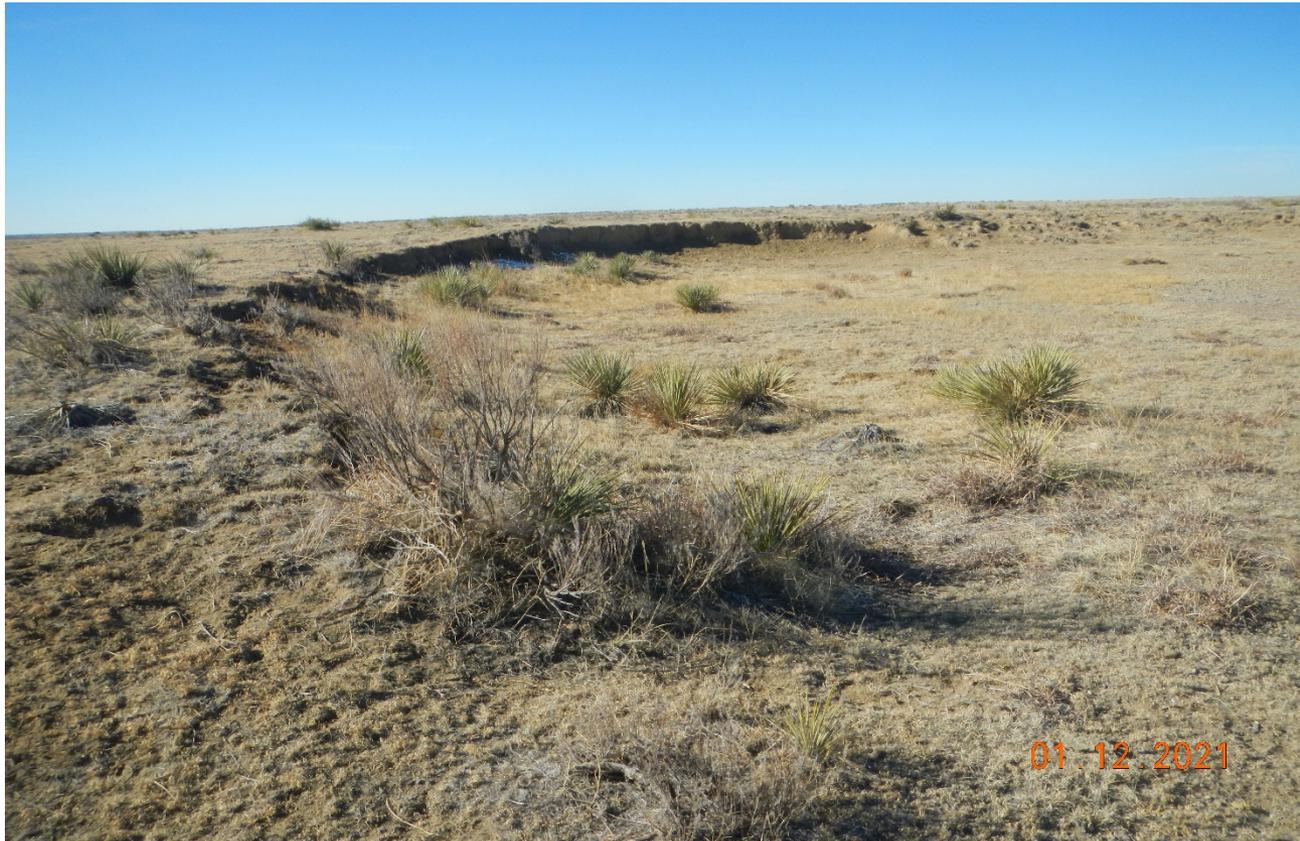
Photo 1. Facing west toward the location. The location has not been recontoured. The cut slope is shown in this photo.

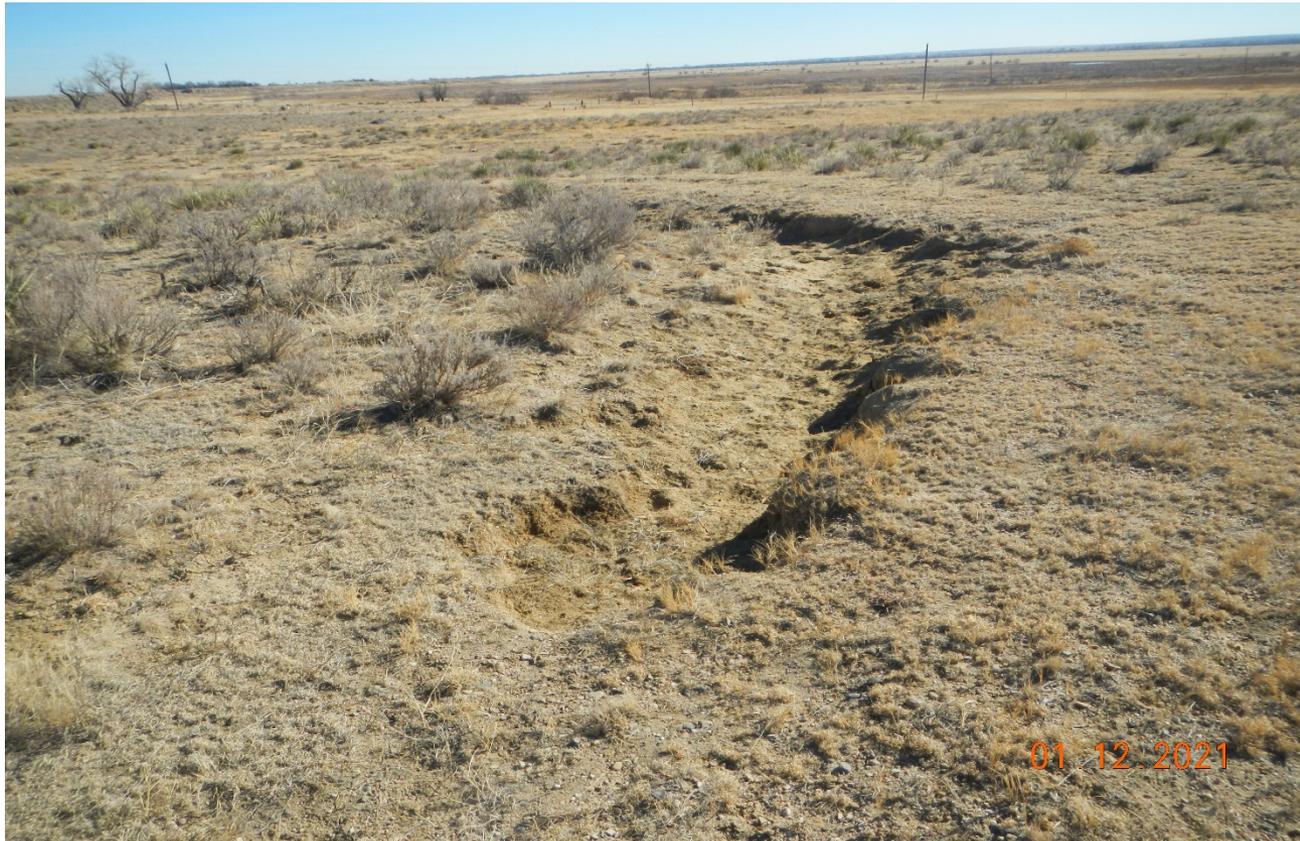
Photo 2. Facing southeast toward the access road. There is erosion gully along the road.

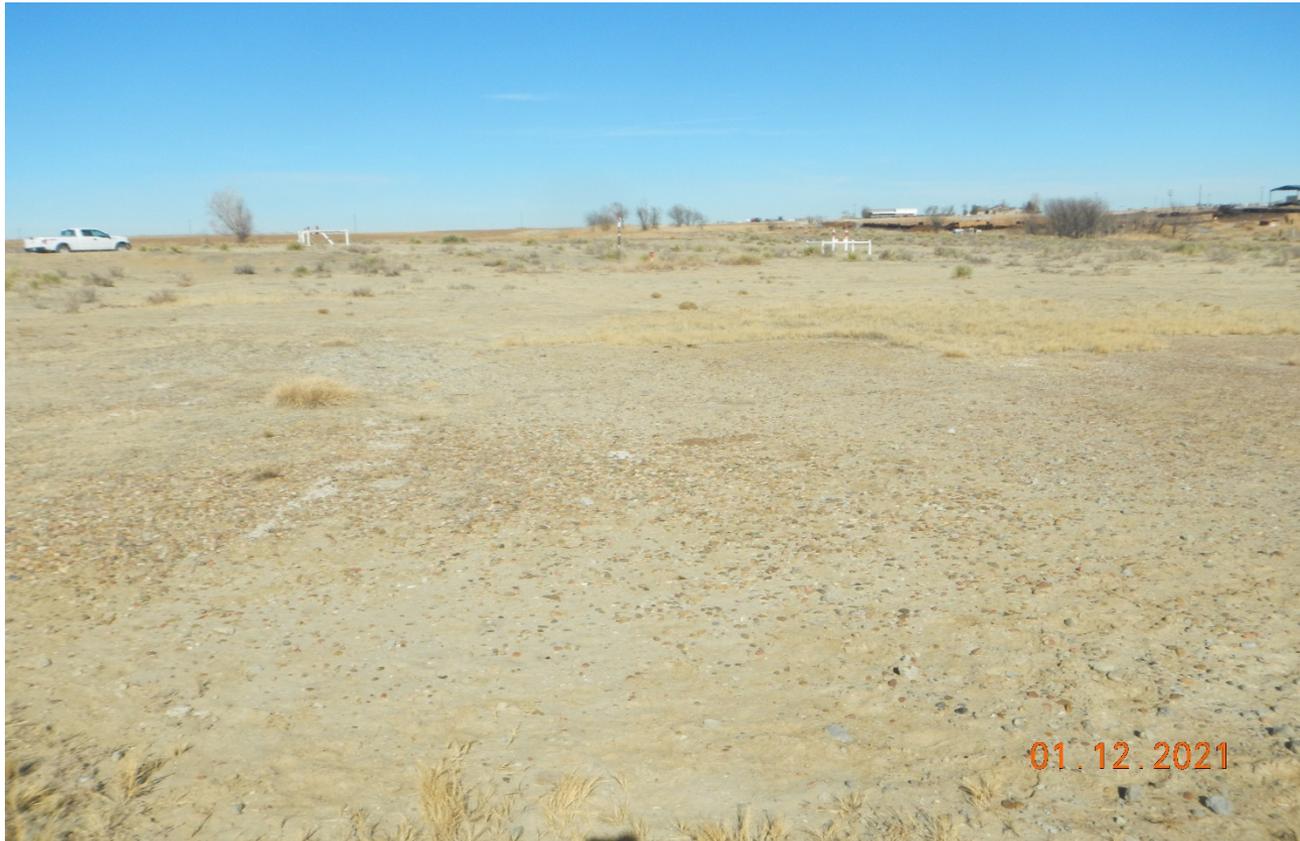
Photo 3. Facing north at the location. This area has no vegetation growth. Soils seem to be compacted in this area.

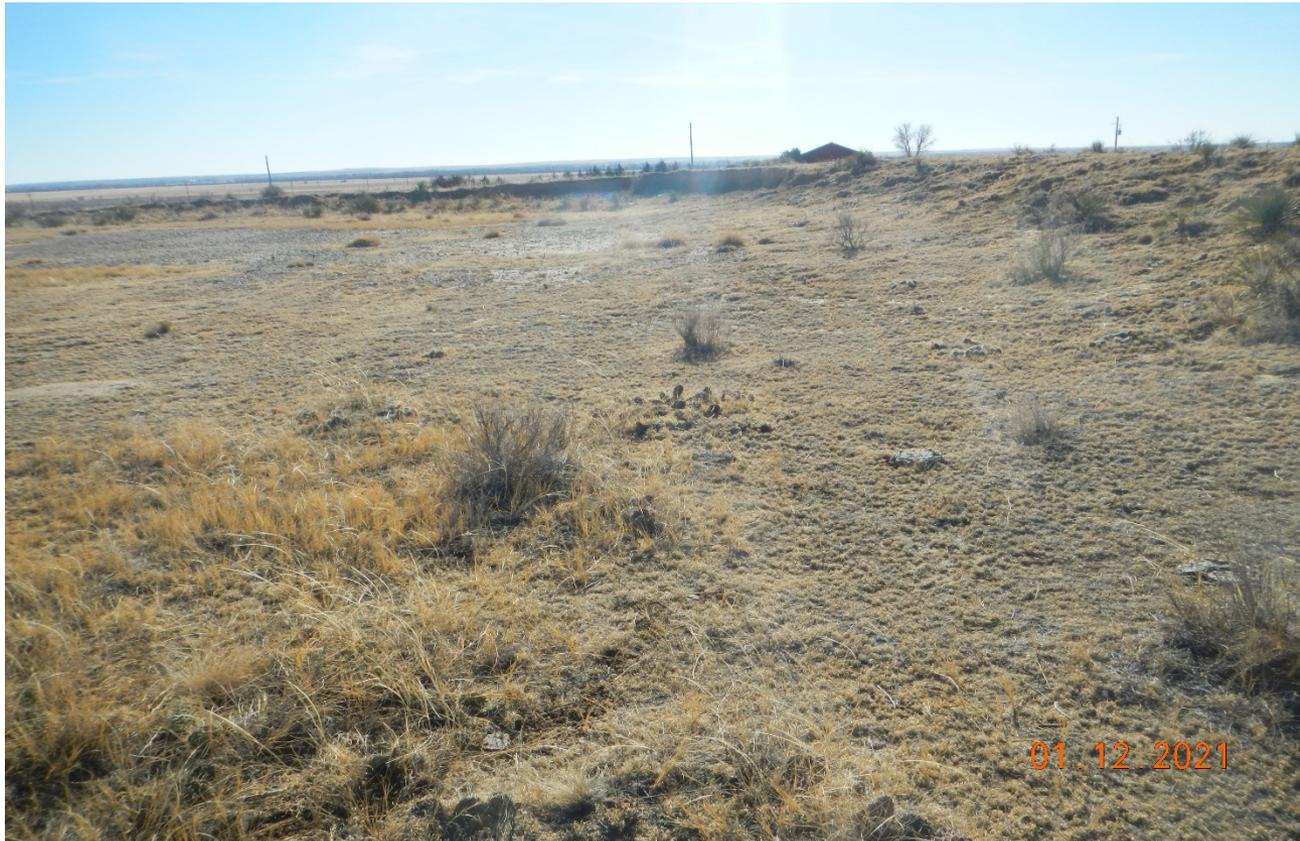
Photo 4. Facing south toward the location.

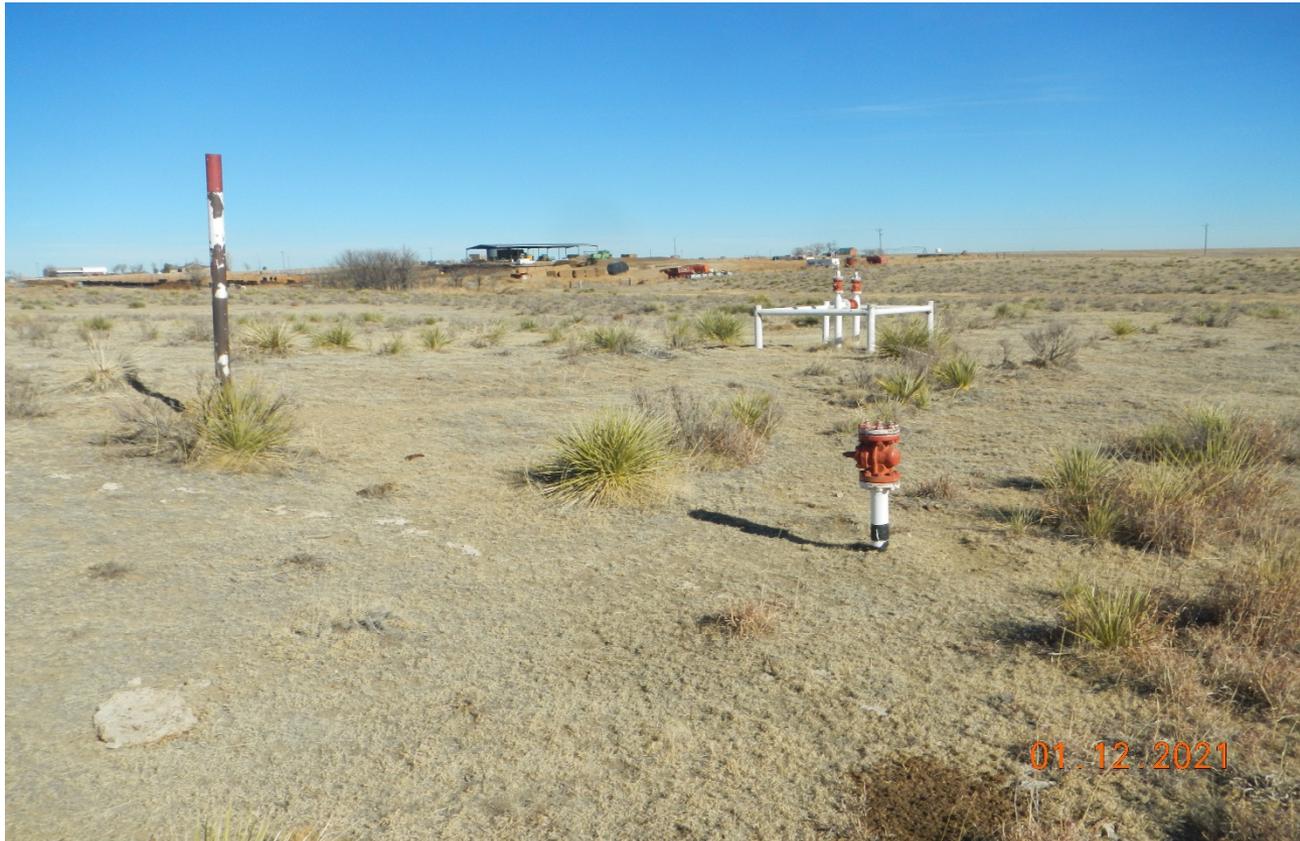
Photo 5. There are pipe risers that remain at the north side of the location.

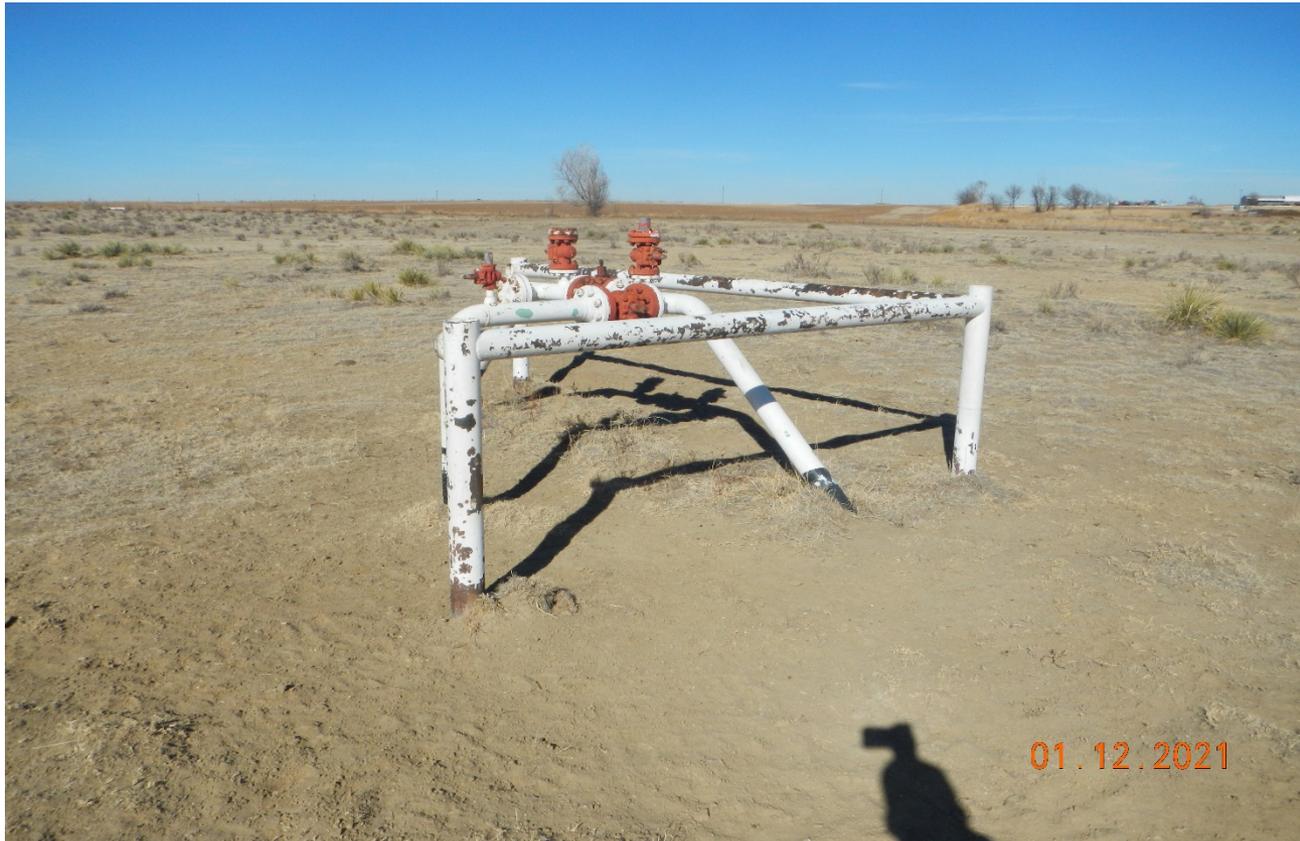
Photo 6. This pipe riser remains at the northwest side of the location.
