Inspection Photos
Operator: Simcoe
API: 067-05226
Date: 1/11/2021

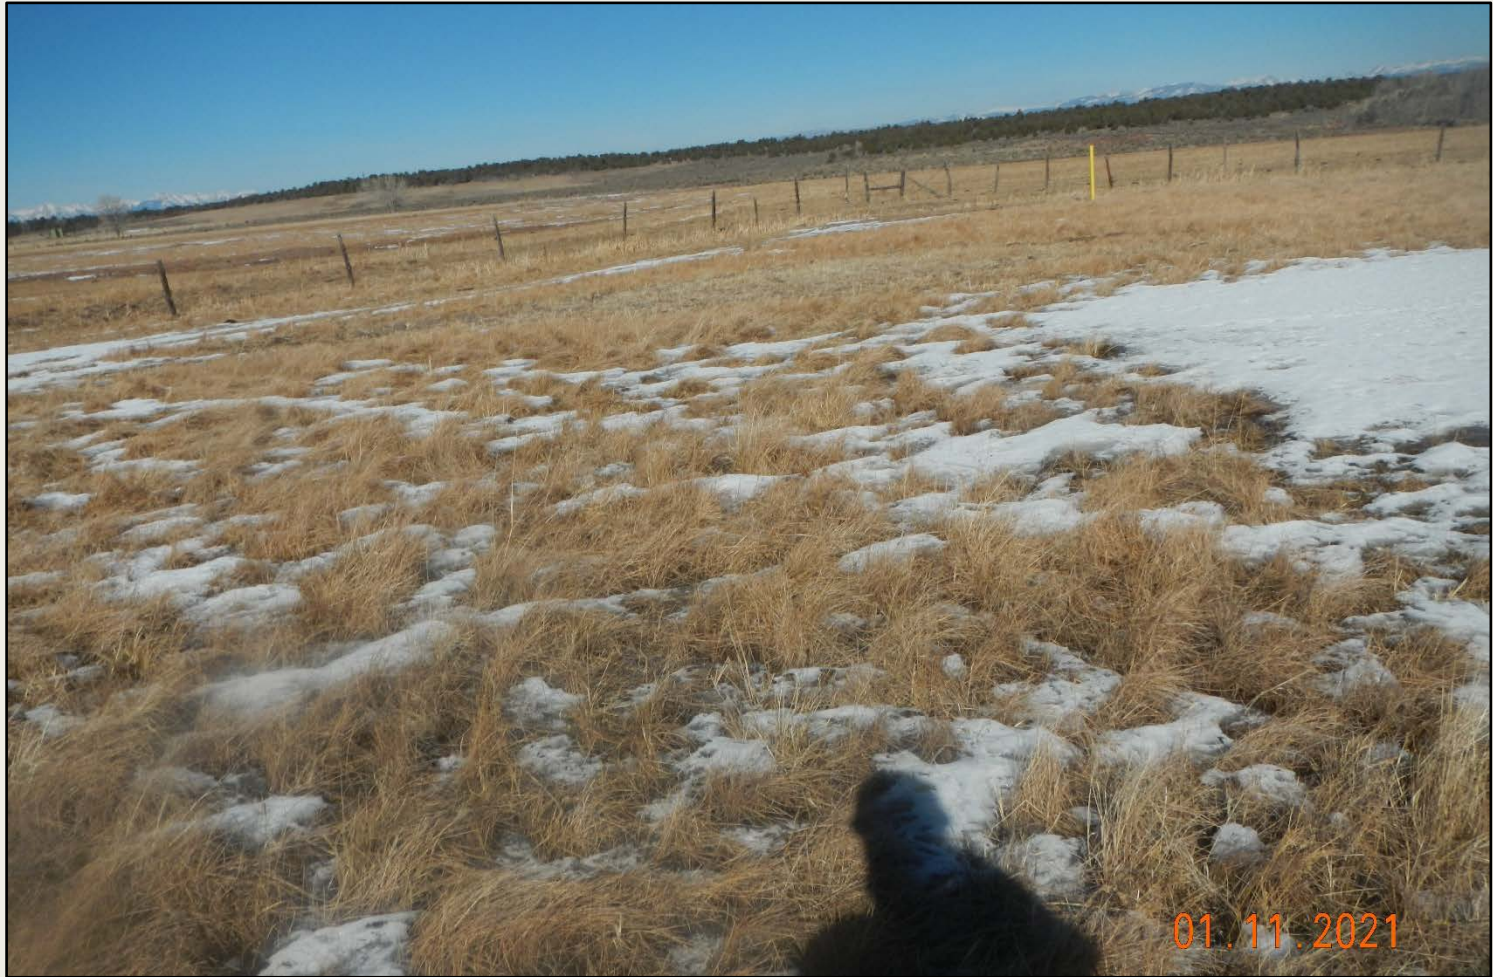
Photo 1. View of the plugged well and reclaimed project area facing northward. Plugged well marker is yellow.

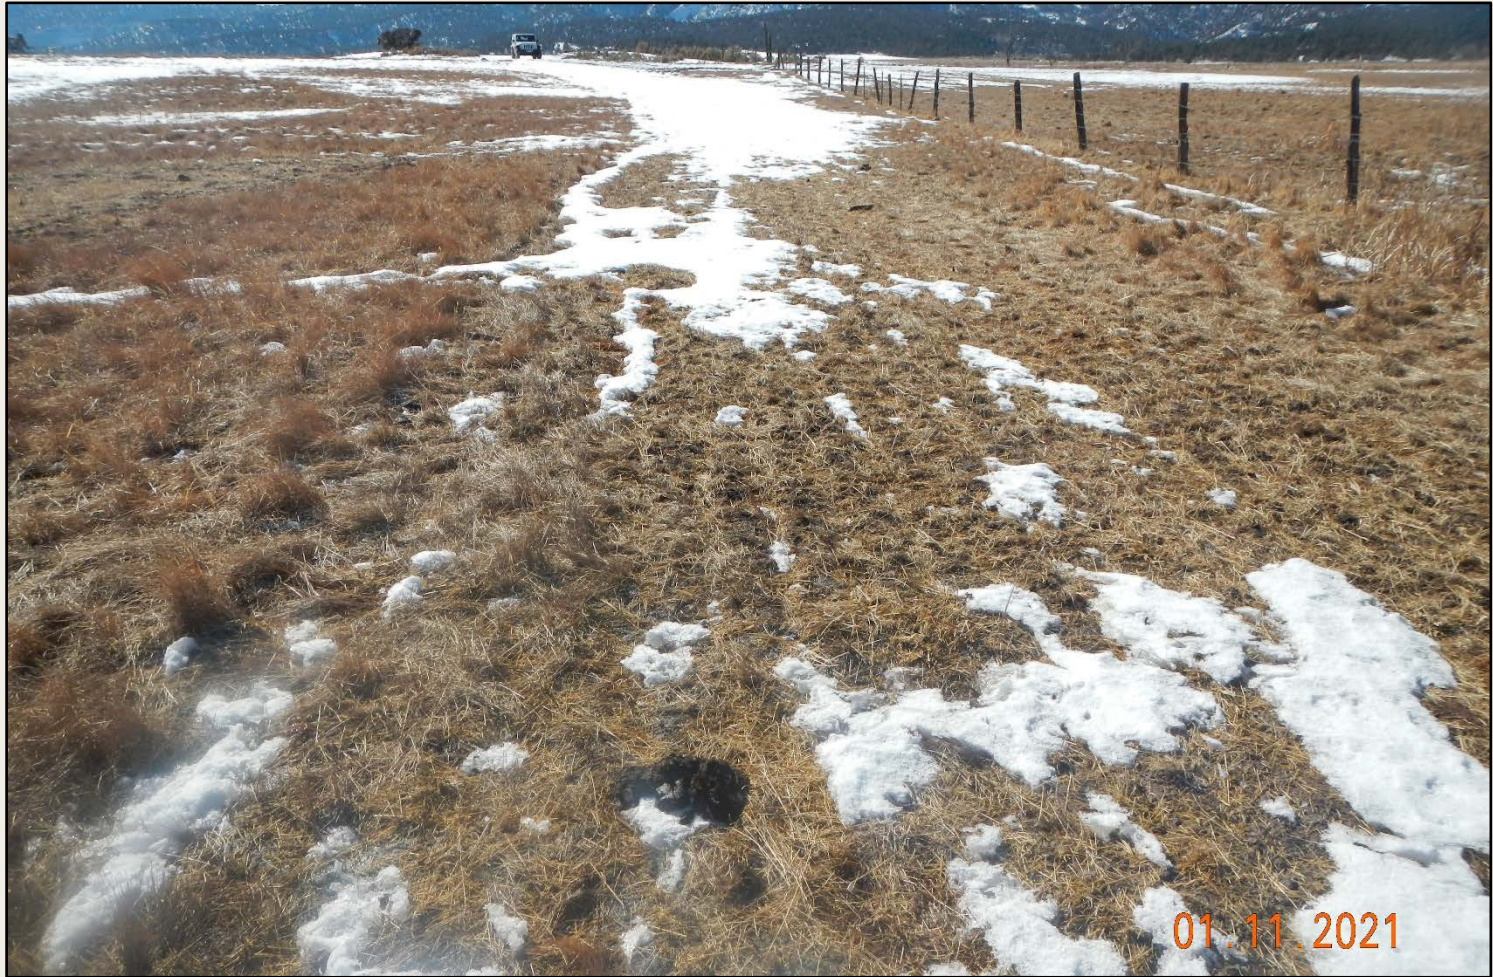
Photo 2. View of seeding along the access road facing southward. Drill rows are visible.

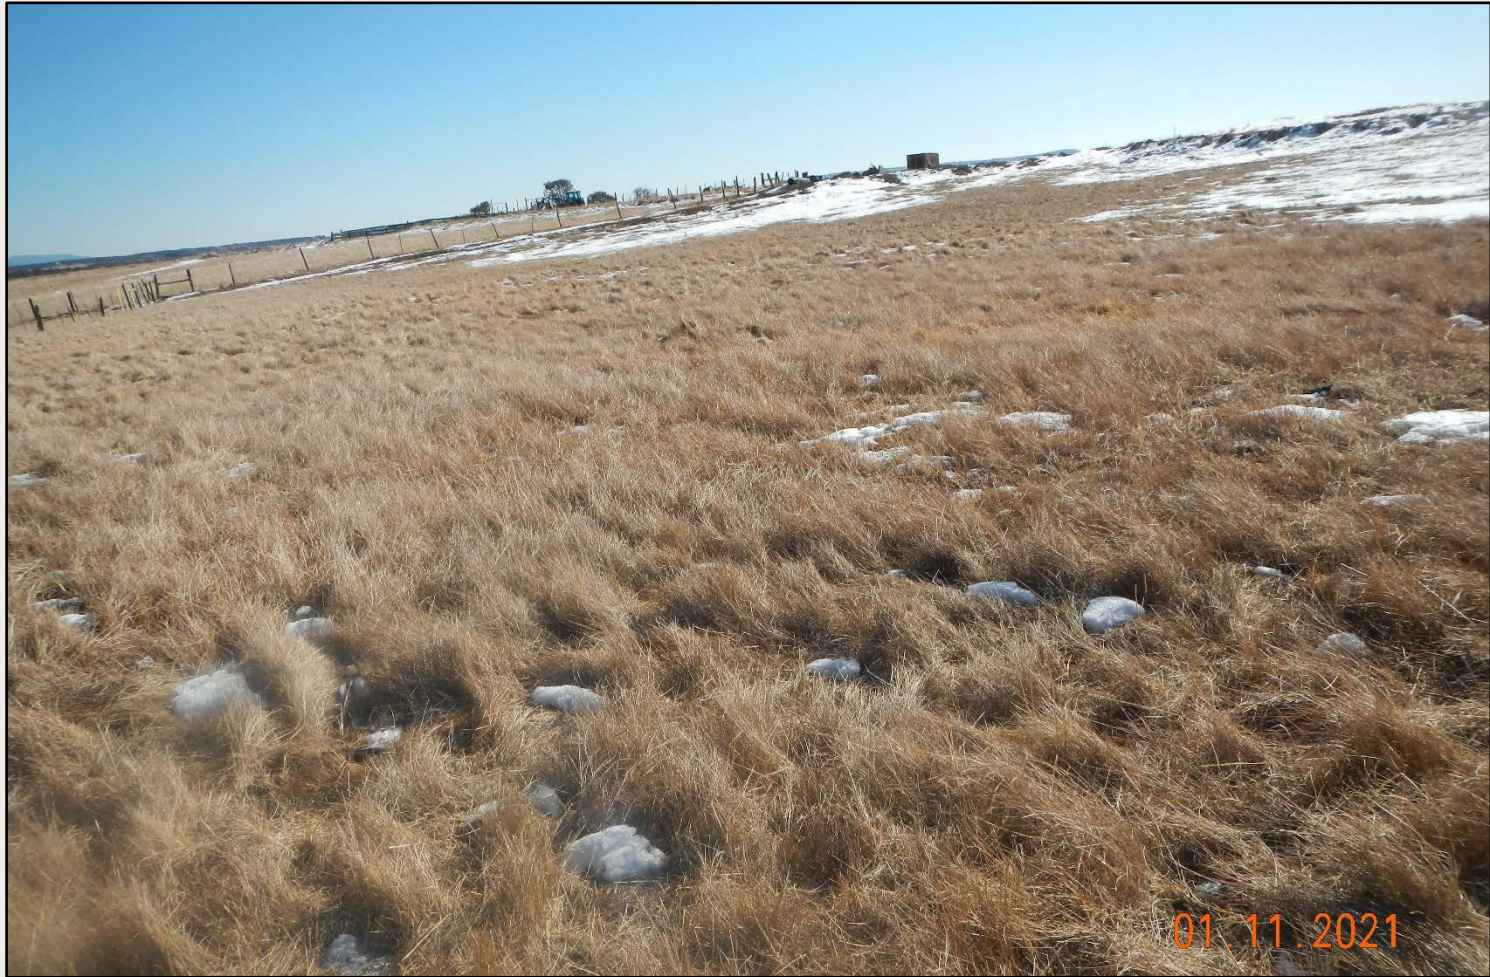
Photo 3. View of the southern project area facing eastward. Vegetation is well established. Partial snow covering present.

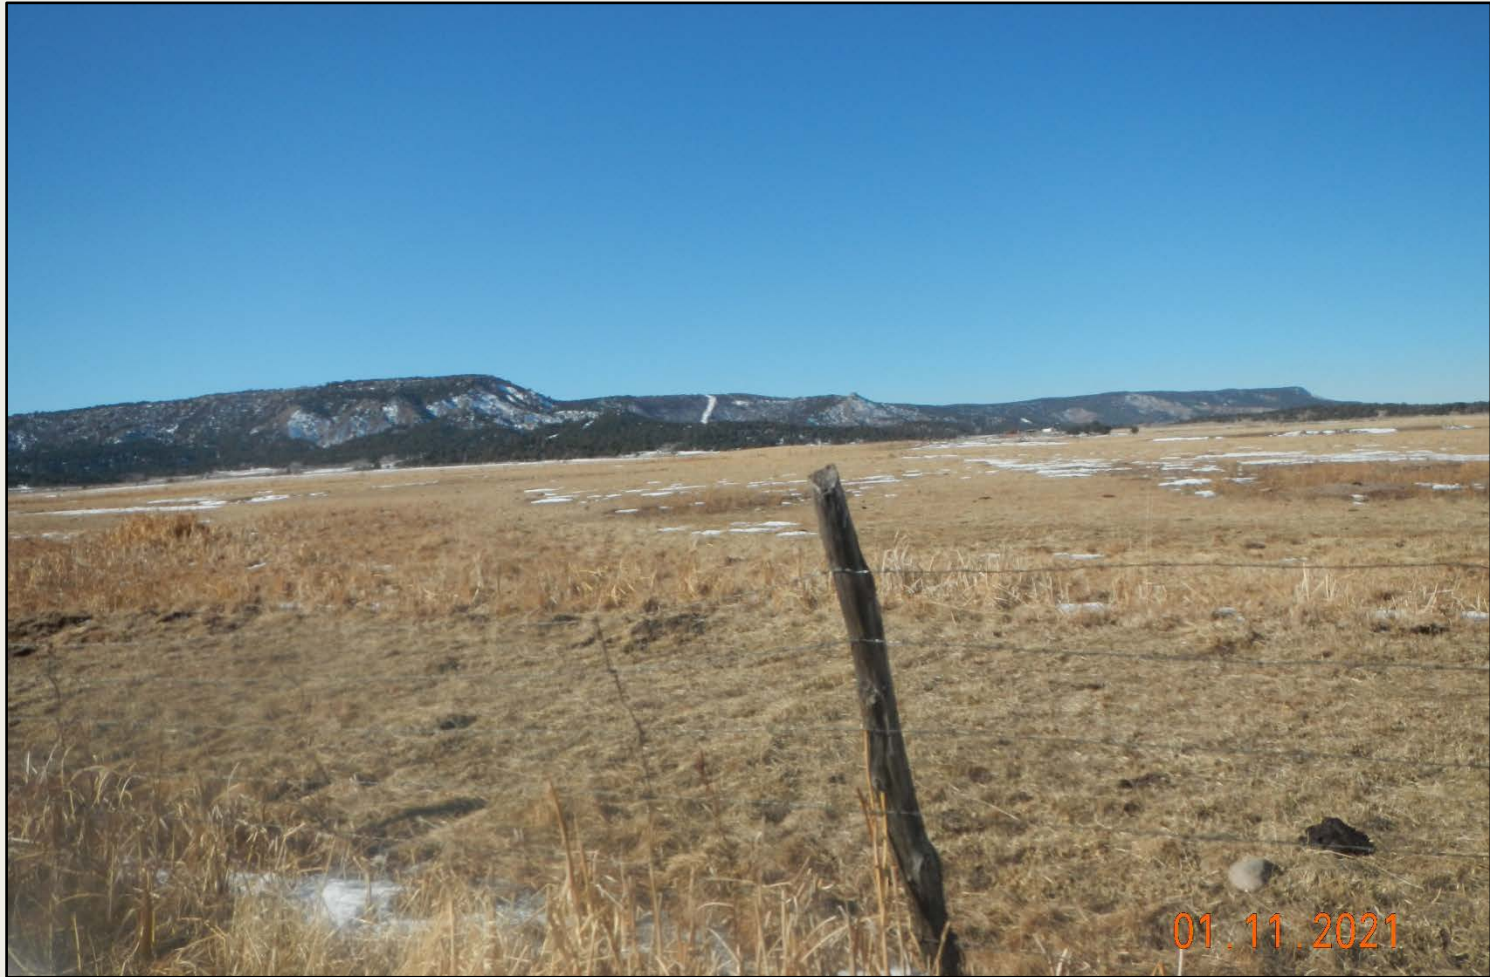
Photo 4. View of reference area comprised of irrigated grass field with Baltic rush, Timothy, and other irrigated grasses.
