Inspection Photos

API: 099-06150

Operator: BERRY ENERGY INC

Inspection Date: 1/12/2021

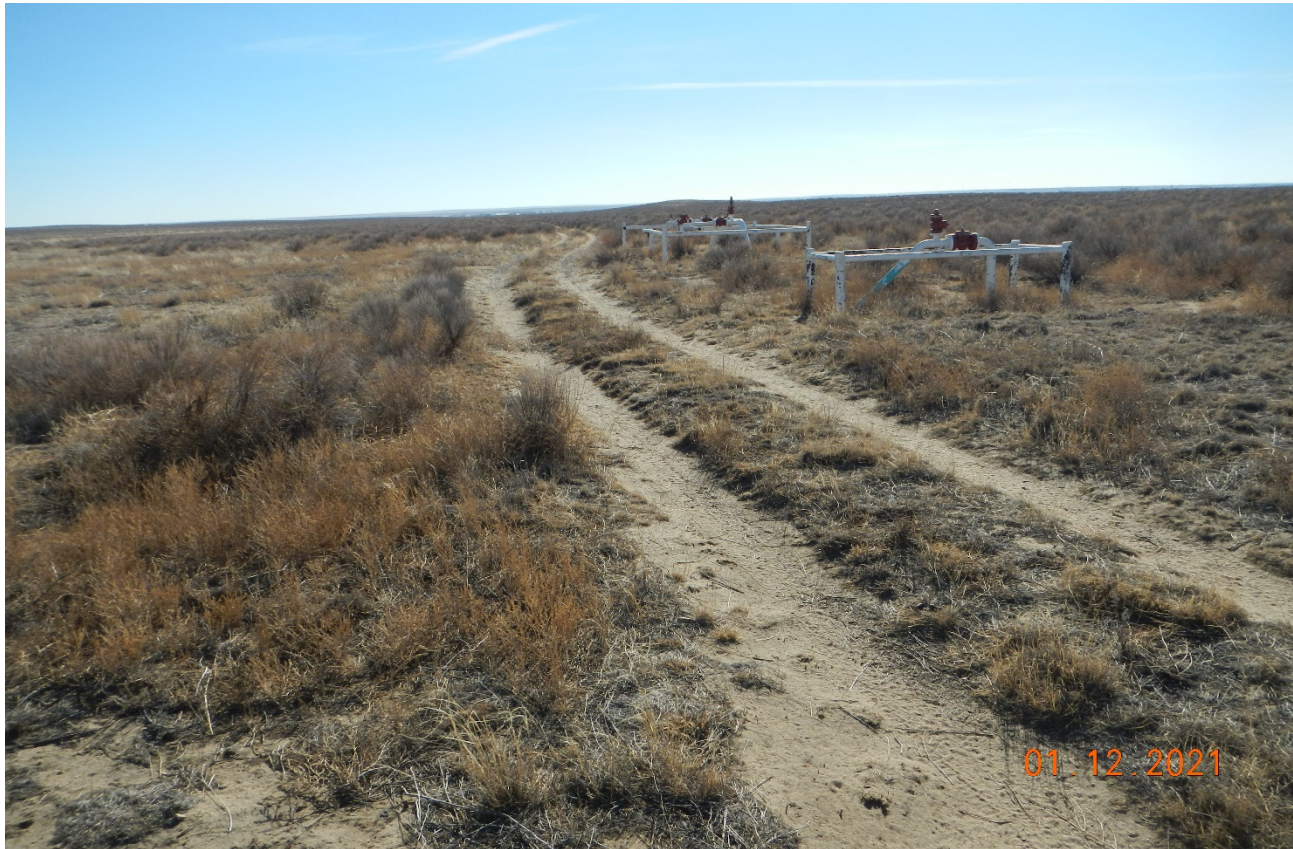
Photo 1. Facing south toward the location. The access road continues thru the location. There are pipe risers that remain at the west side of the location.

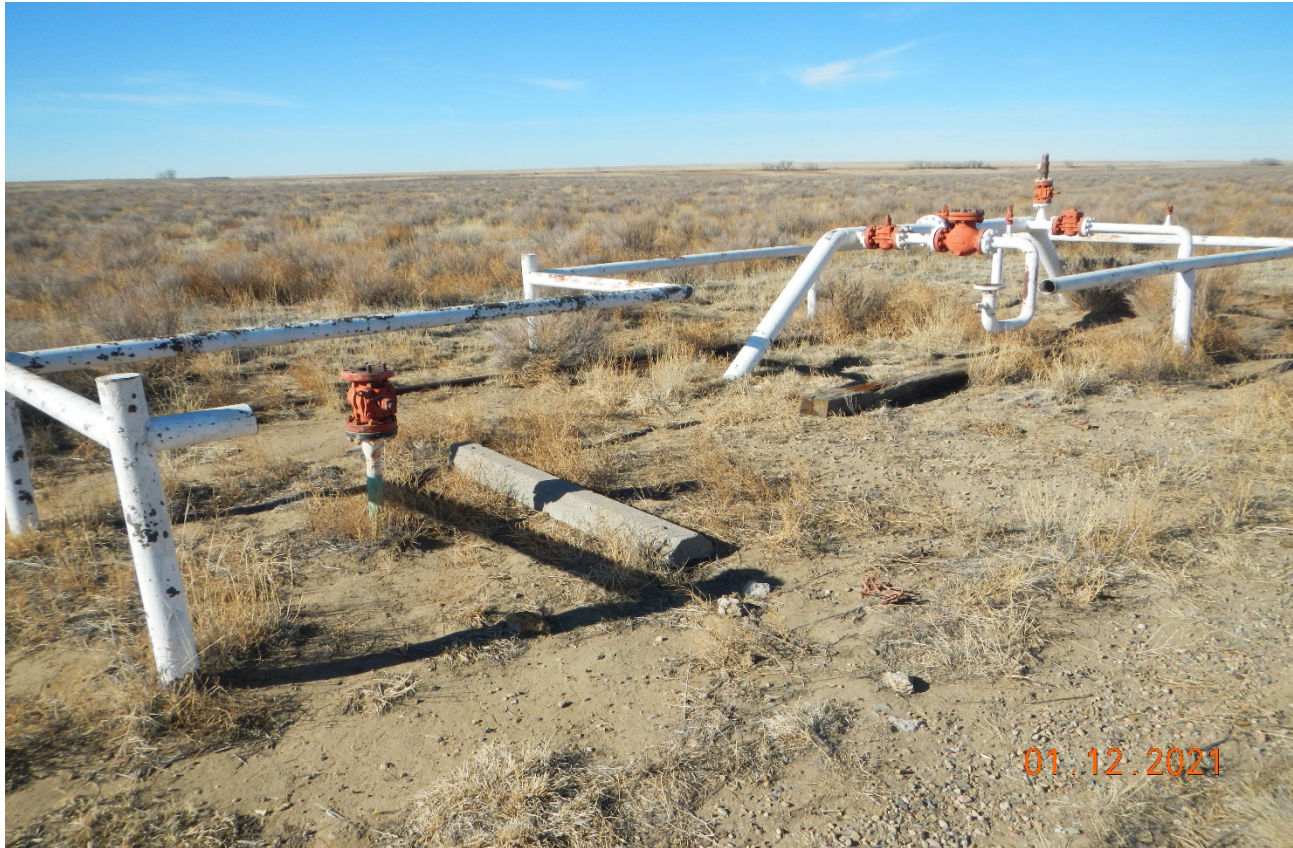
Photo 2. Pipe risers have not been removed at the west side of the location.

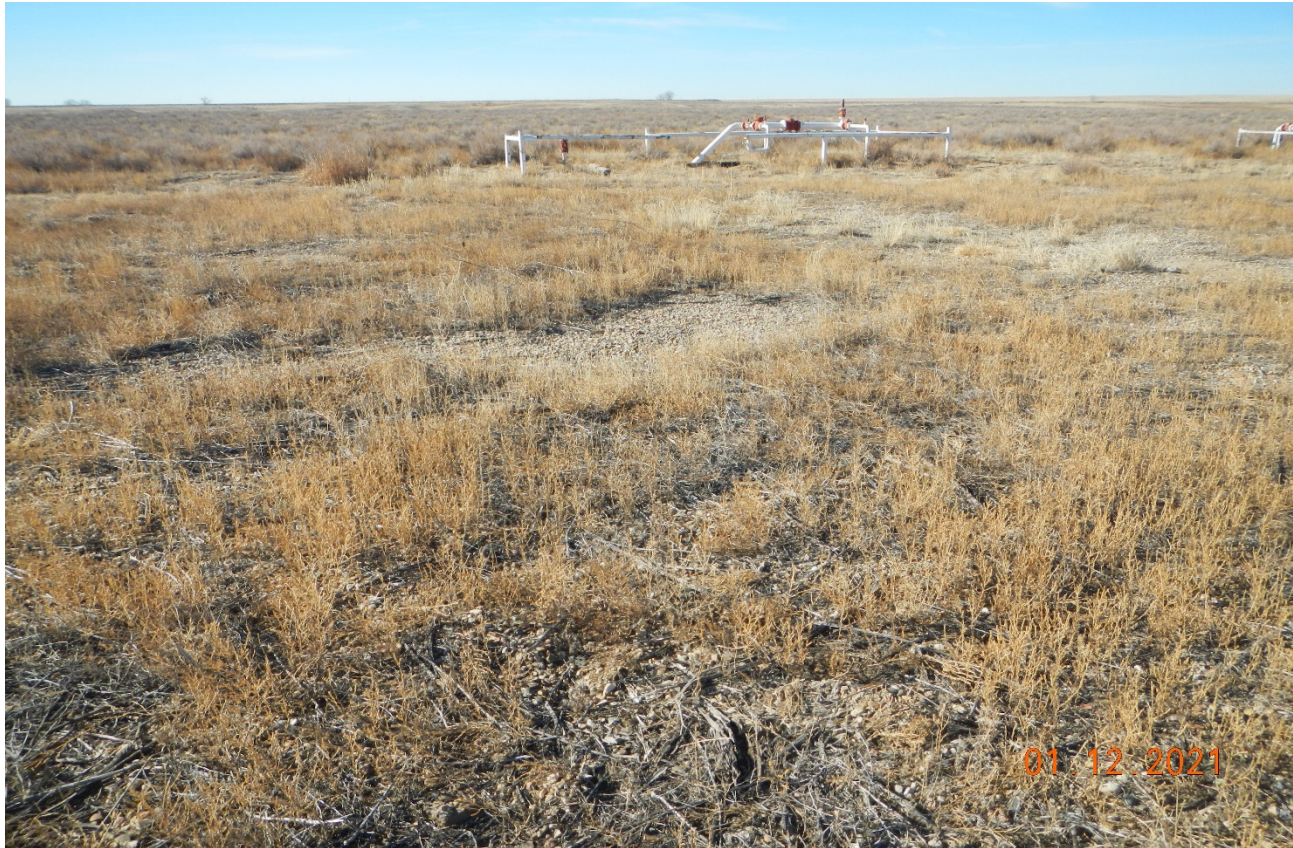
Photo 4. Facing west toward the location. This area has not been reclaimed. Gravel remains and there are undesirable weeds.

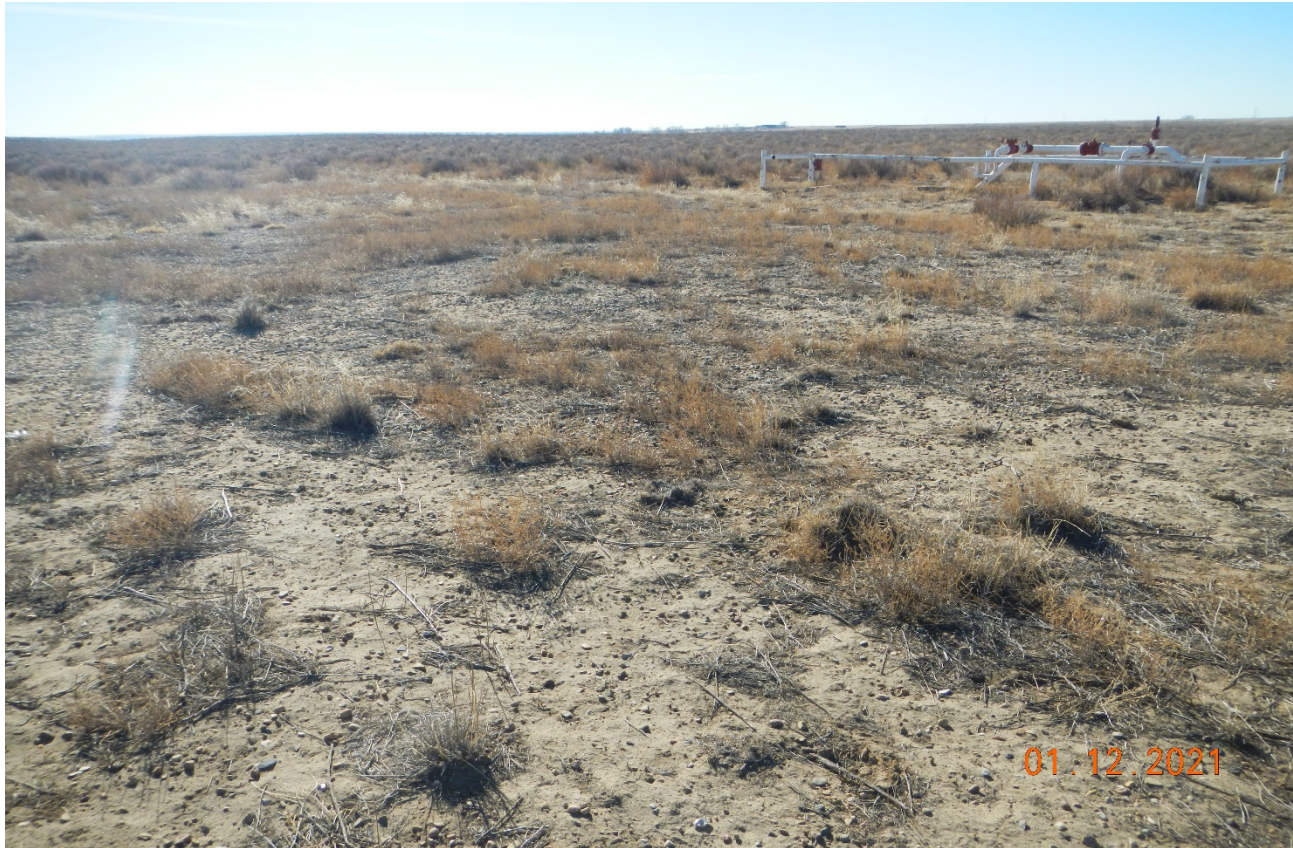
Photo 4. Facing southwest. The location has not re-established vegetation cover.

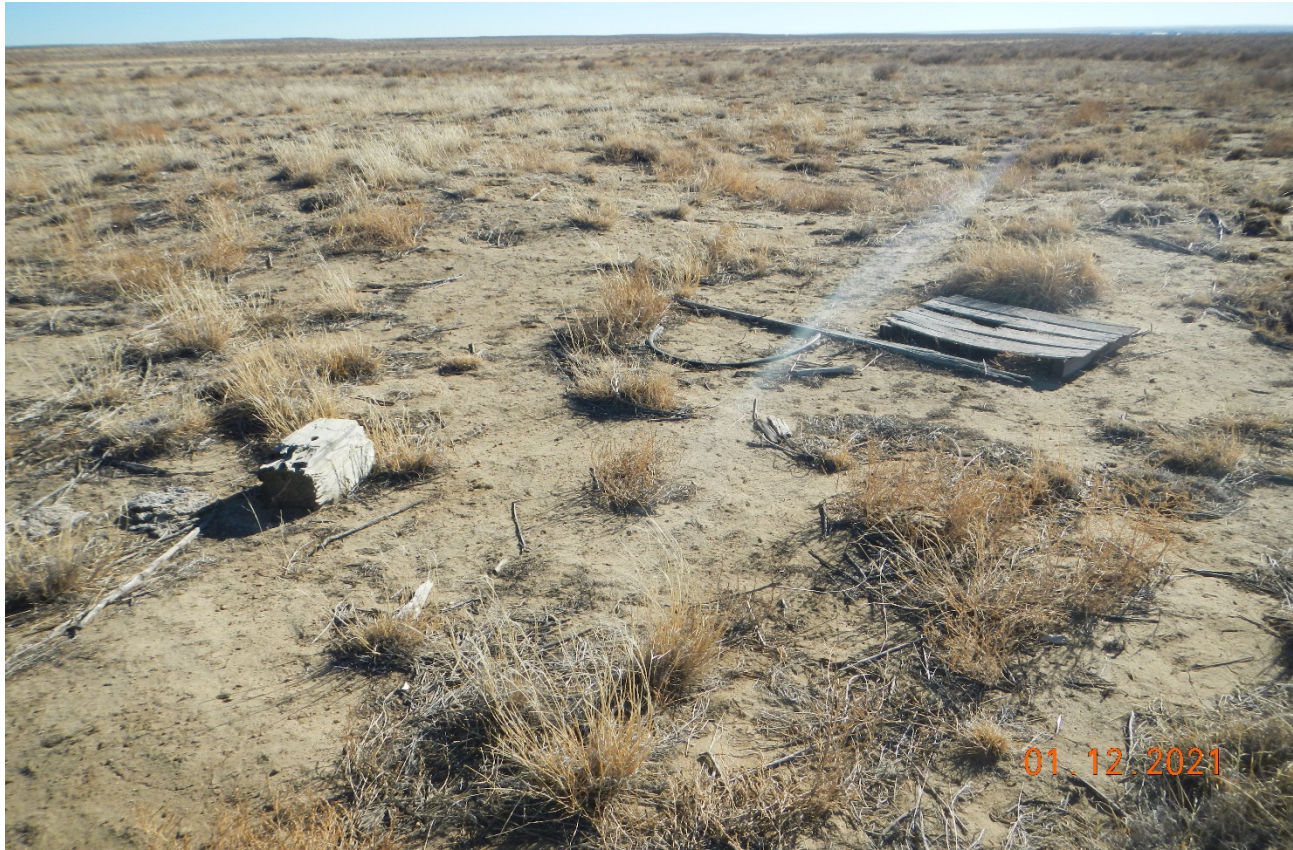
Photo 5. Facing north west at the northern side of the location. There is a pipe riser shown at red arrow.

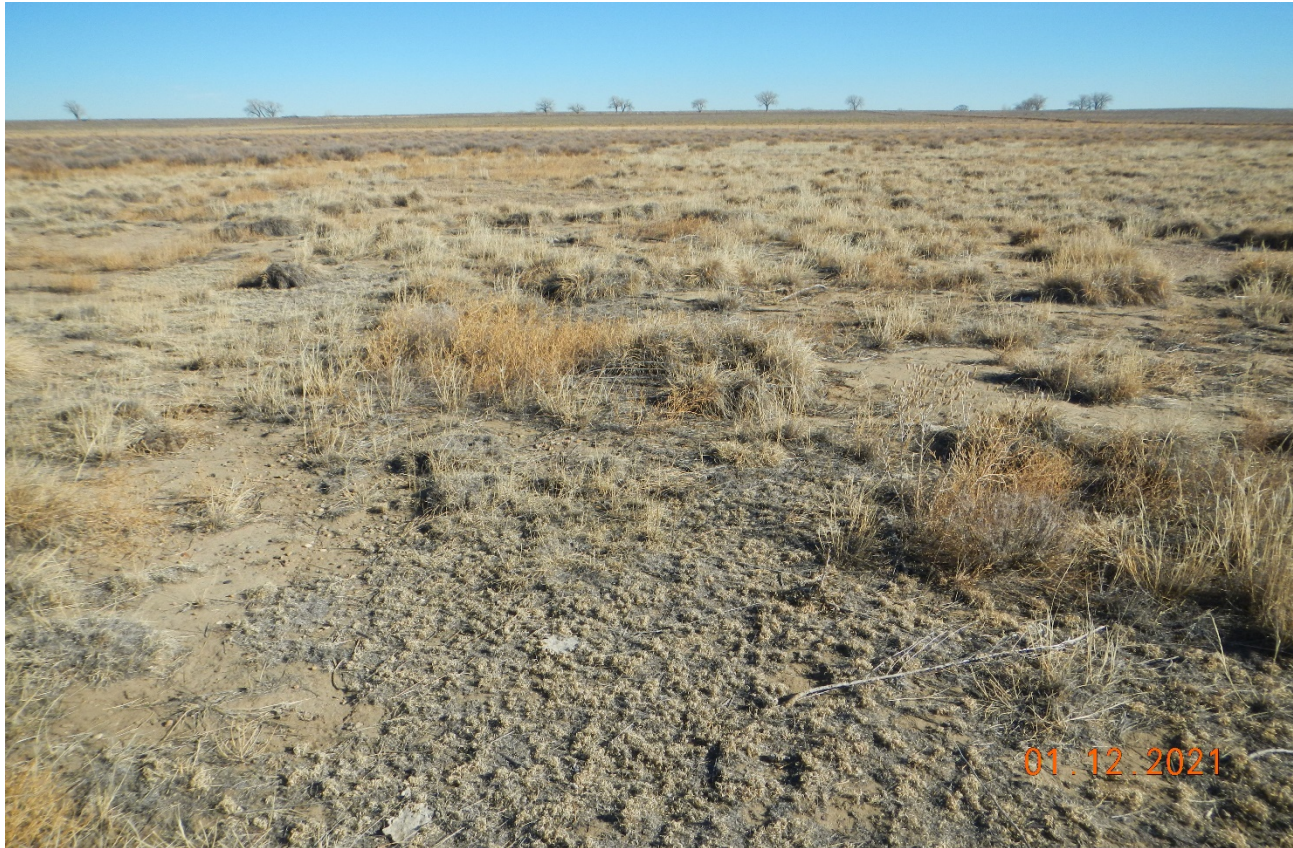
Photo 6. Facing east toward the surrounding undisturbed reference area.
