Inspection Photos
Operator: Enduring
API: 067-08502
Date: 1/14/2021

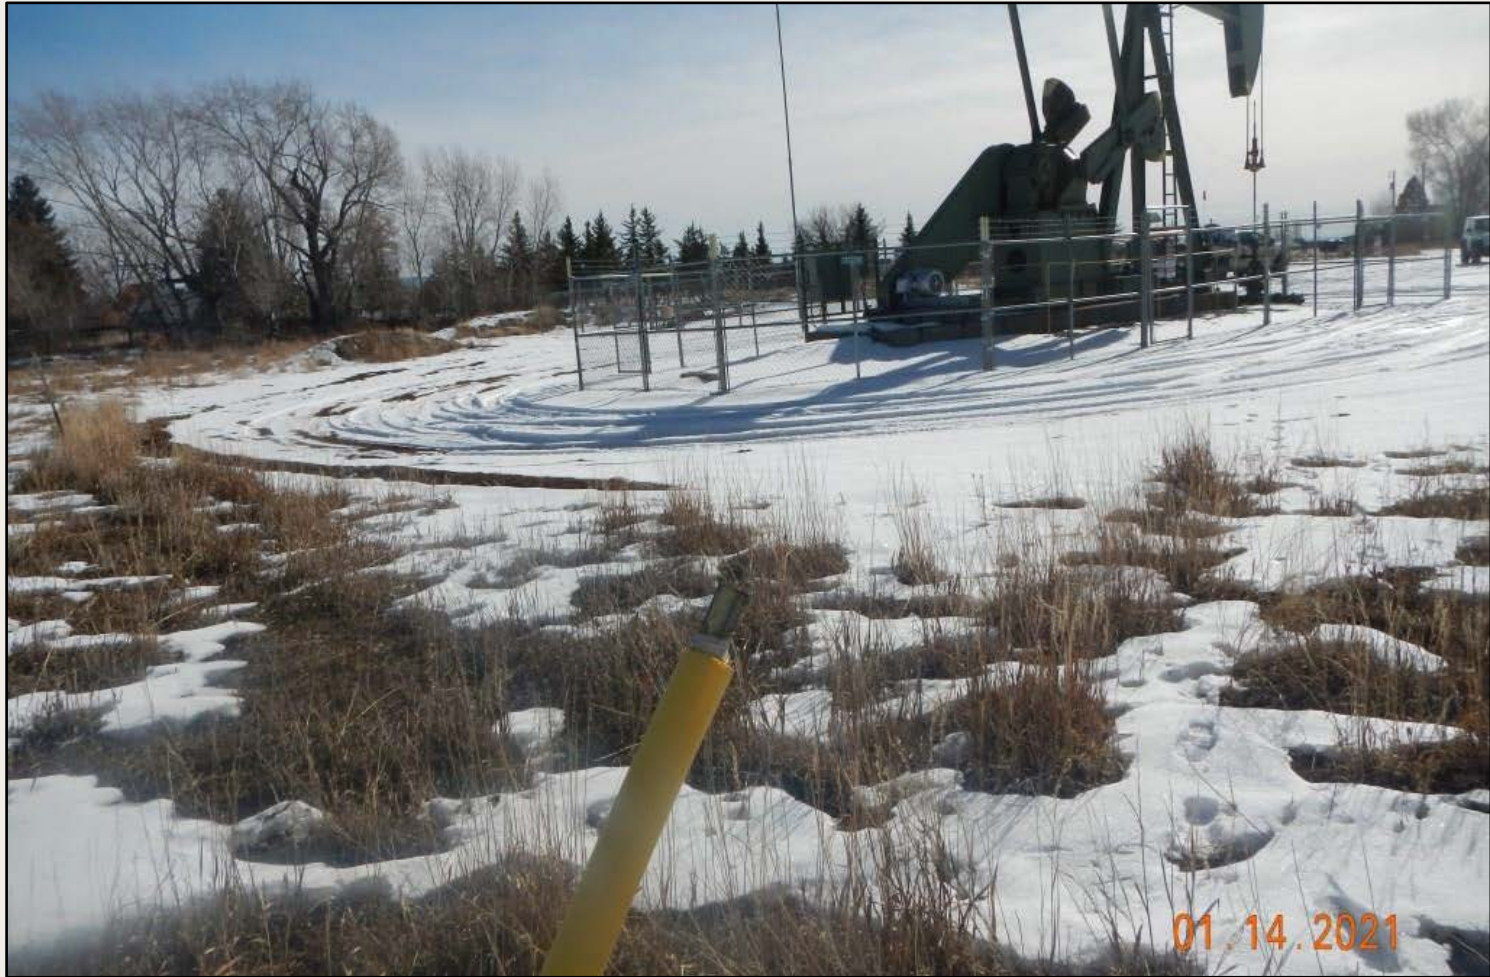
Photo 1. View of the project area from the northwestern corner facing center.

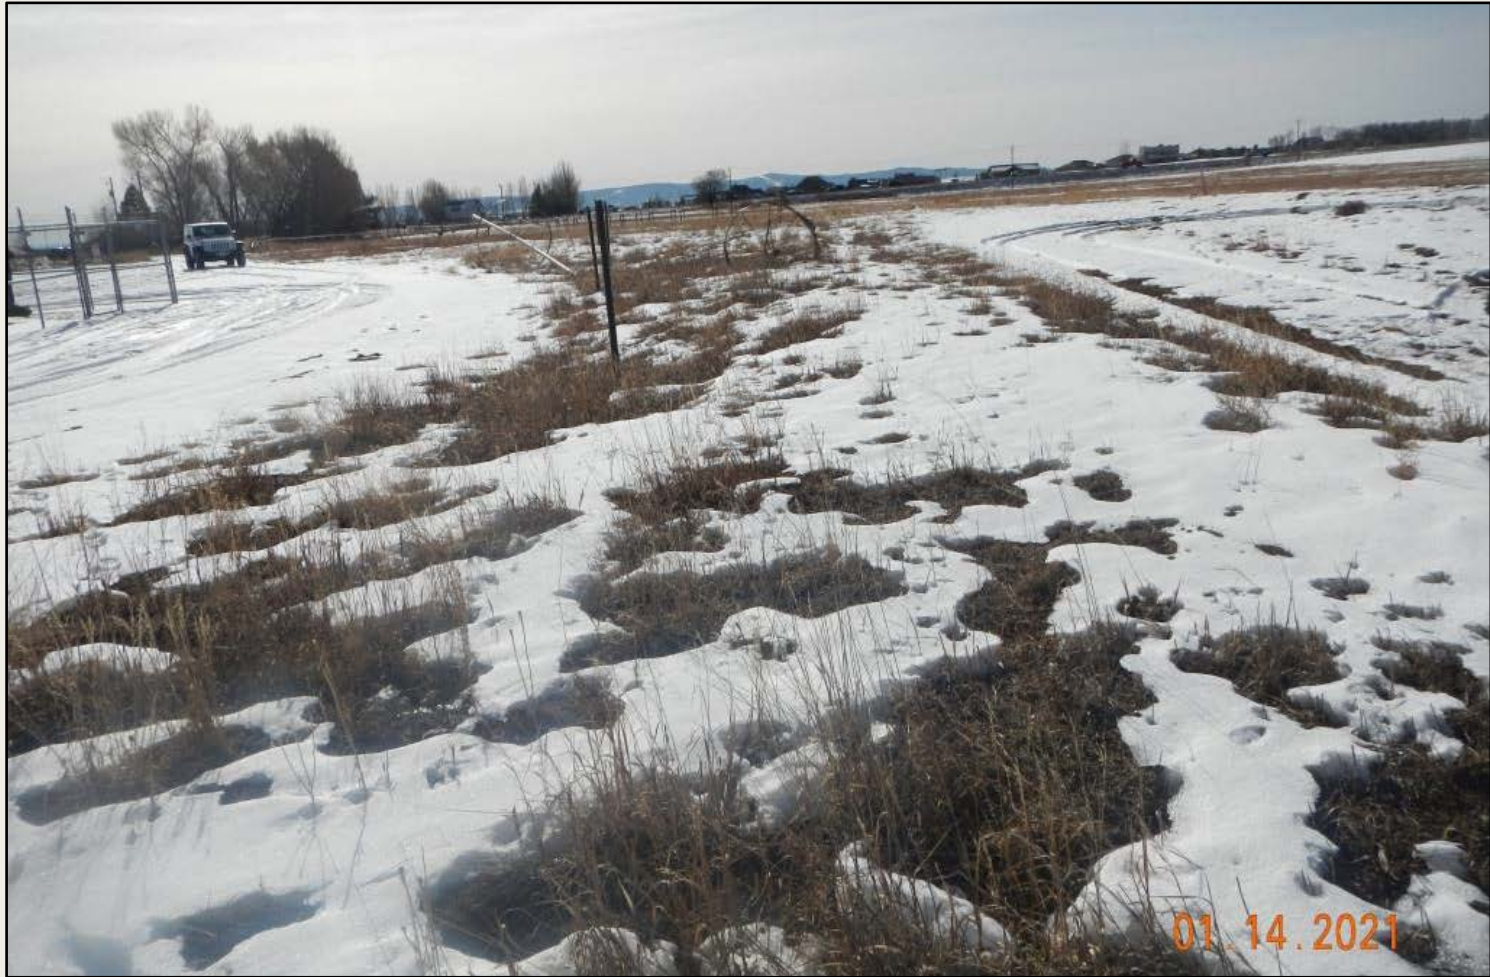
Photo 2. View of the western project area from the northwestern corner facing southward. Vegetation is largely snow covered recovered, and revegetation is progressing with smooth brome.

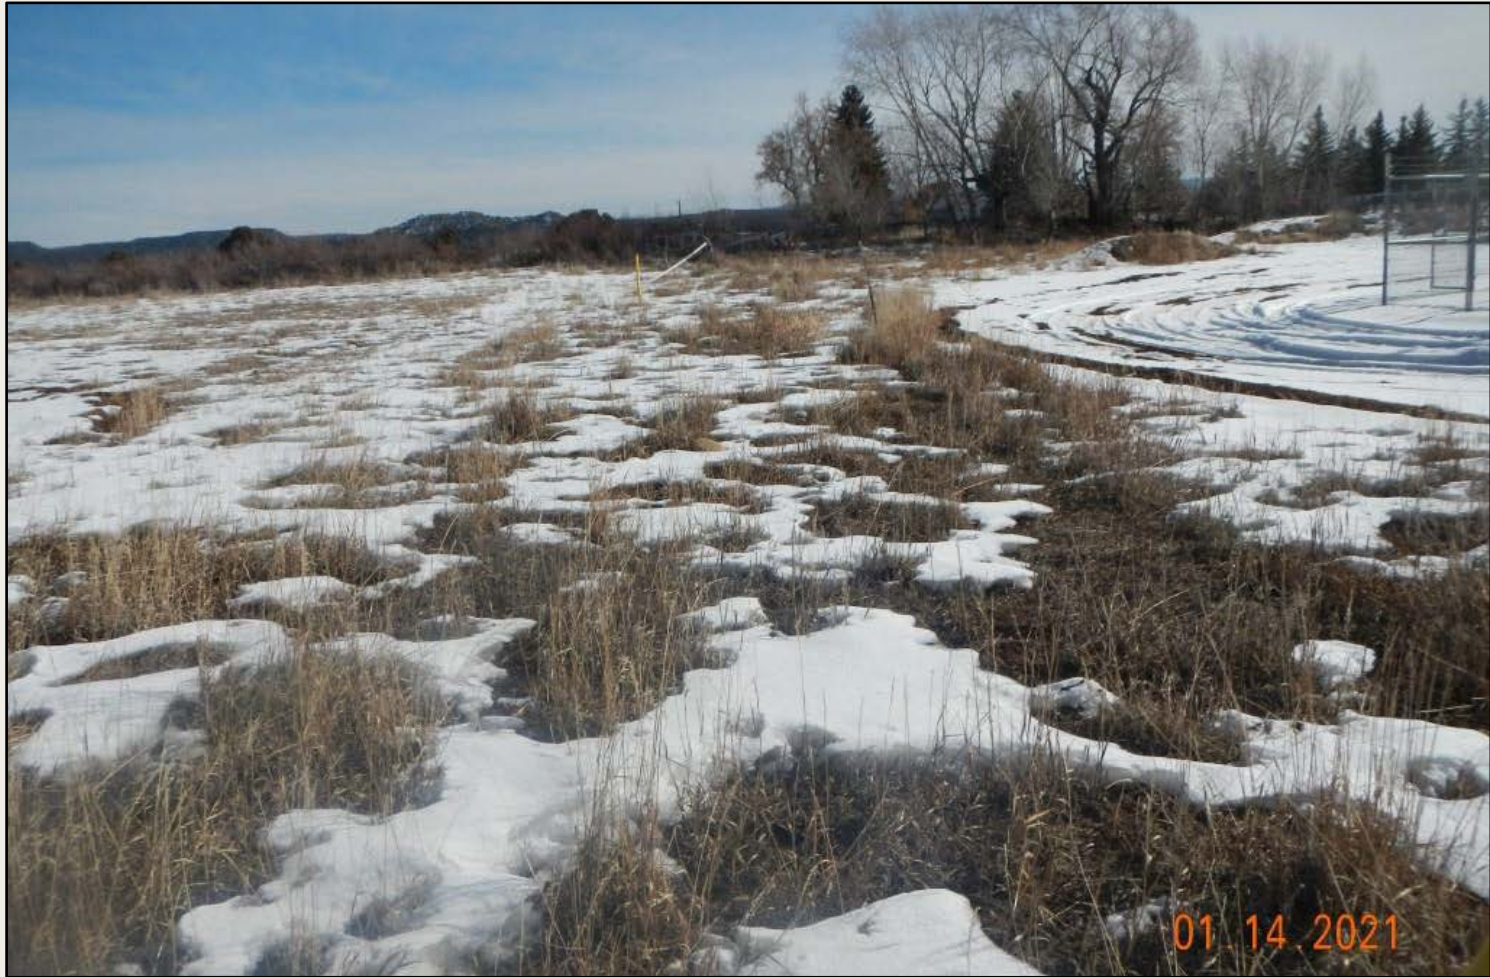
Photo 3. View of the northern project area facing eastward.

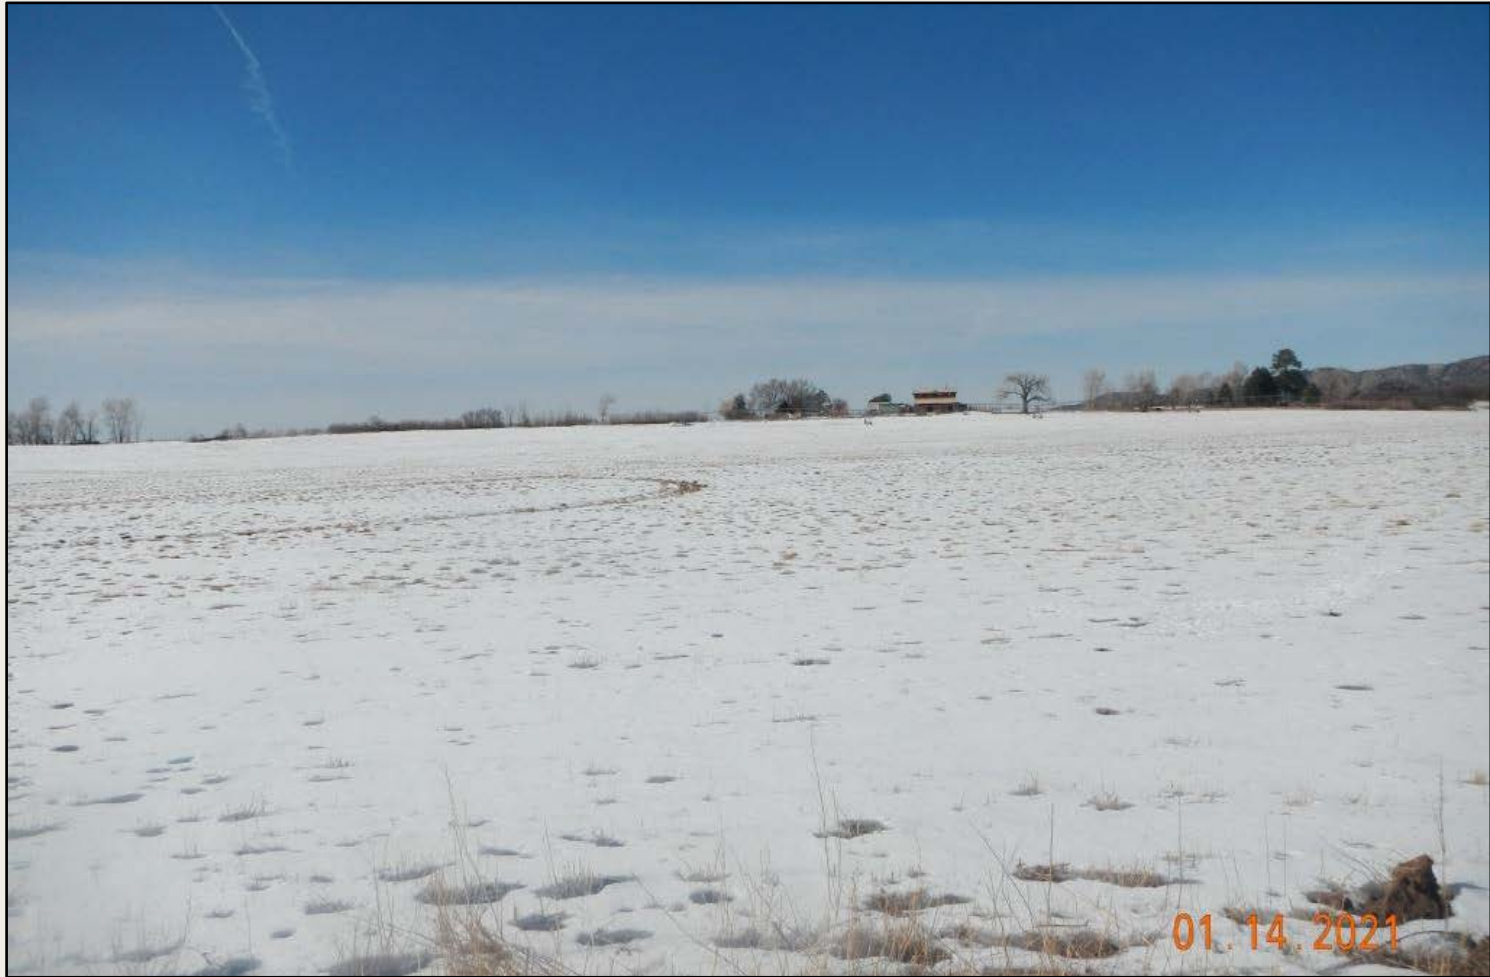
Photo 4. View of the reference area comprised of irrigated grass field.
