Inspection Photos
Operator: Enduring
API: 067-07762
Date: 1/14/2021

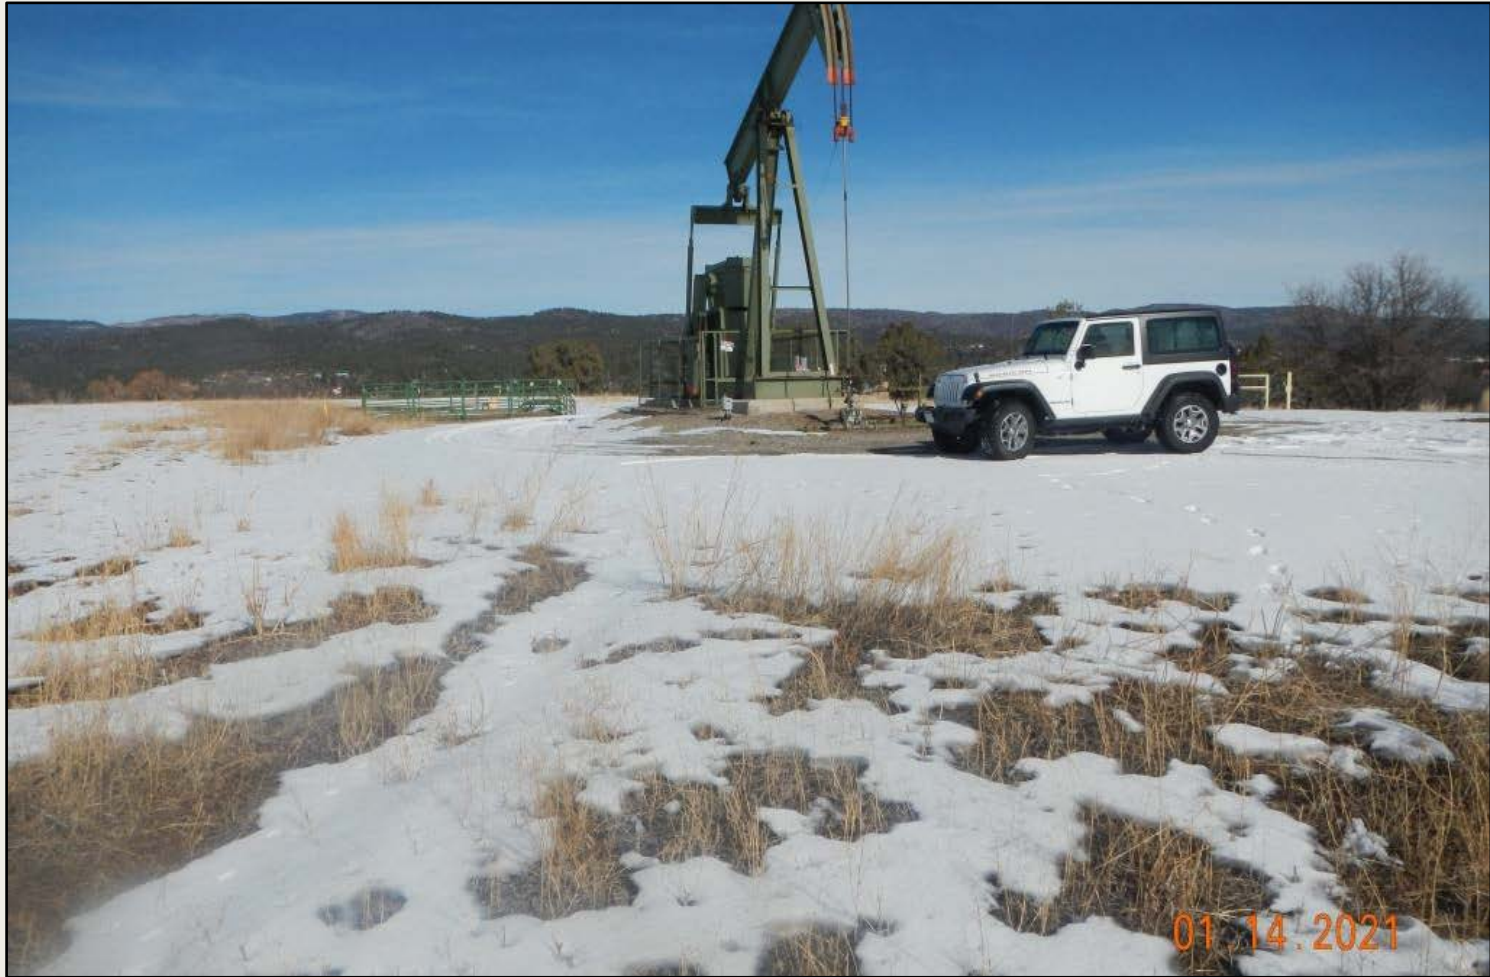
Photo 1. View of the project area from the southwestern corner facing center.

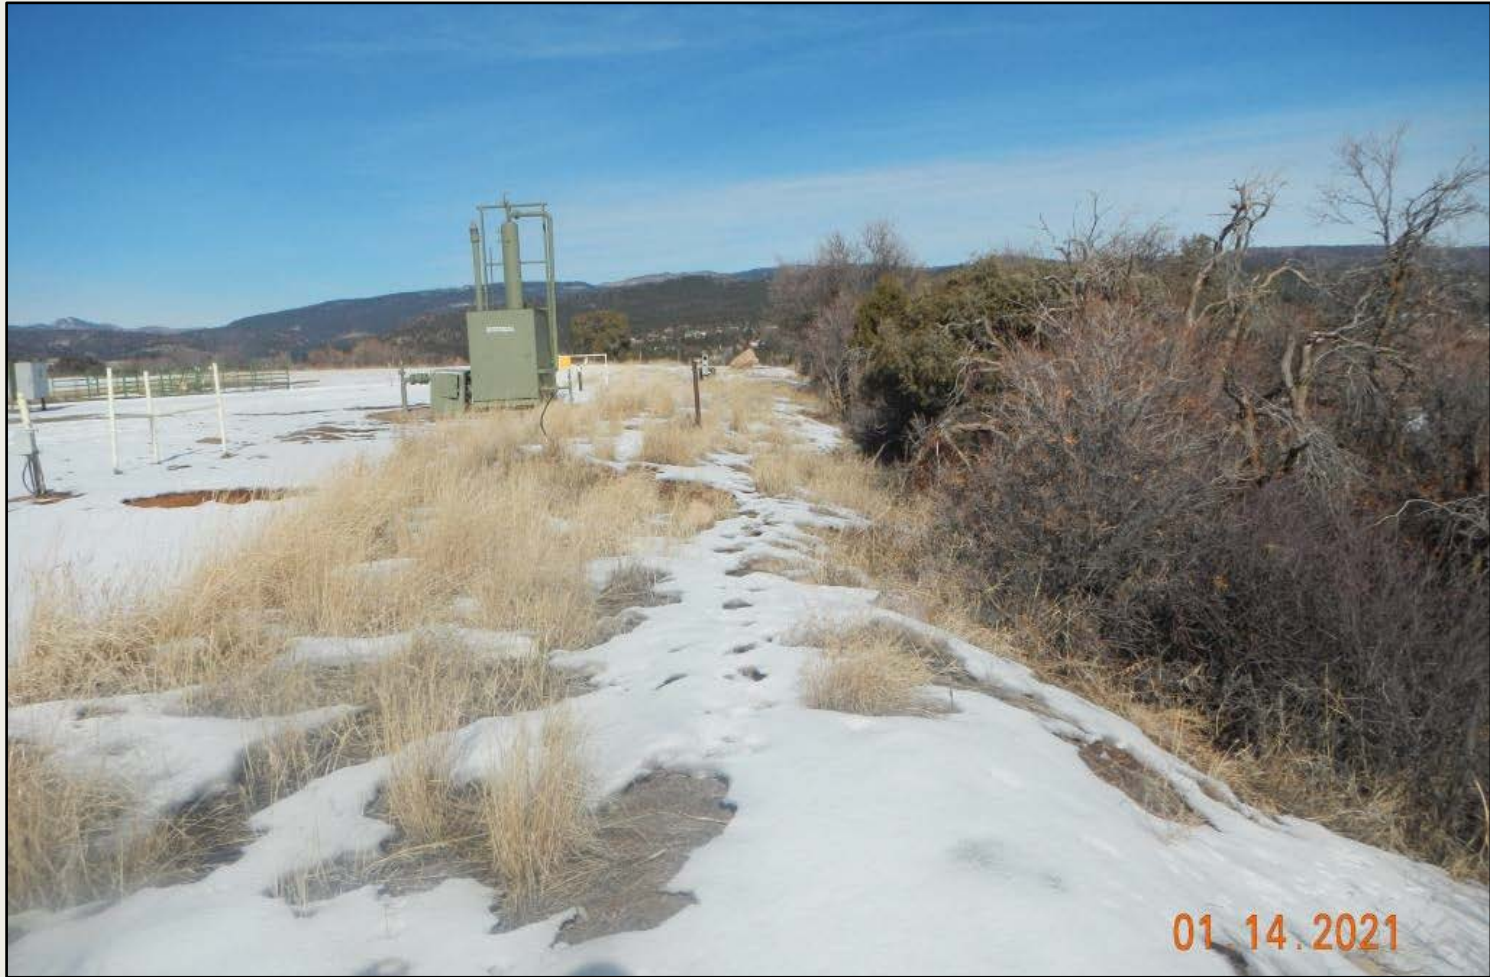
Photo 2. View of the eastern project area from the southeastern corner facing northward. Vegetation is largely snow covered recovered, and revegetation is progressing with western wheatgrass, crested wheatgrass, smooth brome, and gambel oak.

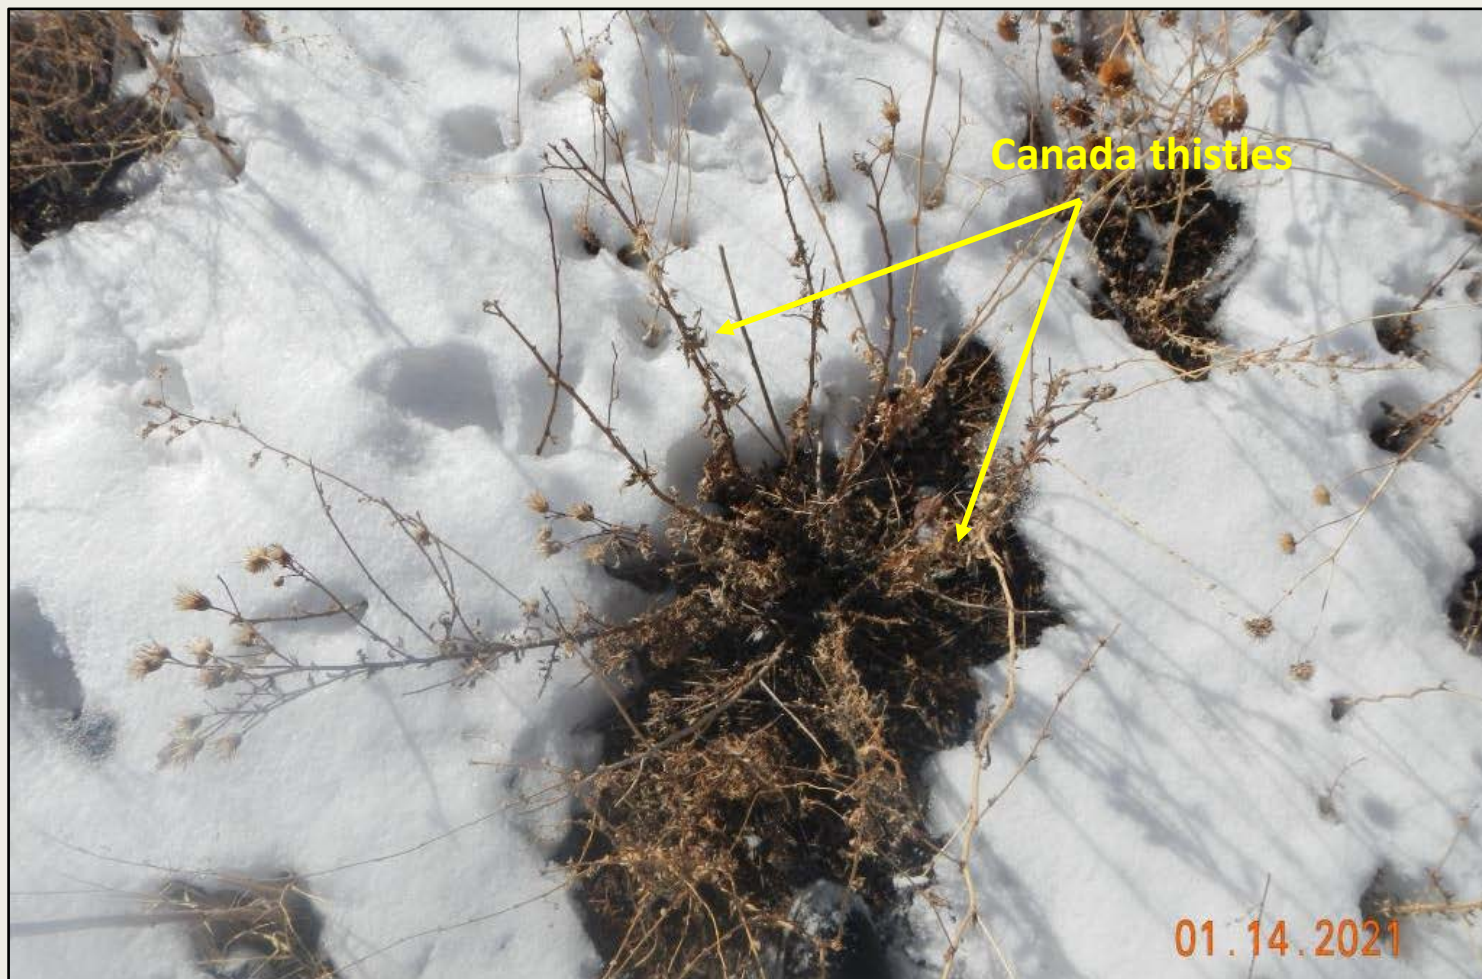
Photo 3. View of Canada thistles within the southwestern project area. Approximately 75 individuals observed.

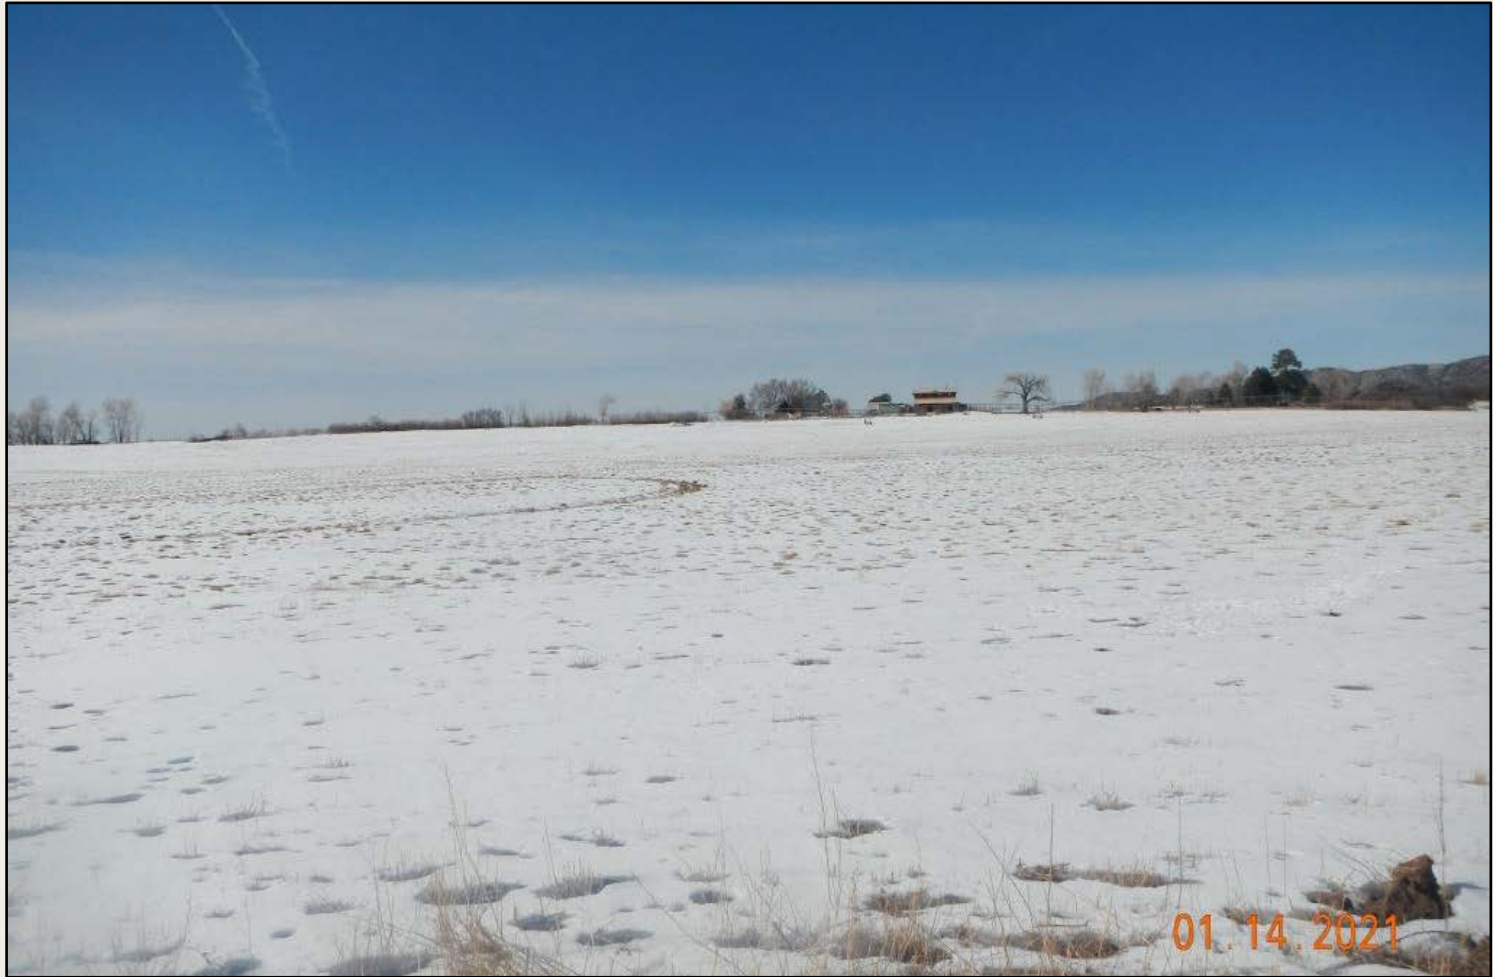
Photo 4. View of the reference area comprised of irrigated grass field.
