Inspection Photos

Operator: WINDSOR ENERGY GROUP LLC -
10081

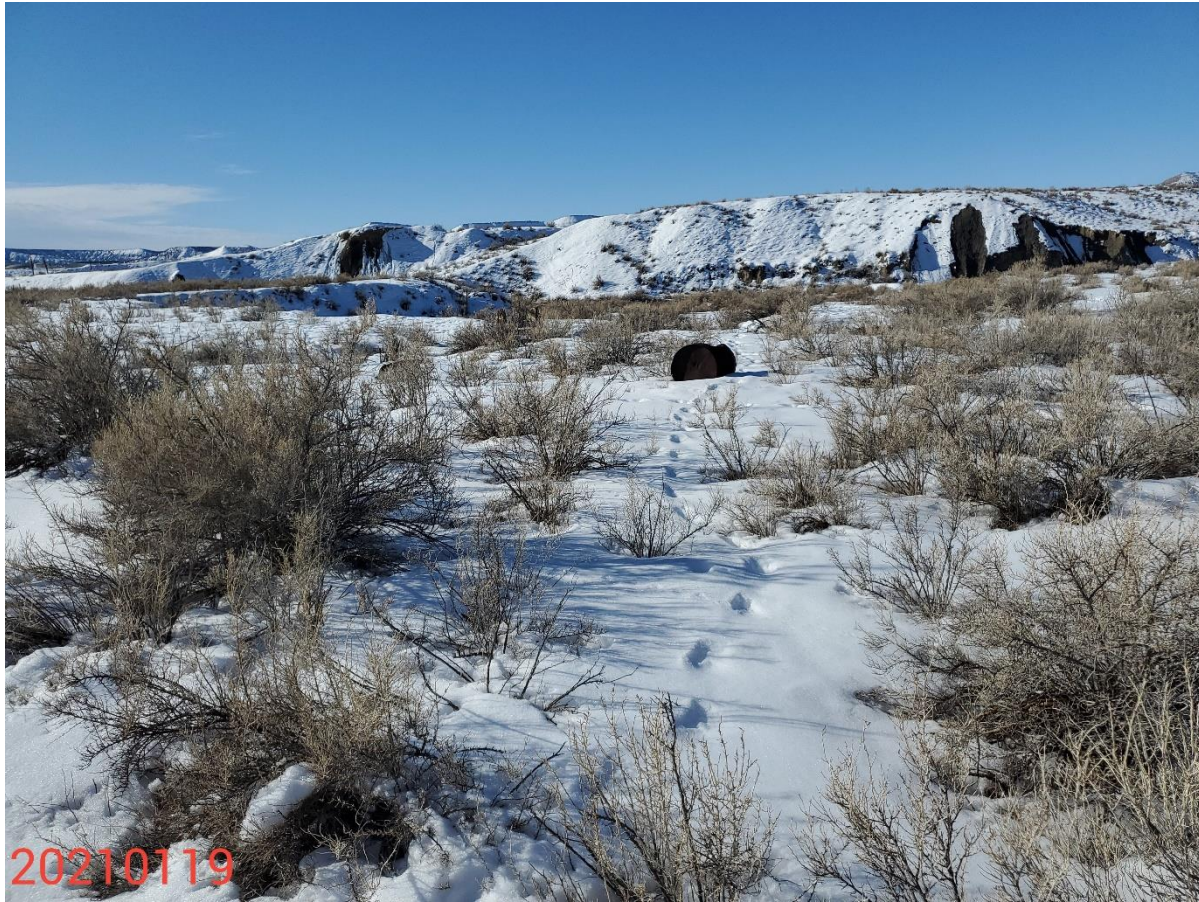
Photo 3: Photo of trash debris (barrel) observed remaining adjacent to northern access road.

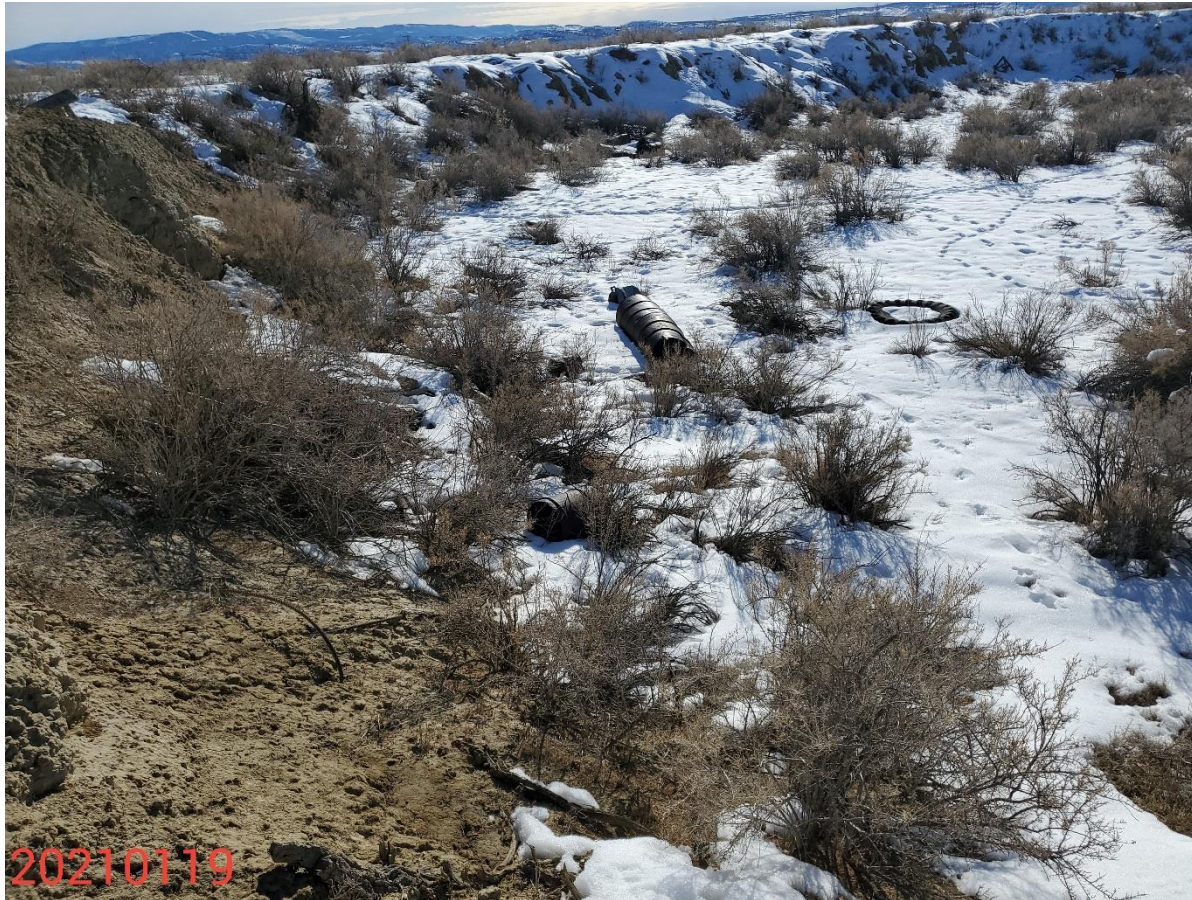
Photo 4: Photo of trash debris (barrels, tires, etc...) observed remaining adjacent to northern access road.

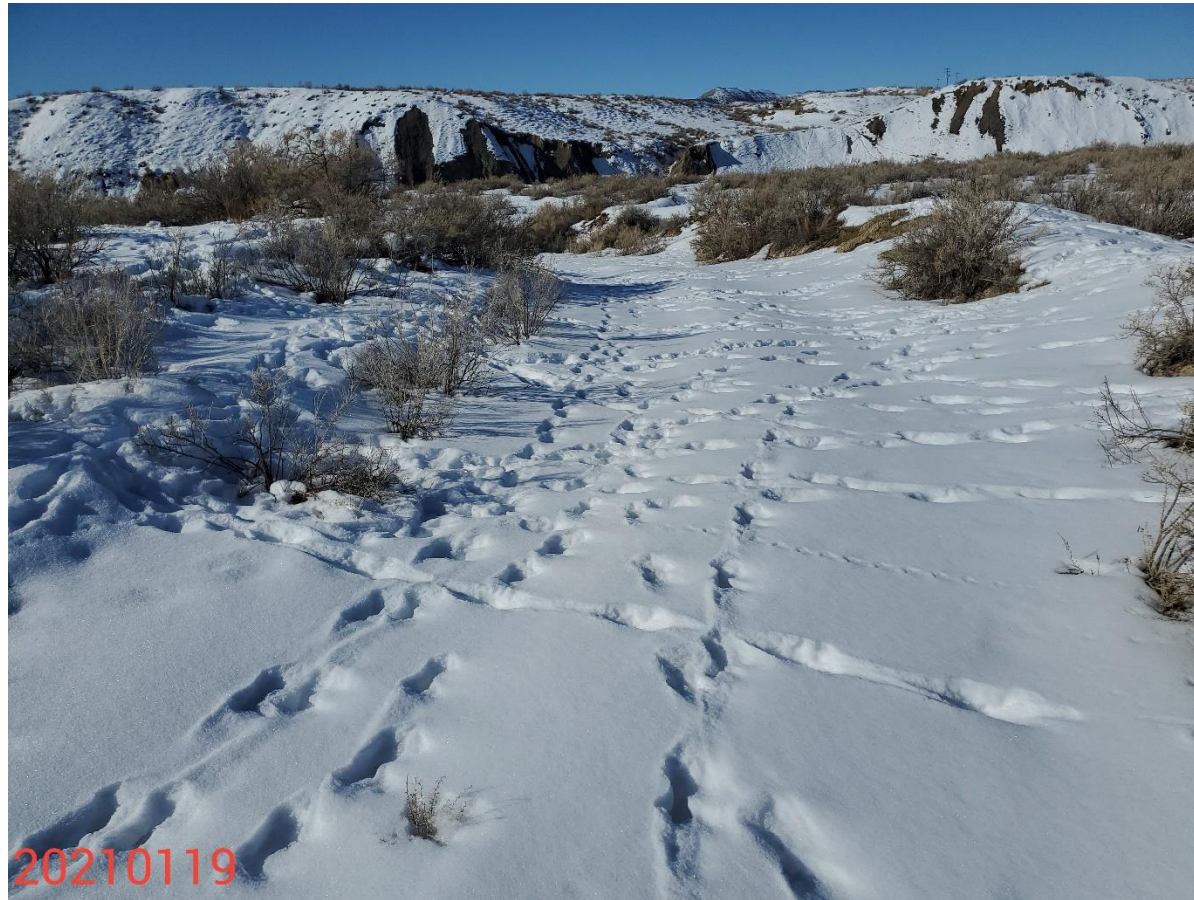
Photo 5: Photo taken from the northern section of access road, facing west. Photo shows access road has not been recontoured/regraded/reclaimed.

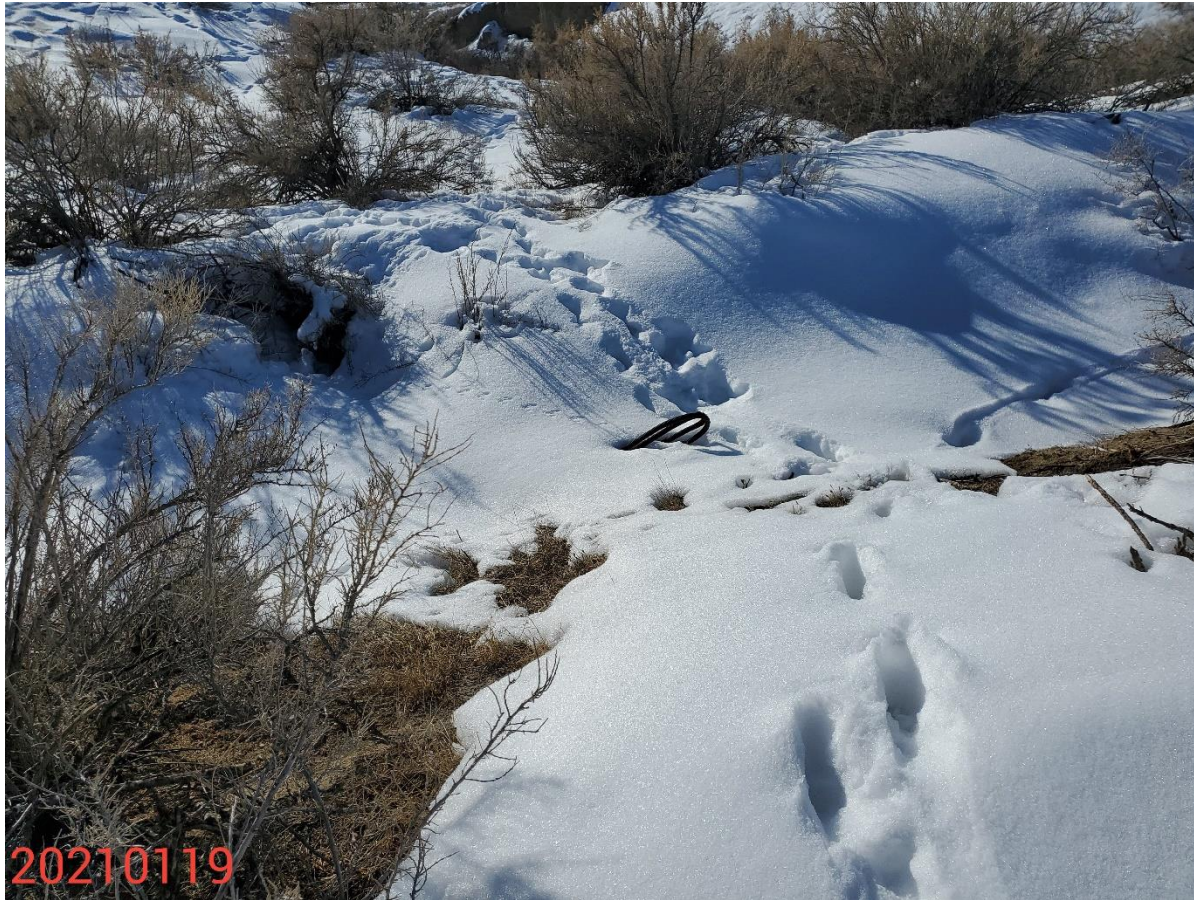
Photo 10: Photo of trash debris (cable) observed remaining adjacent to southern access road.

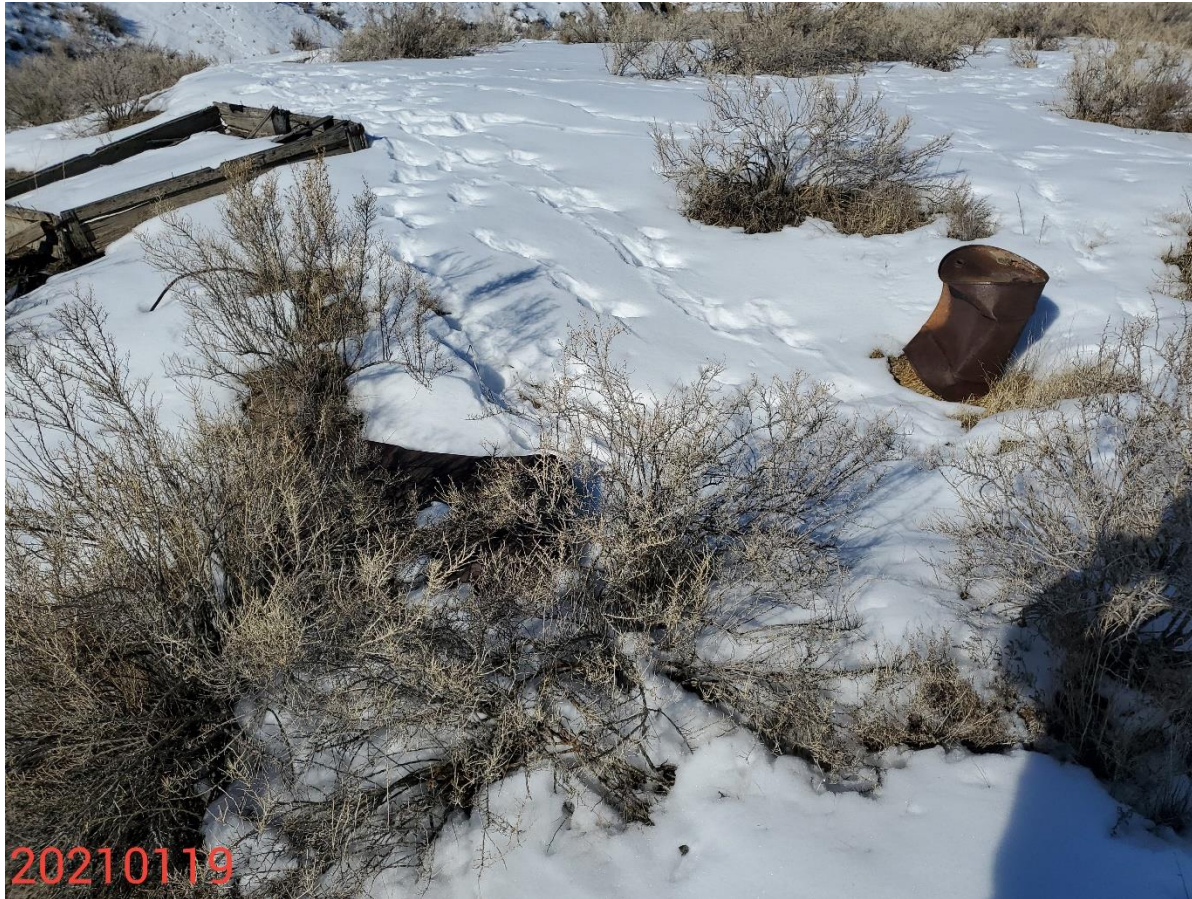
Photo 11: Photo of trash debris (barrels, etc...) observed remaining adjacent to northern access road.
