COLORADO
Oil & Gas Conservation
Commission
Department of Natural Resources

Arrowhead 9

API: 05-103-05301

Inspection: 700405102

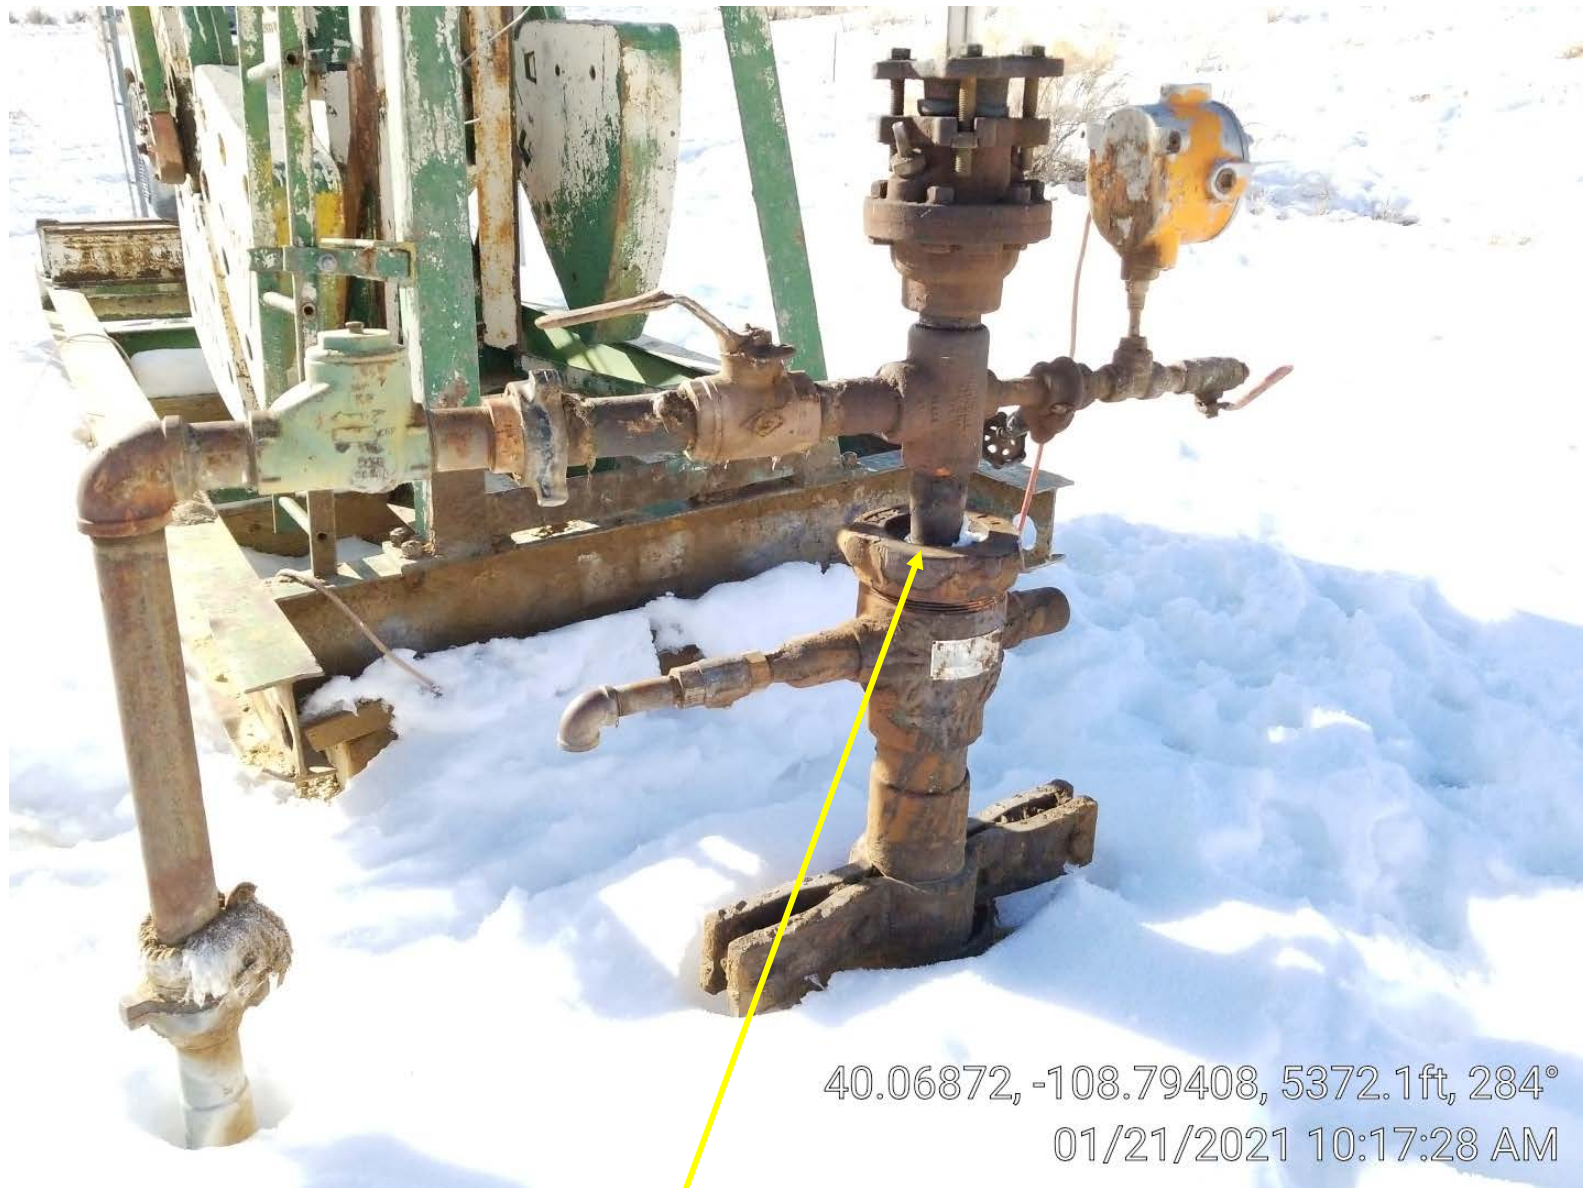
Photo 2. Well

Gas leak.

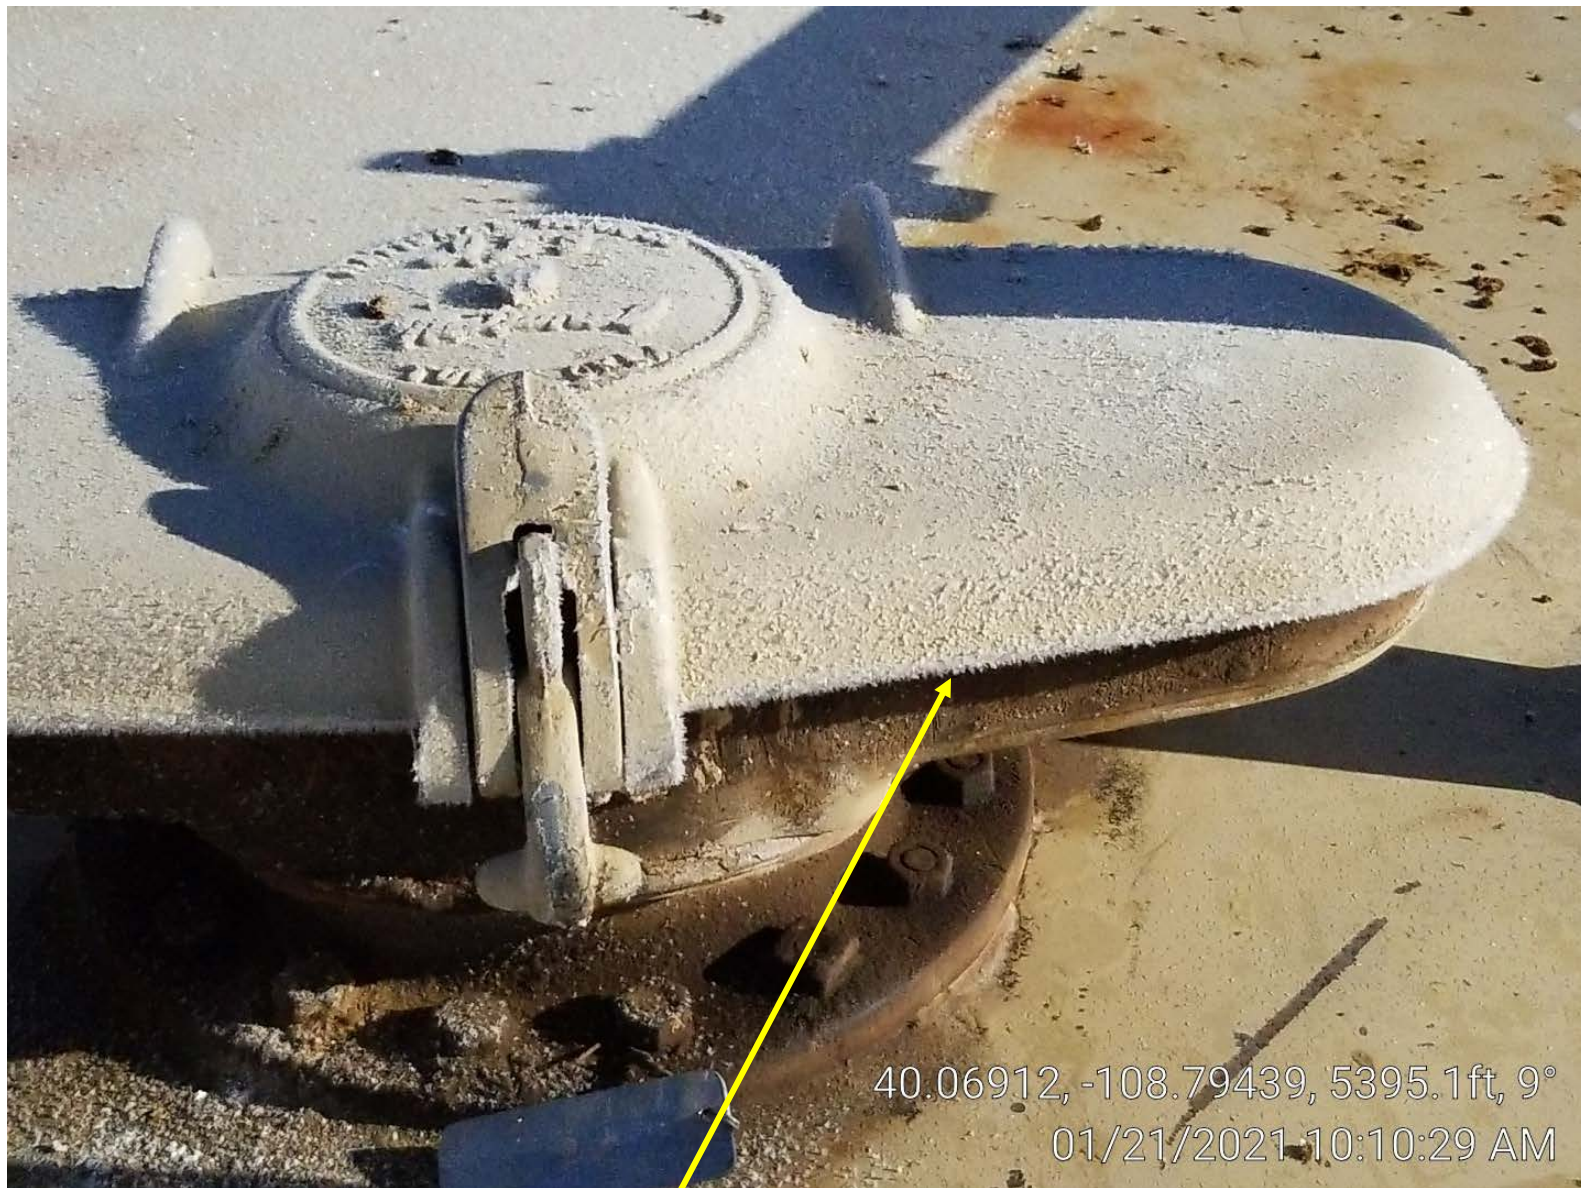
Photo 5. Tank hatch

Gas leak.
