# Final Reclamation Inspection

Operator: LILIS ENERGY INC - 10495

API: 05-039-06608

Inspection Photos  
Location Name: COGGINS #10-34  
API: 05-039-06608

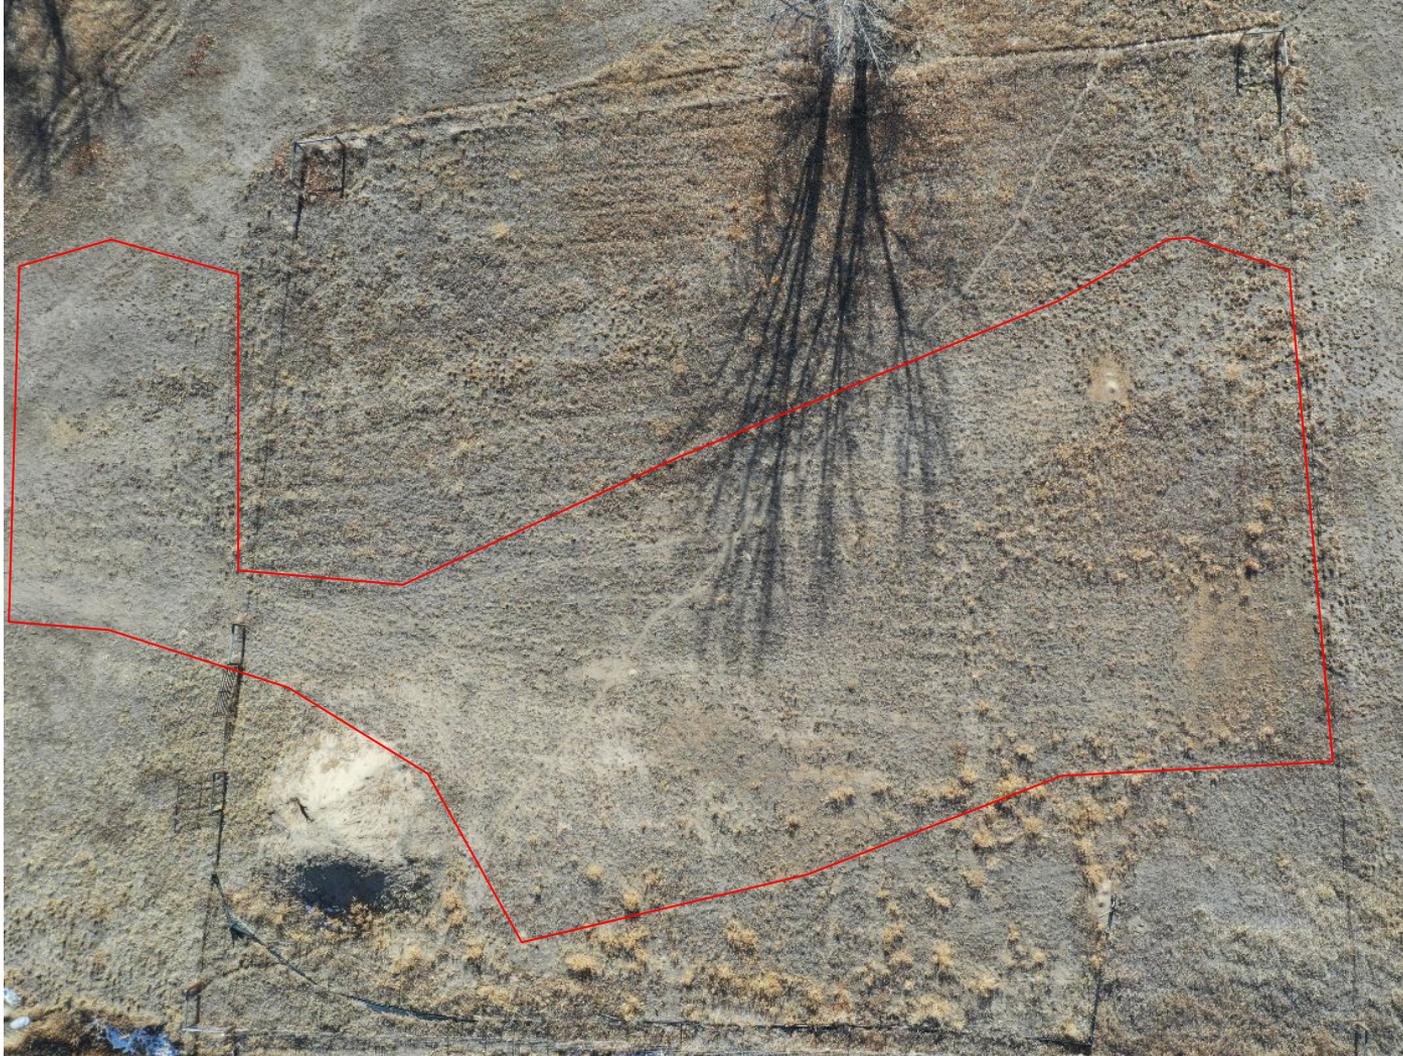
**Photo 2.** Drone aerial imagery taken 1/19/2021 illustrates the location which has been fenced. The above red-circled area illustrates the approximate reclamation area still needing additional work, which is essentially the former production areas.

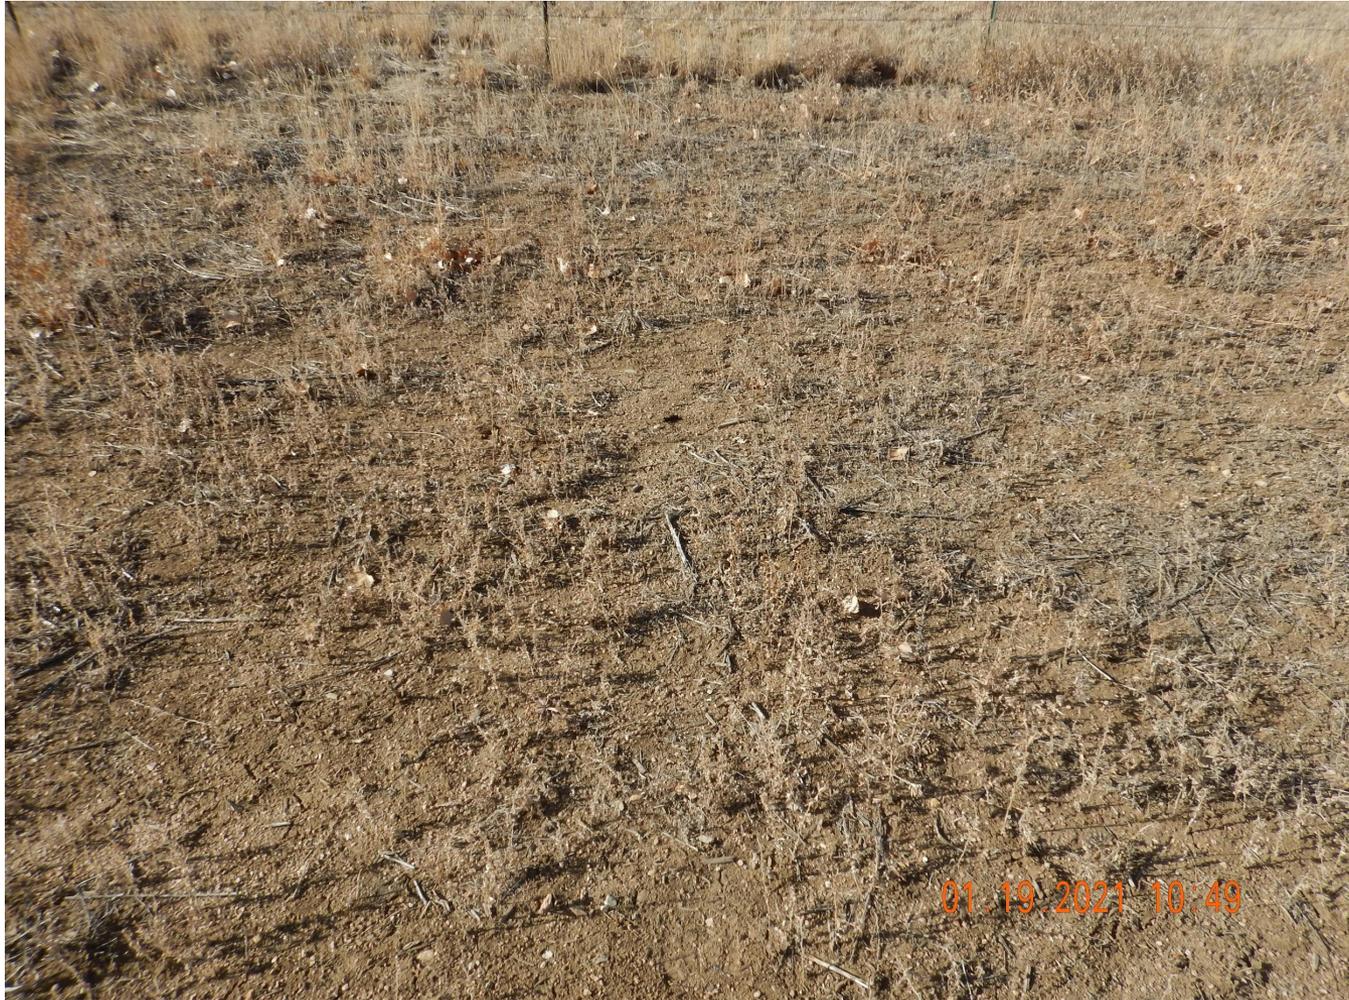
**Photo 3.** Close up photo taken from the southern location, facing South. Photo illustrates the lack of perennial vegetative growth. Annual, weedy growth has only established.

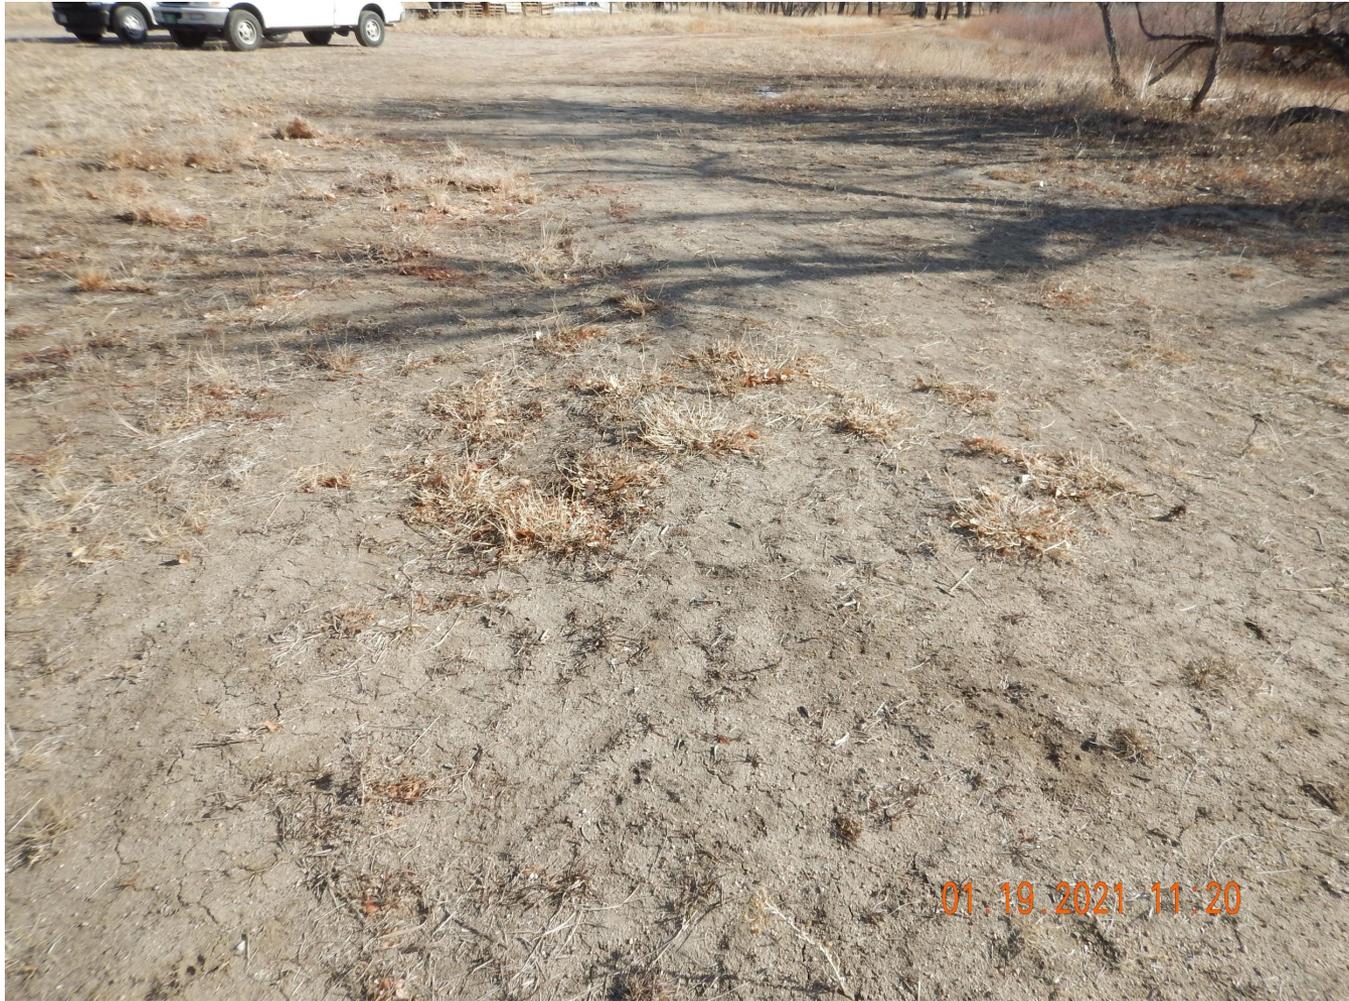
**Photo 4.** Photo taken from a portion of the access road, facing North. Photo illustrates the lack of perennial vegetative growth. Annual, weedy growth has only established.

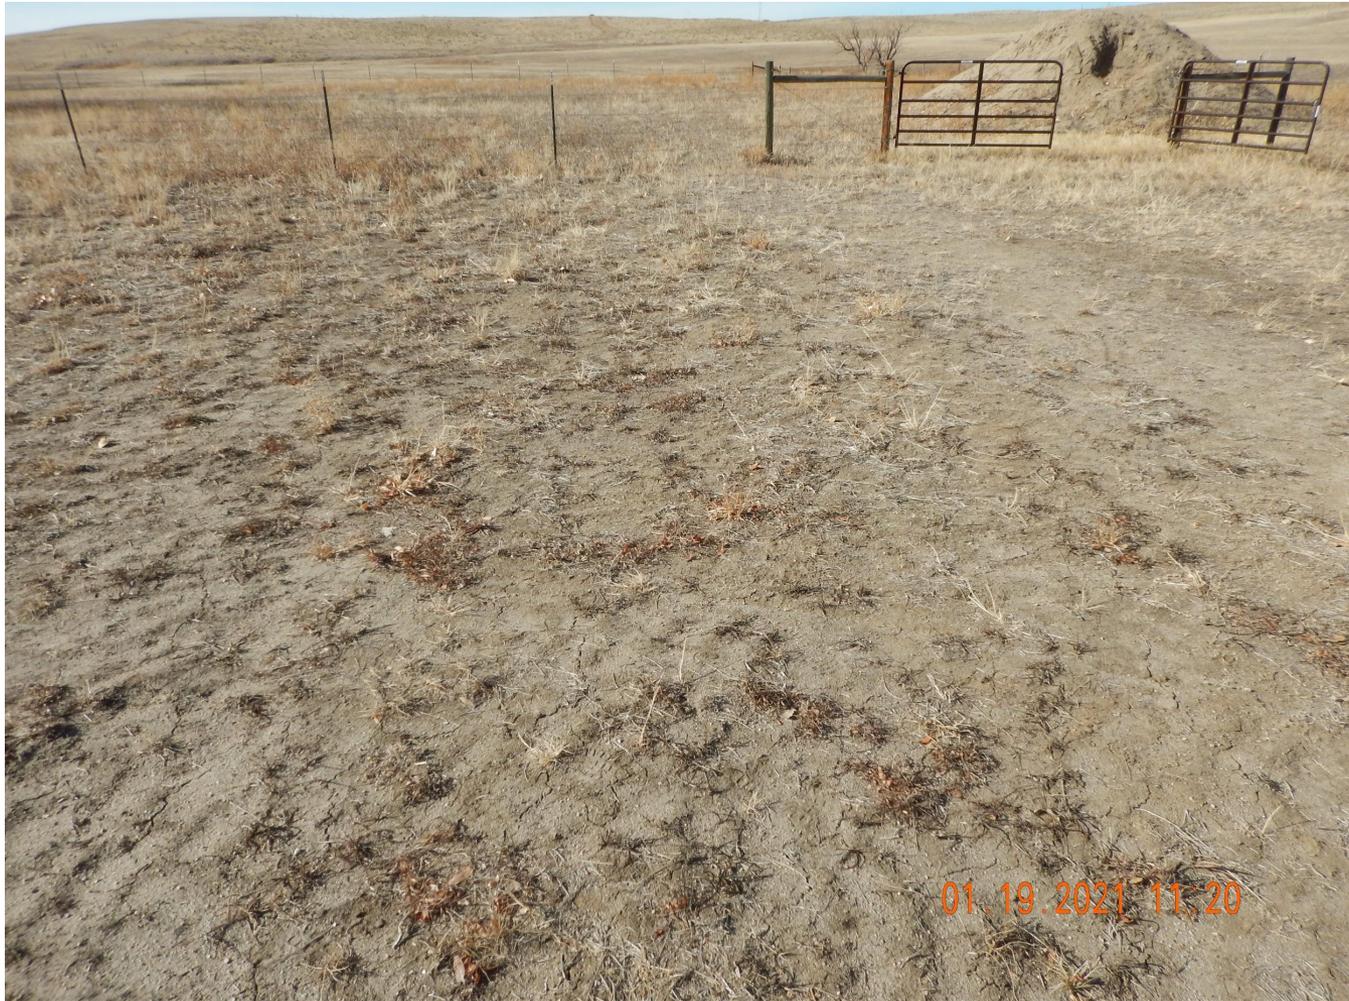
**Photo 5.** Photo taken from a portion of the access road, facing South. See comments under Photo 4.

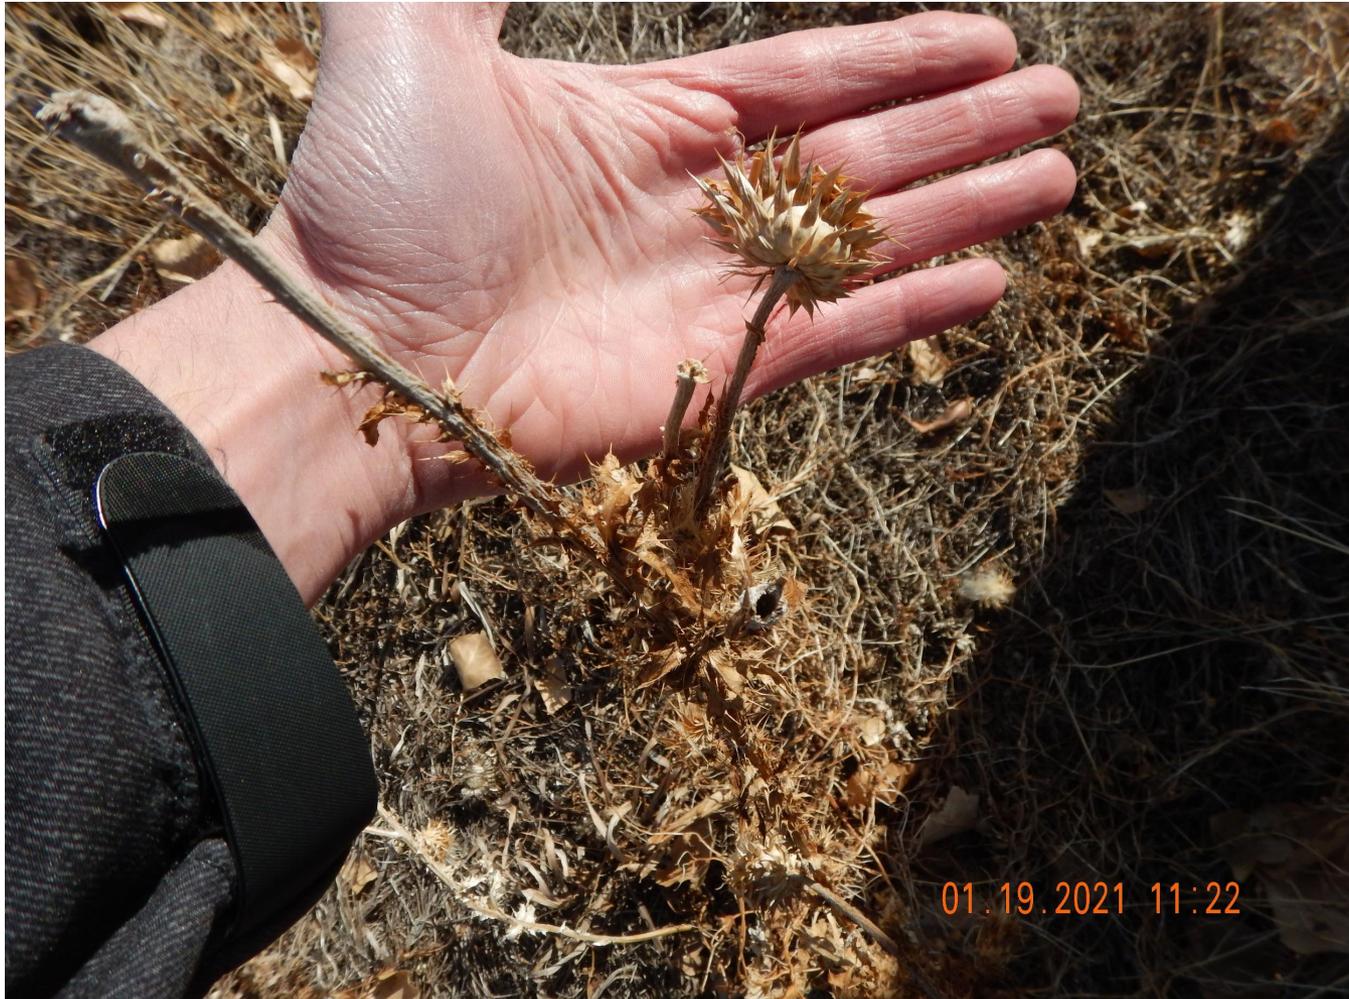
**Photo 6.** Close up photo taken from the northeastern location. Photo illustrates a List B Colorado noxious weed, Musk thistle.

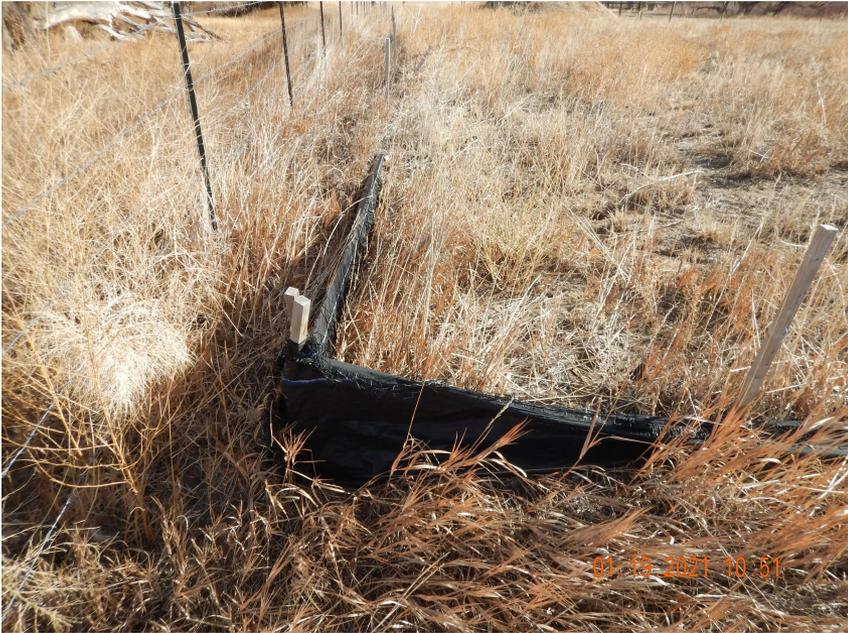
**Photo 7.** Photo taken from the northwestern perimeter of location, facing East. Photo illustrates the silt fence is no longer in proper functioning condition.

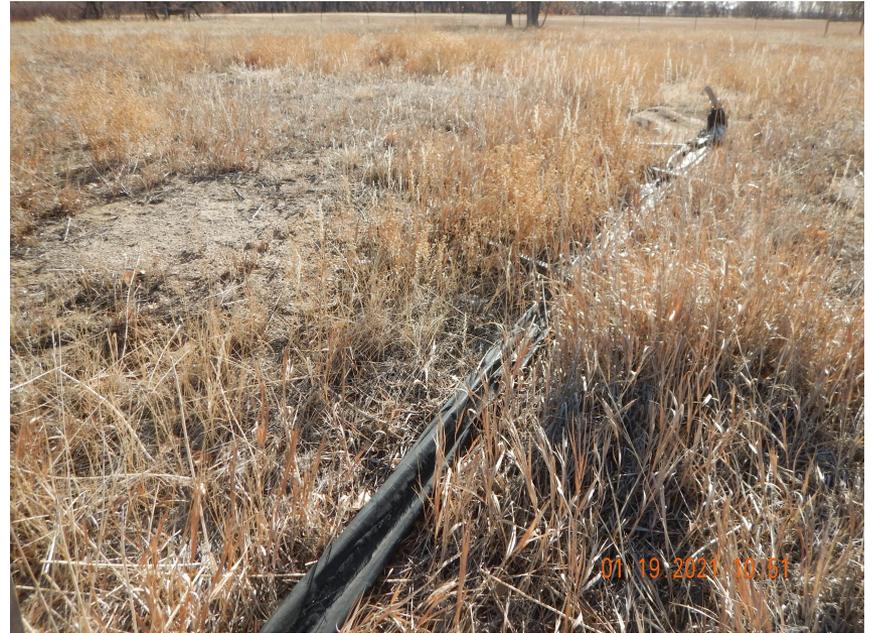
**Photo 8.** Photo taken from the northwestern perimeter of location, facing South. See comments under Photo 6.
