**CAERUS PICEANCE LLC**  
**MF H17 696**  
**Location # 335825**

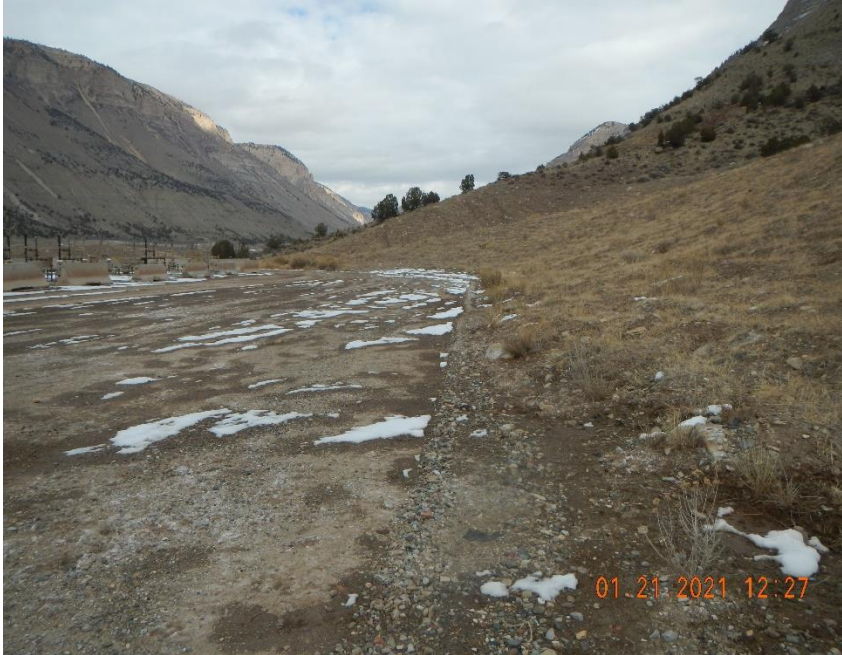
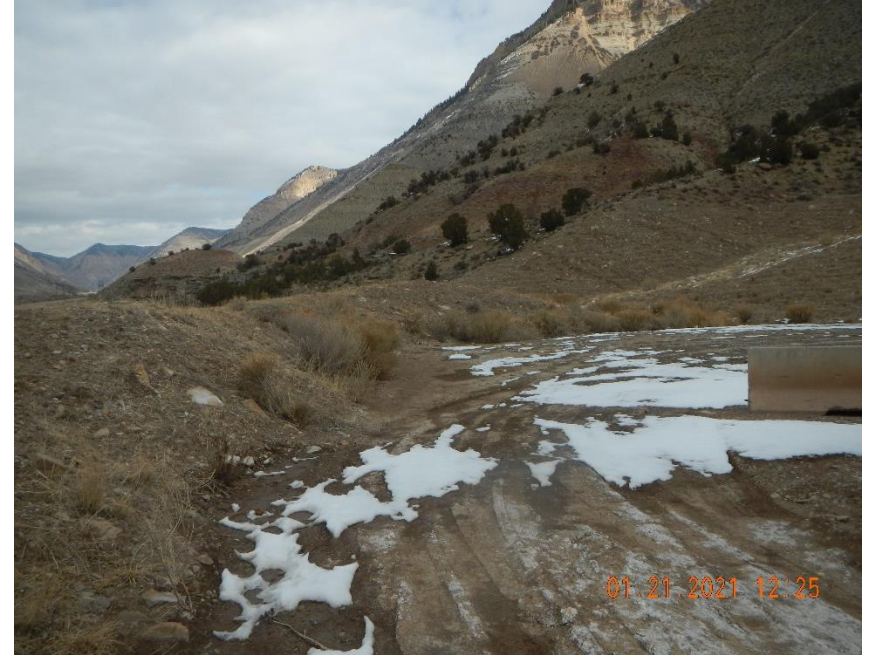
**Perimeter ditch needs maintained.**

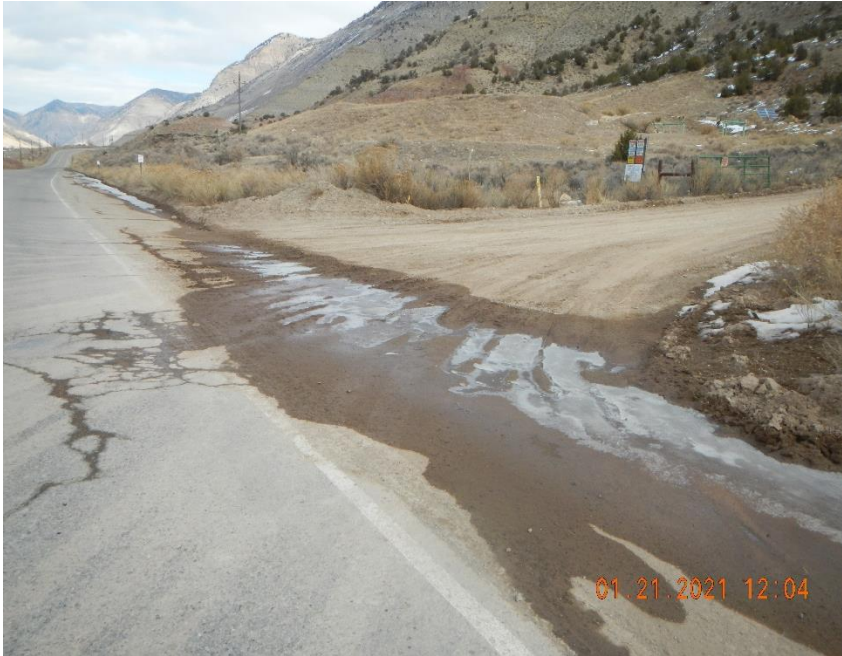
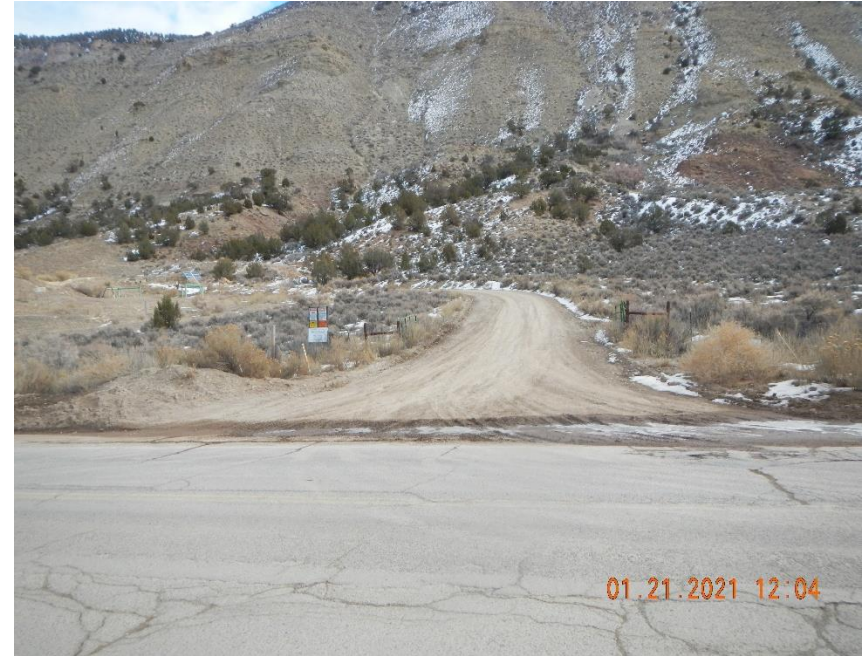
**Storm water stalling at intersection of  
county road and access road.**

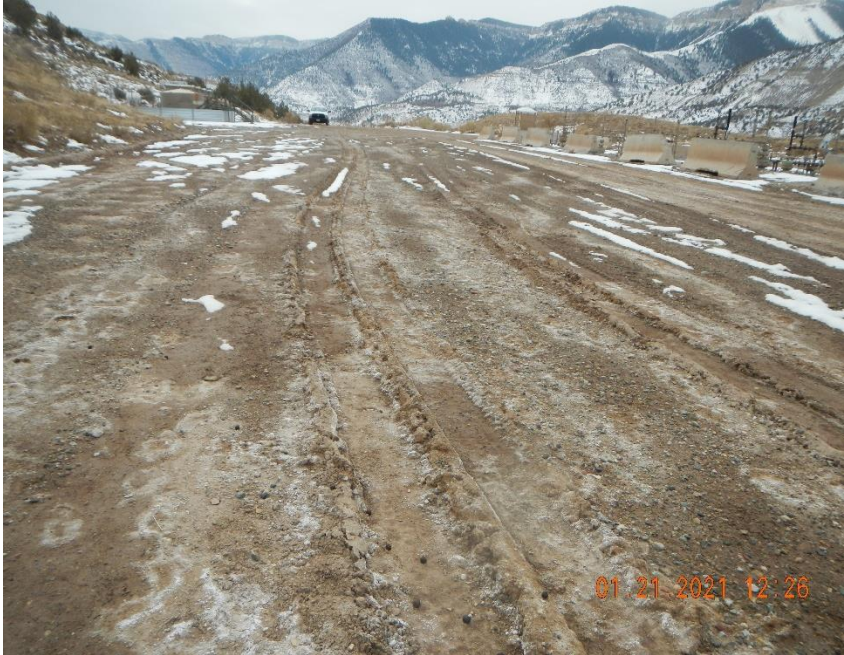
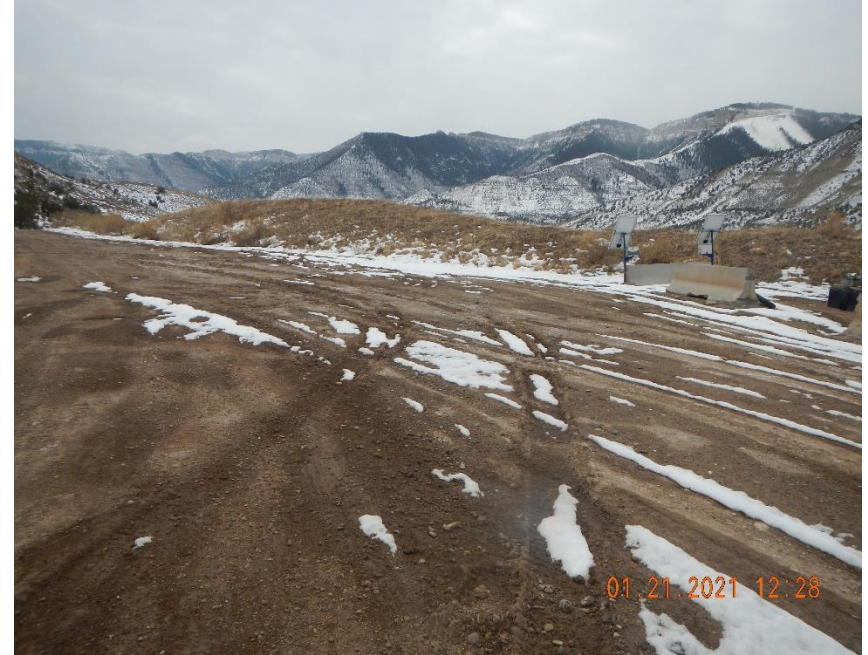
**Location shows signs of lack of stabilization  
BMP's in some areas (rutting is present)**

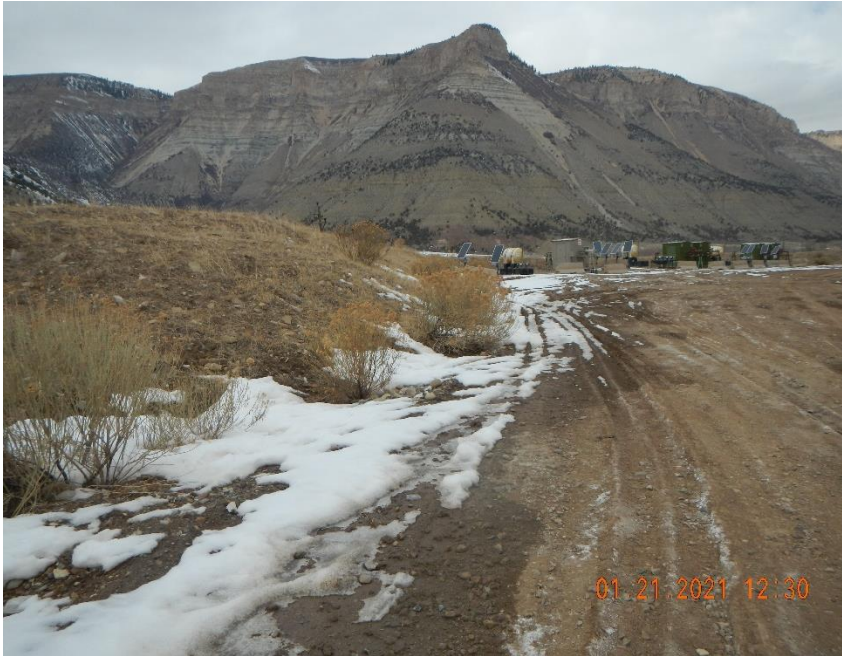
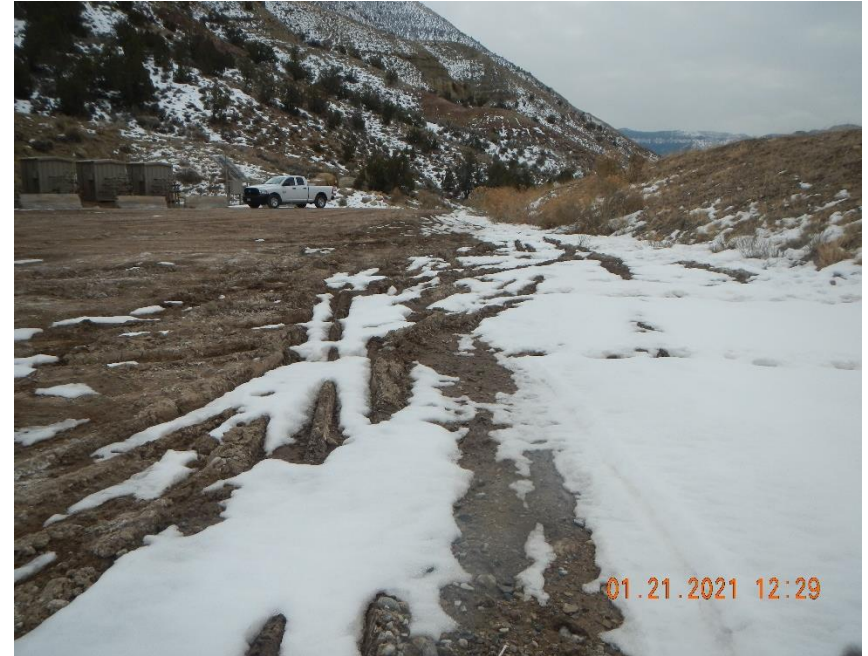
**Location shows signs of lack of stabilization  
BMP's in some areas (rutting is present)**

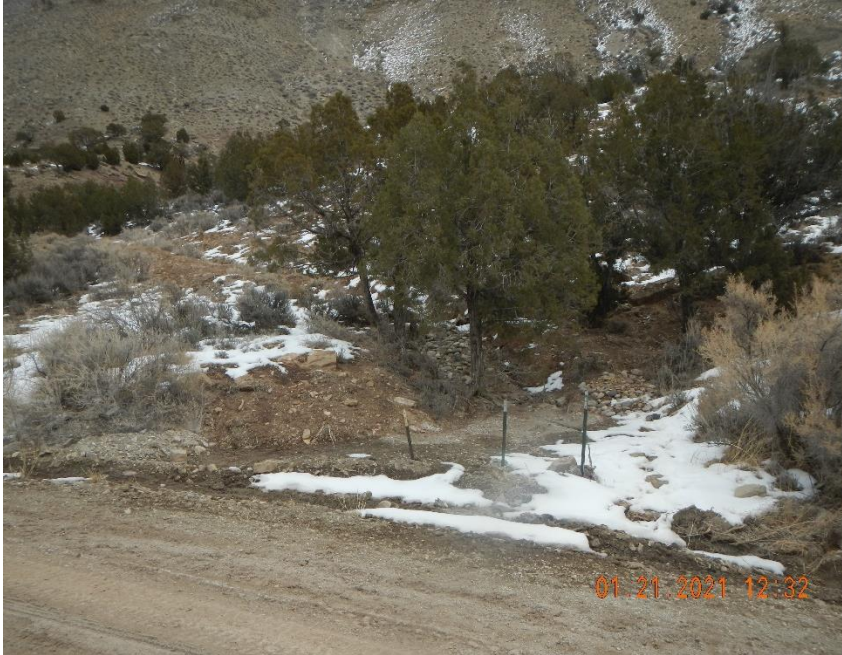
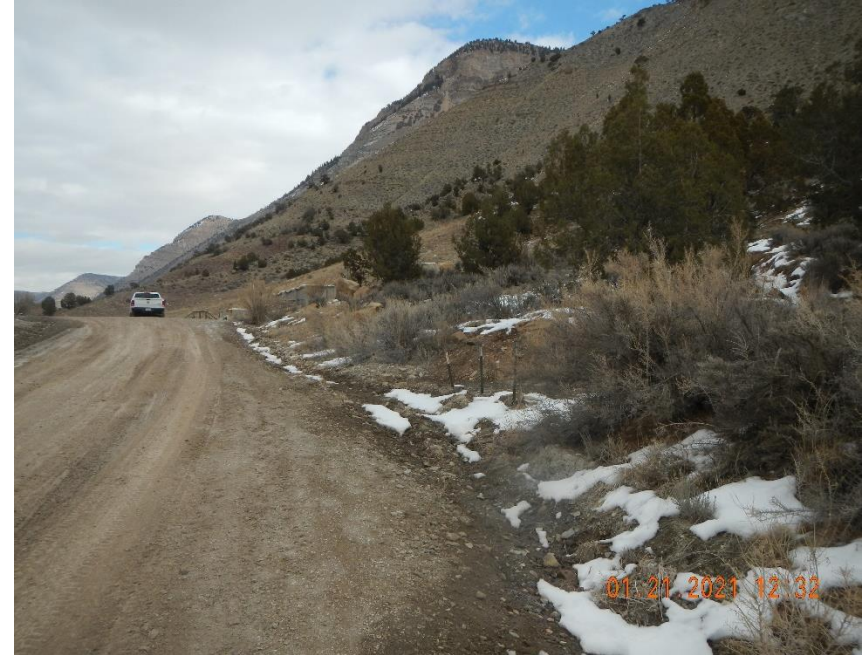
**Drainage merging with road ditch is full of sediment.**
