Inspection Photos
Operator: Enduring
API: 067-08706
Date: 1/22/2021

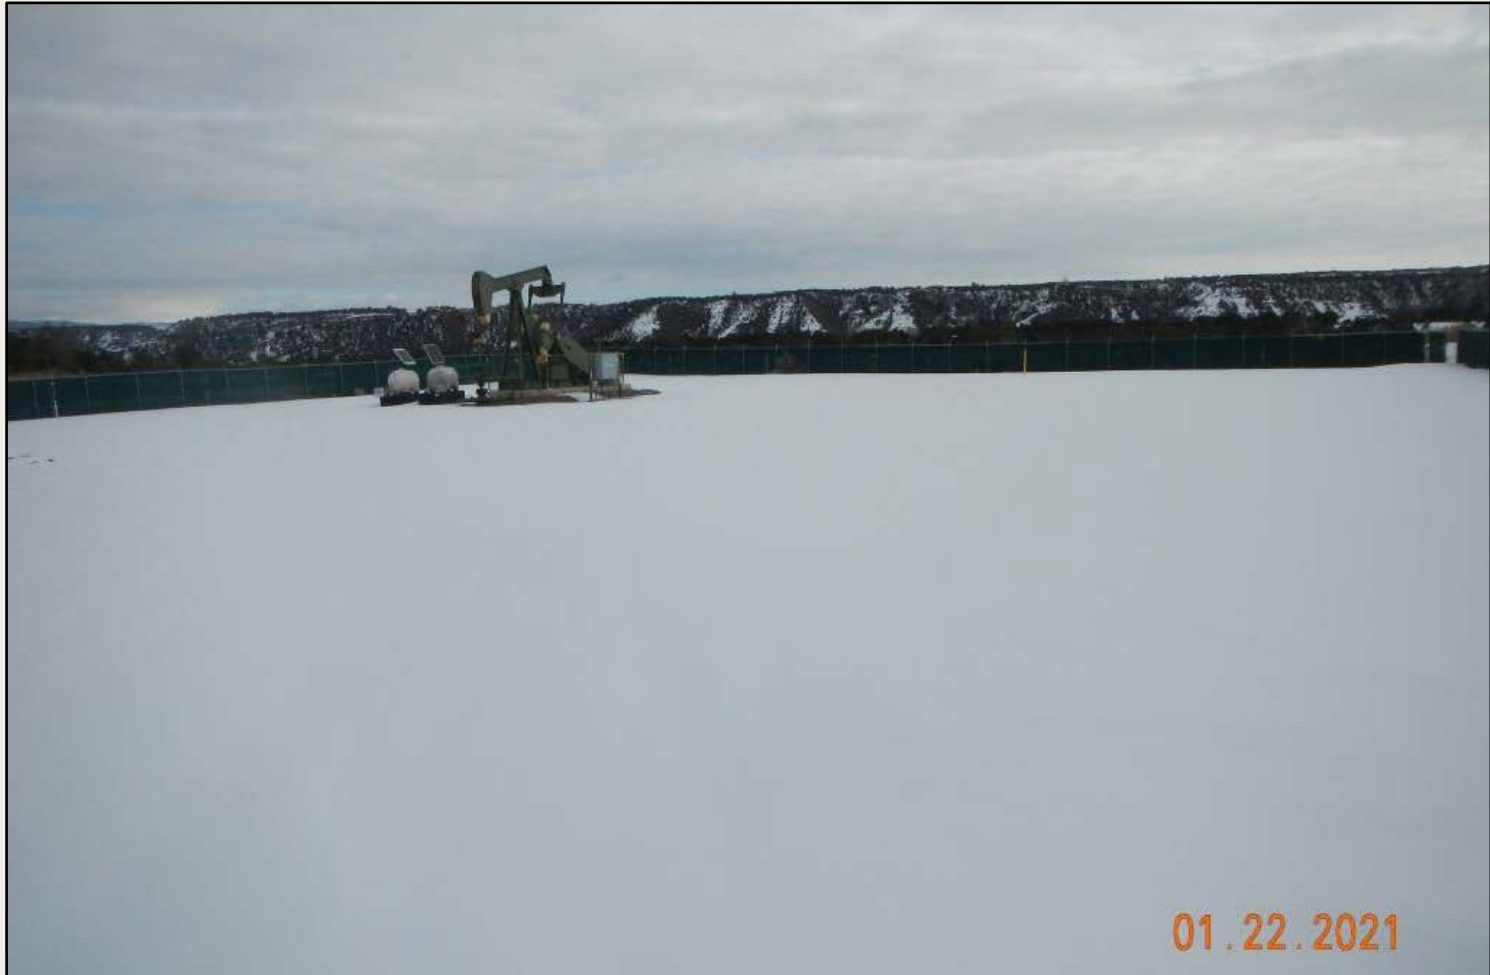
Photo 1. View of the project area from the well pad entrance facing center.

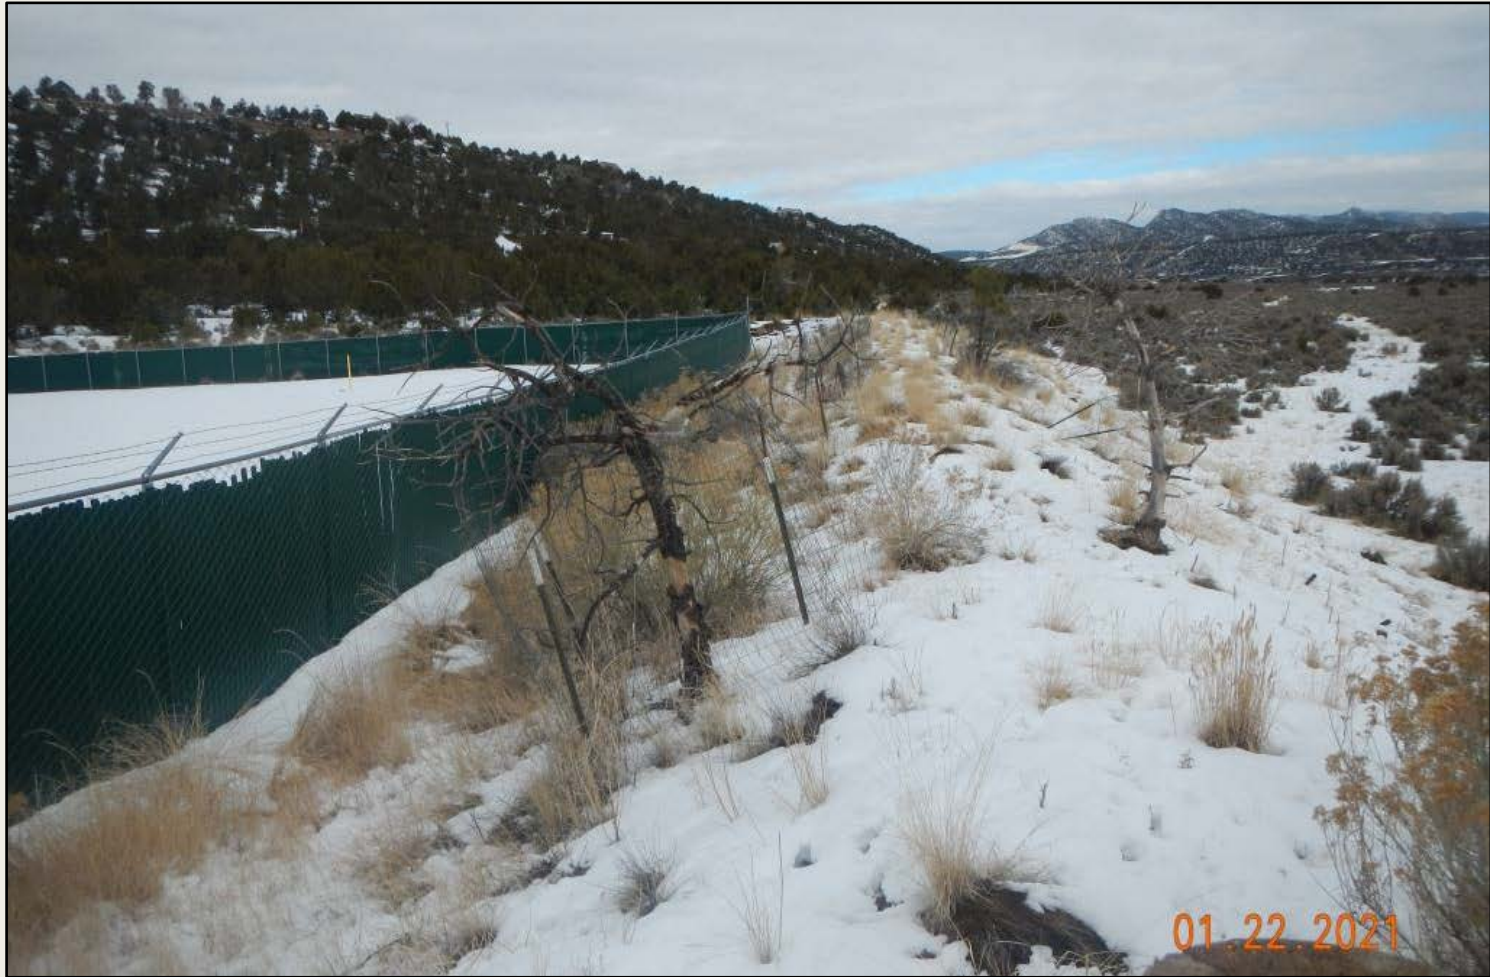
Photo 2. View of the eastern project area from the southeastern corner facing northward. Location largely snow covered. Taller perennial vegetation such as crested wheatgrass, western wheatgrass, and sand dropseed observable through the snow. Planted trees are largely dead.

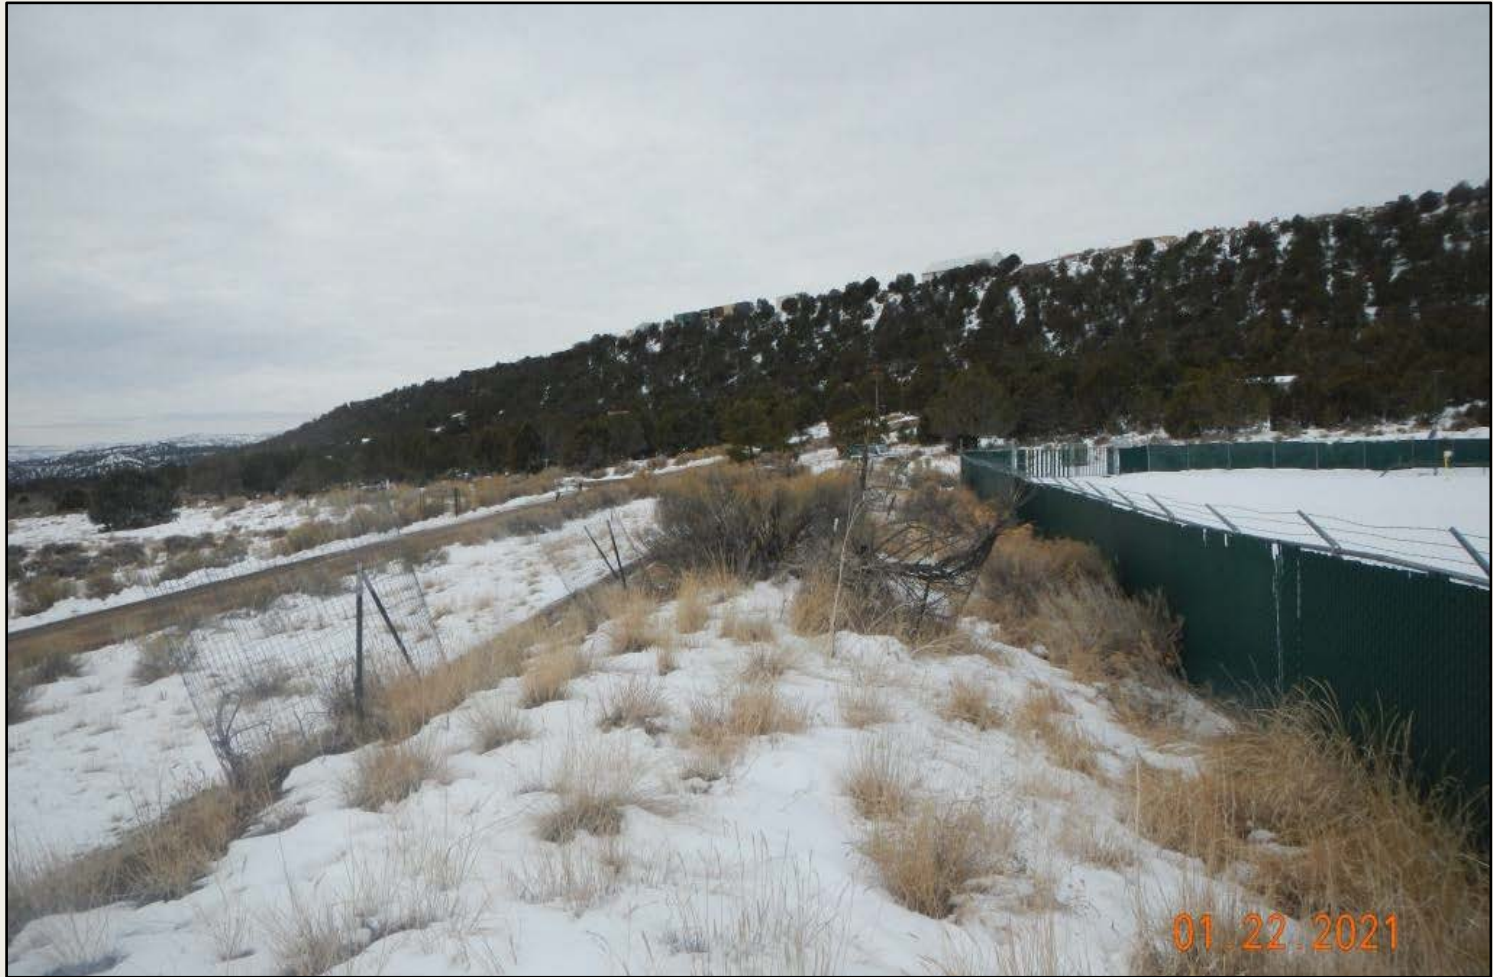
Photo 3. View of the southern project area from the southeastern corner facing eastward.

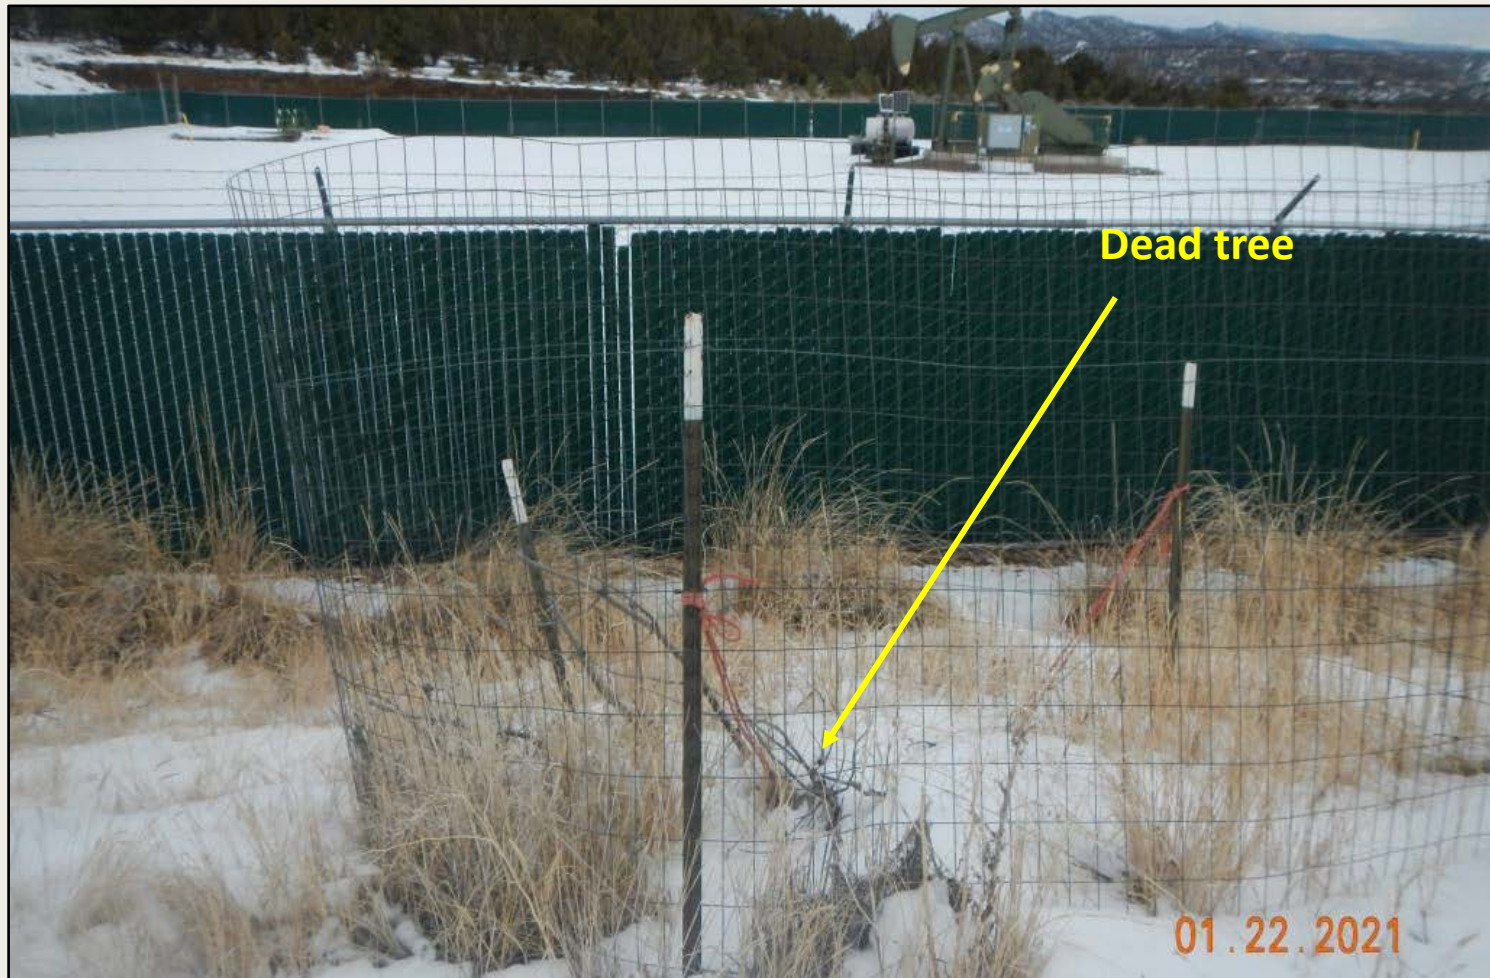
Photo 4. View of dead tree within the project area, fencing and staking present and only dead wood remains.

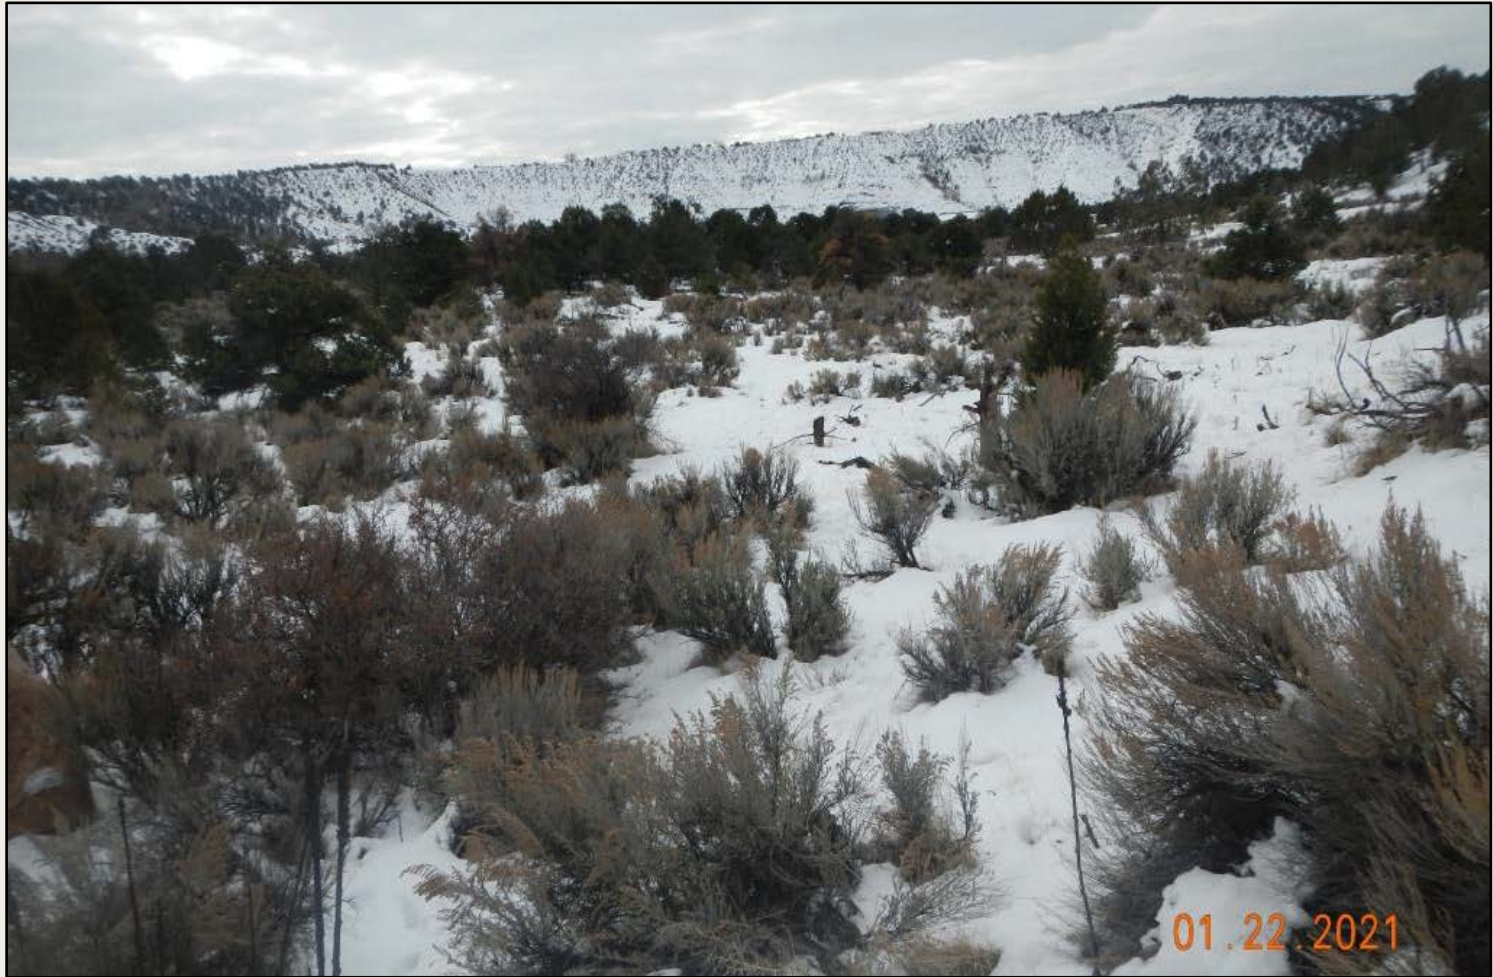
Photo 5. View of the reference area comprised of sagebrush shrubland with scattered pinyon and juniper trees, mountain mahogany, James galleta, and purple threeawn.
