Inspection Photos
Operator: Enduring
API: 067-08652
Date: 1/22/2021

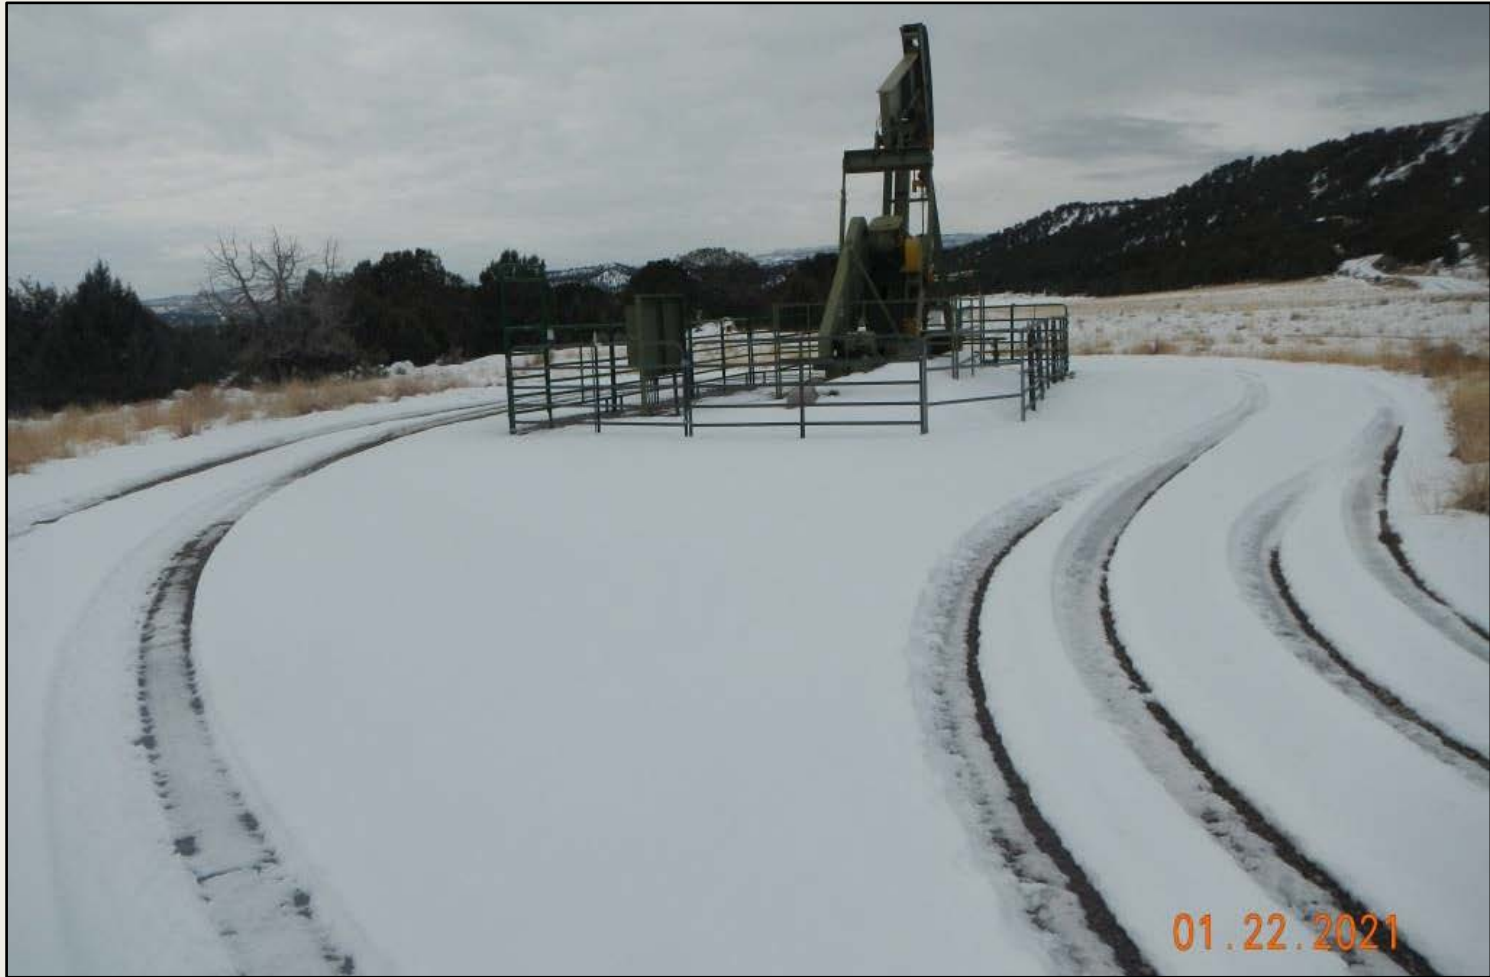
Photo 1. View of the project area from the well pad entrance facing center.

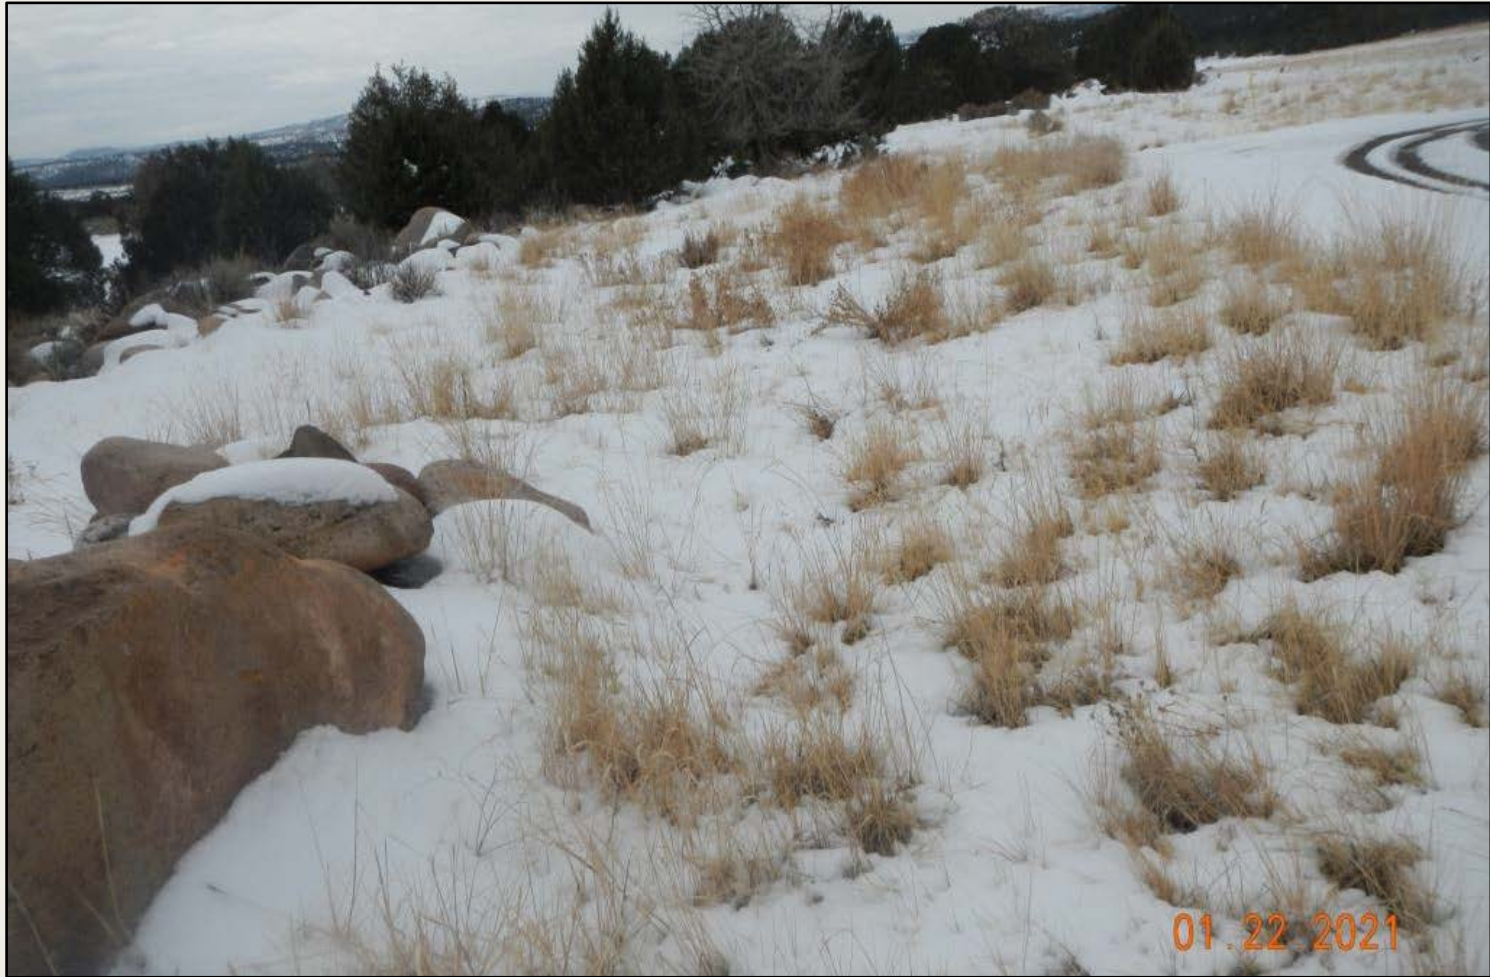
Photo 2. View of the eastern project area from the northeastern corner facing southward. Location largely snow covered. Taller perennial vegetation such as blue grama, western wheatgrass, and sand dropseed observable through the snow.

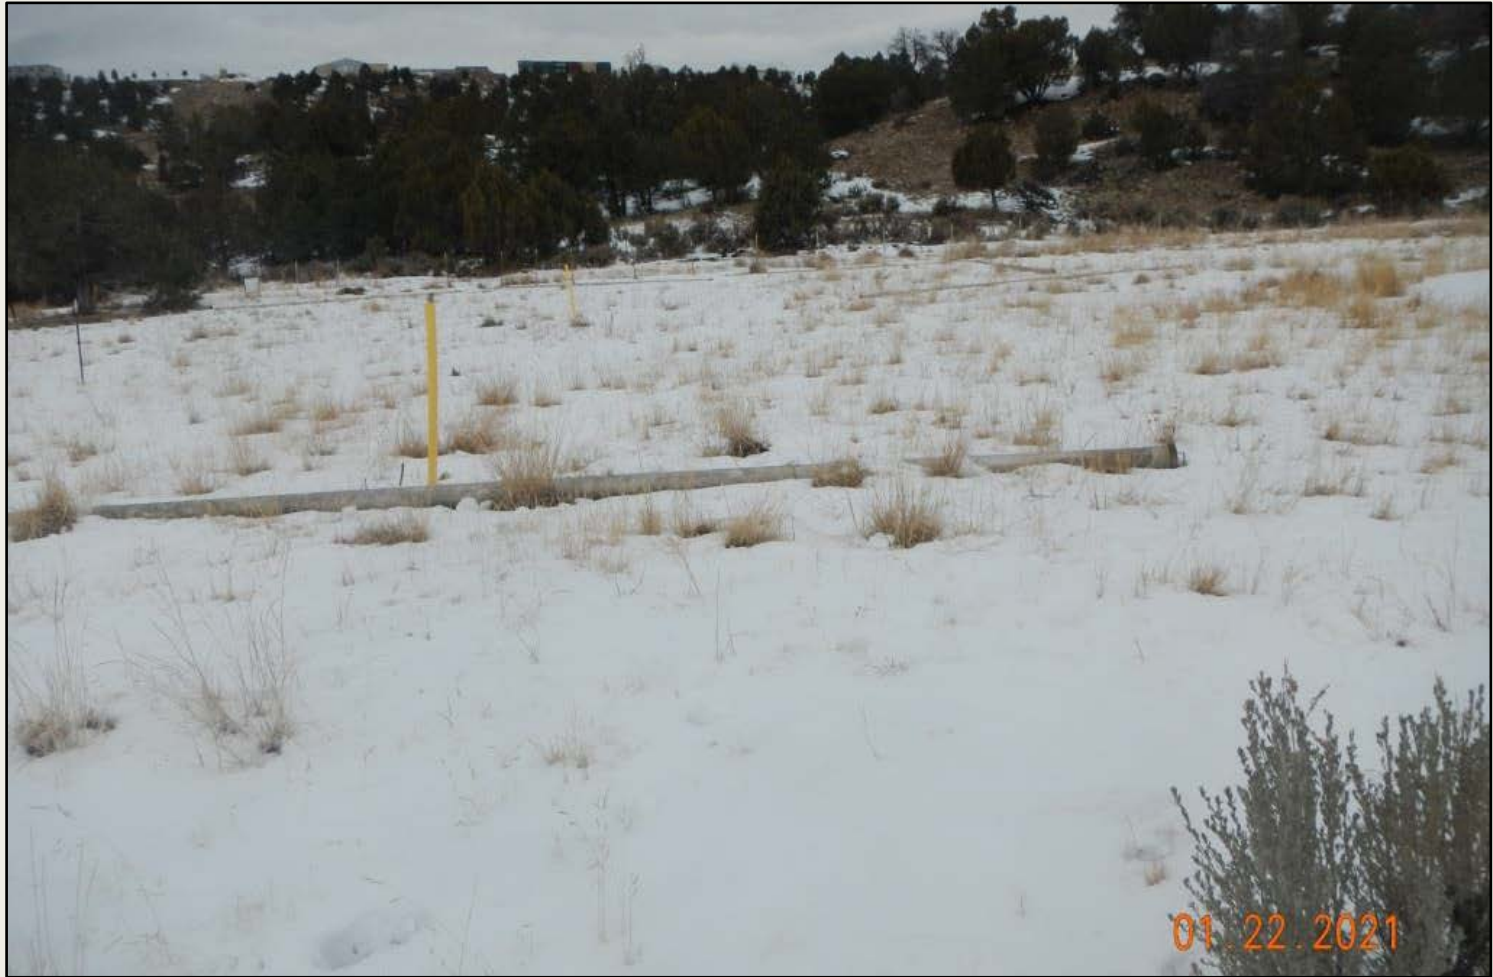
Photo 3. View of the southern project area from the southeastern corner facing westward. Irrigation pipe from adjacent crop field is placed within the southern project area.

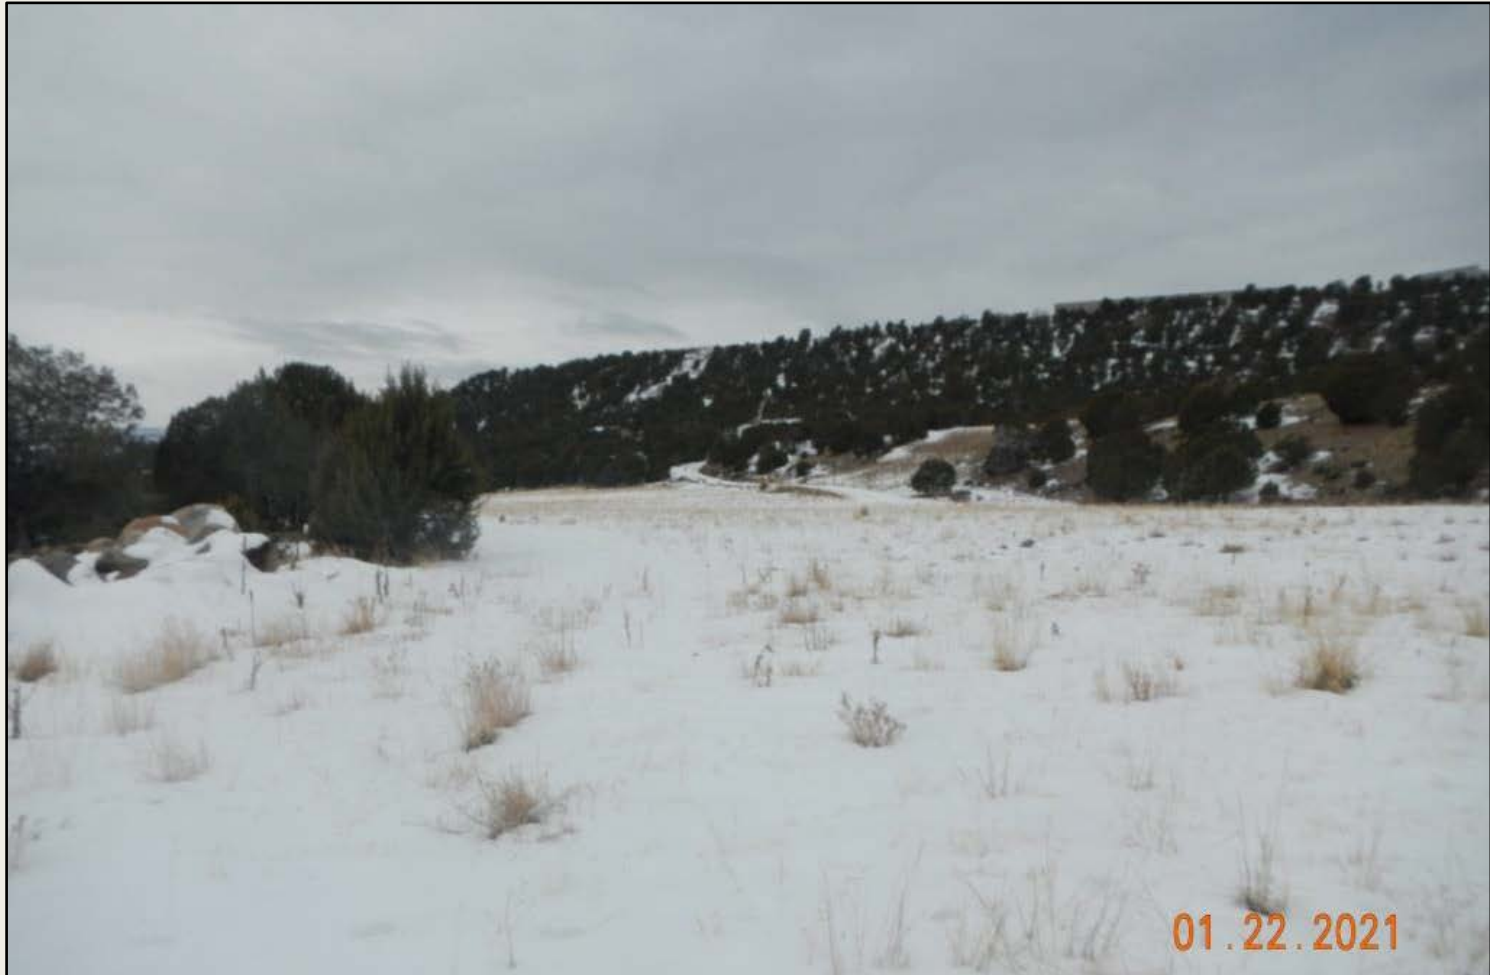
Photo 4. View of the reference area comprised of irrigated grass field (at right) and pinyon/juniper woodland with sagebrush understory (on the right).
