Inspection Photos
Operator: Simcoe
API: 067-06067
Date: 1/22/2021

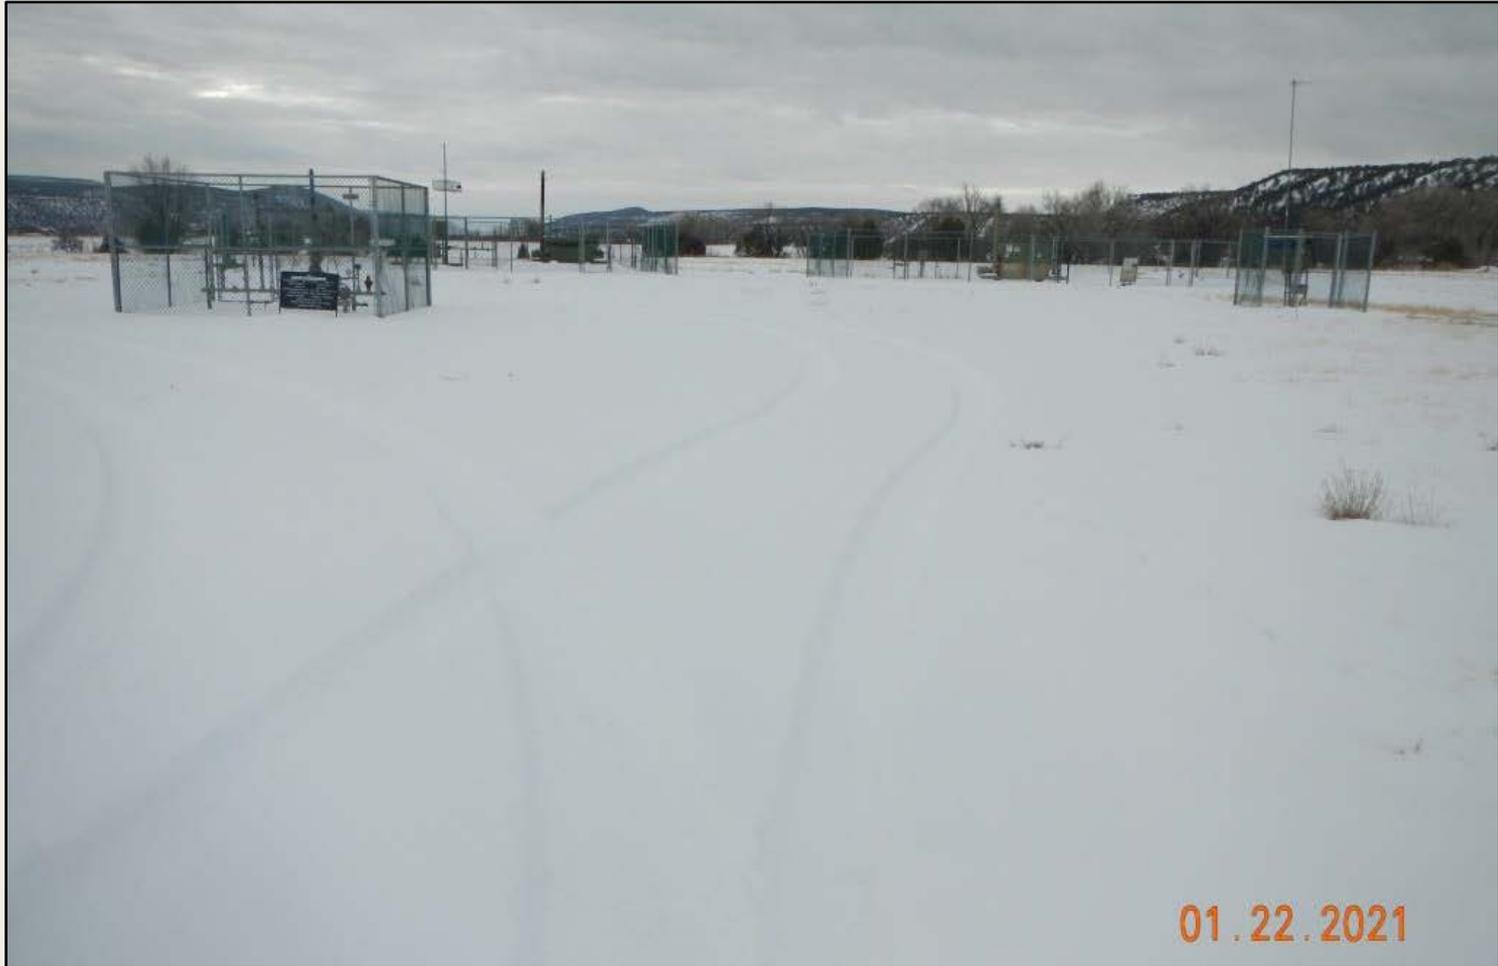
Photo 1. View of the project area from the well pad entrance facing center.

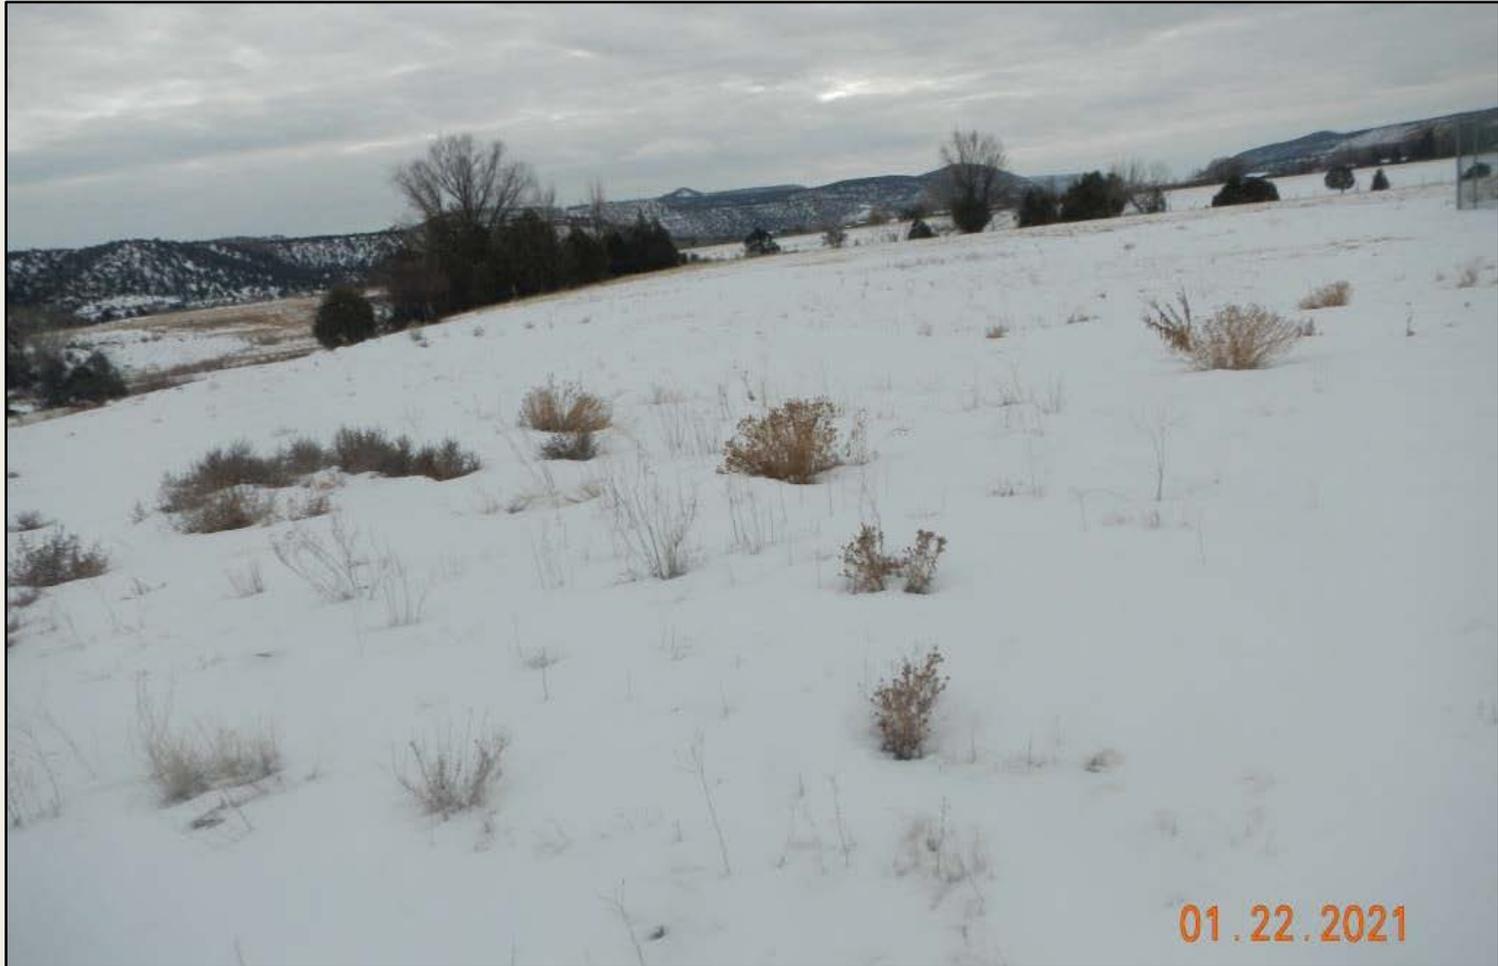
Photo 2. View of the eastern project area from the northeastern corner facing southward. Location largely snow covered. Taller perennial vegetation such as smooth brome, western wheatgrass, and sand dropseed observable through the snow. Scattered musk thistles observed.

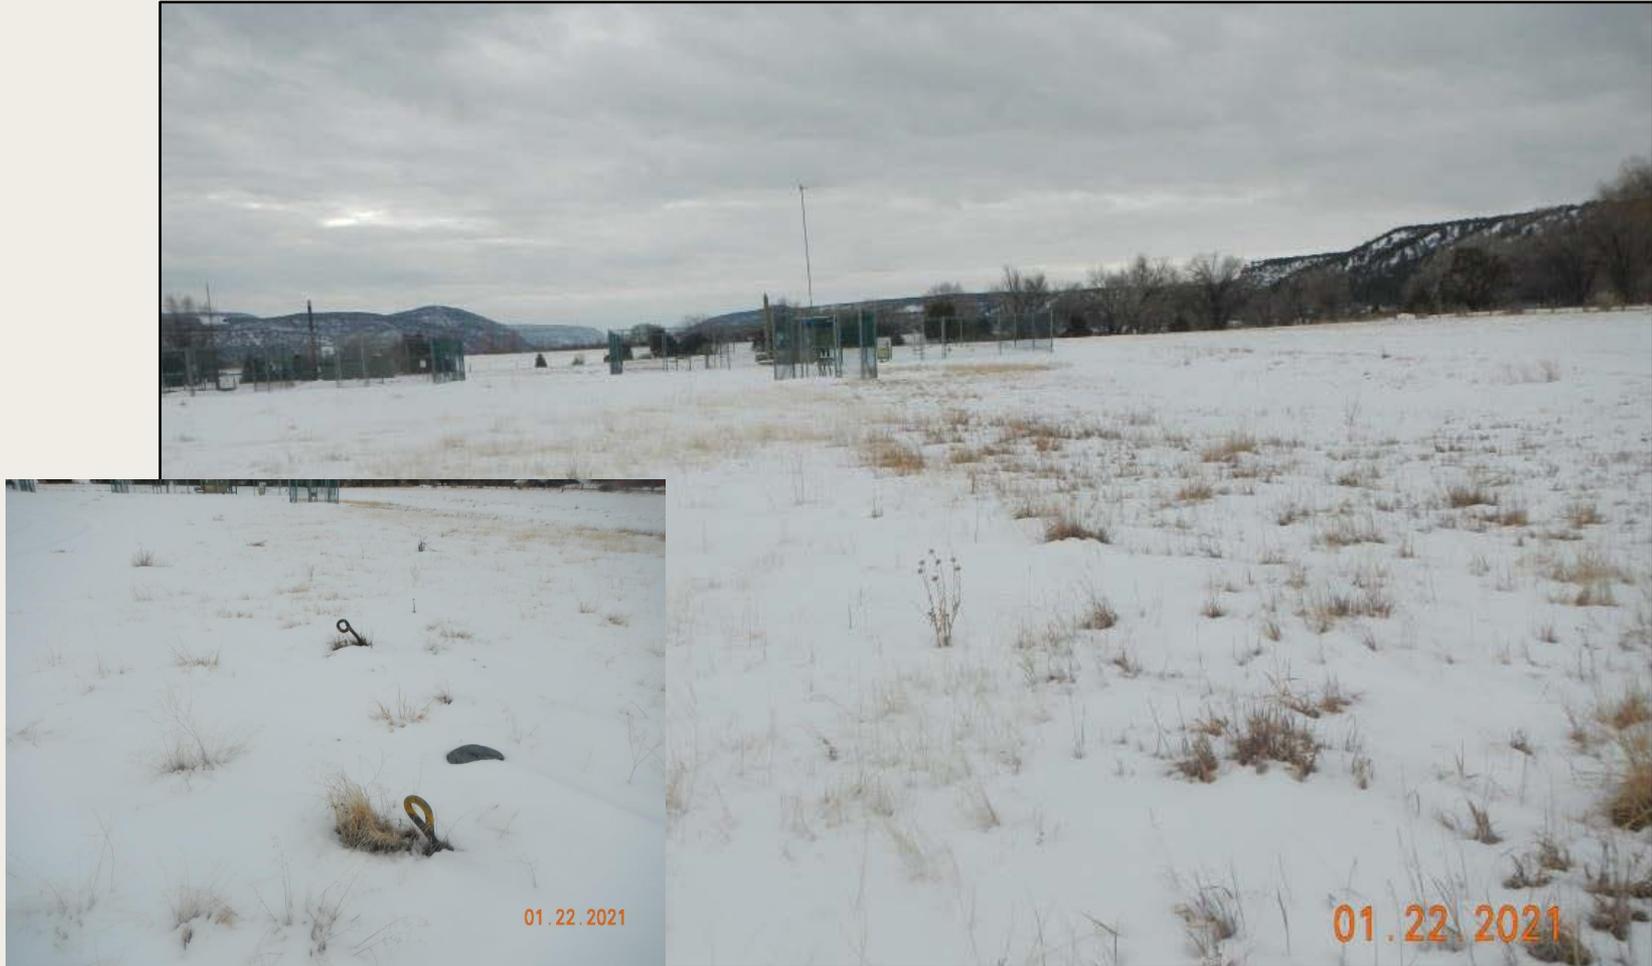
Photo 3. View of the western project area from the northwestern corner facing northward. Irrigation pipe from adjacent crop field is placed within the southern project area. Unmarked guyline anchors in the northwestern project area (see inset).

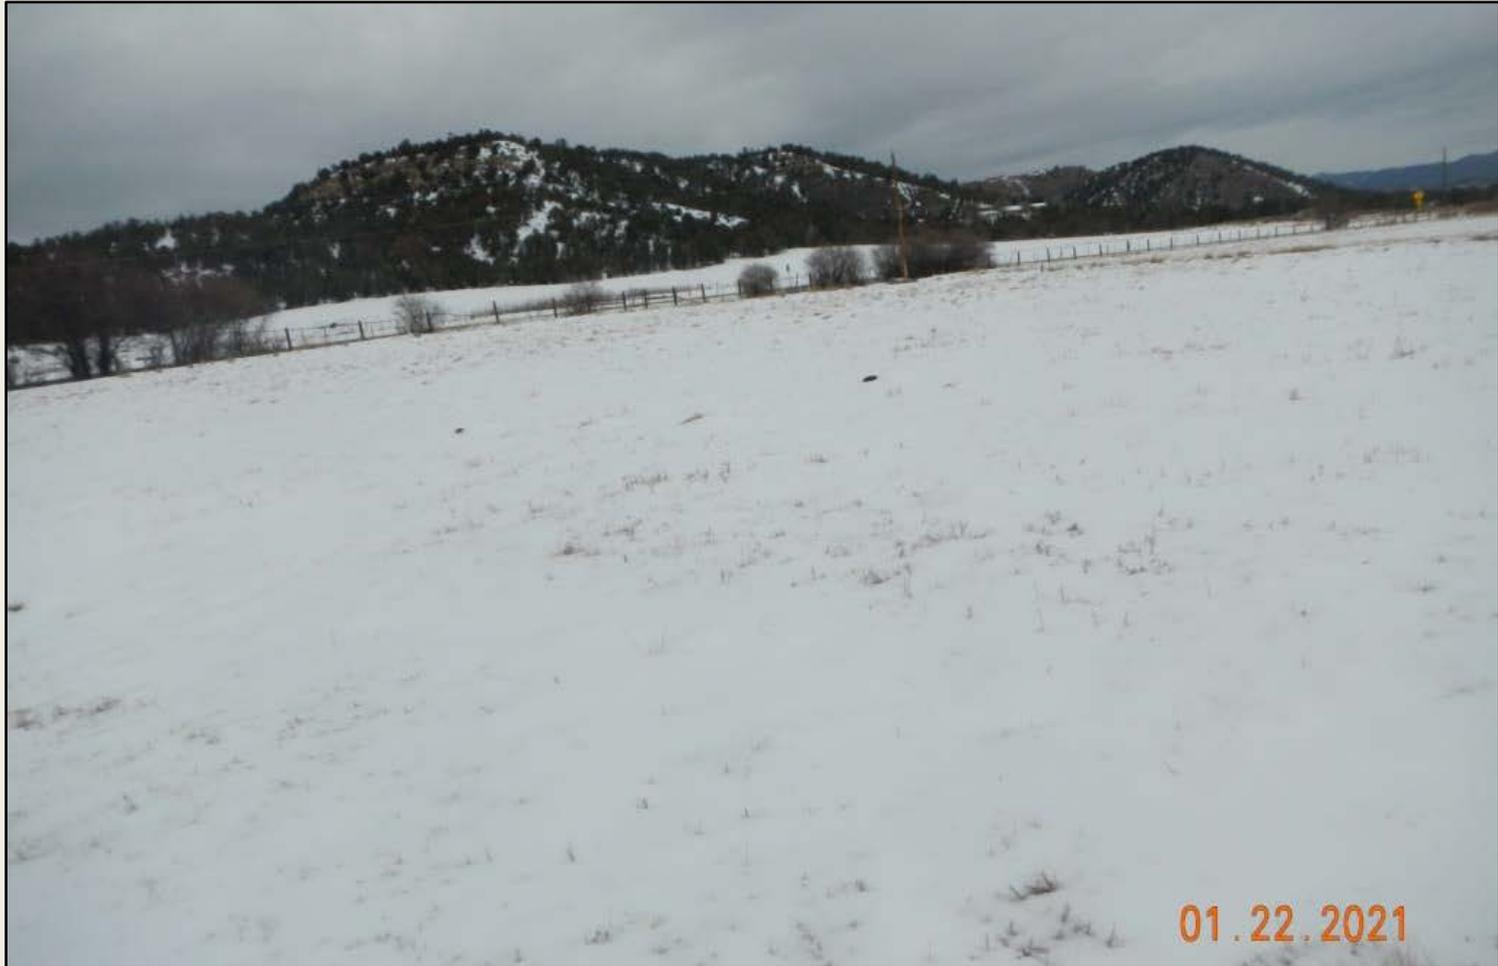
Photo 4. View of the reference area comprised of irrigated grass field, with smooth brome observed, although largely snow covered at this time.
