Inspection Photos  
Operator: Enduring  
API: 067-07644  
Date: 1/22/2021

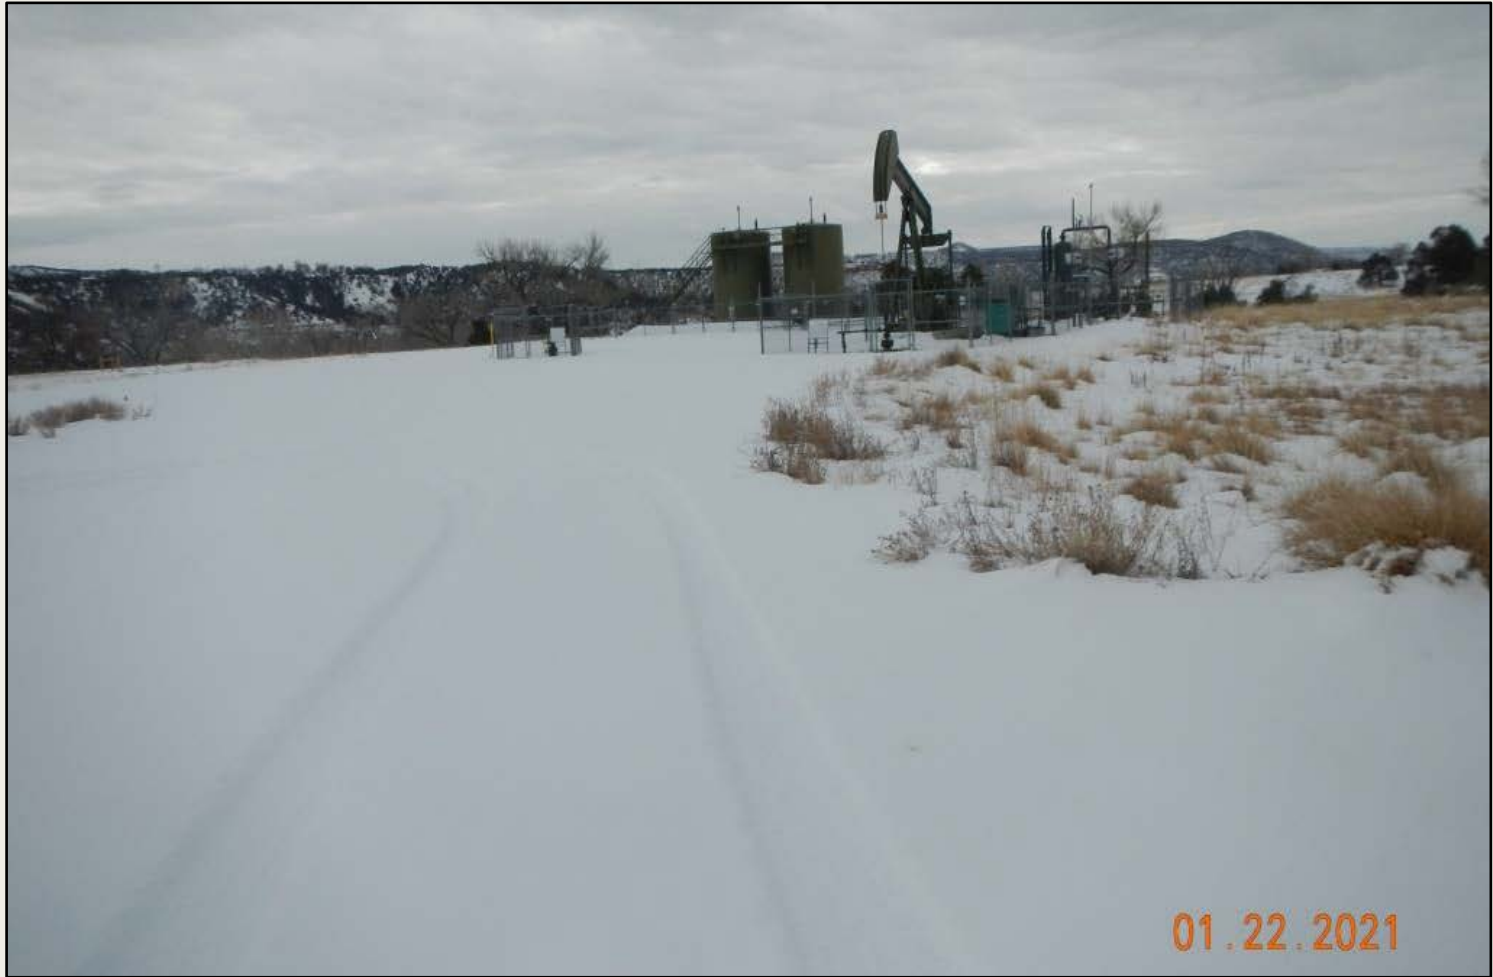
Photo 1. View of the project area from the well pad entrance facing center.

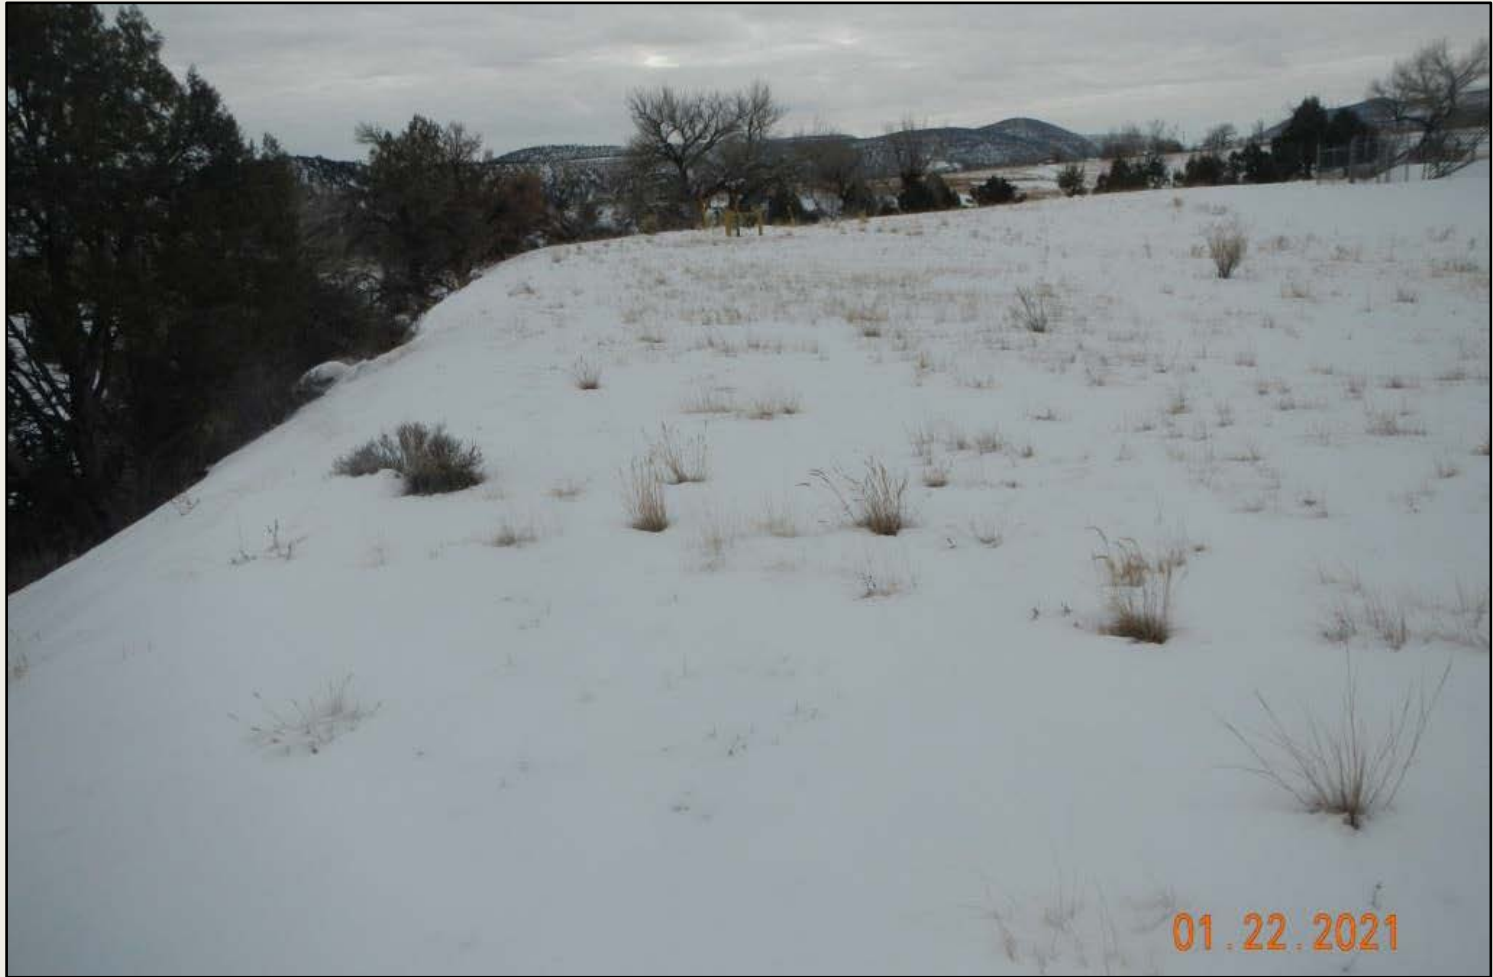
Photo 2. View of the eastern project area from the northeastern corner facing southward. Location largely snow covered. Taller perennial vegetation such as western wheatgrass and sand dropseed observable through the snow.

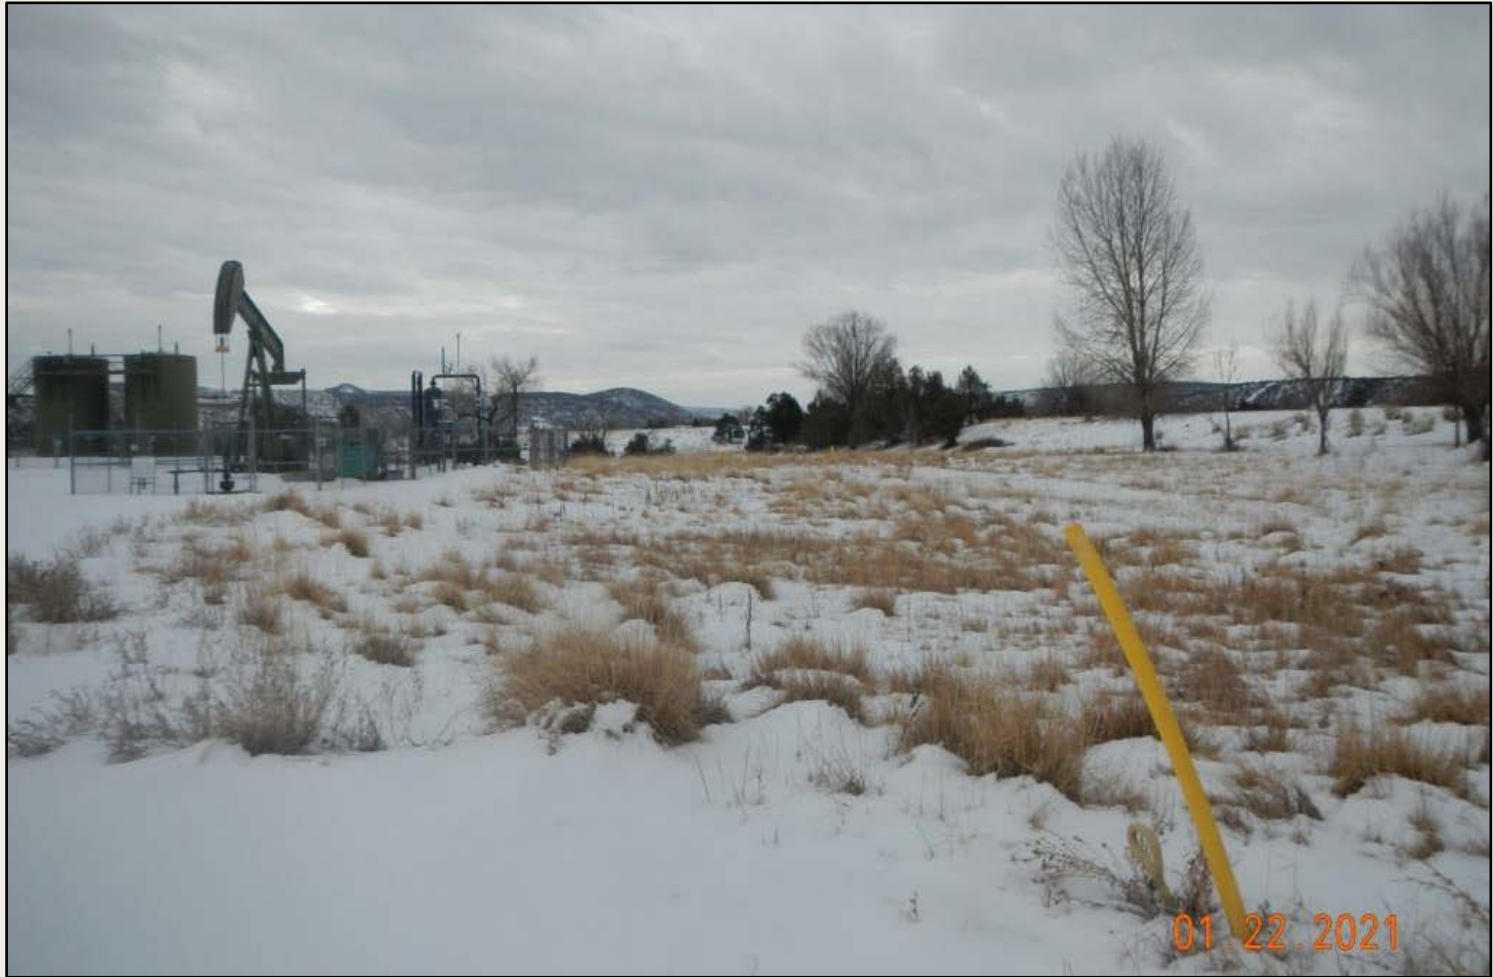
Photo 3. View of the western project area from the northwestern corner facing southward.

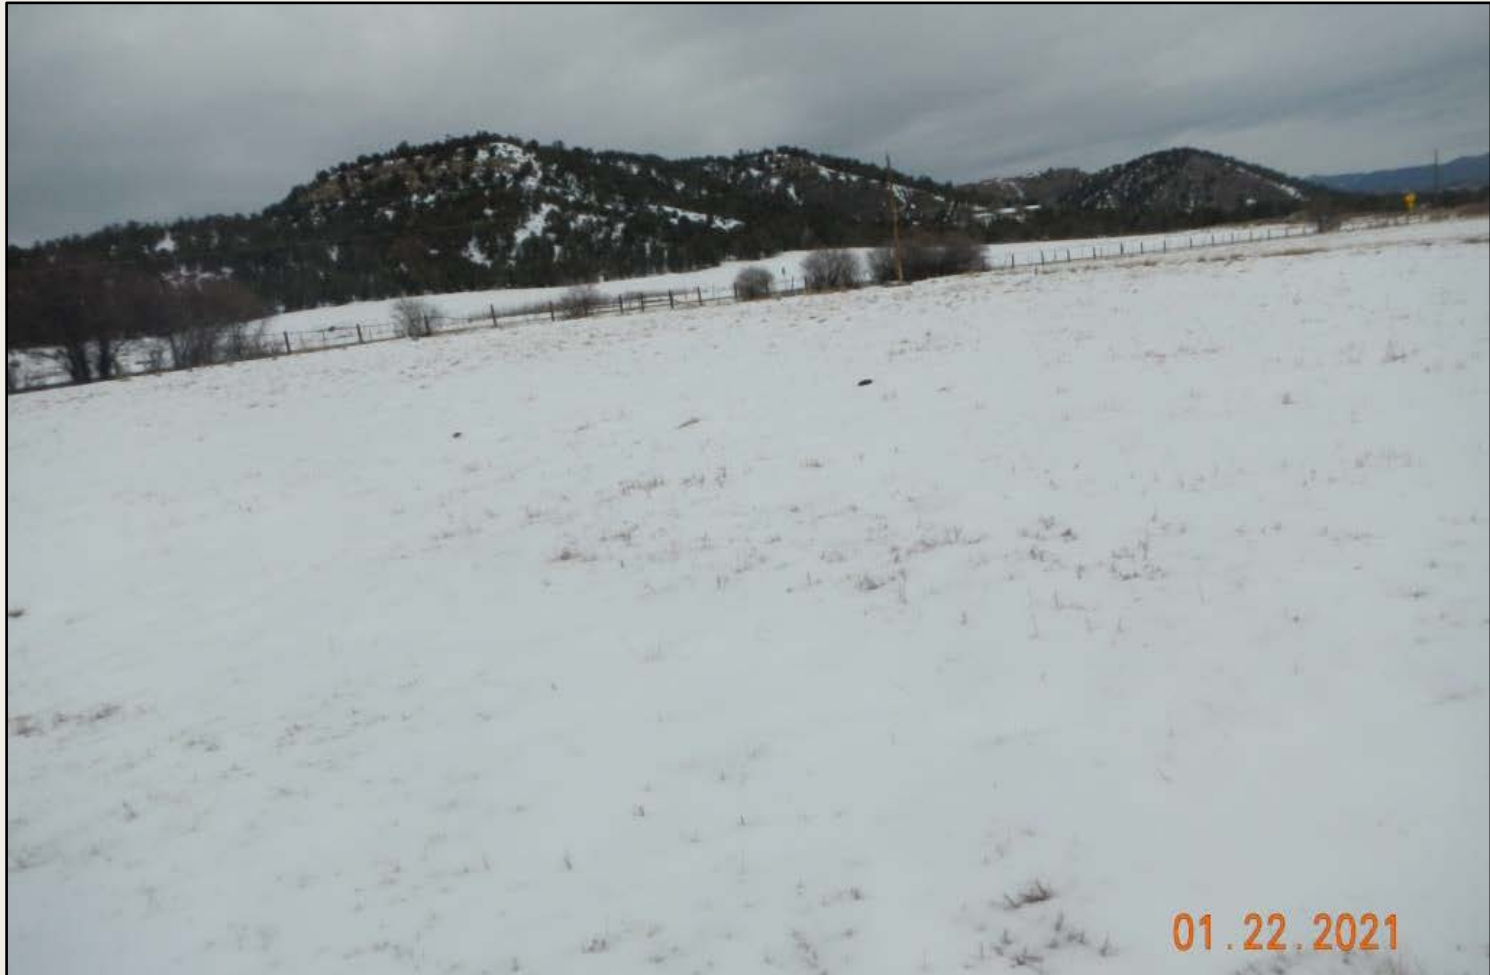
Photo 5. View of the reference area comprised of irrigated grass field, with smooth brome observed, although largely snow covered at this time. Location is also adjacent to a pinyon/juniper woodland with sagebrush understory. Reference area will be determined based on final land use.
