Inspection Photos

Location Name: TEP ROCKY MOUNTAIN LLC KNIGHT-67S95W /5SENE

Location ID: 334652

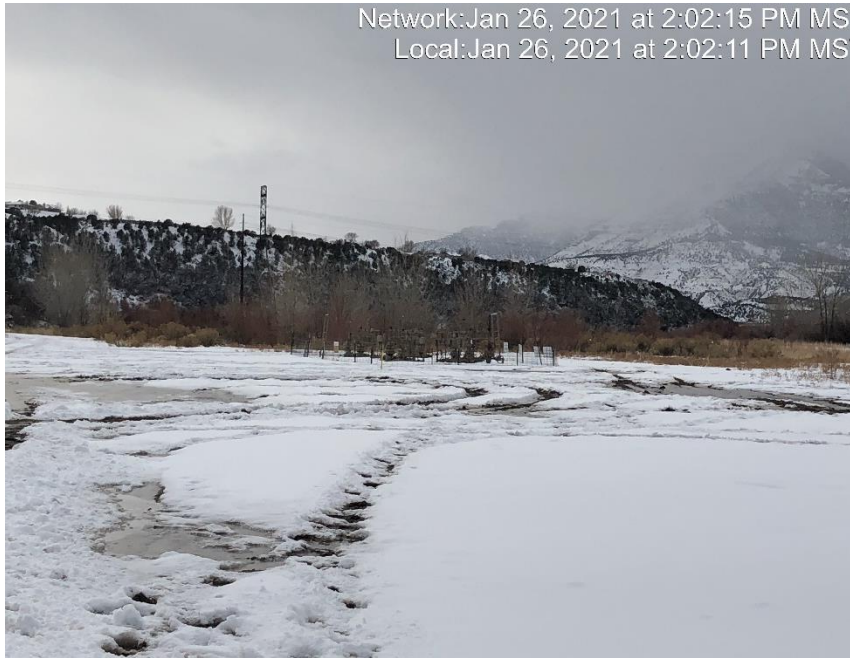
Photo #2718 from entrance to location.

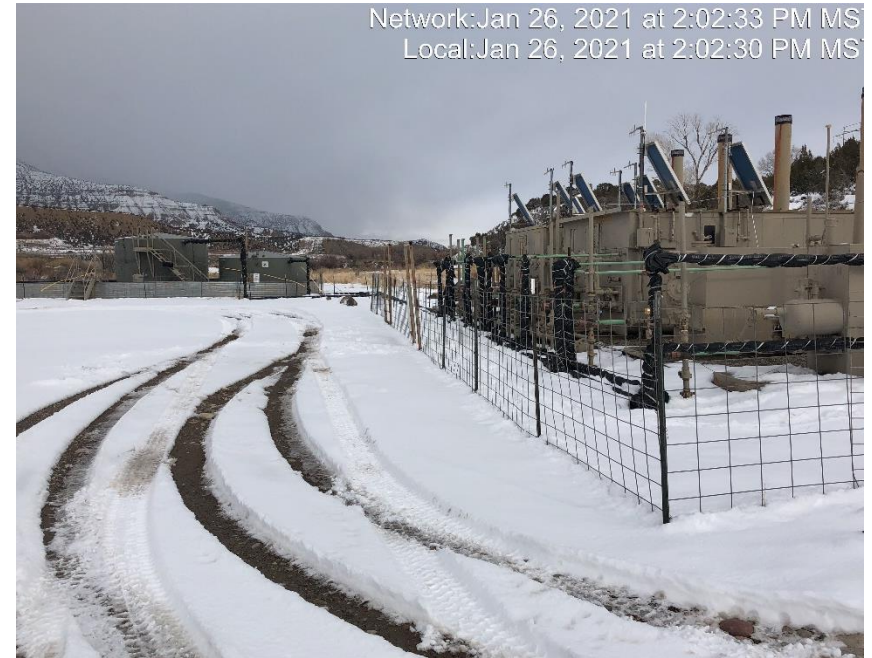
Photo #2719 from entrance to location.

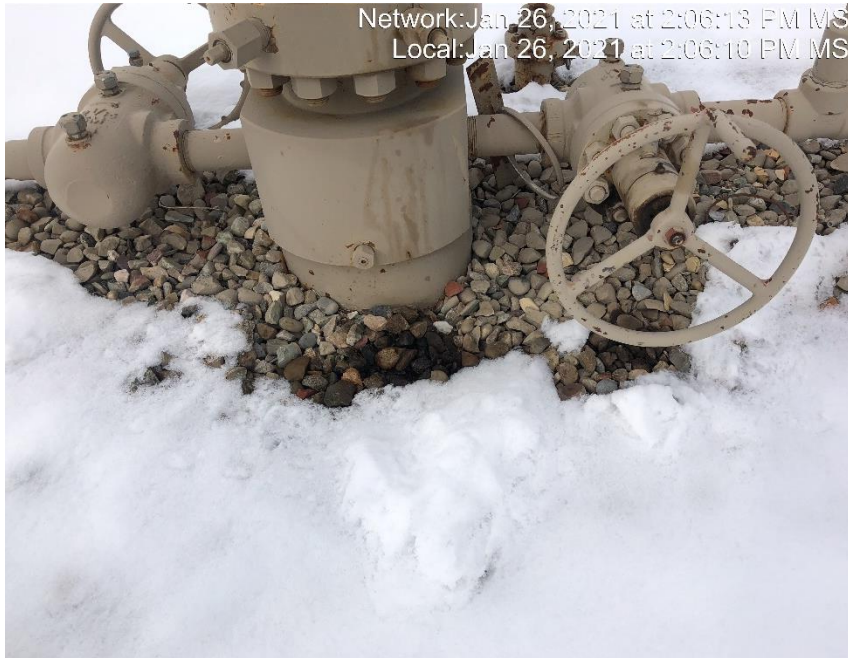
Photo #2720 Stained soils located at wellhead.

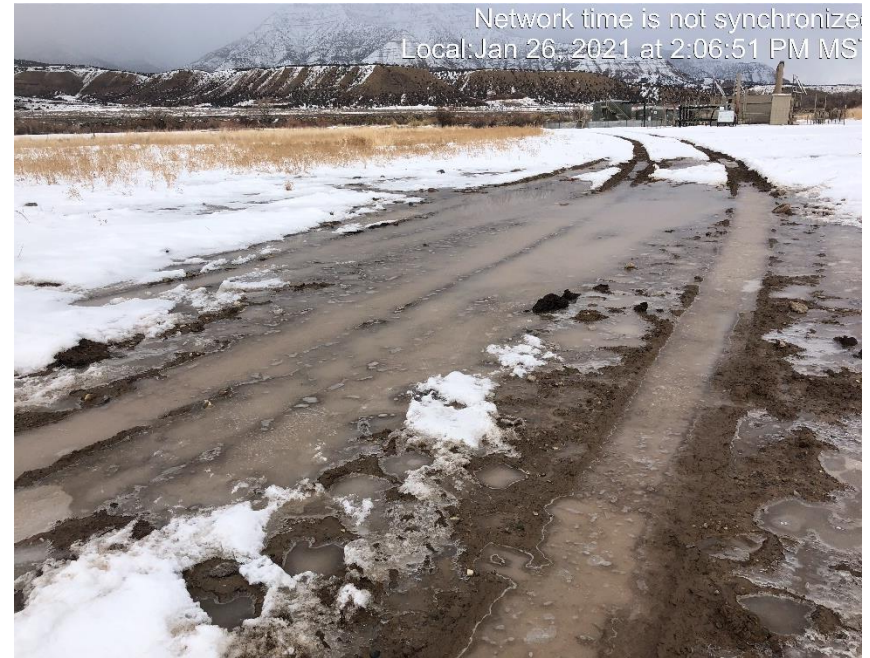
Photo #2721 Ruts present on location due to lack of stabilization.

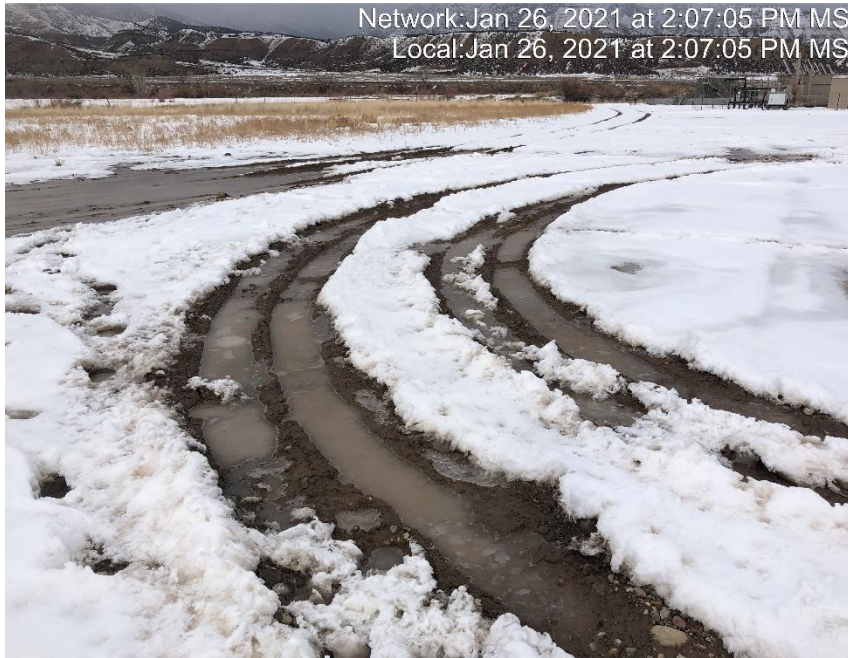
Photo #2722 Ruts present on location due to lack of stabilization.
