COLORADO
Oil & Gas Conservation
Commission
Department of Natural Resources

Arrowhead 9

API: 05-103-05301

Inspection: 700405198

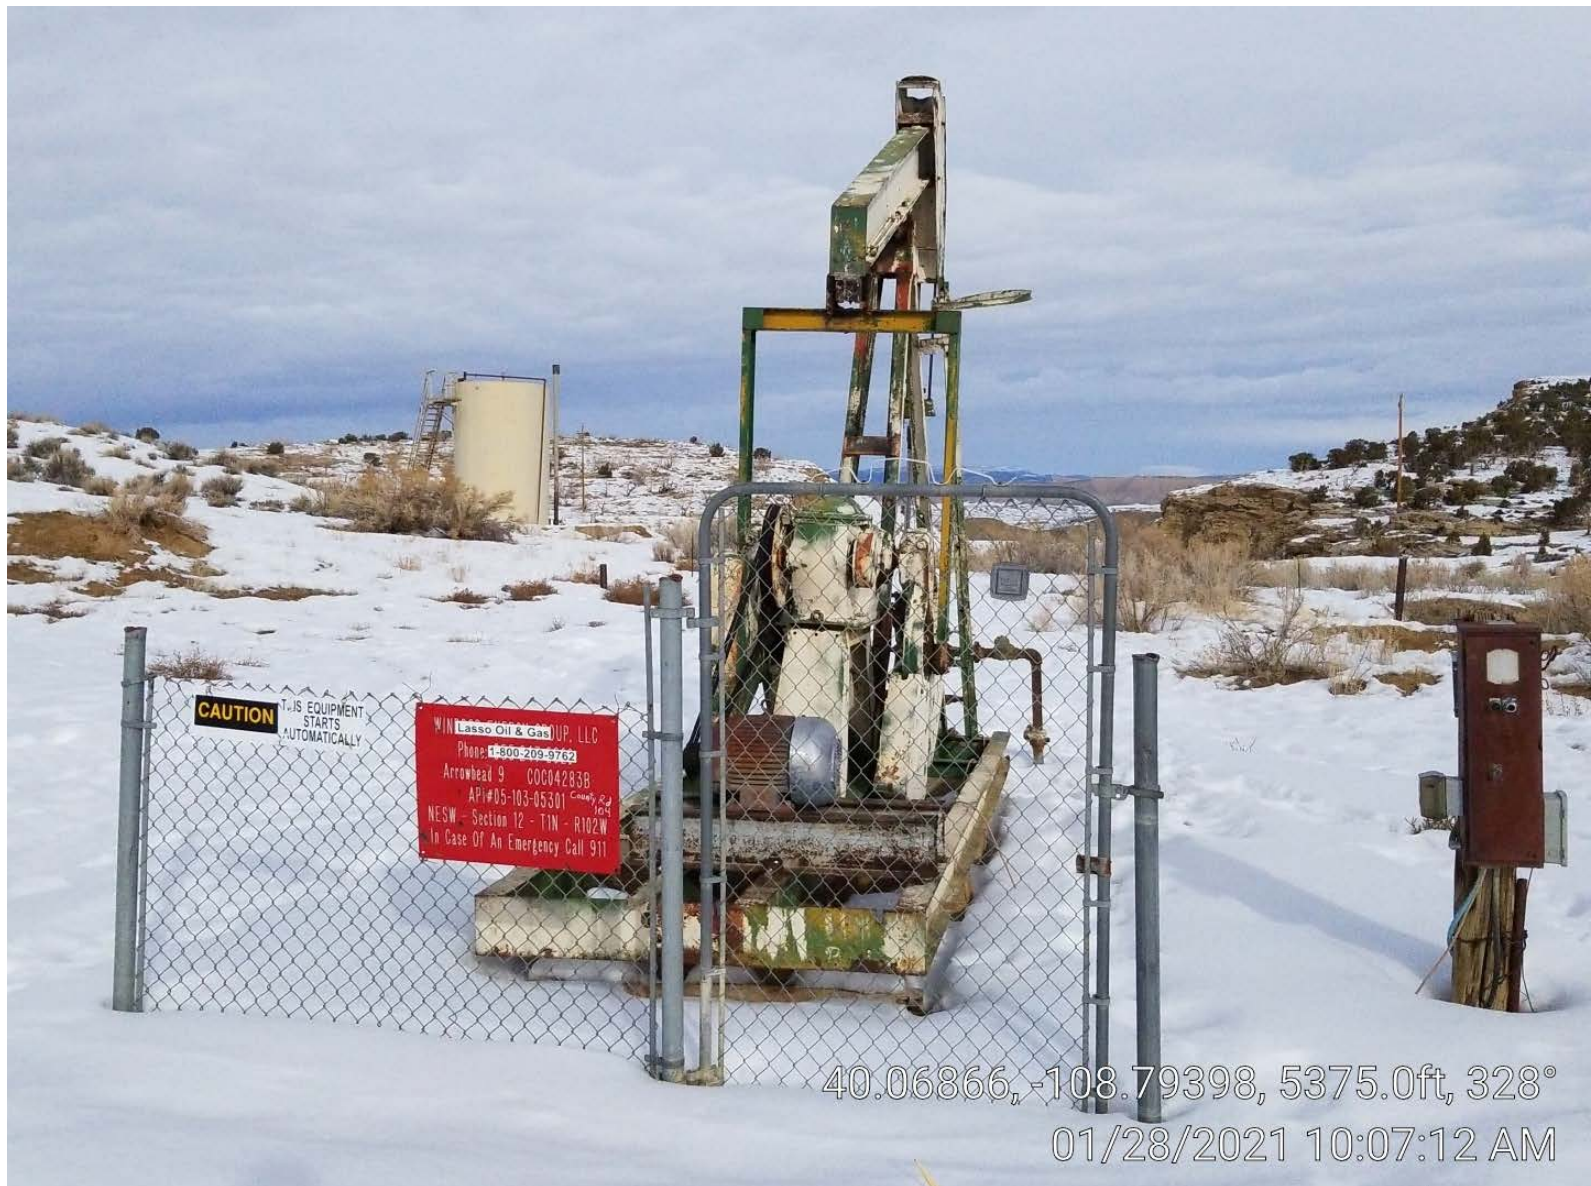
Photo 1. Location.

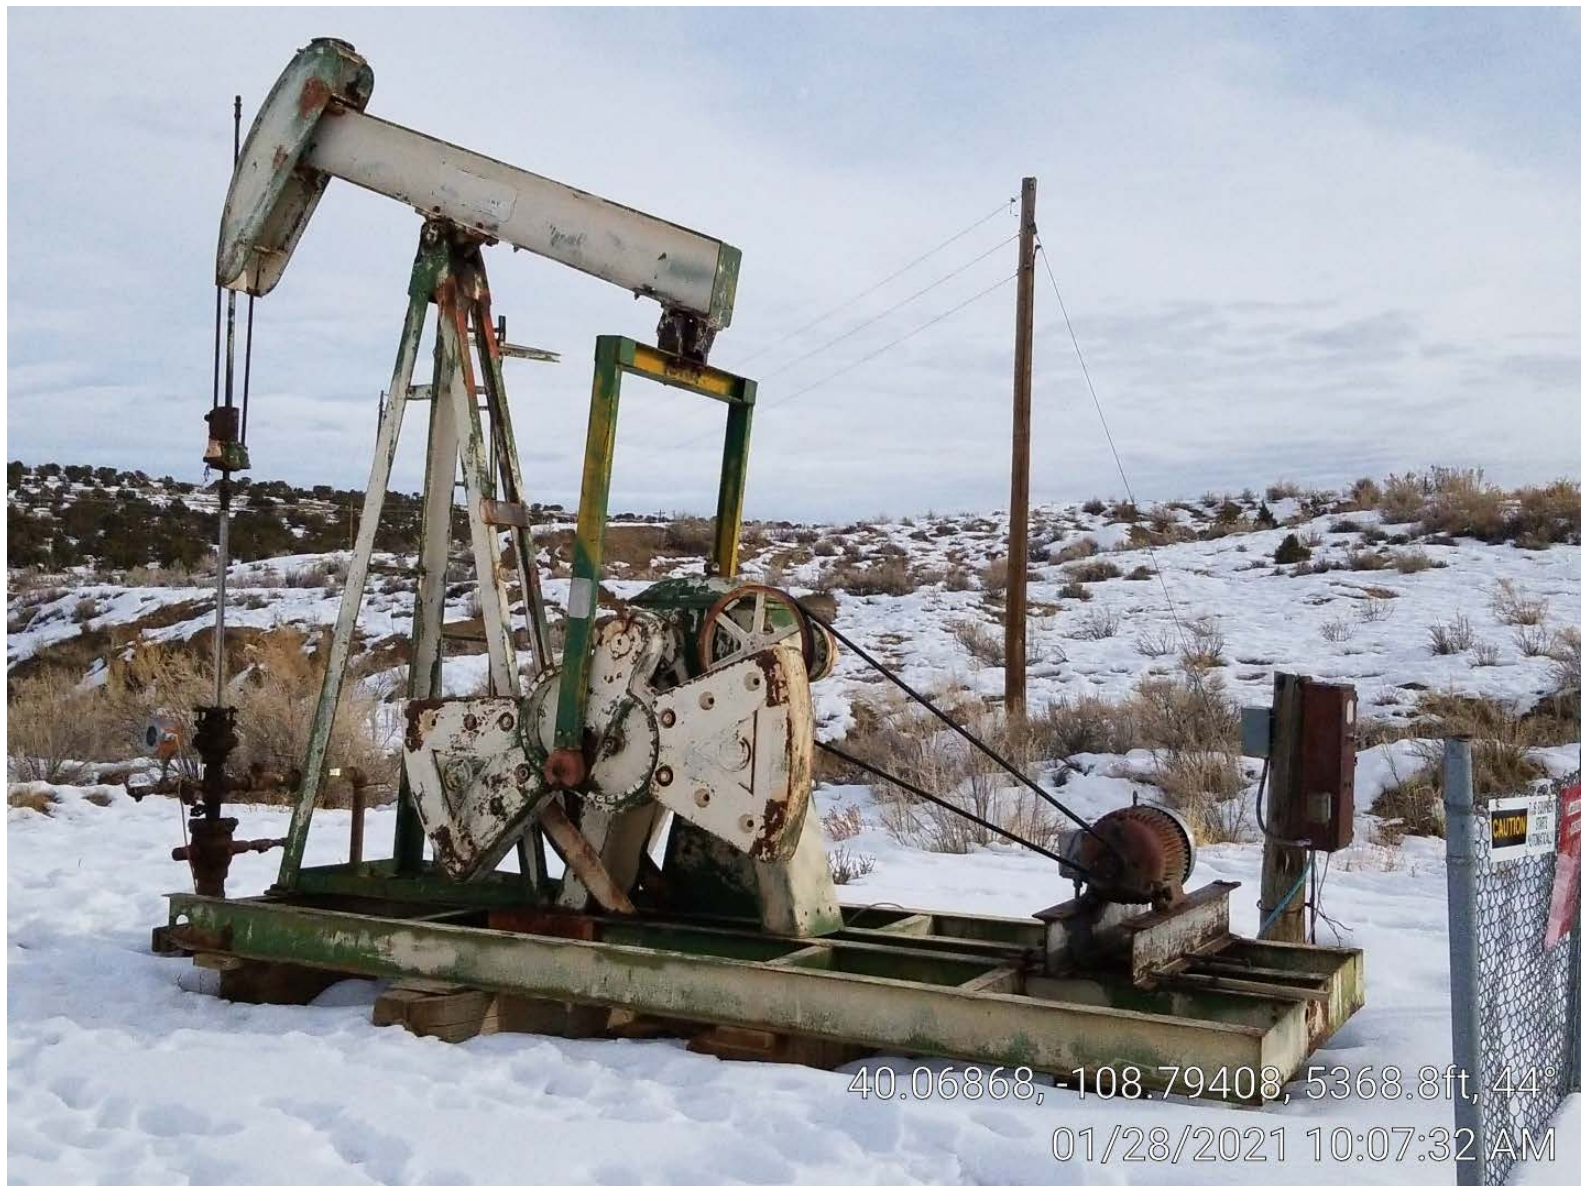
Photo 2. Pump jack.

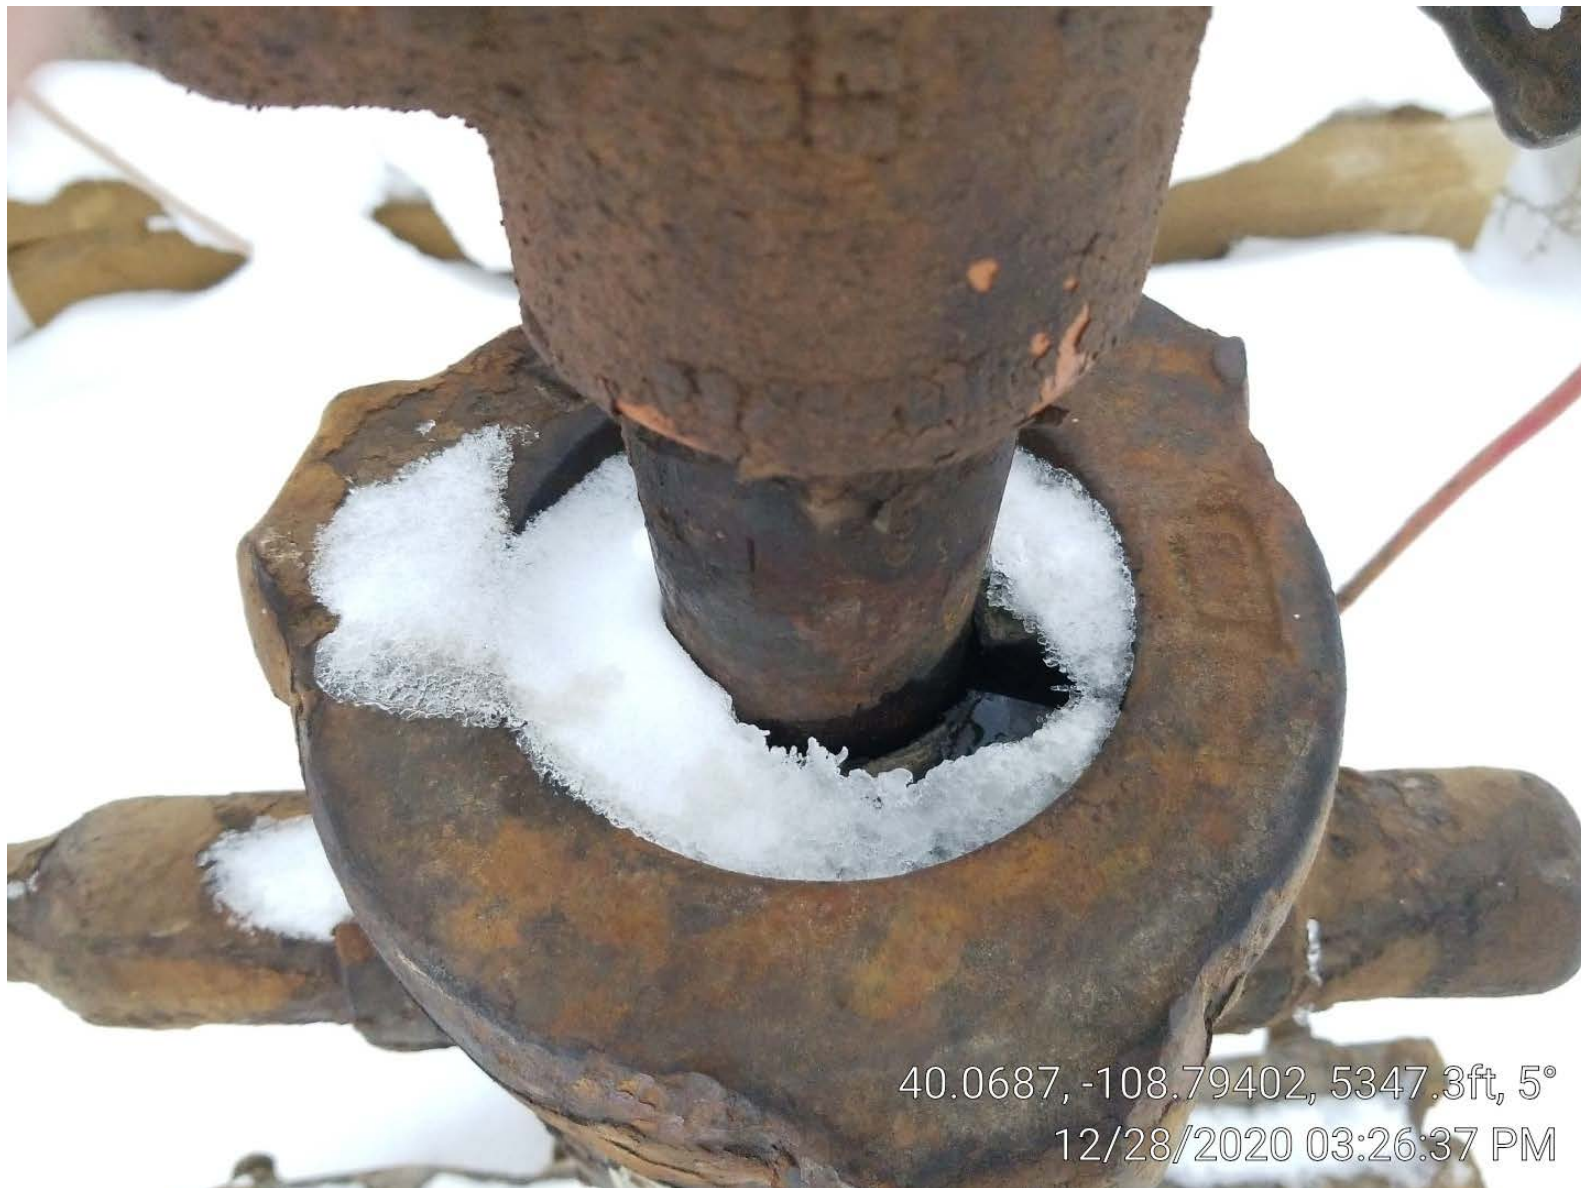
Photo 4. Larkin nut on 12-28-2020.

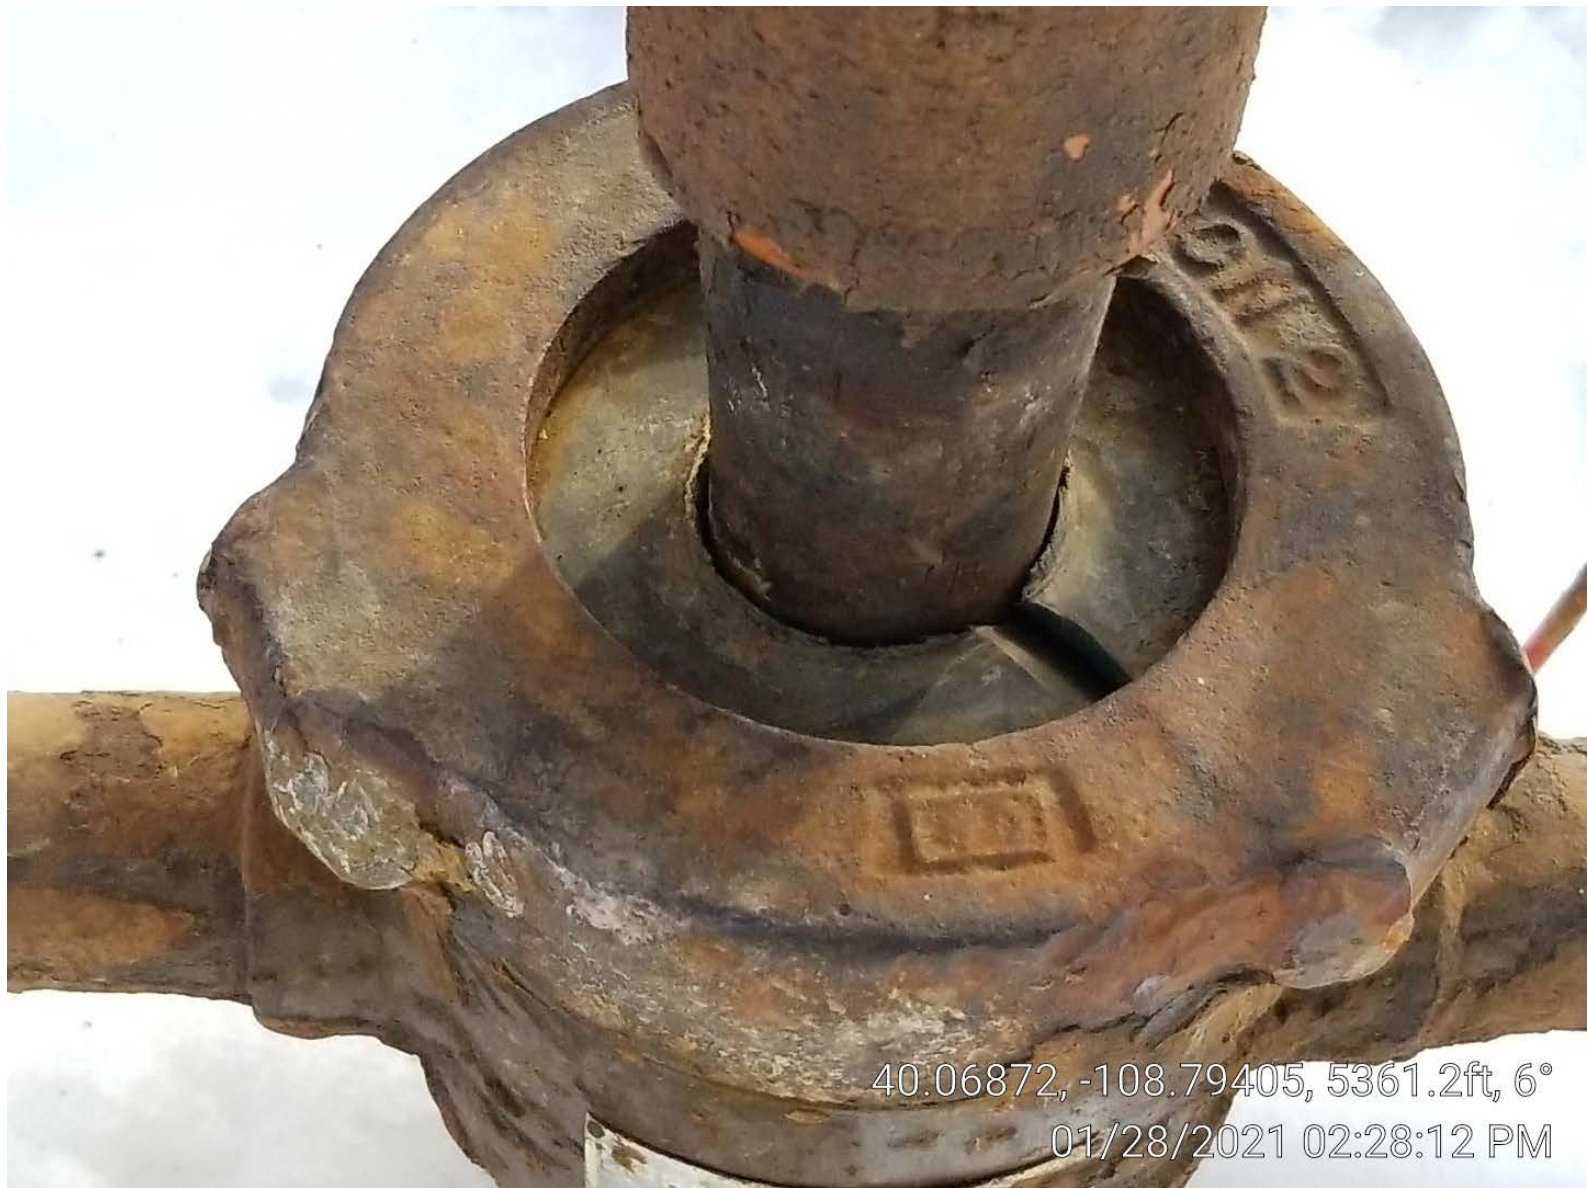
Photo 7. Larkin nut on 1-28-2021 @ 14:28.

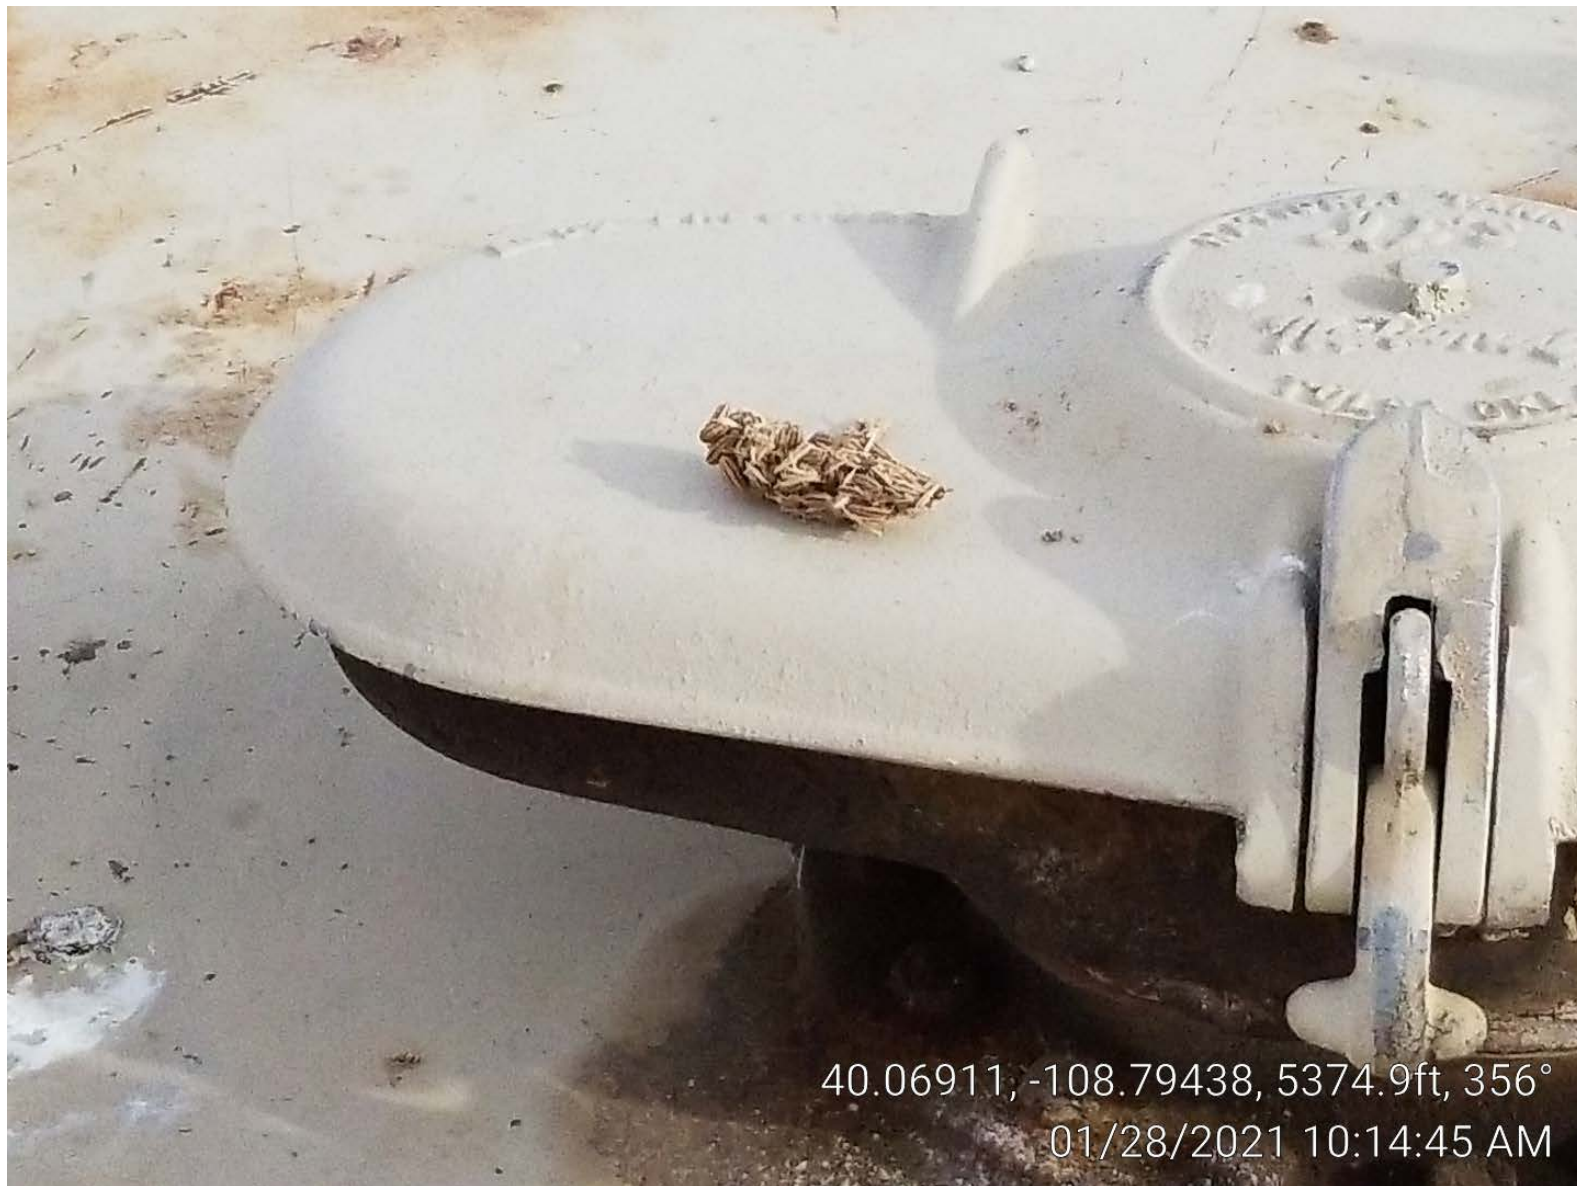
Photo 8. Tank hatch.

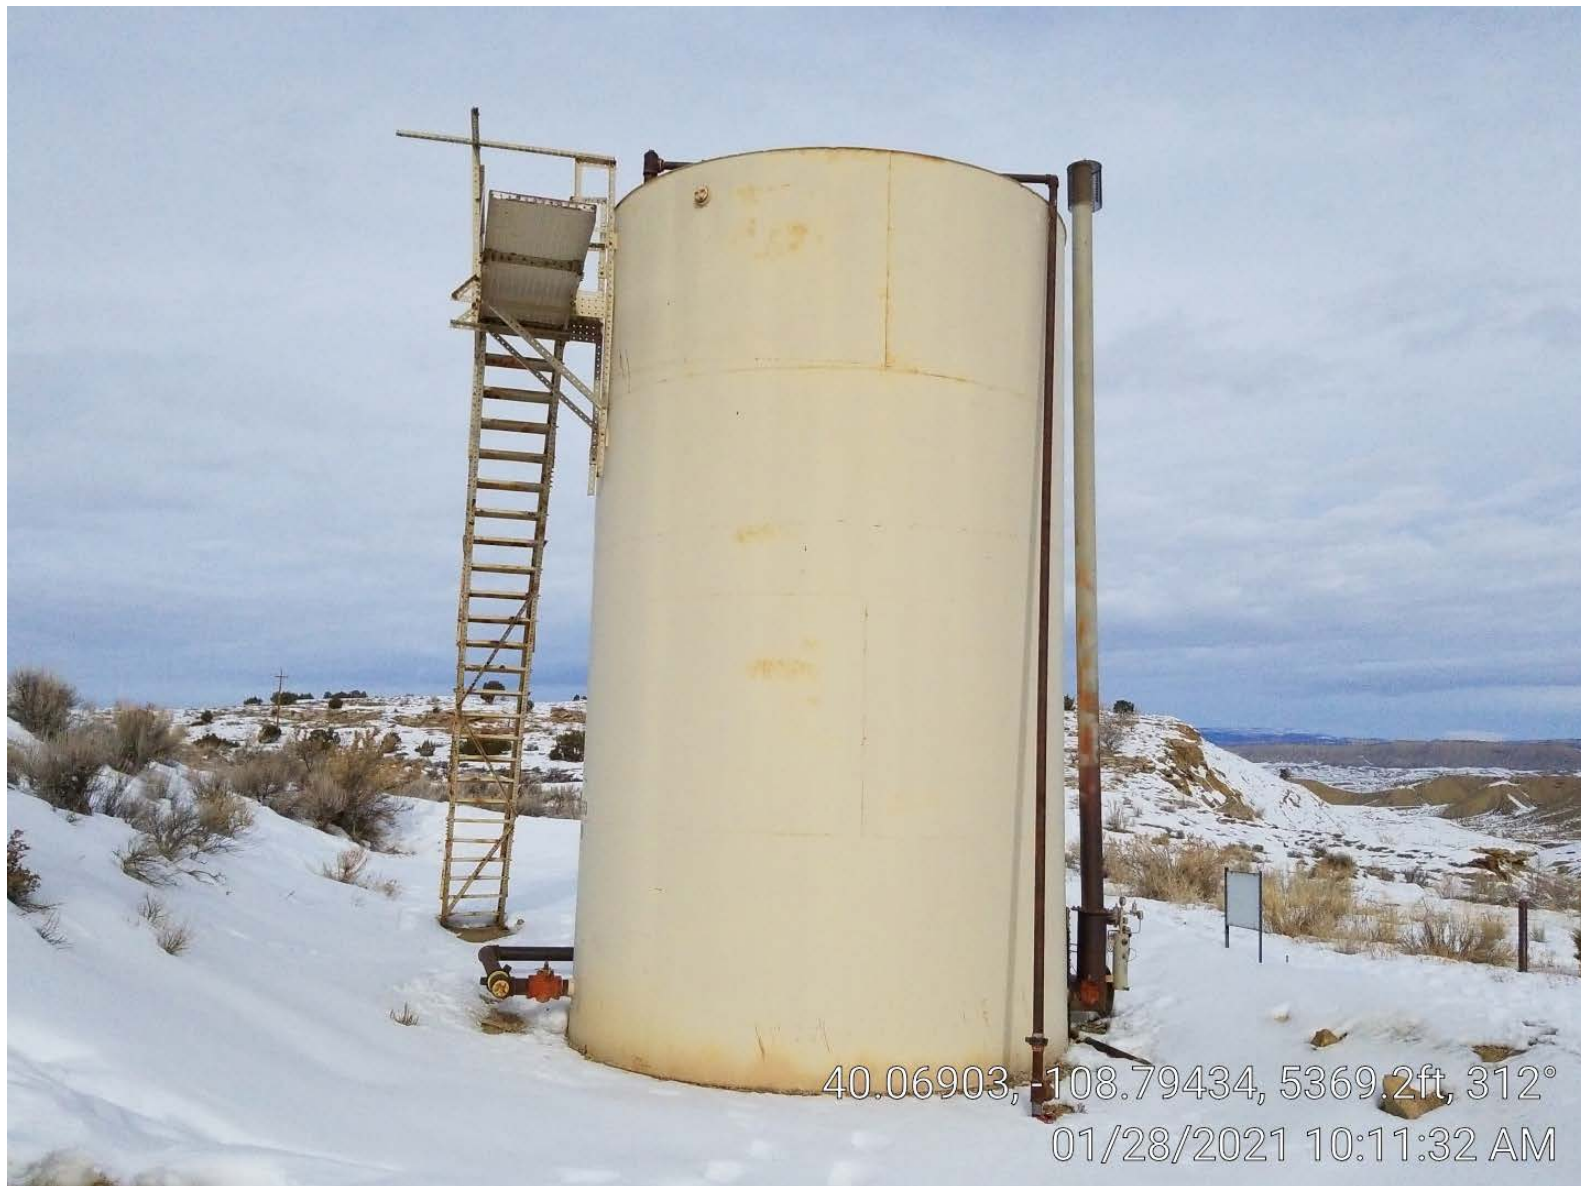
Photo 9. Tank.

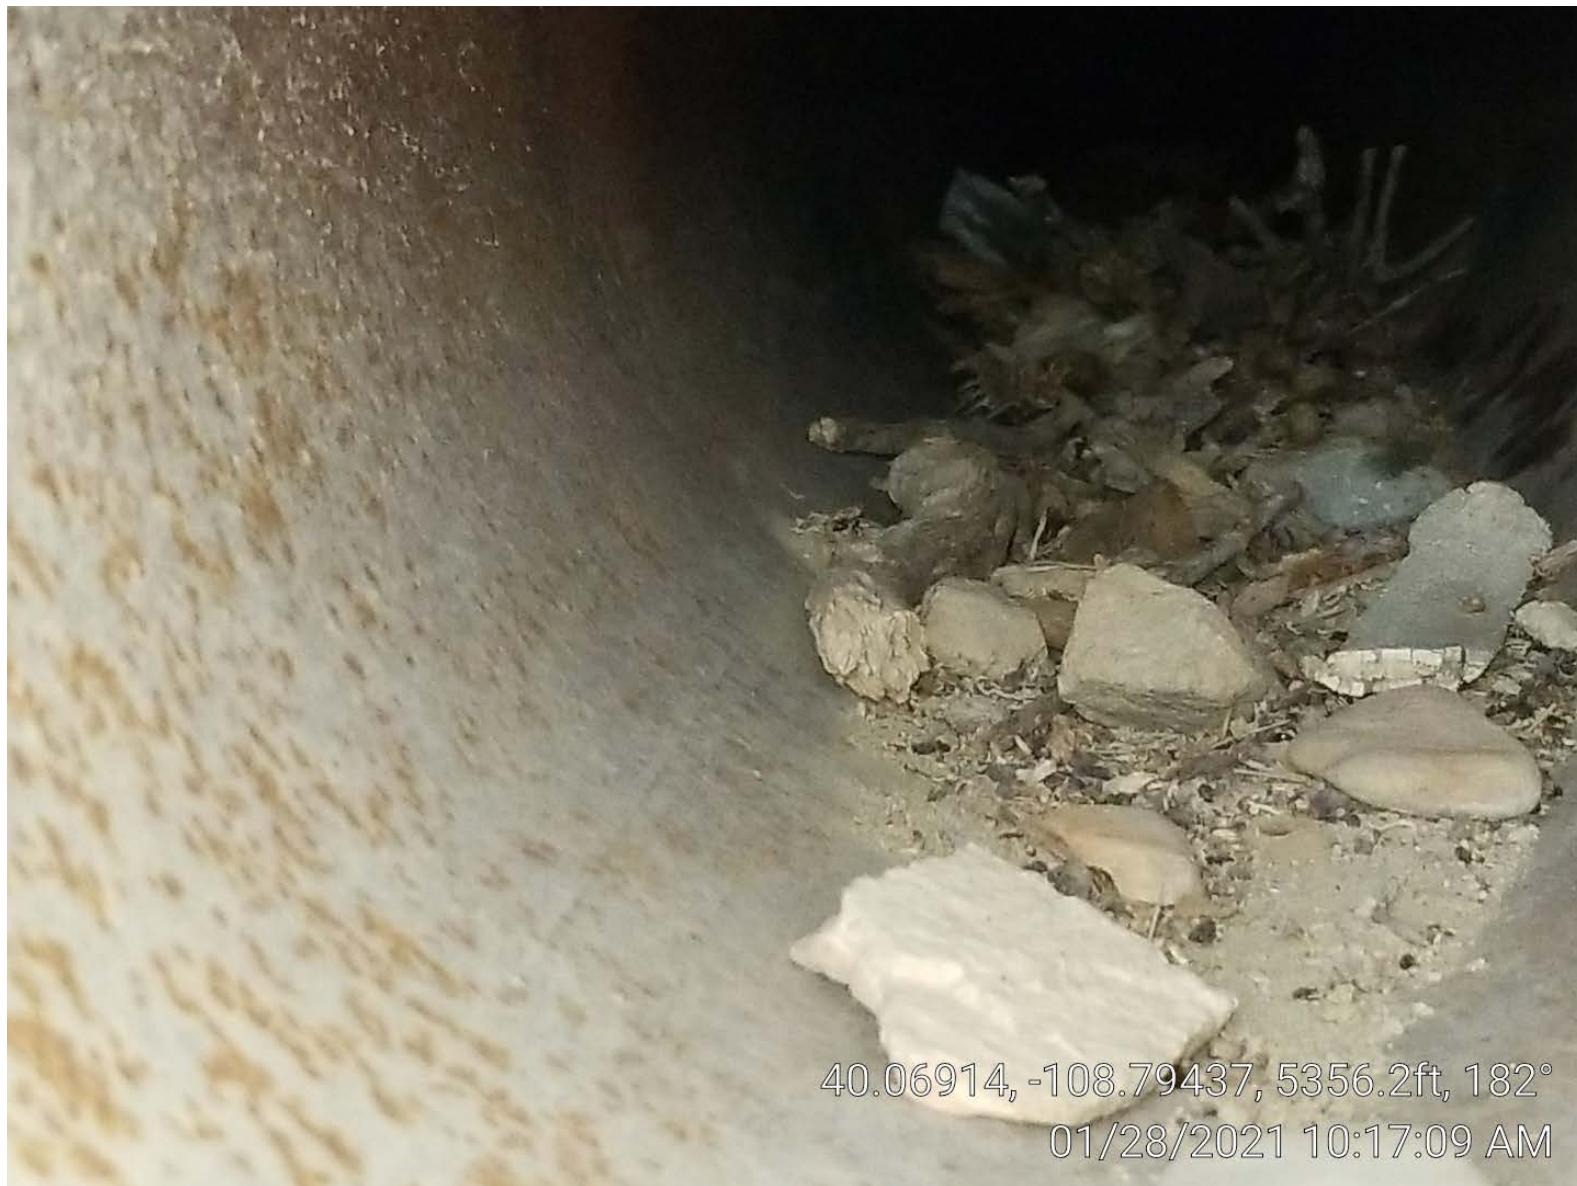
Photo 11. View looking into bottom tank pipe.
