## Inspection Photos

Location Name: CAERUS PICEANCE LLC DAYBREAK FEDERAL /30-12 (PL30)

Location ID: 414077

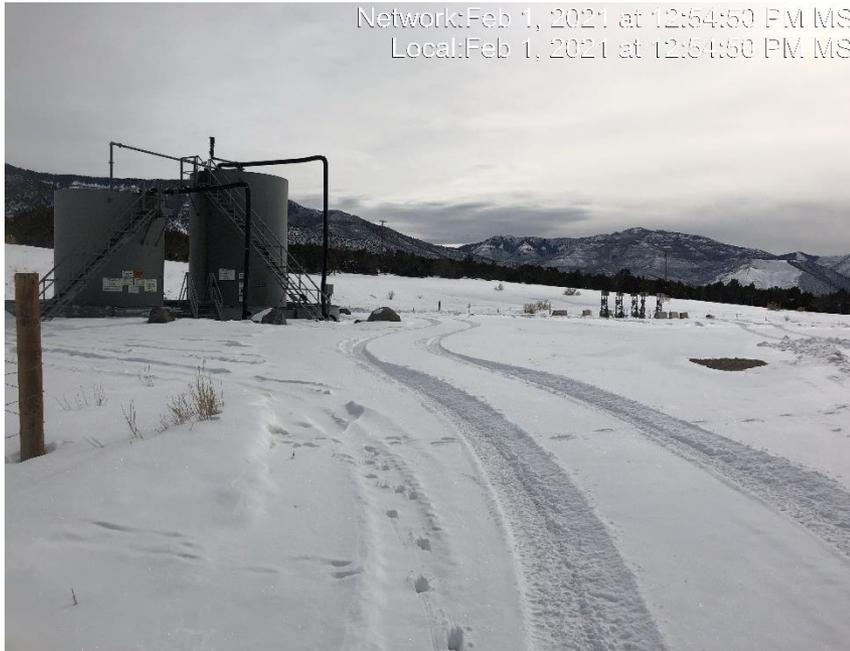
Photo #2768 from entrance to location.

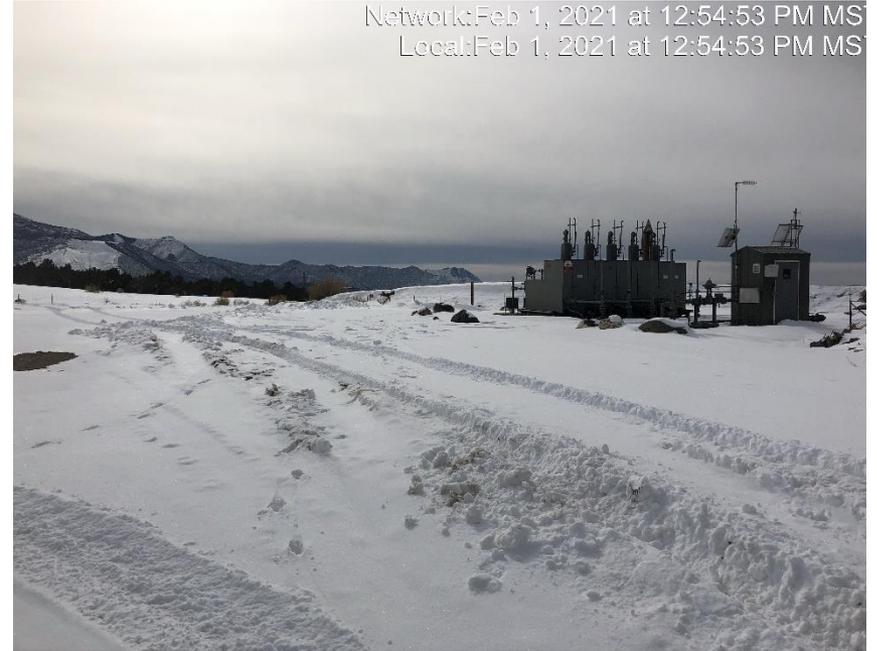
Photo #2769 from entrance to location.

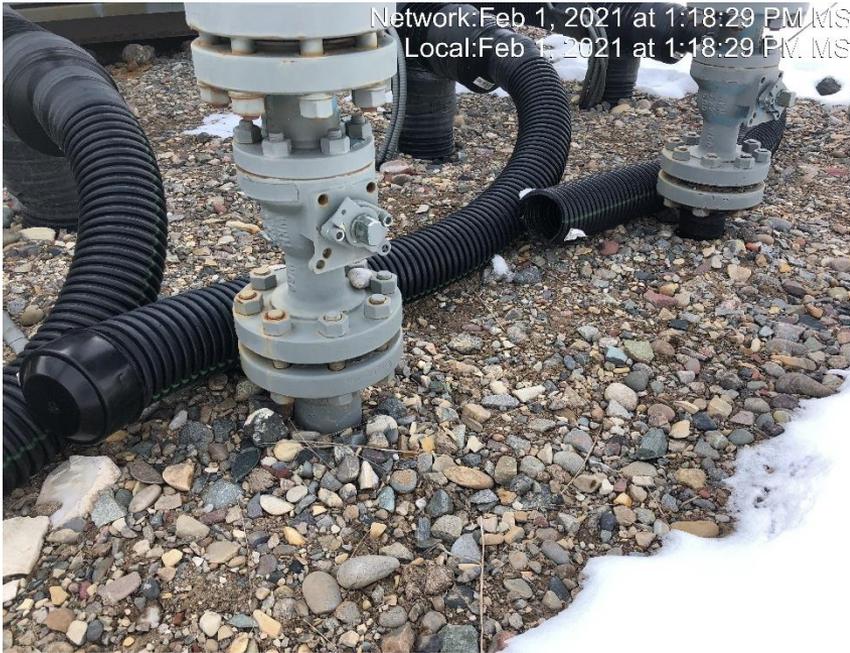
**Photo #2770 Multiple places with flow line exhaust heating insulation open ended and not capped.**

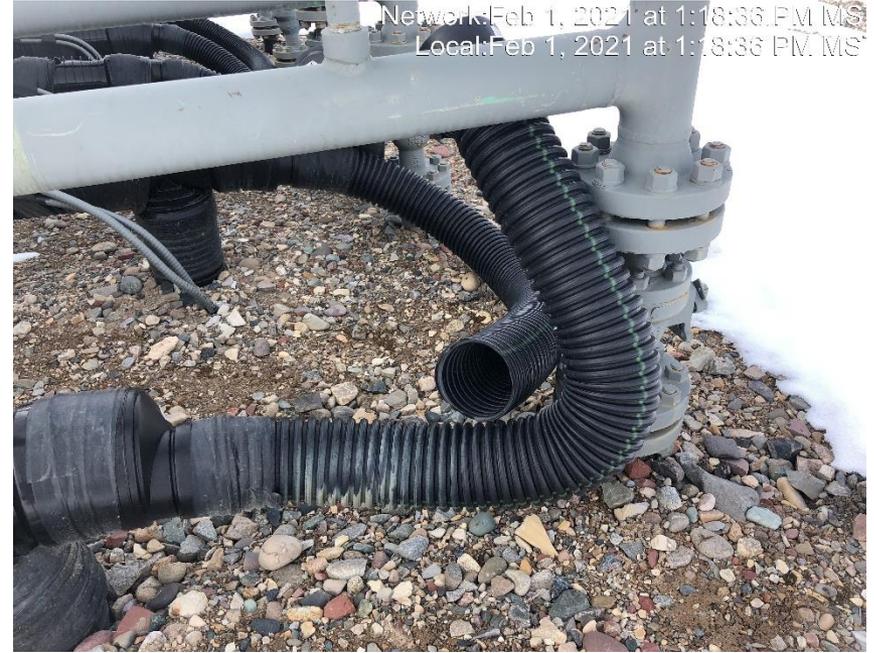
**Photo #2771 Multiple places with flow line exhaust heating insulation open ended and not capped.**

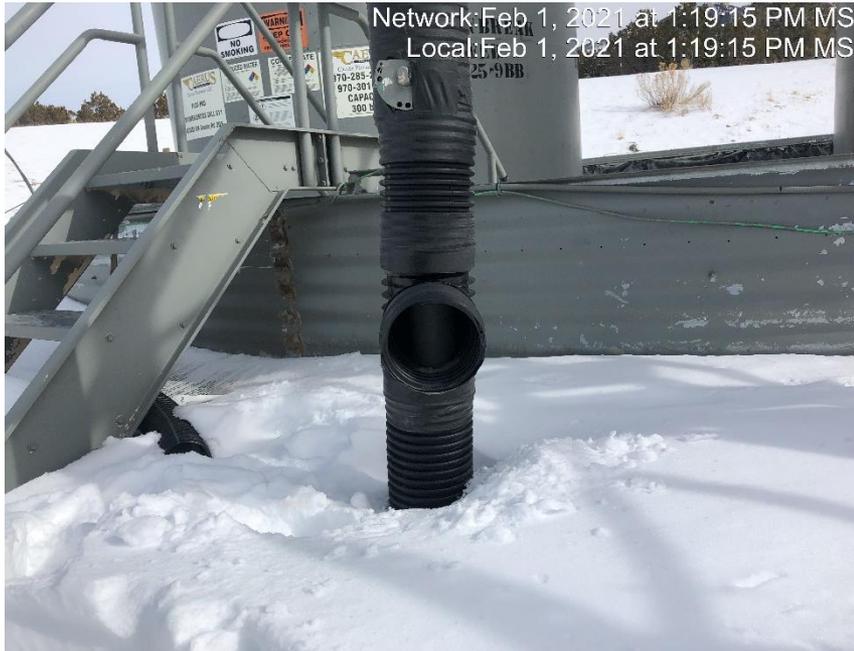
**Photo #2772 Multiple places with flow line exhaust heating insulation open ended and not capped.**
