Inspection Photos

Location Name: CAERUS PICEANCE LLC DAYBREAK FEDERAL-67S95W /30SWNE

Location ID: 334657

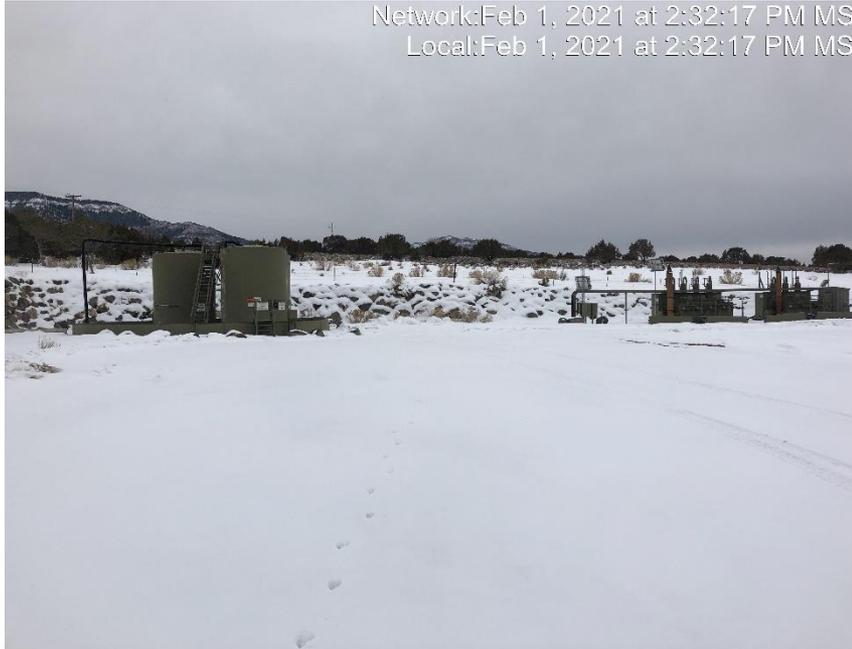
Photo #2778 from entrance to location.

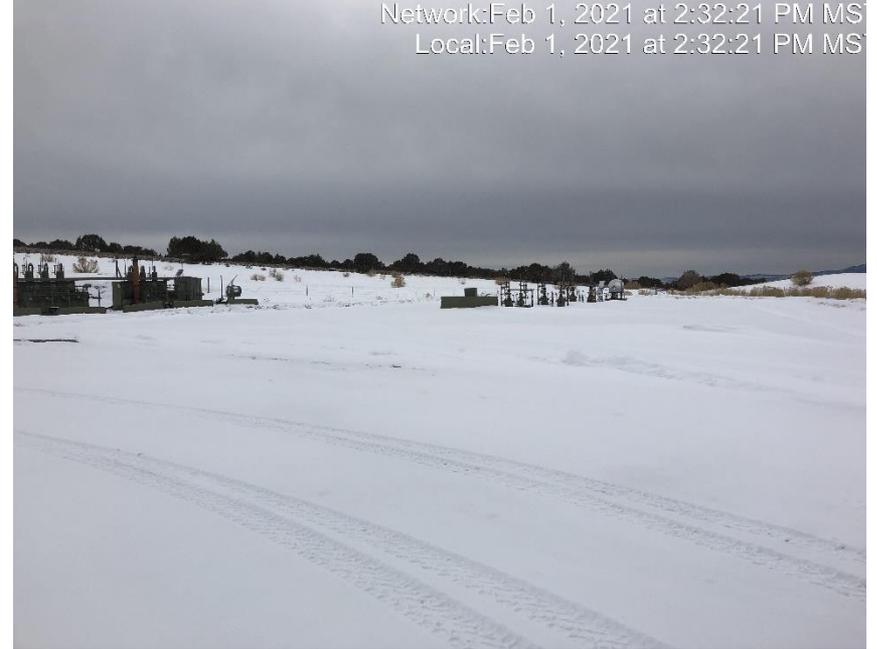
Photo #2779 from entrance to location.

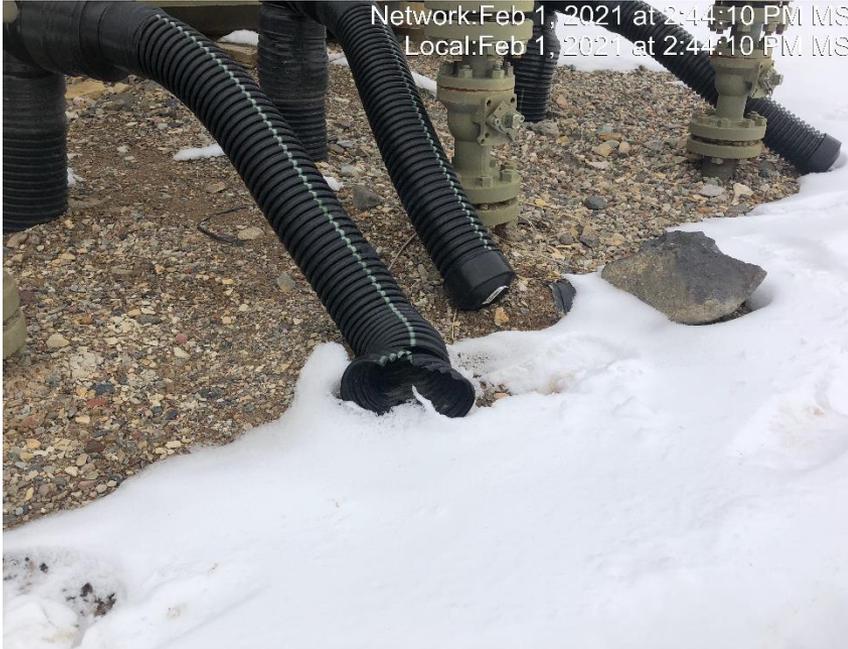
Photo #2783 Flow line exhaust heating insulation open ended and not capped.

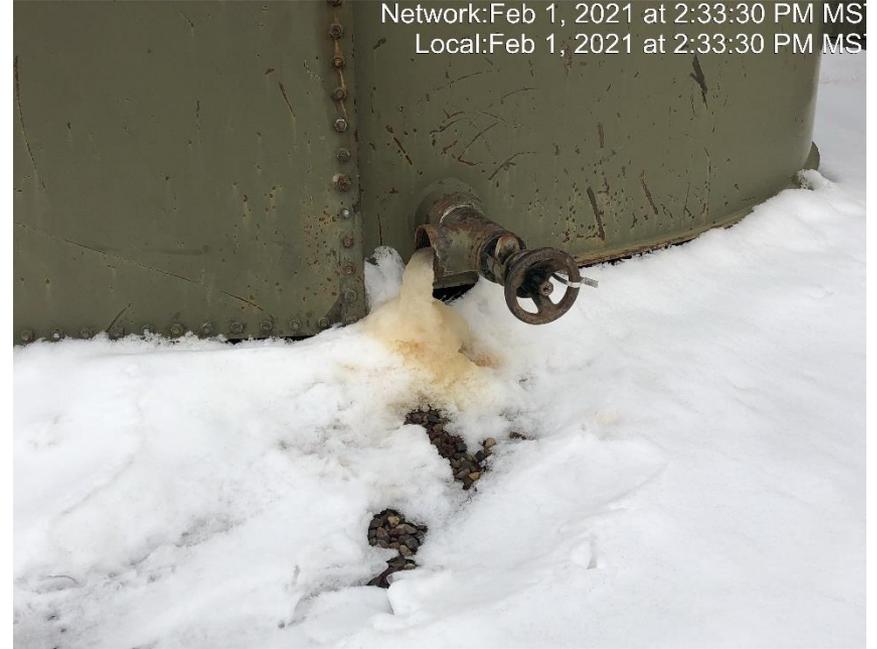
Photo #2780 Drain valve on tank #82965 leaking.

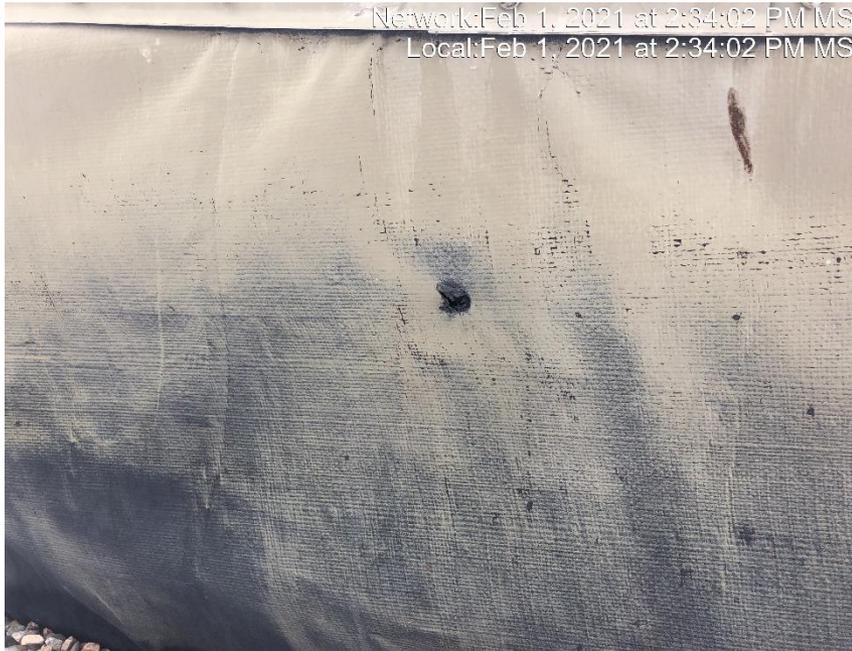
Photo #2781 Hole in tank containment.
