Inspection Photos

Location Name:CAERUS PICEANCE LLC SHORE-67S95W /16NWSE

Location ID: 334656

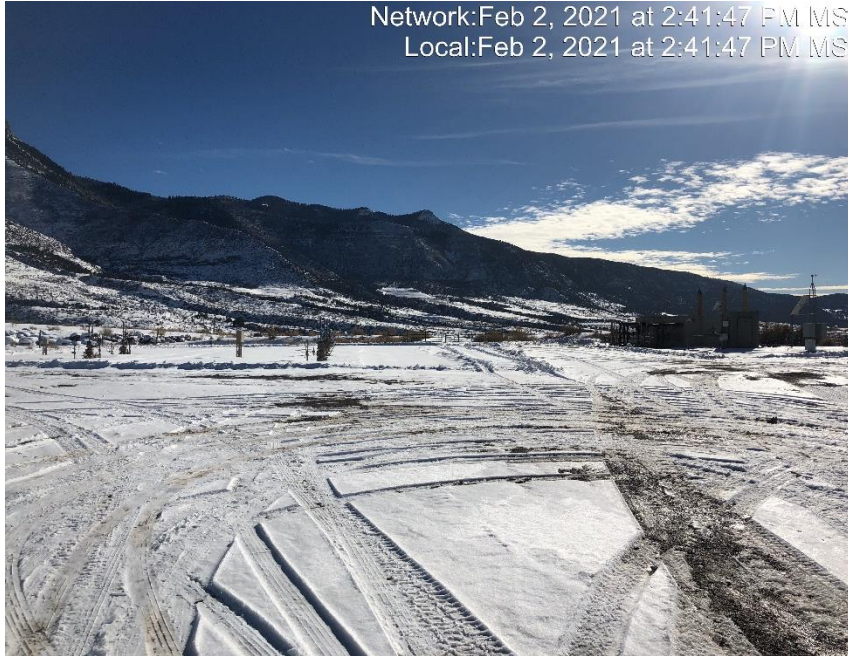
Photo #2795 from entrance to location.

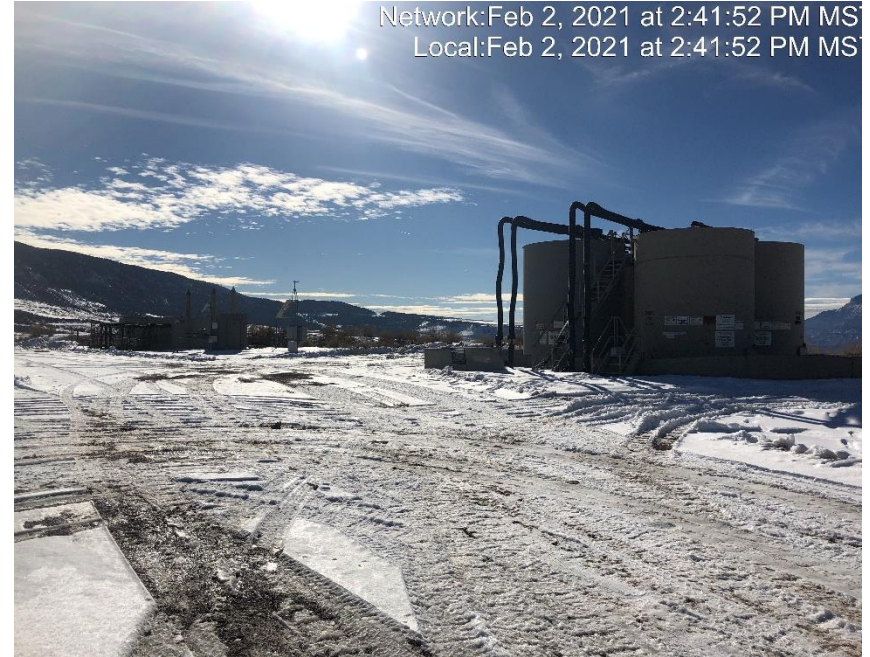
Photo #2796 from entrance to location.

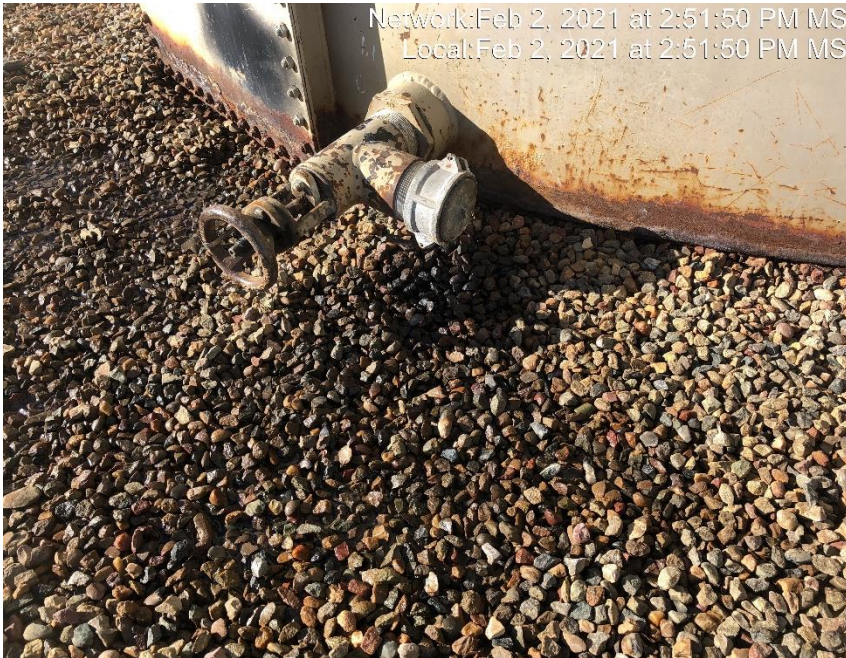
Photo #2797 Stained soils under drain valve.
