Inspection Photos

API: 061-06742

Operator: NEWELL ENERGY LTD

Inspection Date: 2/2/2021

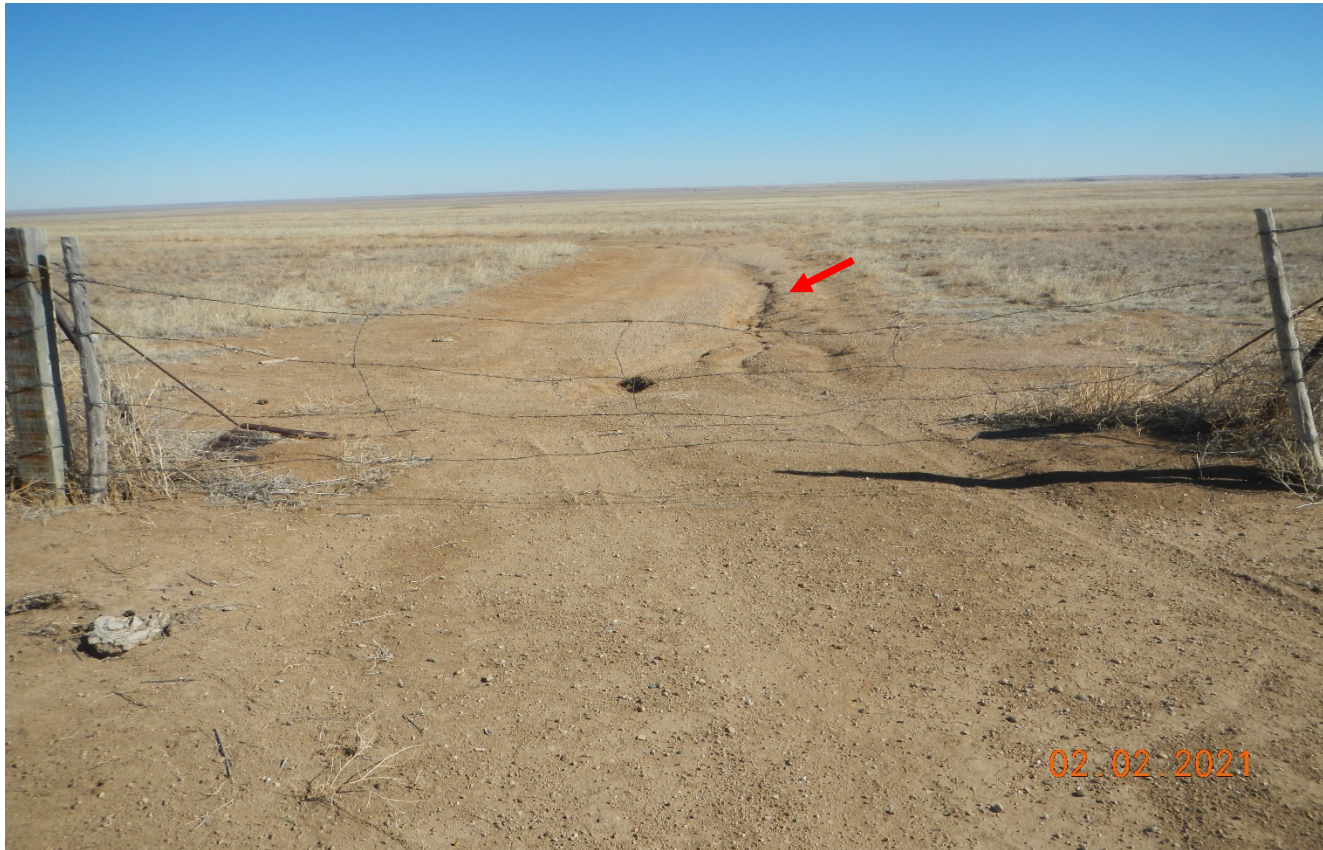
Photo 1. Facing east along the access road. The cattle guard is filled in with sediment and is not maintained. There is erosion occurring down the road shown at red arrow.

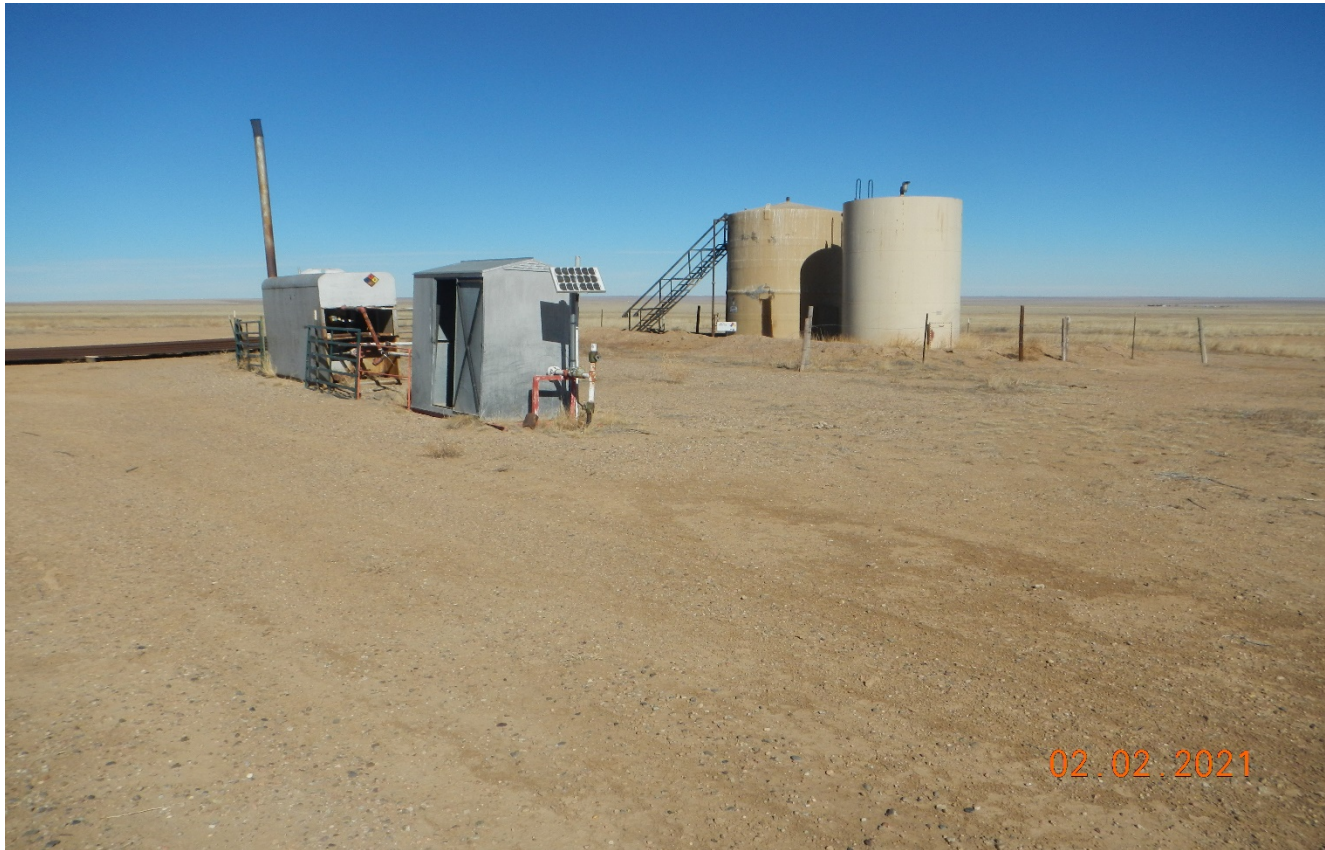
Photo 2. Facing northeast toward the location.

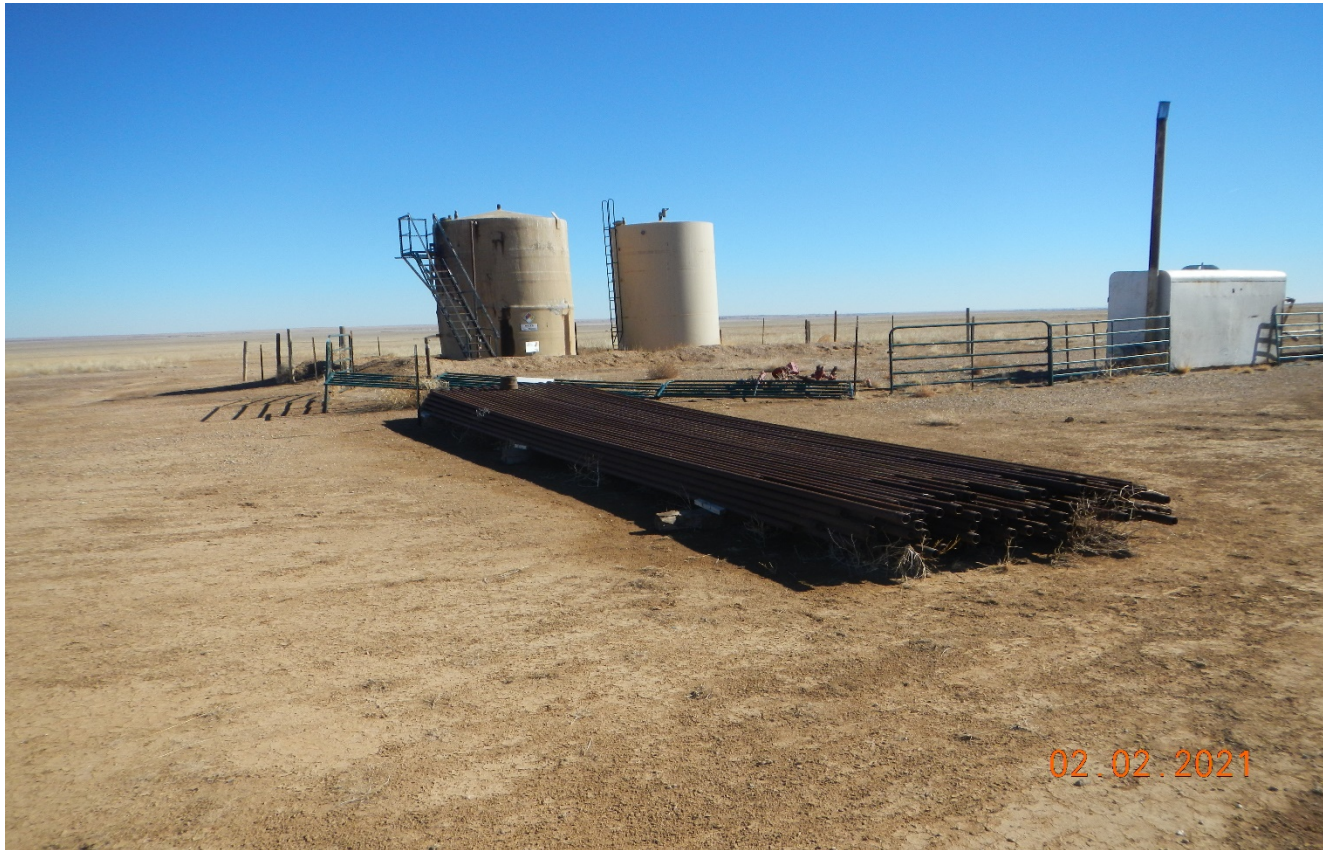
Photo 3. Unused pipe remains at the location. Previous corrective action was not performed.

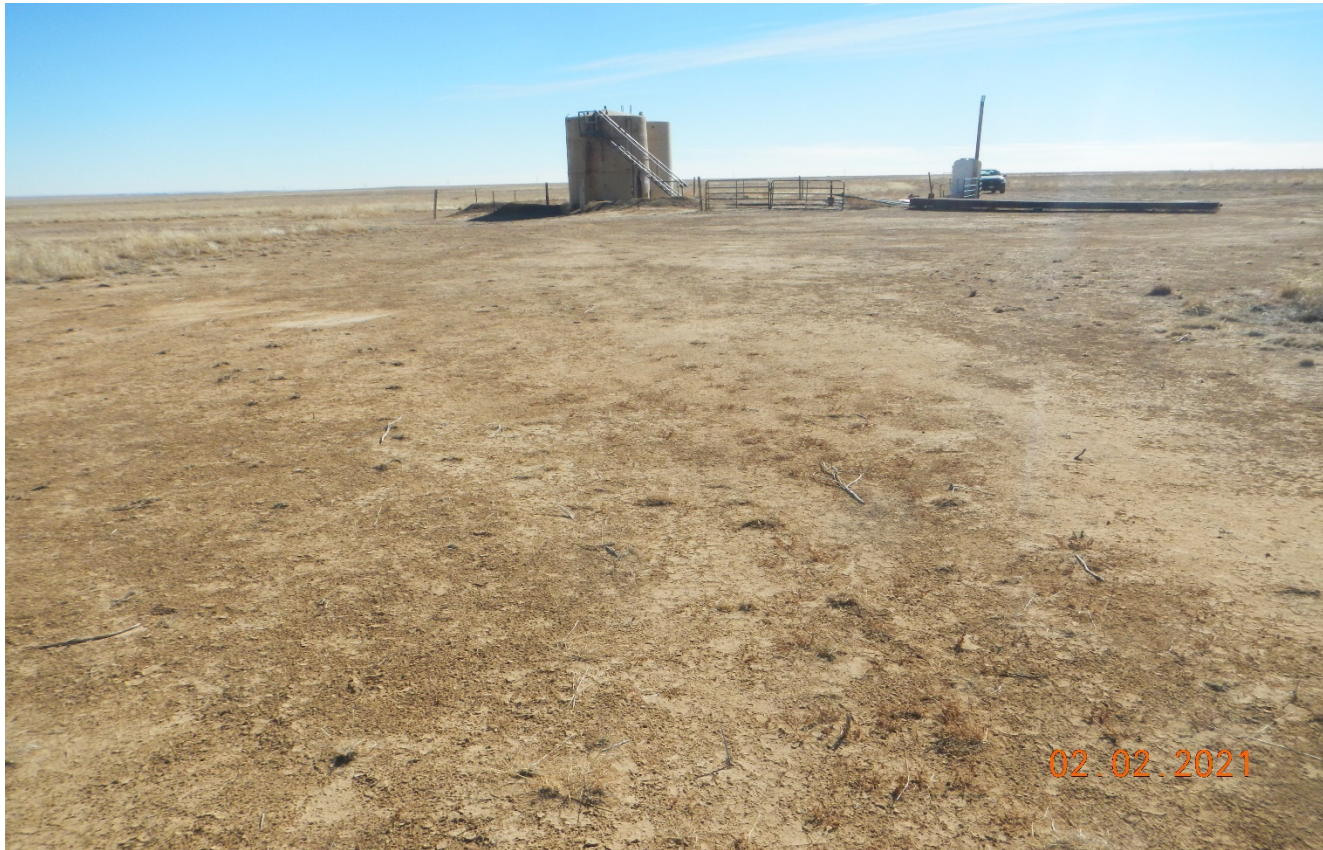
Photo 4. Facing south toward the location. Unused areas of the location are bare of vegetation cover. Interim reclamation has not been performed.

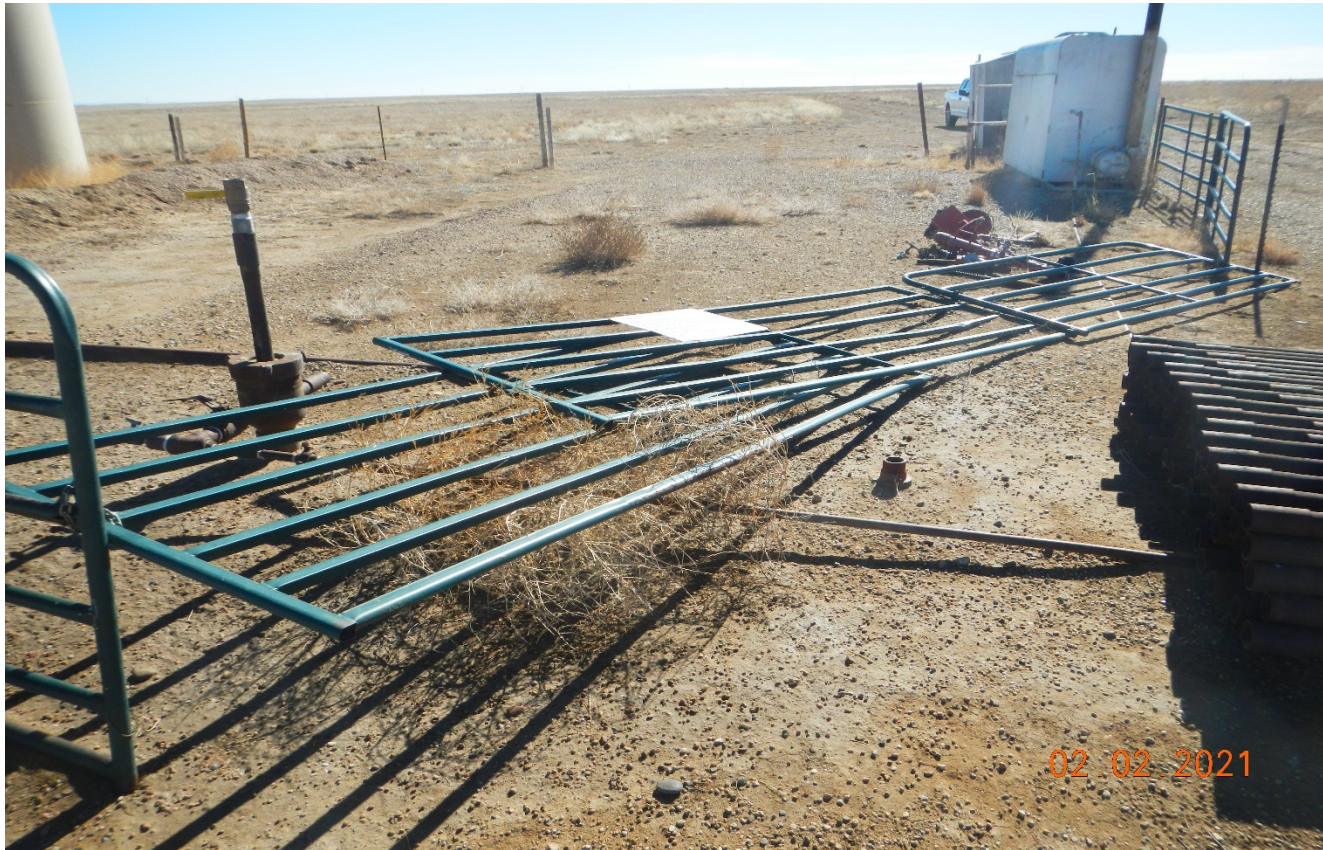
Photo 5. The fence panels at the well are laying on the ground. The location sign on the panels is not properly installed. There is unused equipment that remains.

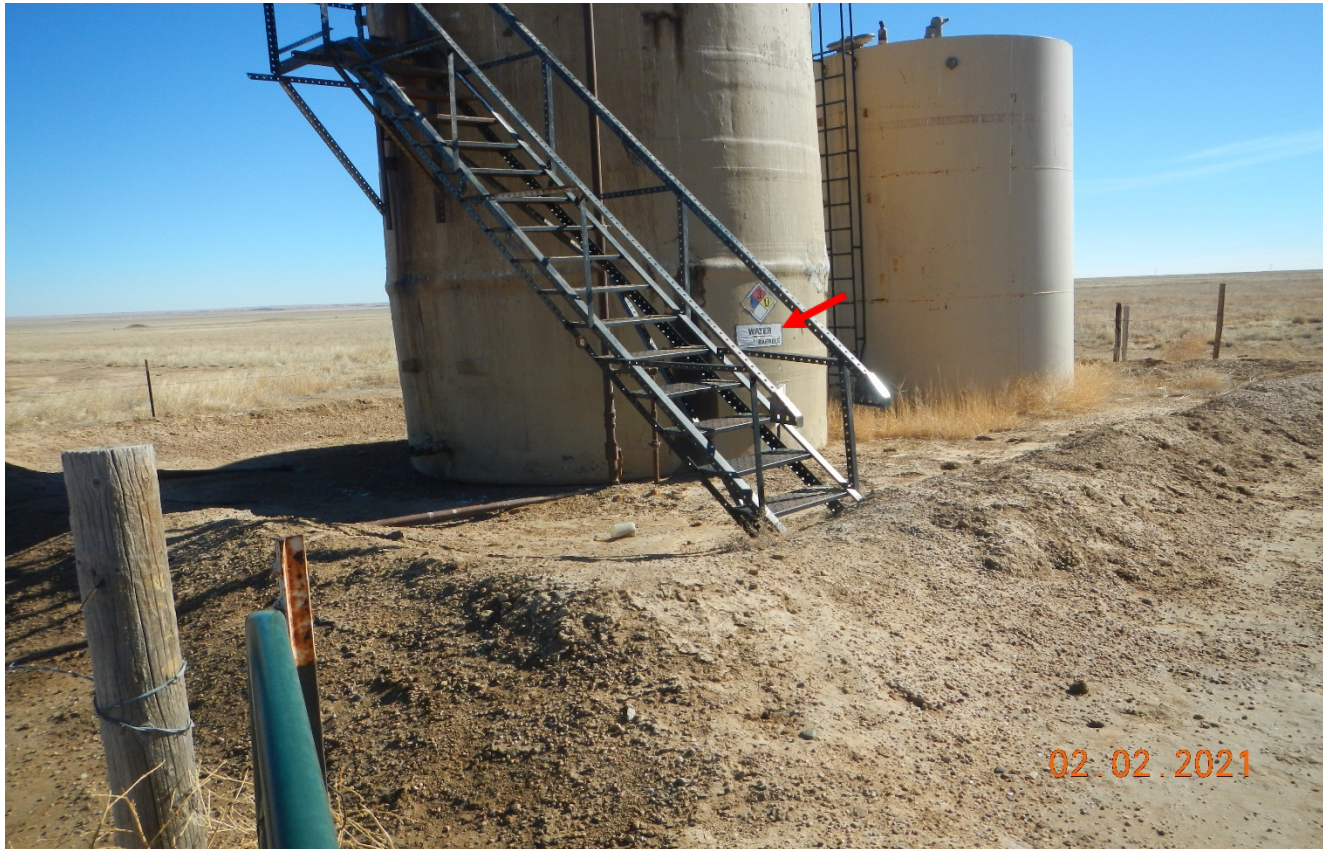
Photo 6. Facing toward the tanks. Tank shown at red arrow is labeled produced water. Other tank contents are not labeled.

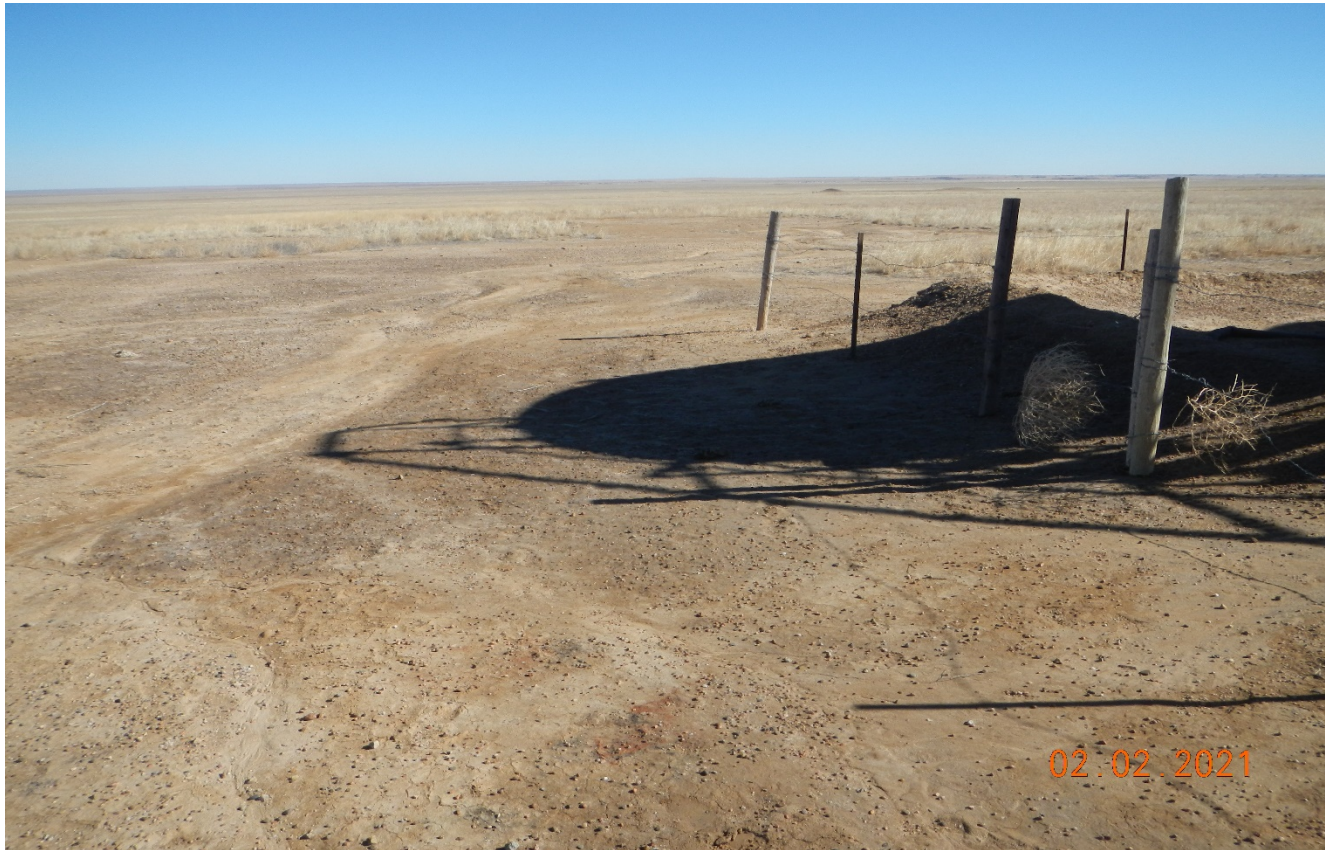
Photo 7. Facing east near the tank. There is no vegetation growth downhill of the tanks indicating a possible spill occurred.

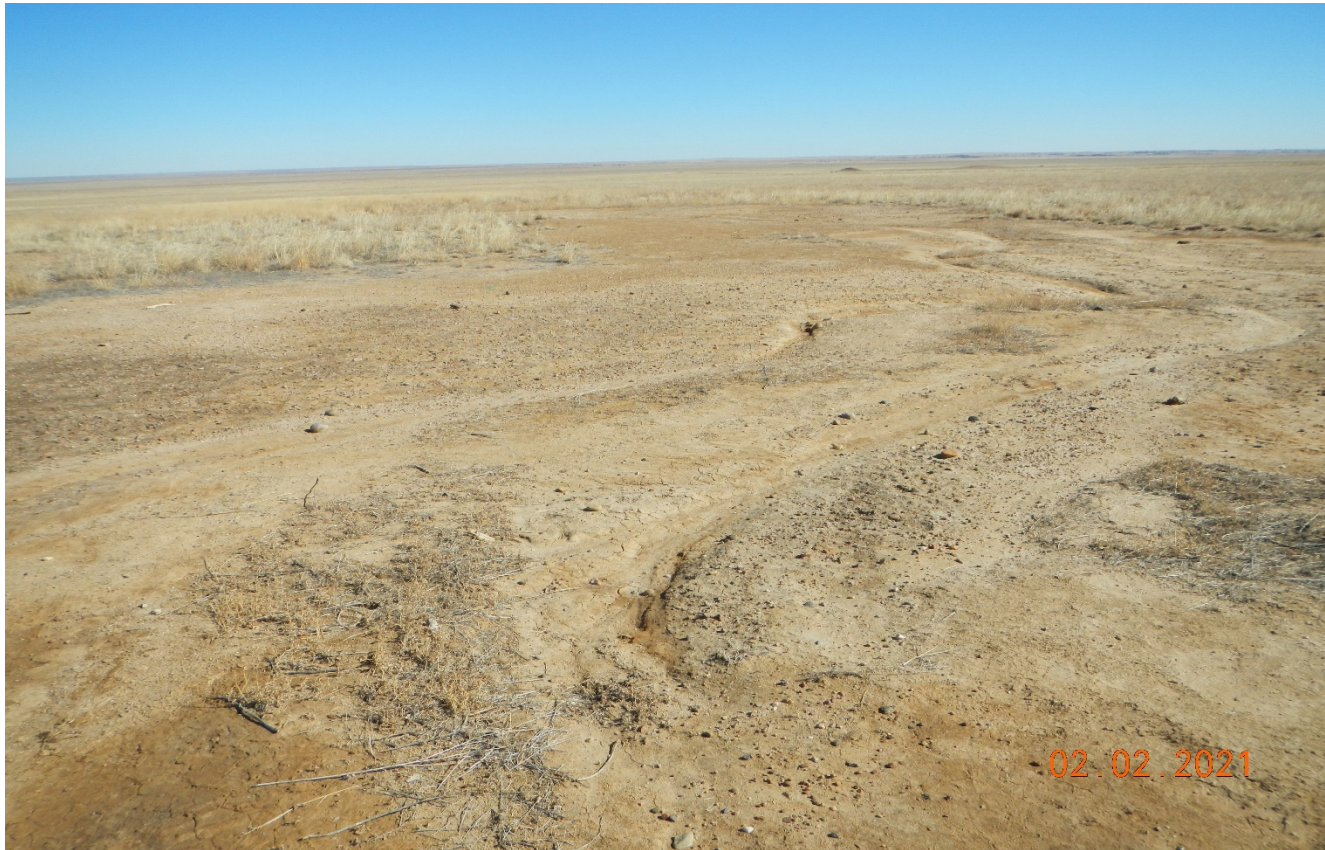
Photo 8. There is no vegetation growth downhill of the tanks indicating a possible spill occurred.

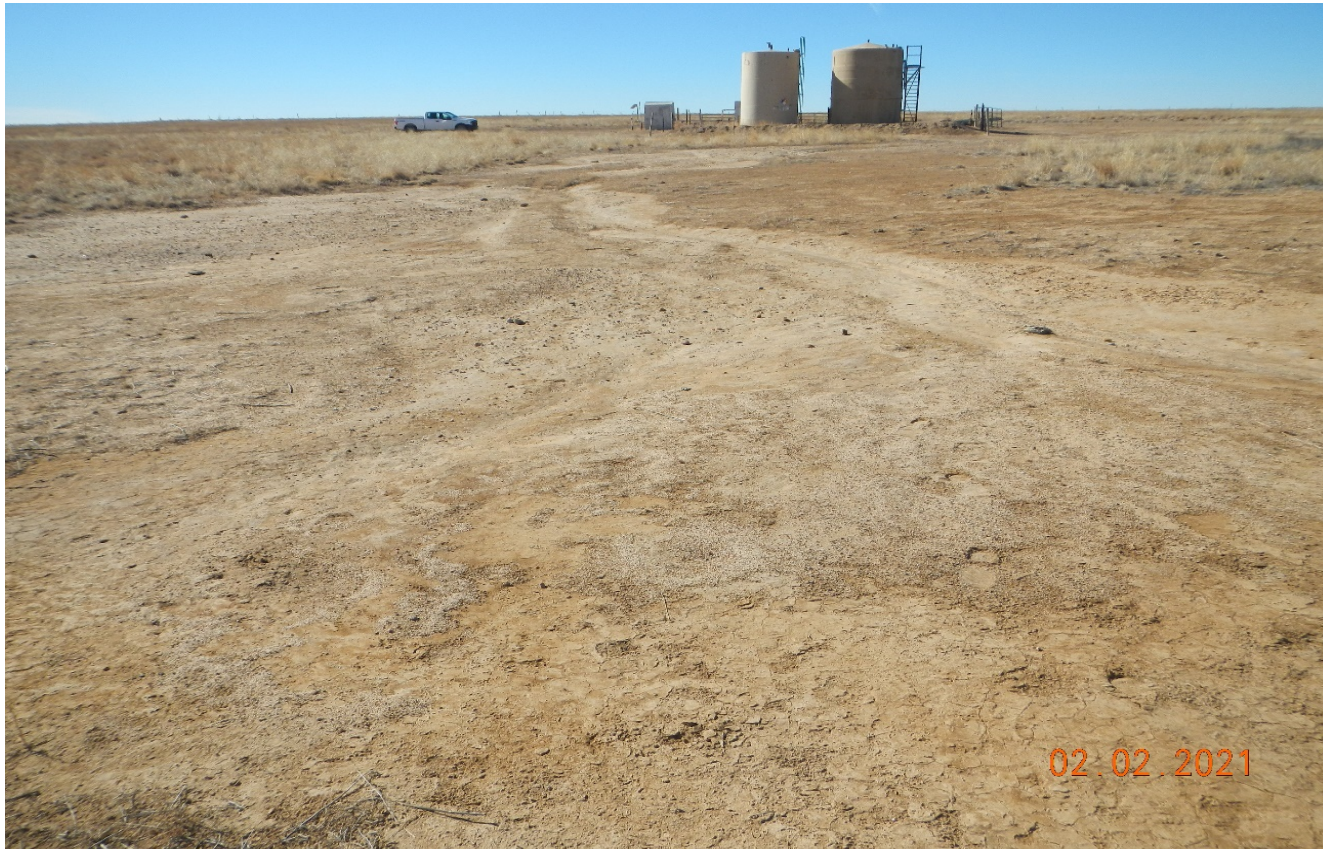
Photo 9. Facing west at the area which is bare of vegetation. It appears this area may have been impacted from a potential spill. This bare area extends 300 ft. downhill from the tank battery.

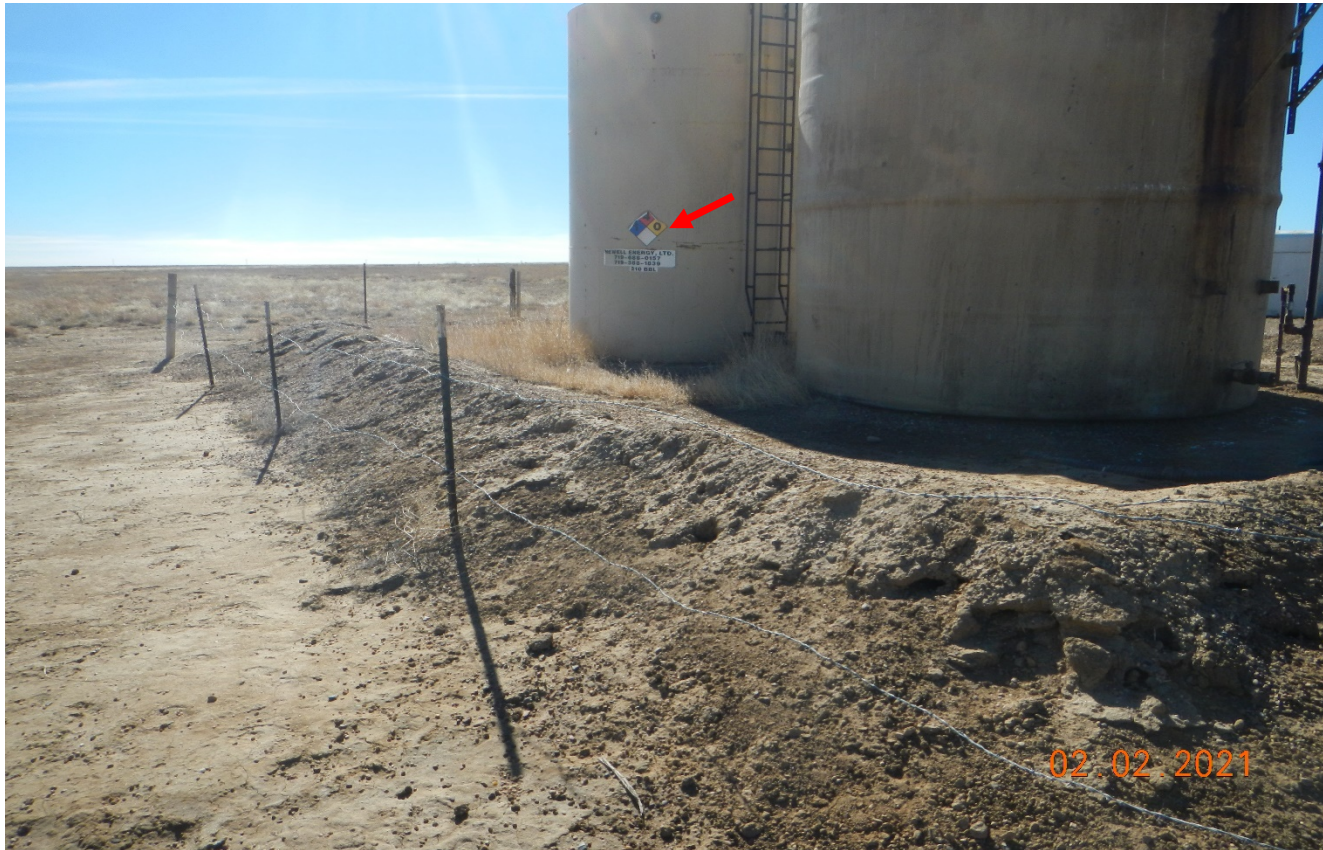
Photo 10. Facing toward the tanks. The berm around the tanks is degraded and has holes in the side. The labeling is shown on the back side of the tank and needs to be posted where it is visible front the front side. Tank does not have contents labeled.

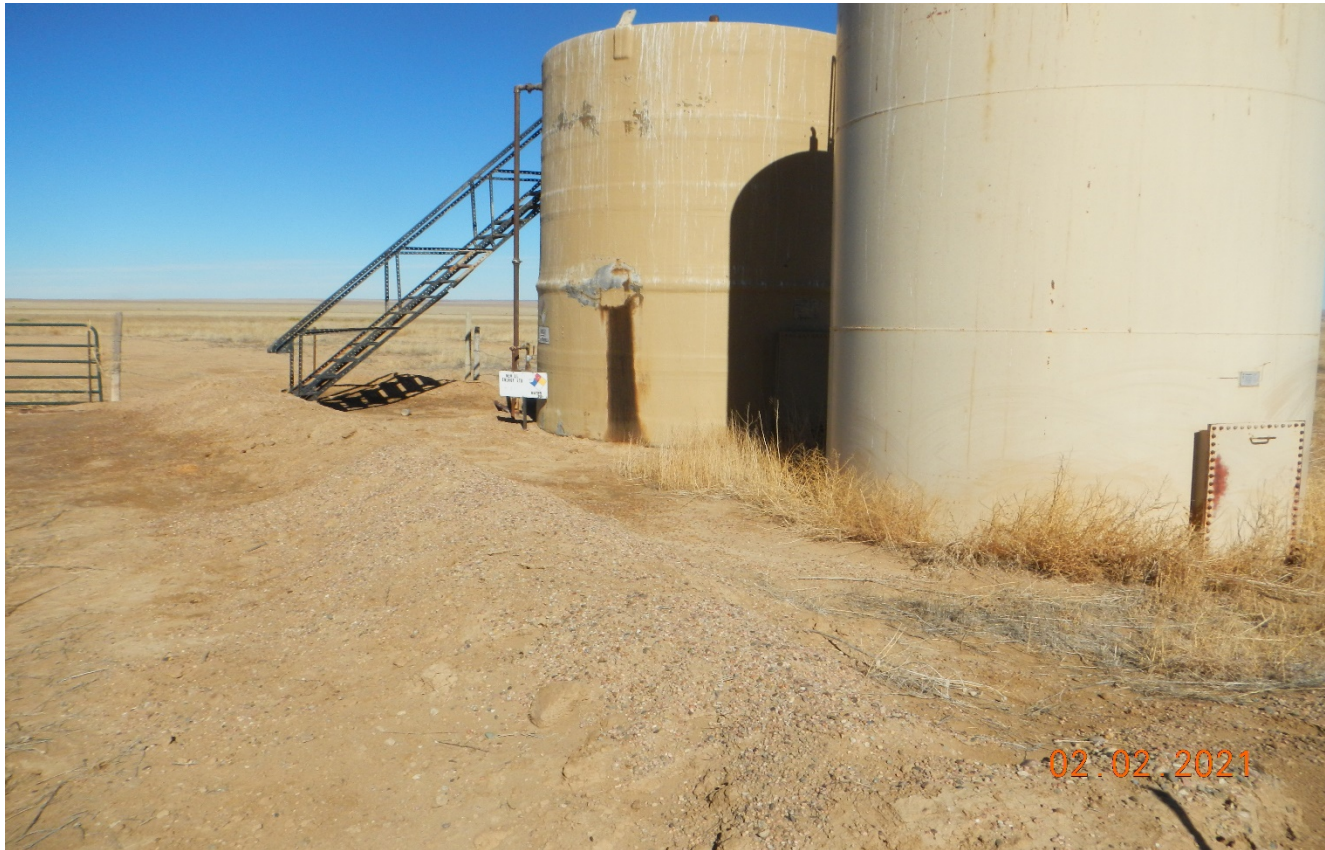
Photo 11. Facing toward the front side of the tanks.
