Inspection Photos
Operator: Simcoe
API: 067-09671
Date: 2/2/2021

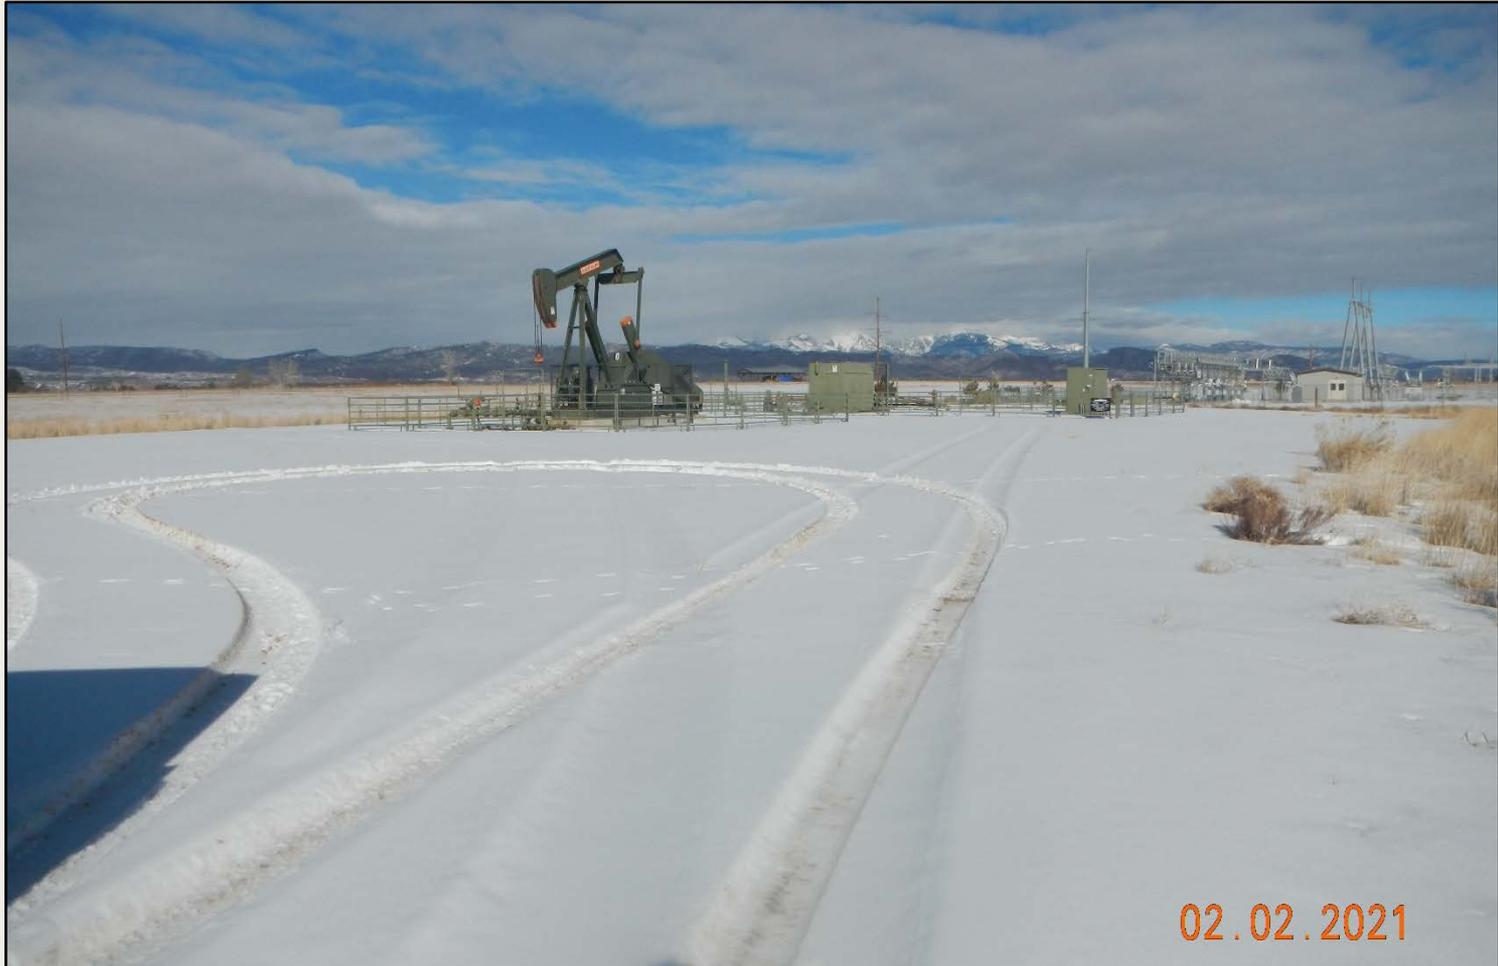
Photo 1. View of the project area from the well pad entrance facing center.

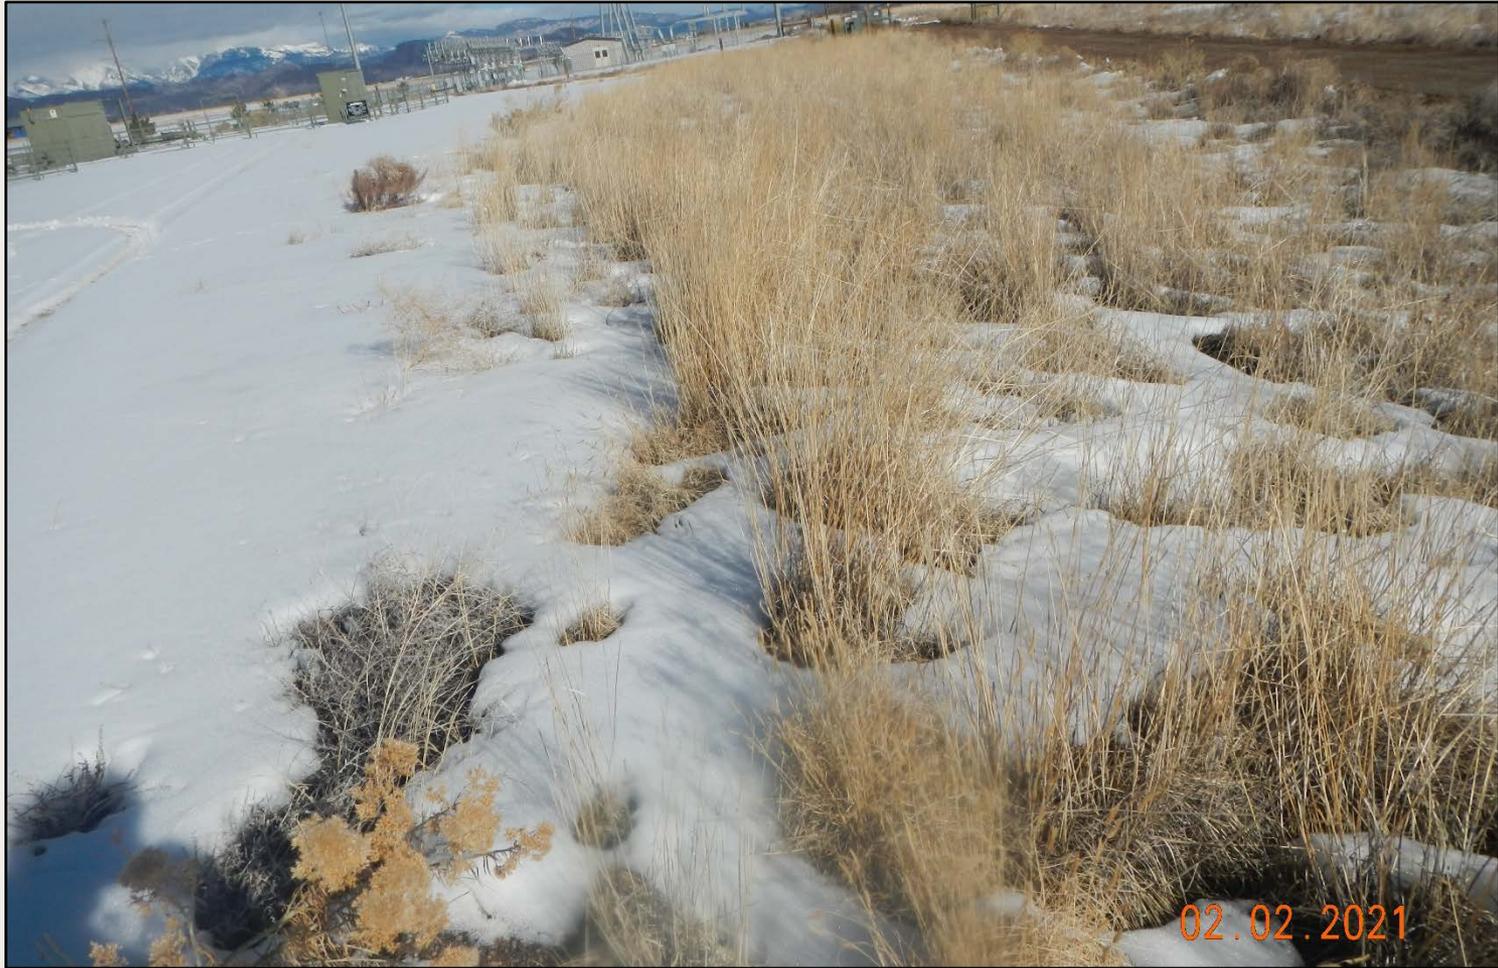
Photo 2. View of the eastern project area from the southeastern corner facing northward. Revegetation is progressing with intermediate wheatgrass, western wheatgrass, smooth brome, and crested wheatgrass.

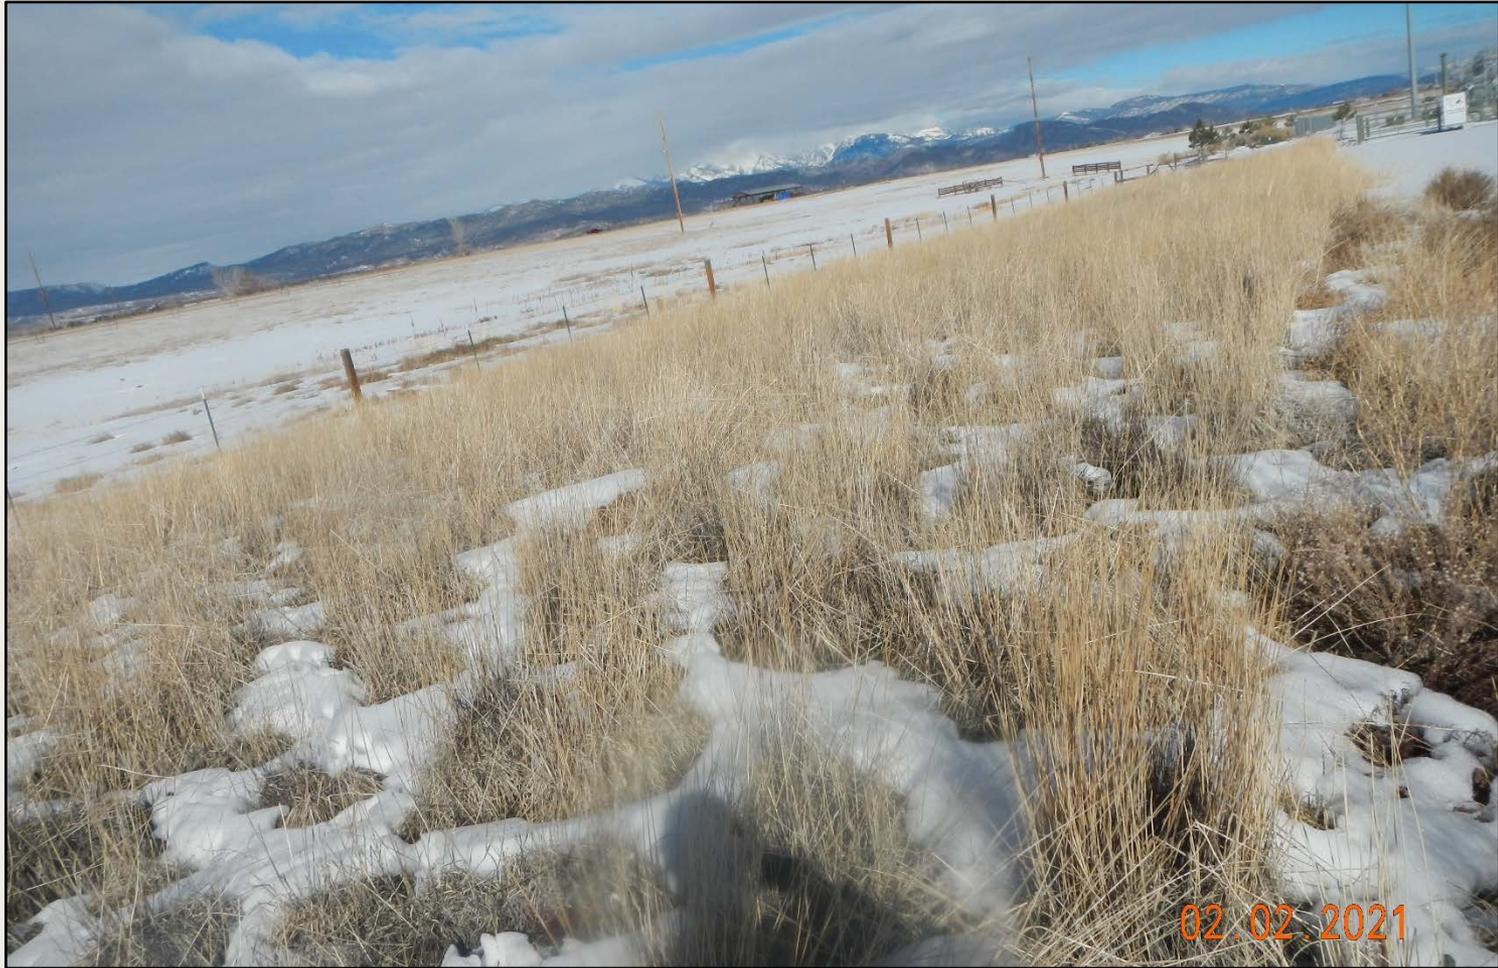
Photo 3. View of the western project area from the southwestern corner facing northward.

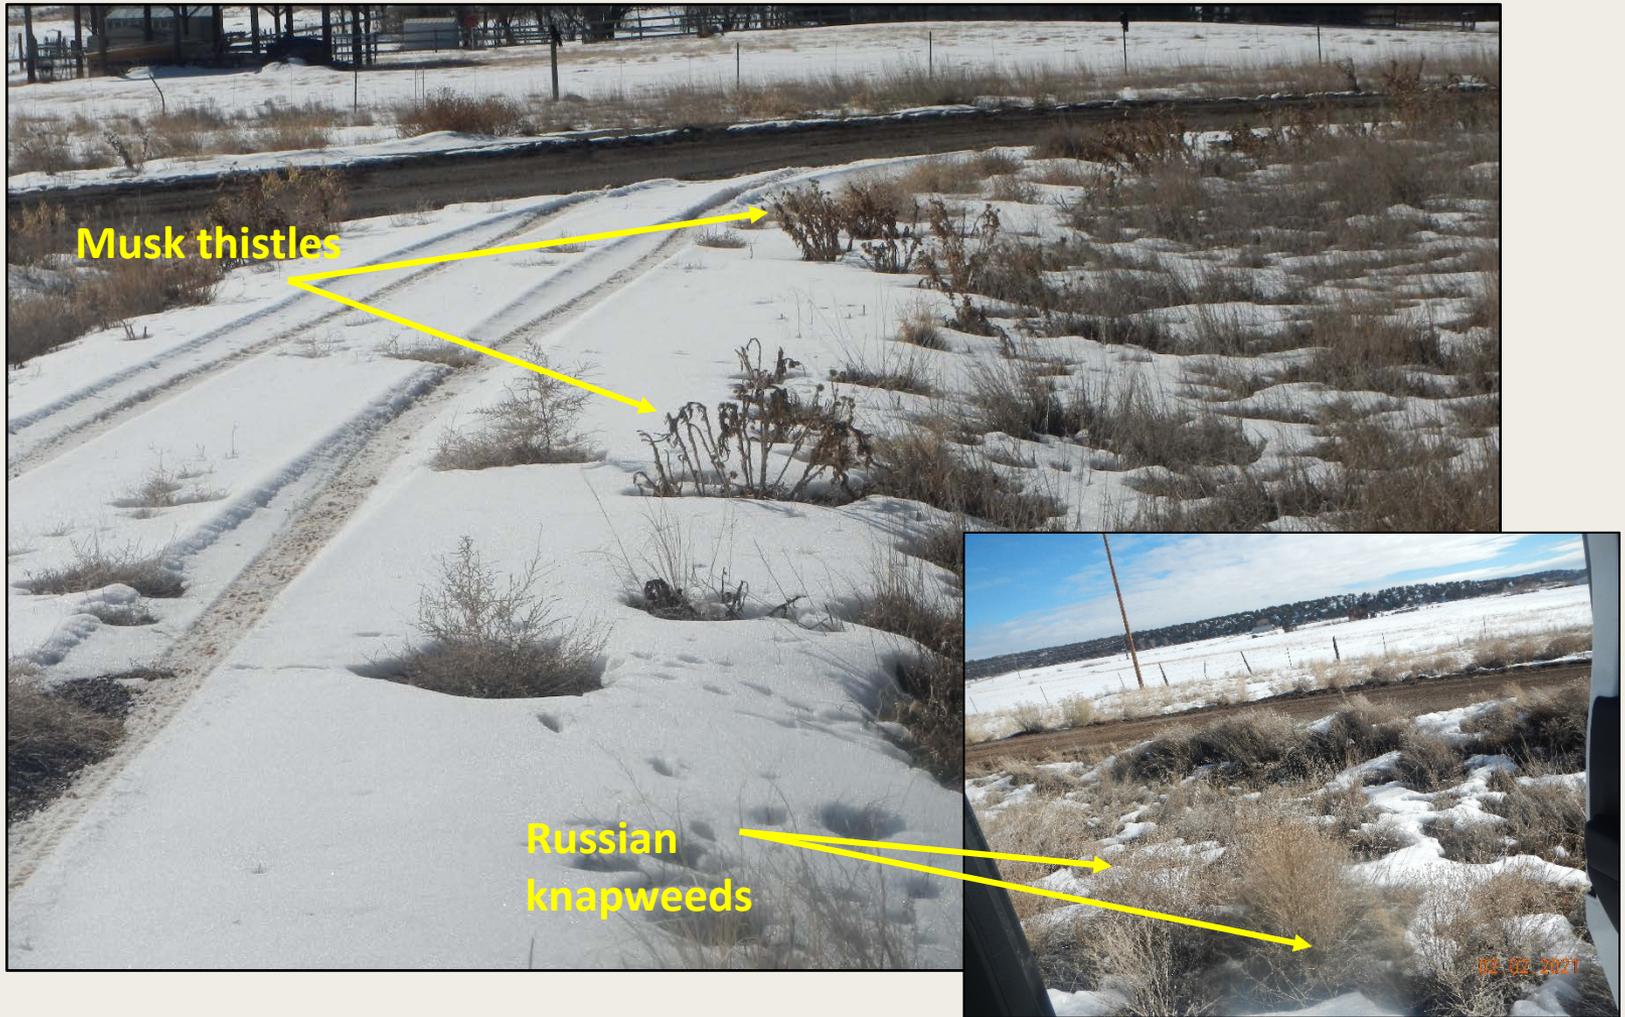
Photo 4. View of musk thistles (approx. 200) observed along the access road. Approximately 500 Russian knapweeds also present along access (see inset)

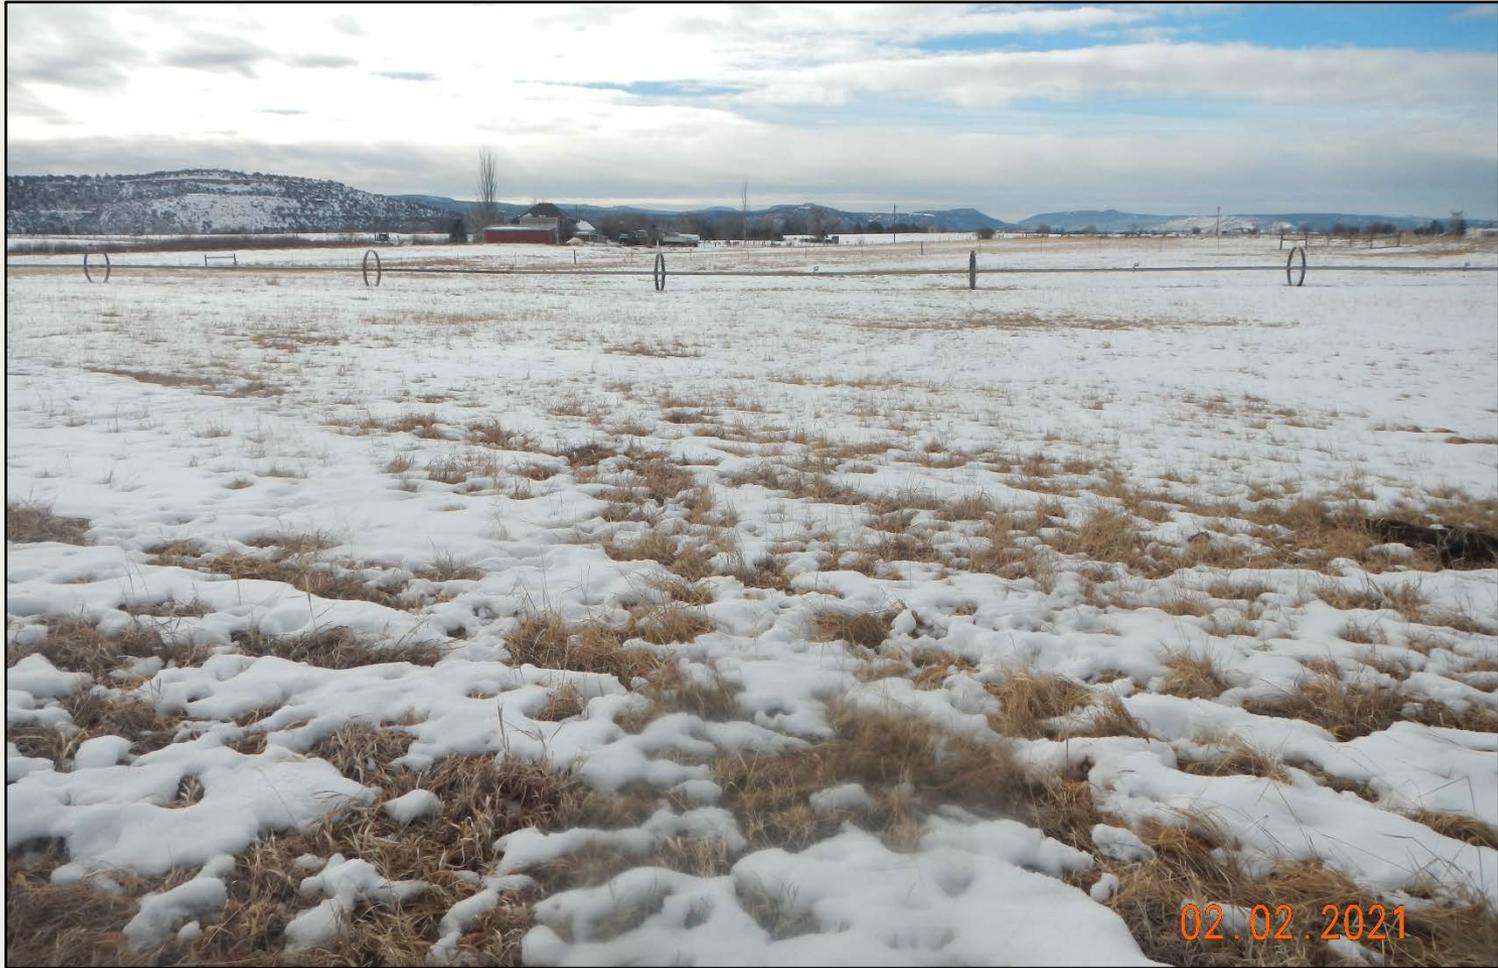
Photo 5. View of the reference area comprised of open pasture, largely snow covered at this time.
