Inspection Photos

Location Name: CAERUS PICEANCE LLC Daybreak Federal /19-2 (PJ19)

Location ID: 417538

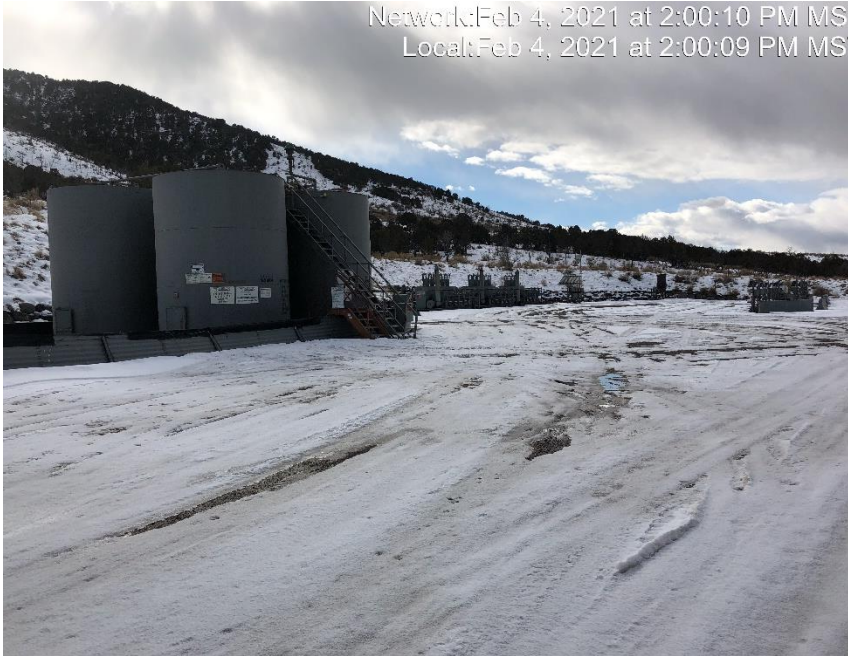
Photo #2813 from entrance to location.

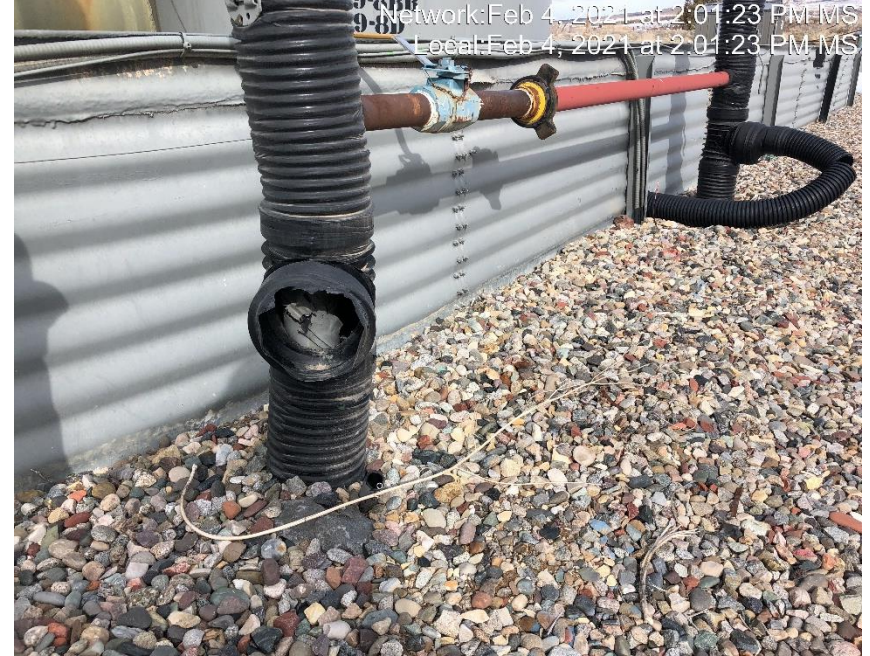
Photo #2815 Multiple places with flow line exhaust heating insulation open ended and not capped.

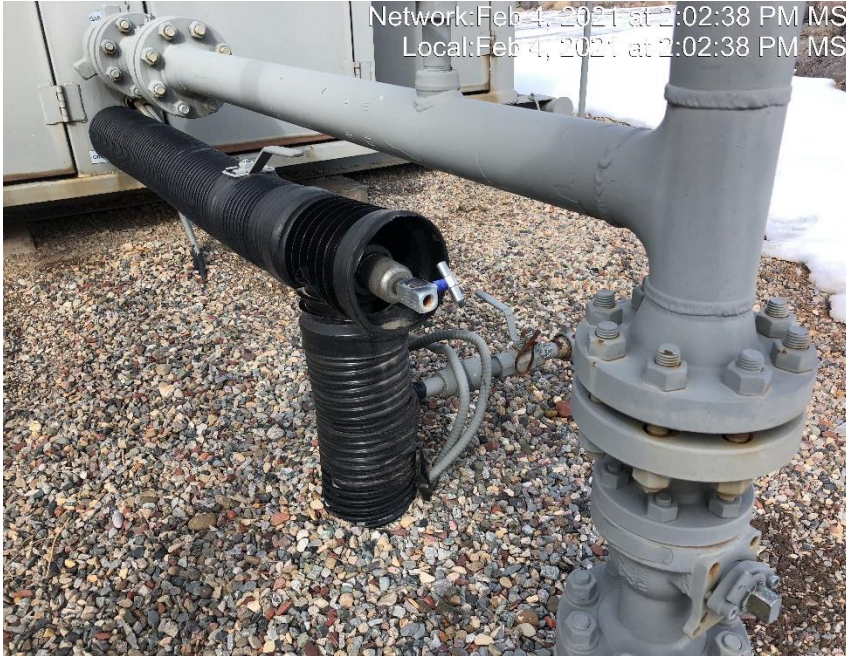
Photo #2816 Multiple places with flow line exhaust heating insulation open ended and not capped.
