Inspection Photos

API: 061-06866

Operator: NAVEX RESOURCES LLC

Inspection Date: 2/2/2021

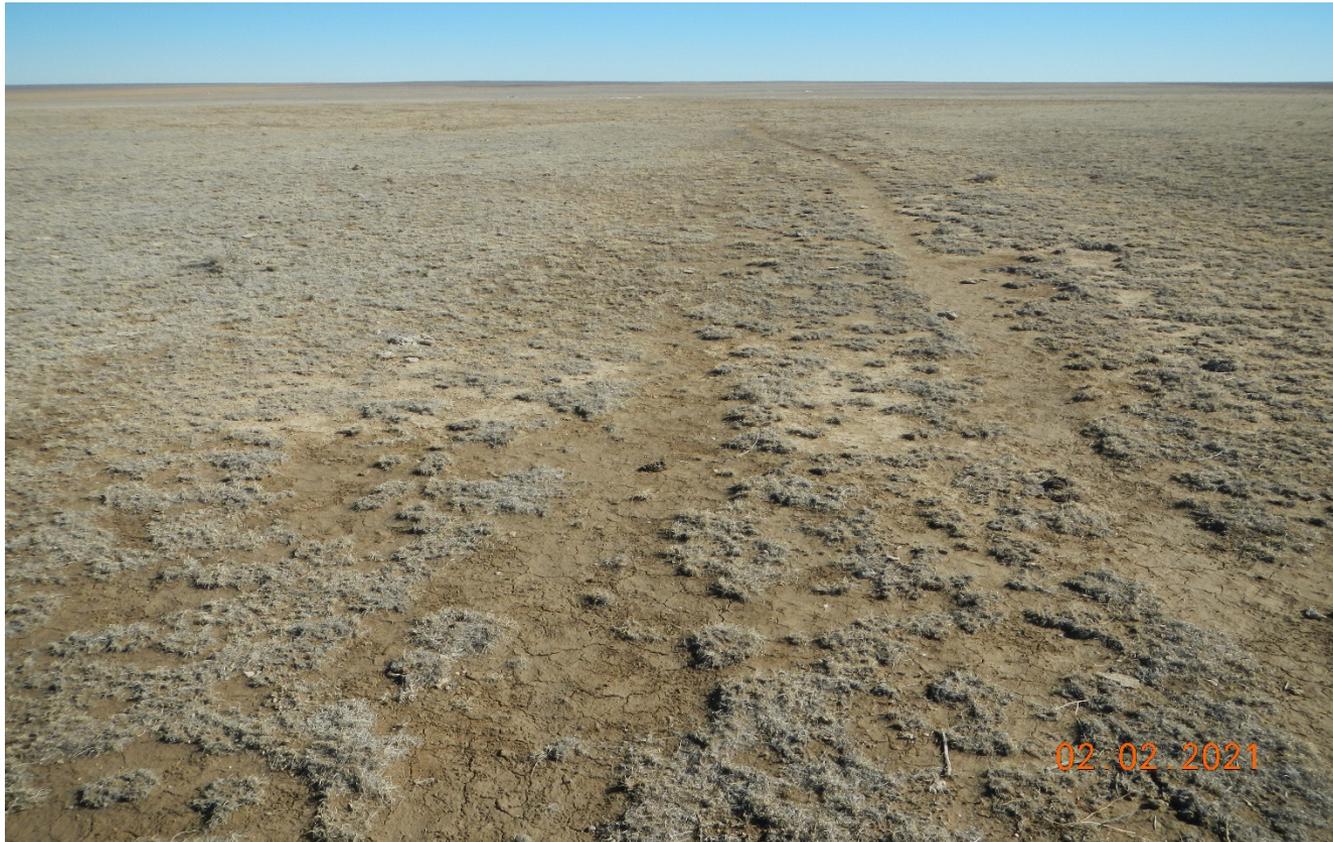
Photo 1. Facing east along the former access road.

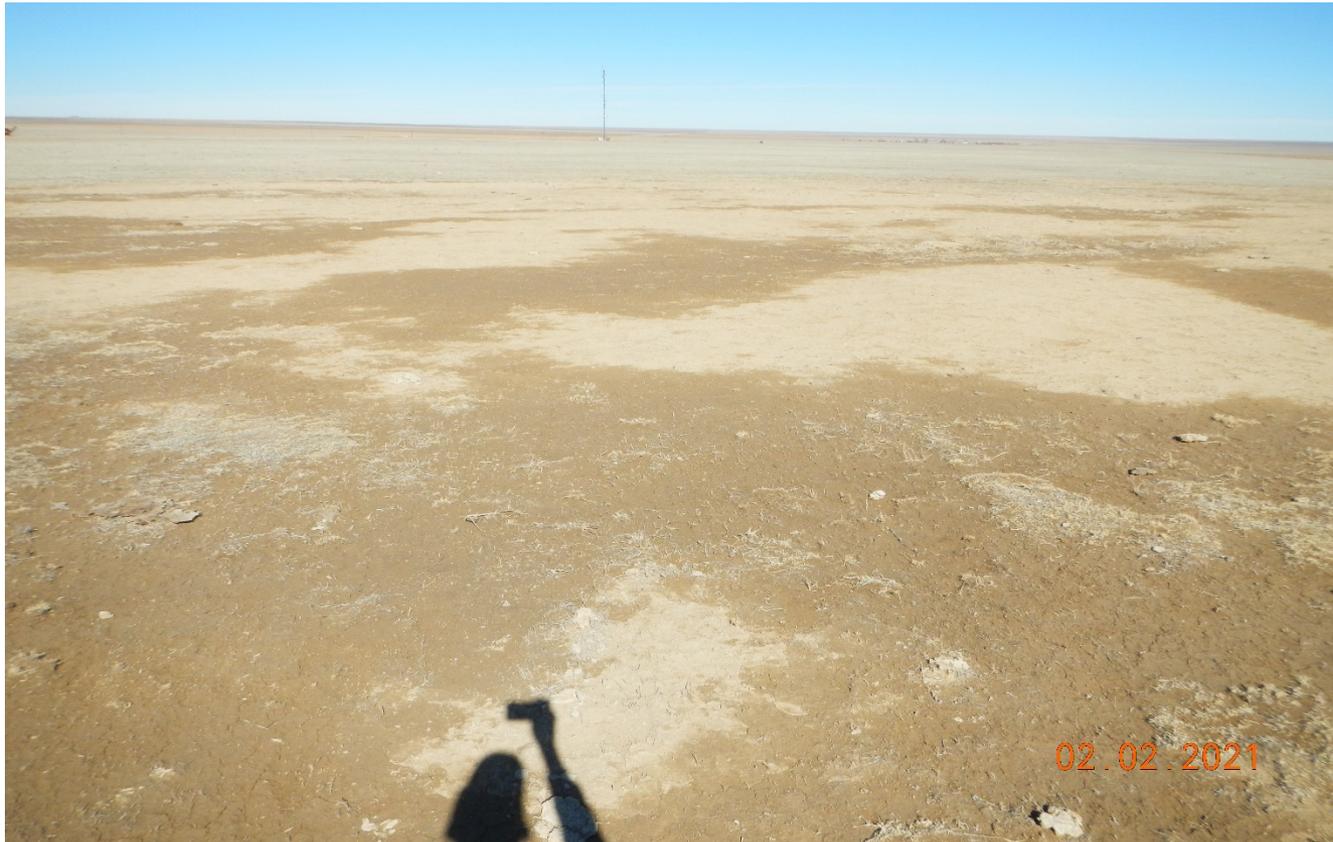
Photo 2. Facing north at the center of the location. Vegetation has not established at the location. Soils are bare of vegetation.

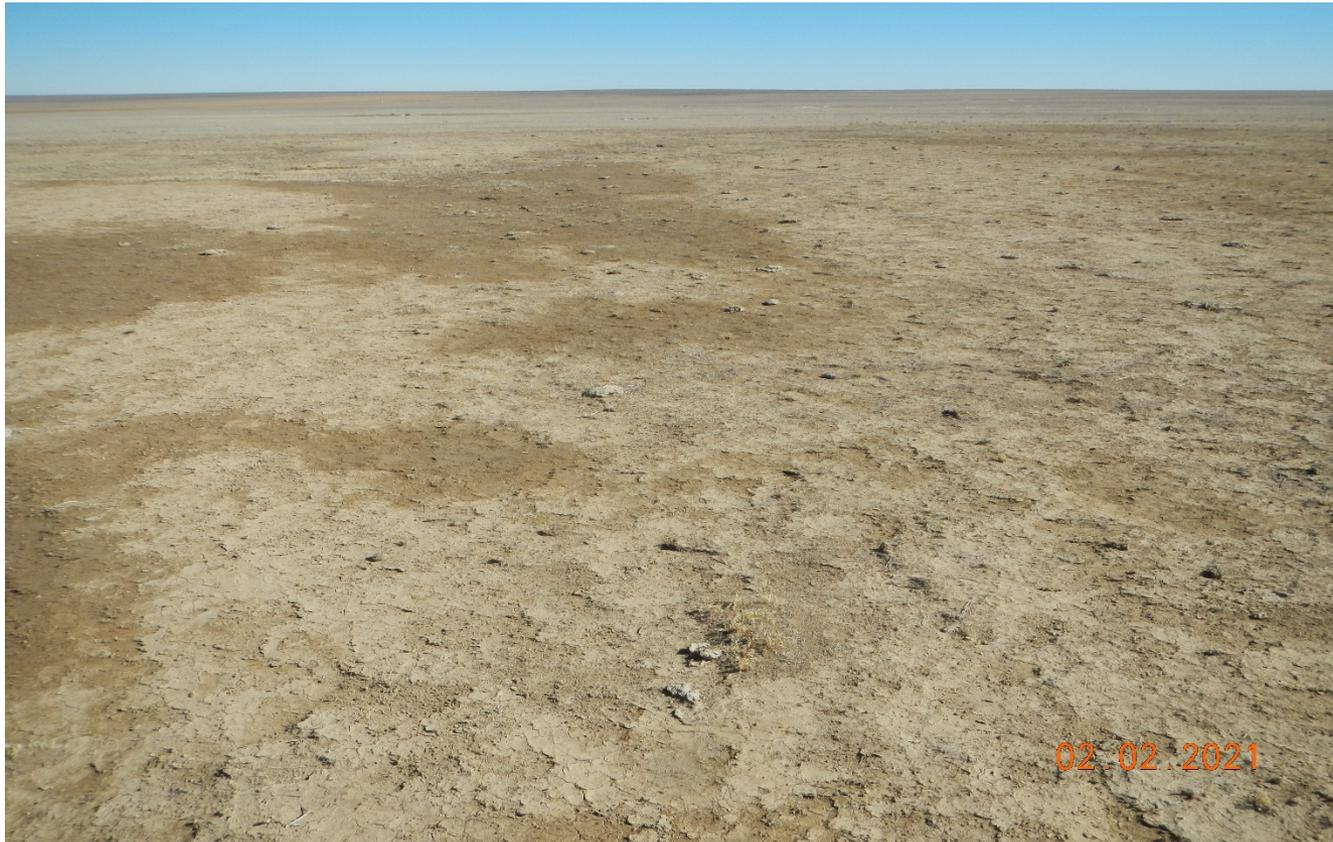
Photo 3. Facing west at the center of the location.

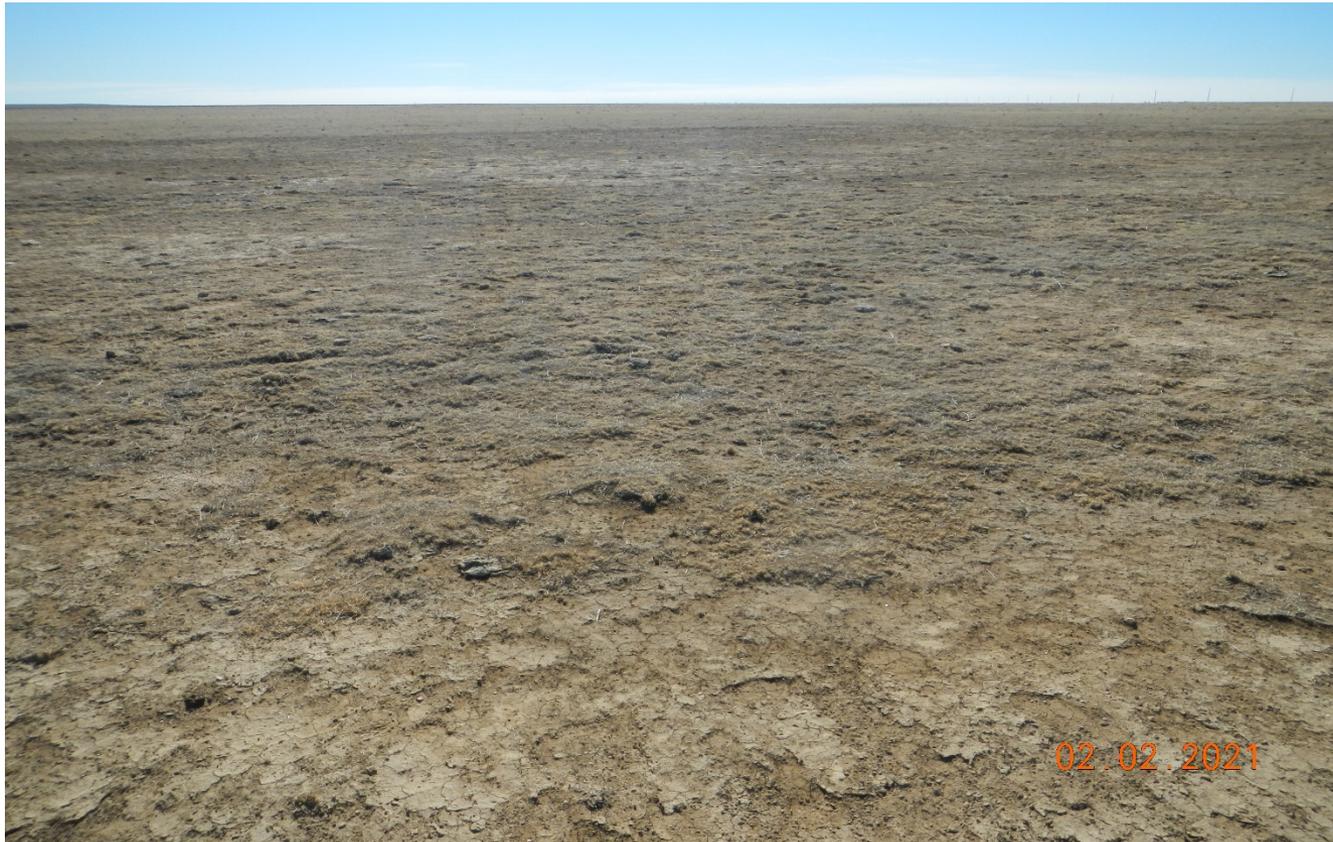
Photo 4. Facing south at the center of the location.

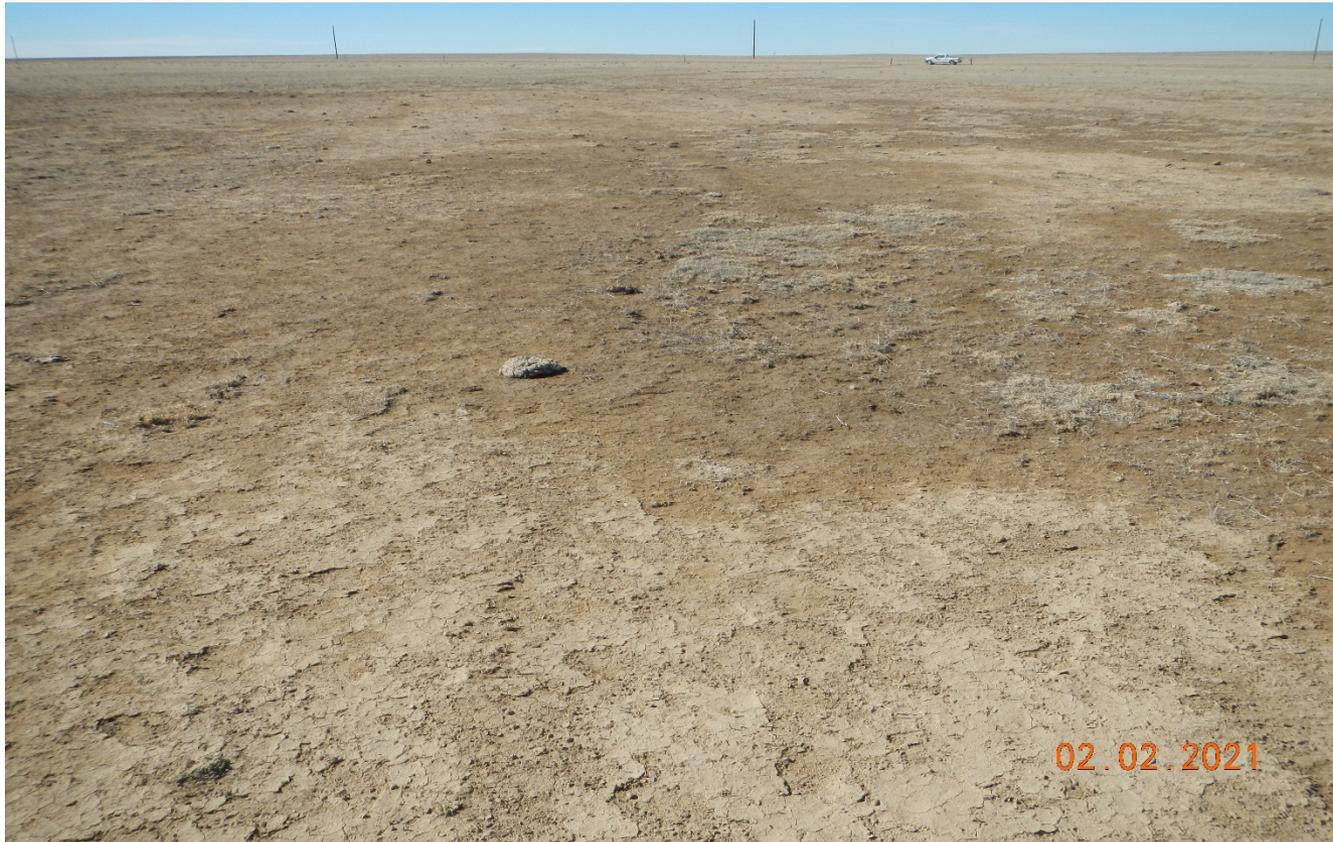
Photo 5. Facing west at the center of the location.

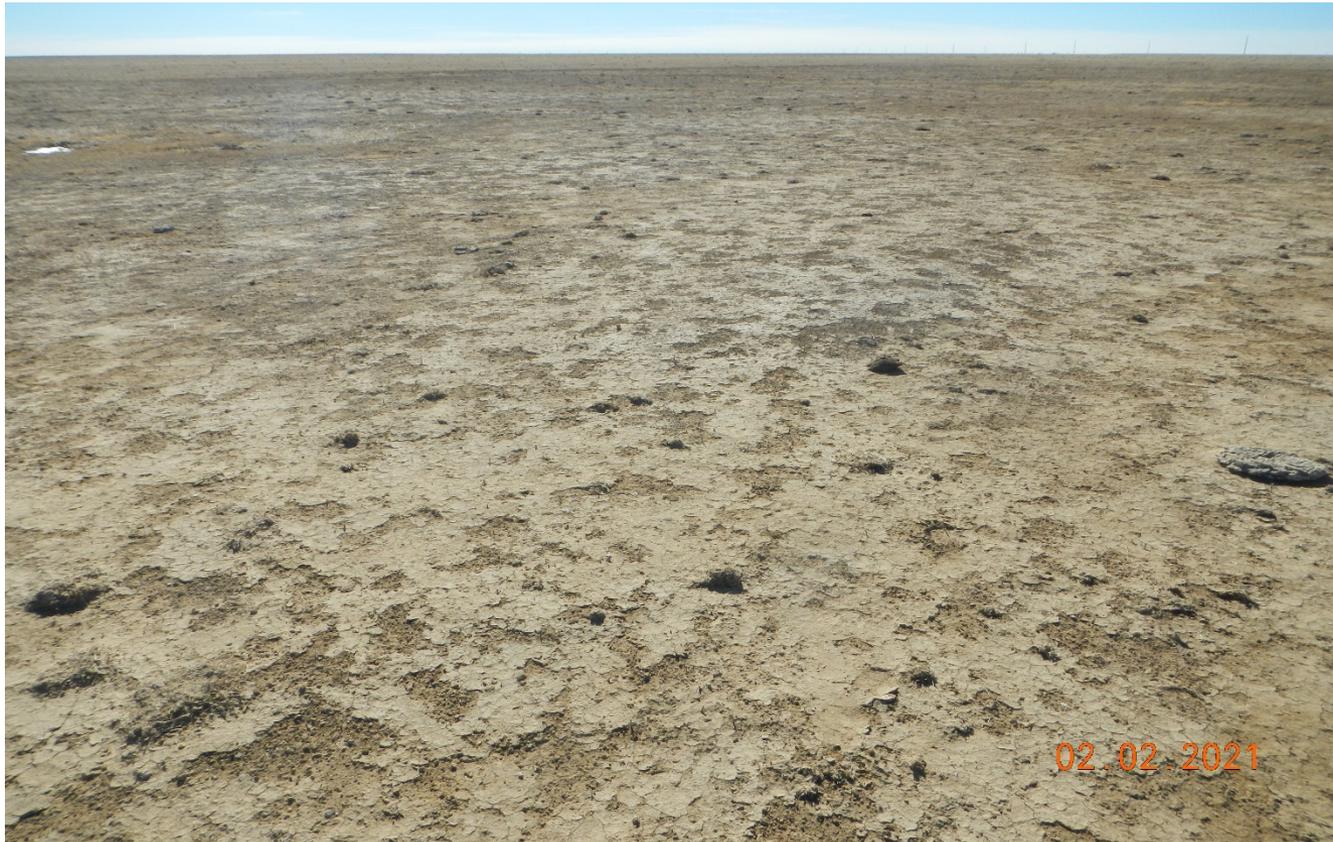
Photo 6. Facing southwest. Vegetation has not established at the location. Soils are bare of vegetation.

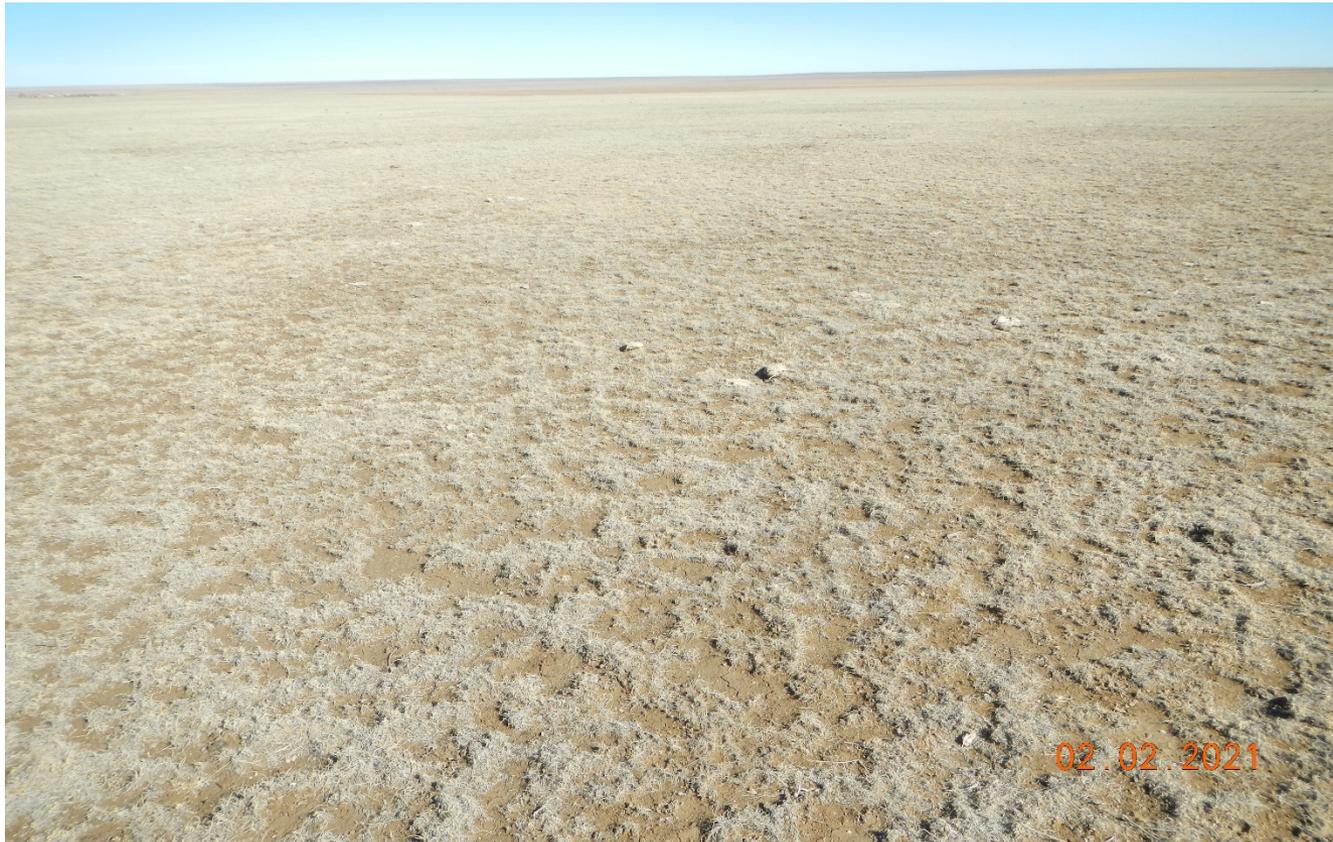
Photo 7. Facing north toward the surrounding undisturbed pasture.
