Inspection Photos

API: 061-06876

Operator: PIONEER NATURAL RESOURCES

Inspection Date: 2/2/2021

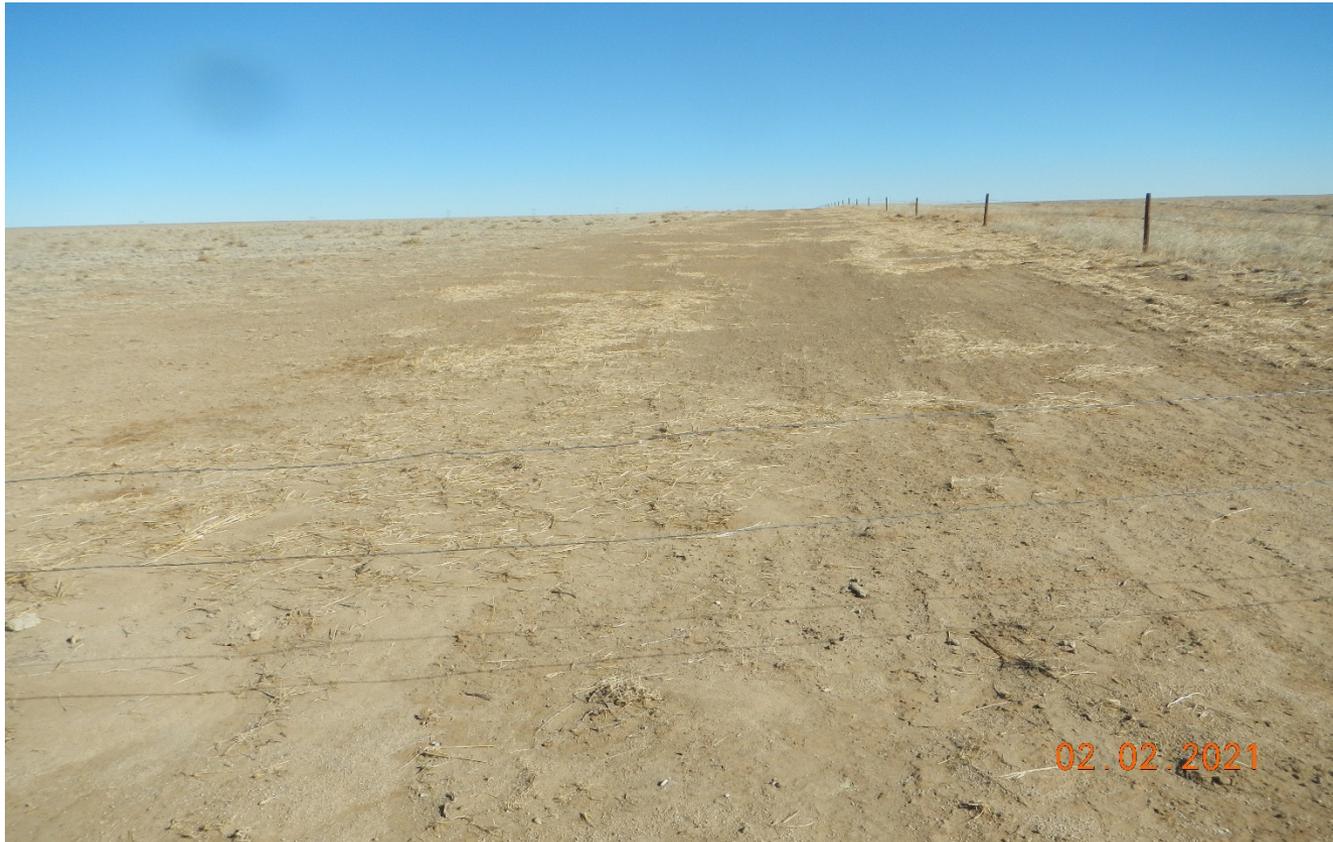
Photo 1. Facing east at the beginning of the access road. The road has recently been reclaimed. Straw mulch was applied to the soil however, much of the straw has blown away in this area of the road.

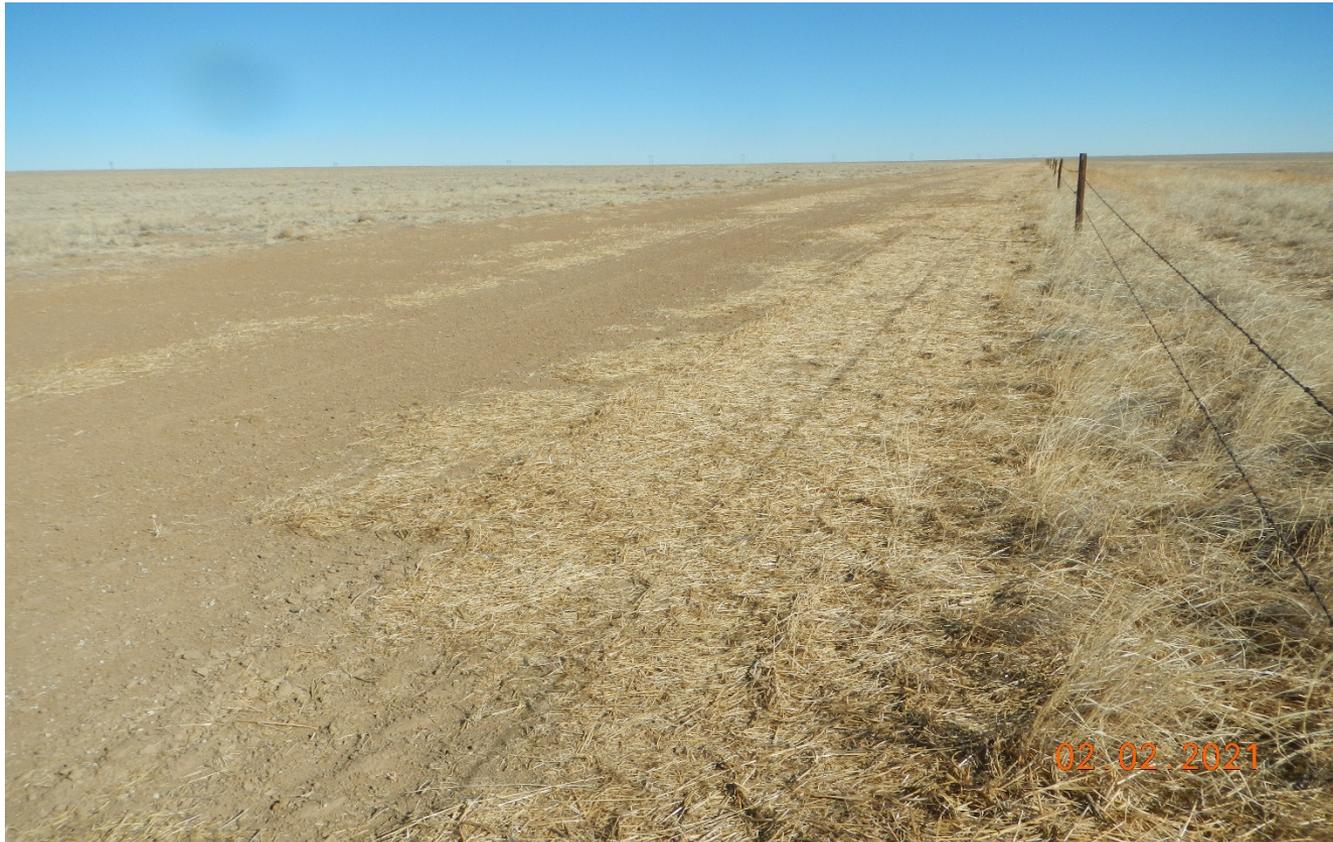
Photo 2. Facing east along the reclaimed access road. Did not inspect past this point of the road.
