Inspection Photos

API: 011-06194

Operator: FOUNDATION ENERGY
MANAGEMENT

Inspection Date: 2/2/2021

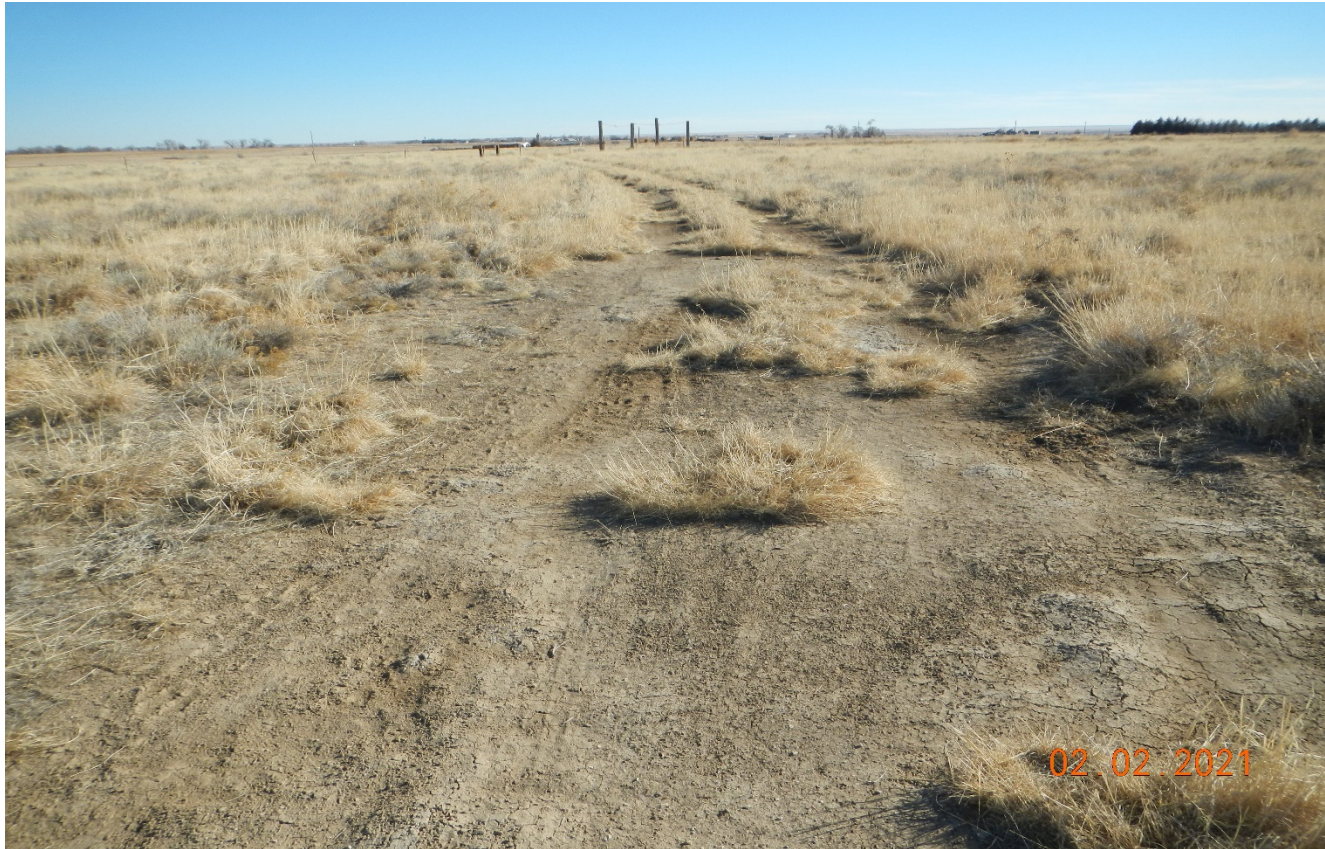
Photo 1. Facing southeast toward the former access road. The two track road remains and will need to be decompacted and reclaimed.

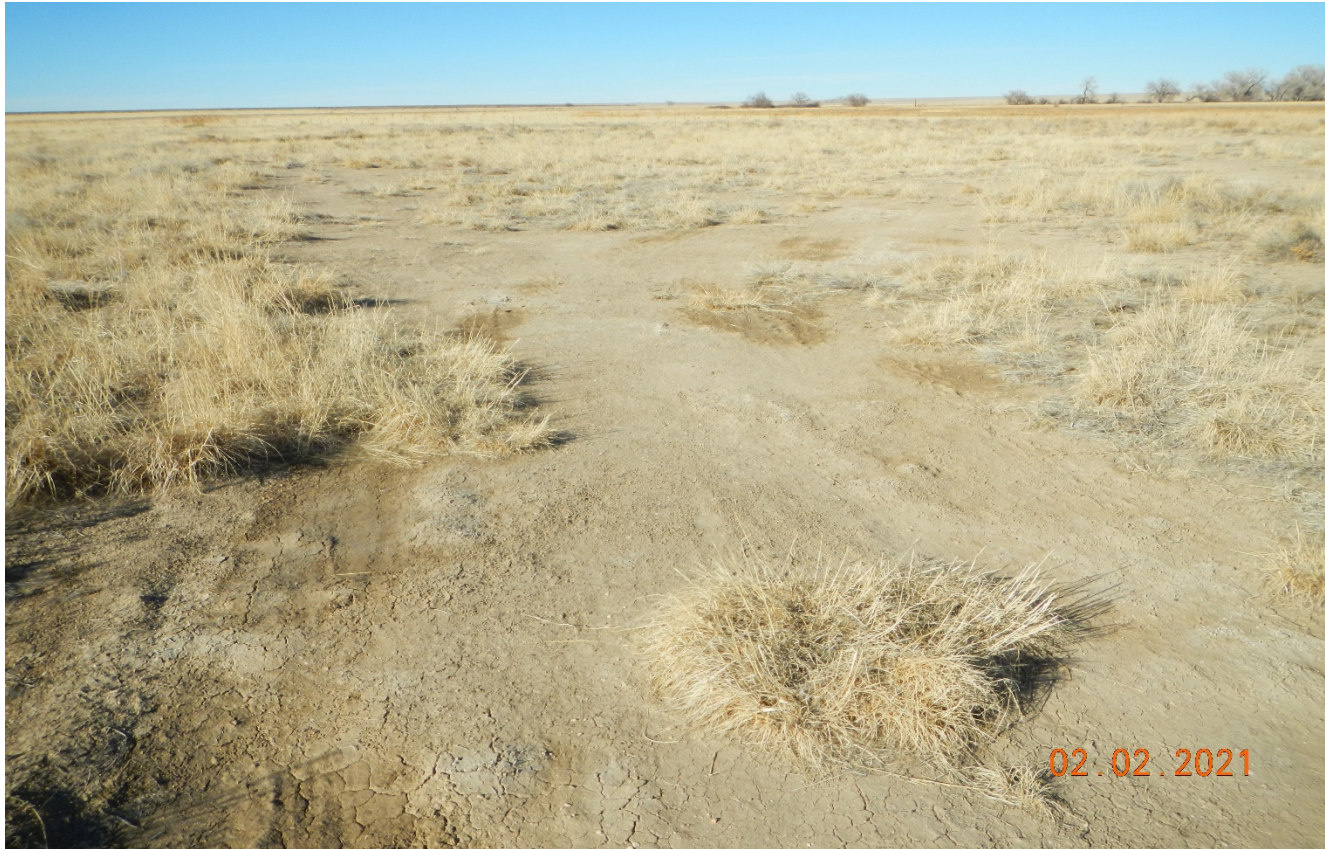
Photo 2. Facing north toward the location. There are areas that do not have vegetation. These areas will likely need to be decompacted.

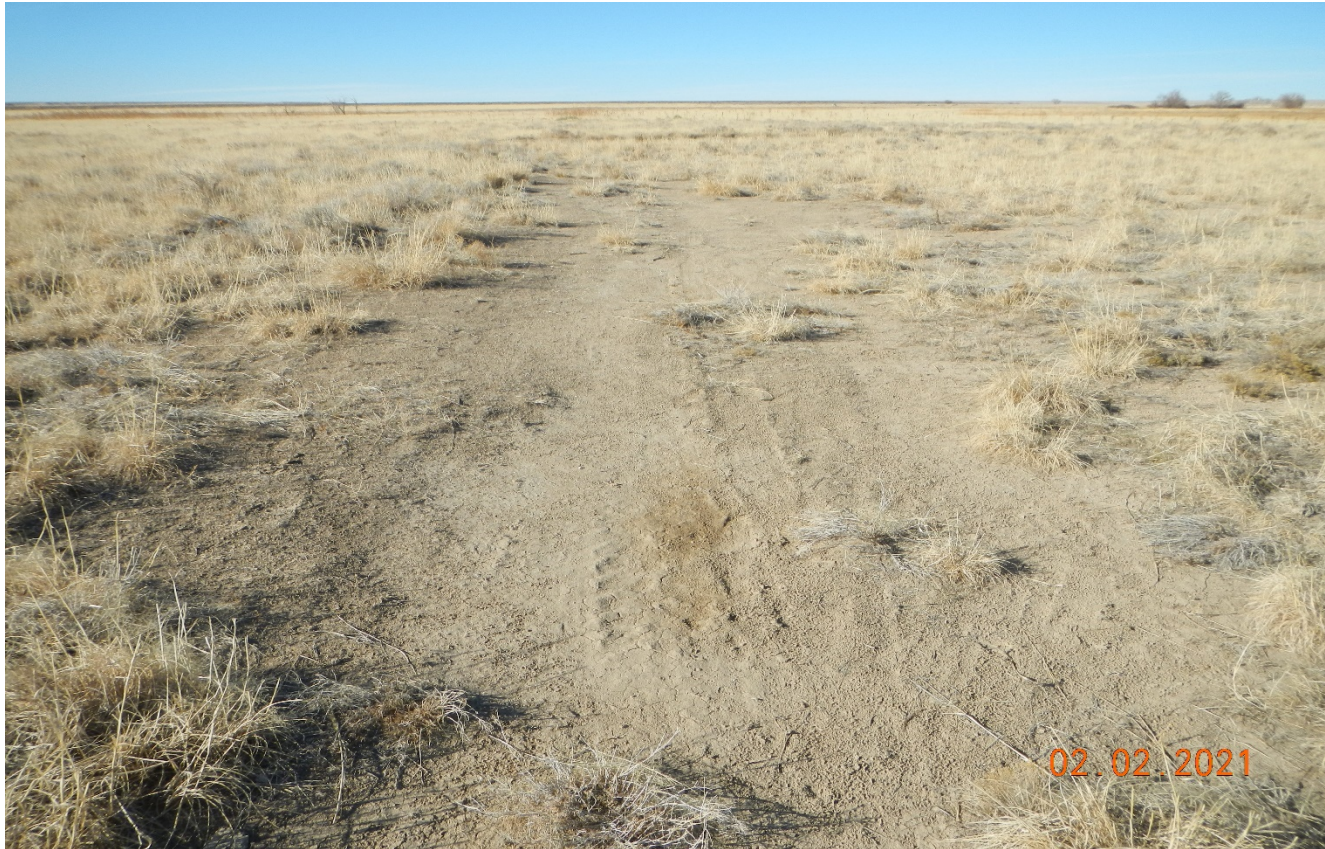
Photo 3. Facing northwest toward the location. The bare areas will need to be decompacted and reseeded.

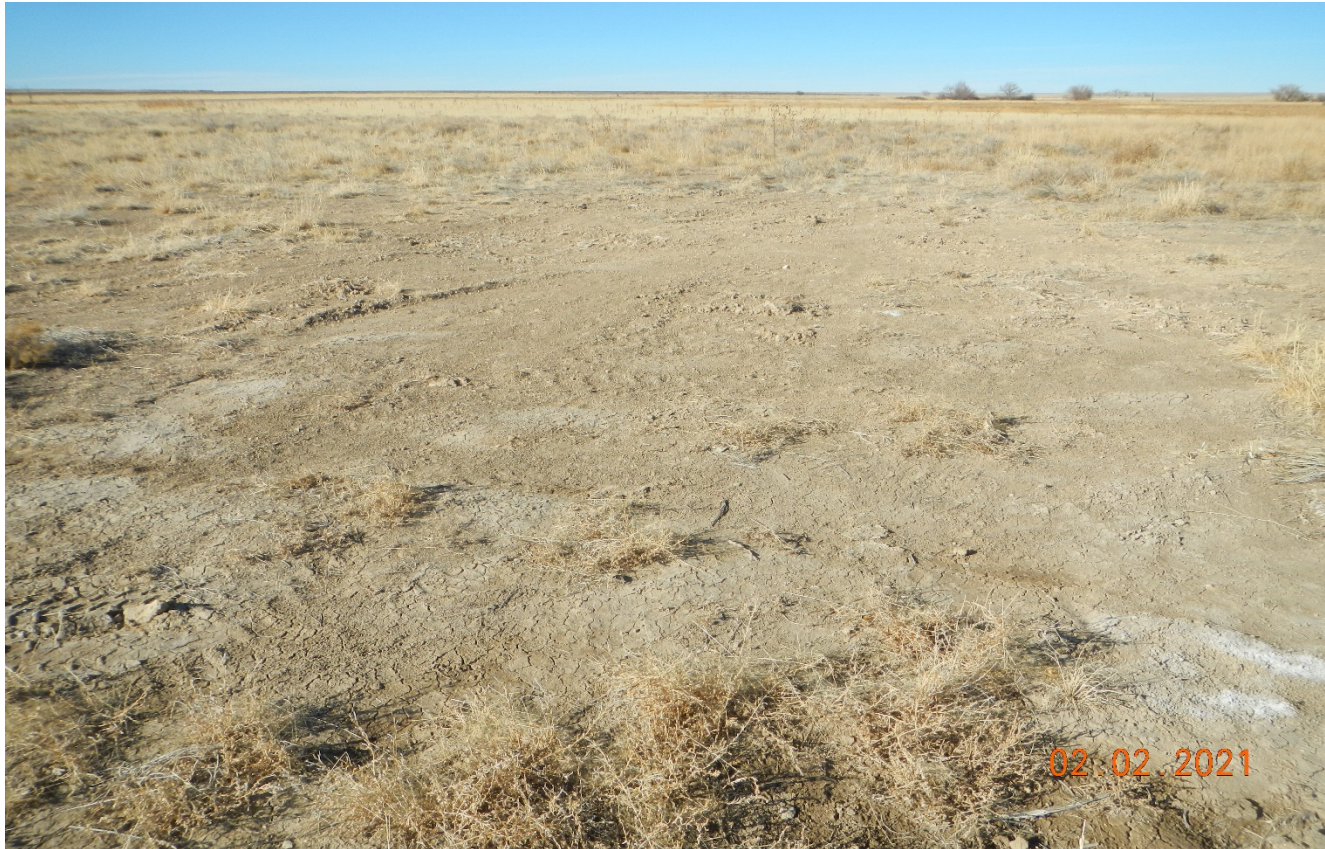
Photo 4. Facing north at the east side of the location. This disturbance area will need to be reclaimed.

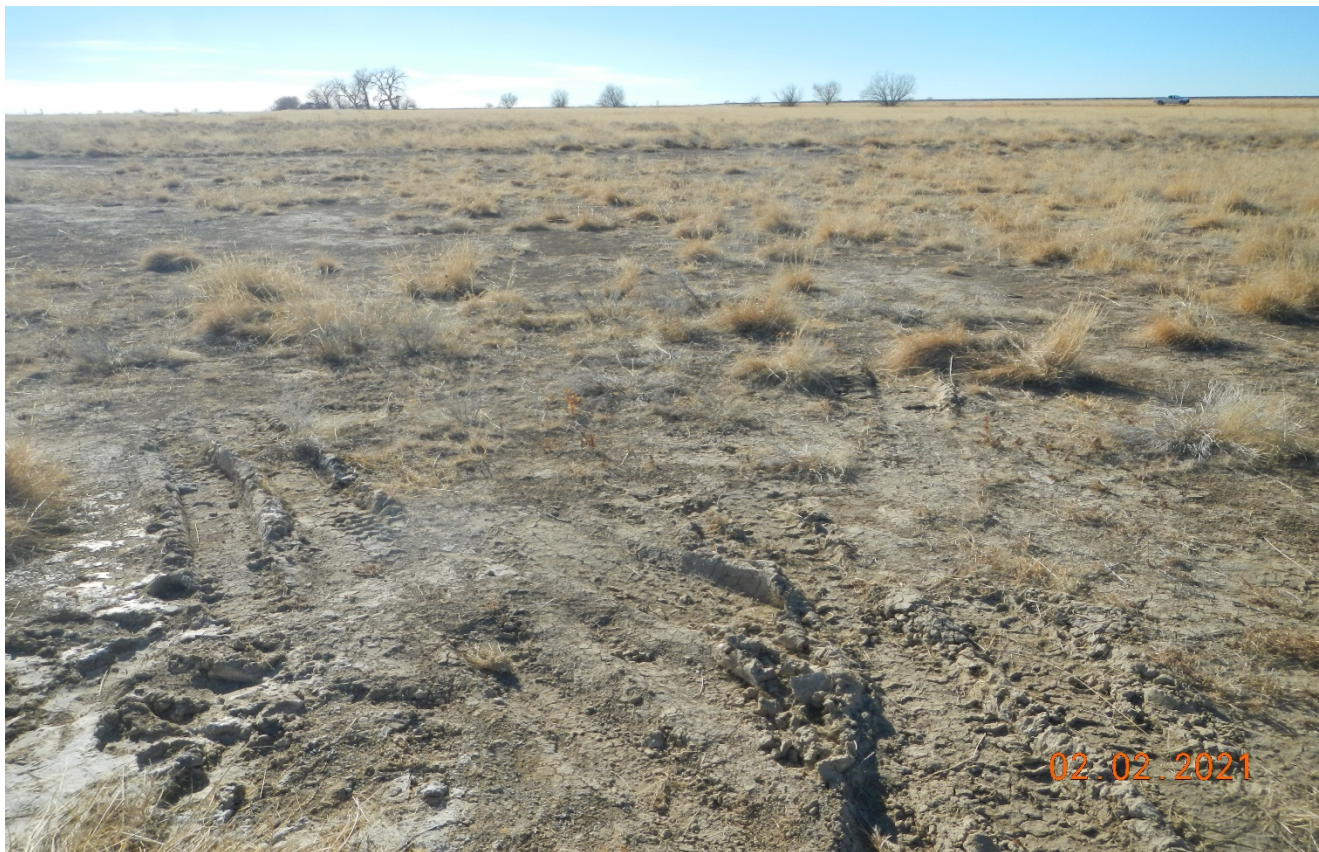
Photo 5. Facing west at the location.

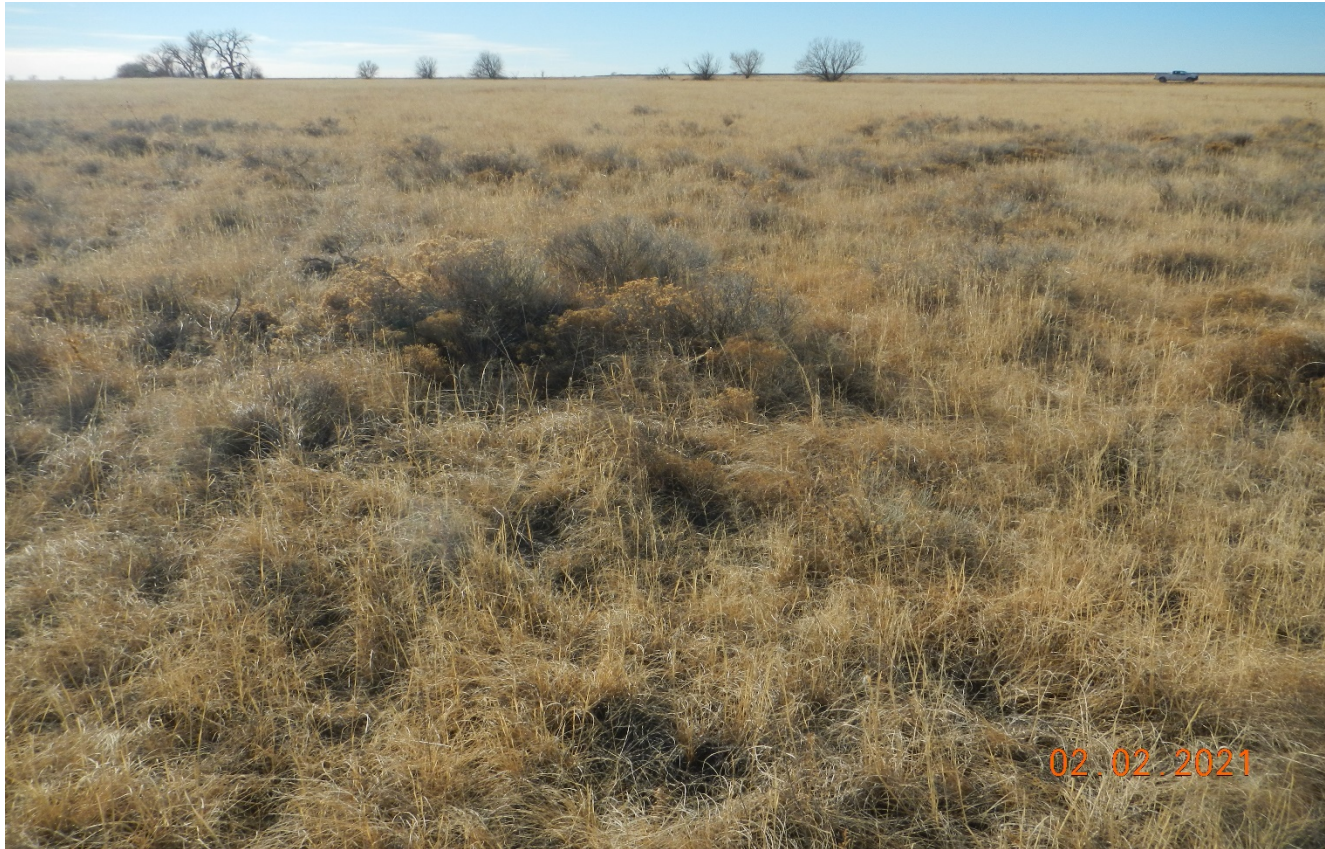
Photo 6. Facing west toward the surrounding undisturbed reference area.
