**CAERUS PICEANCE LLC  
N. Parachute MF H17 696  
Location # 335825**

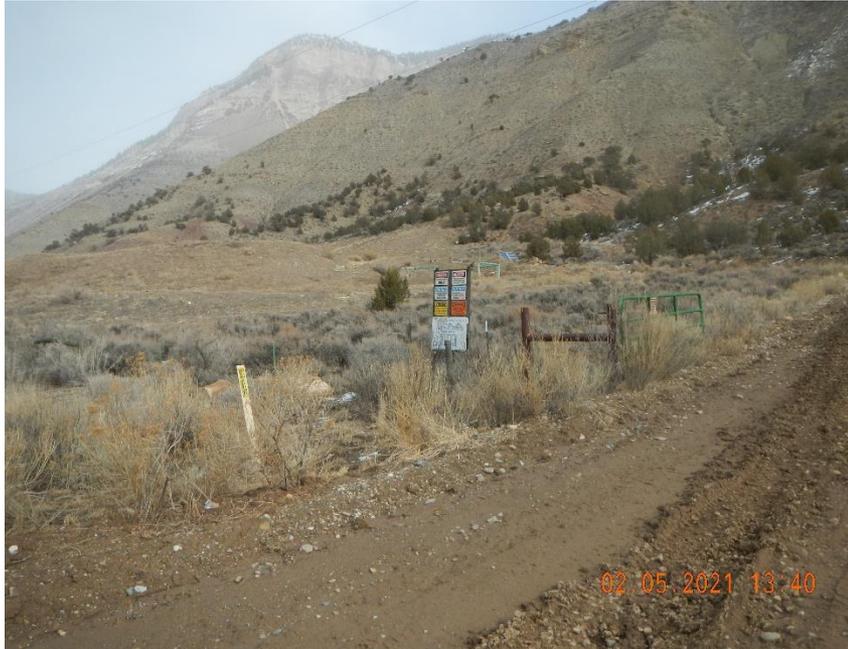
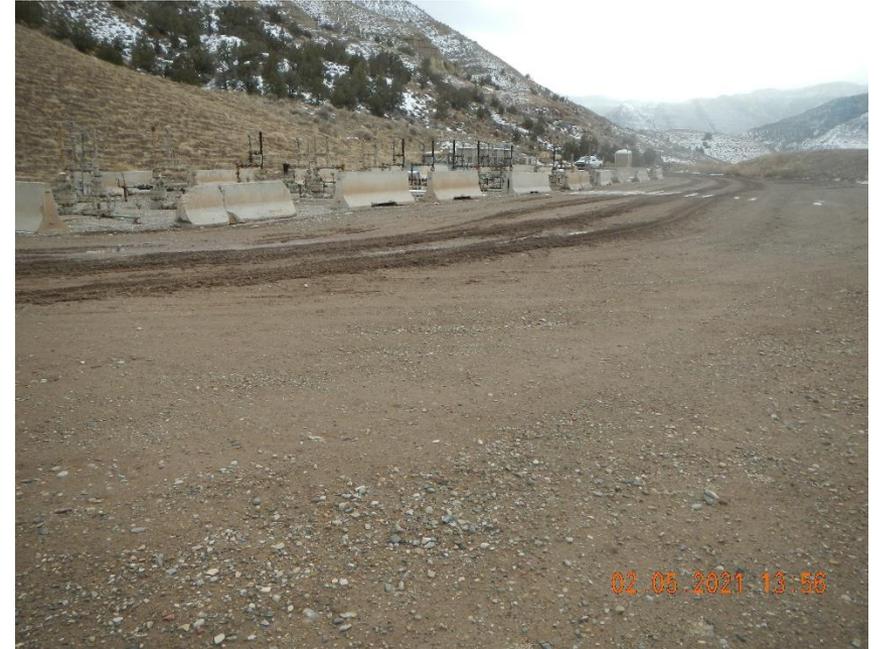
**Location shows signs of lack of stabilization  
BMP's in some areas (rutting is present)**

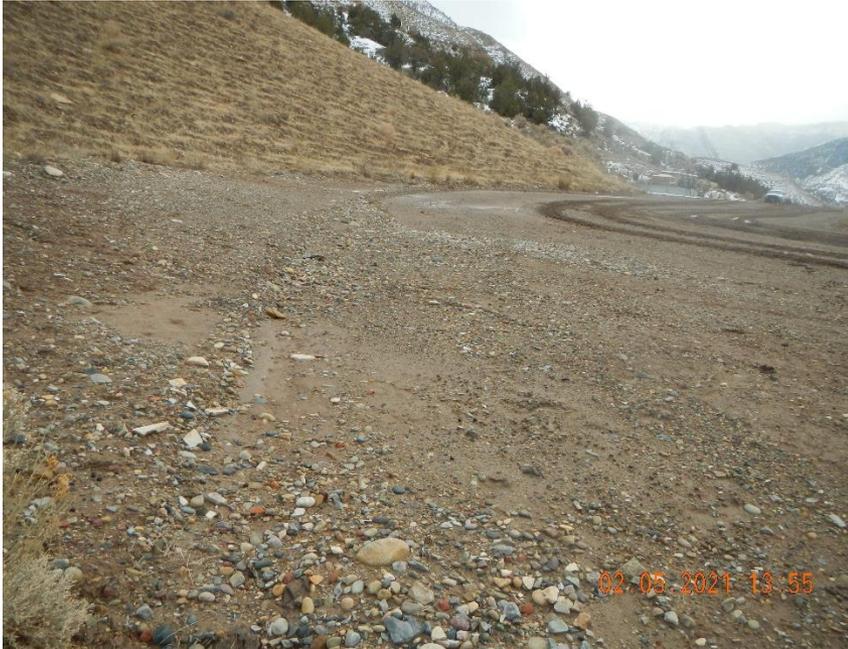
**Perimeter ditch needs maintained.**

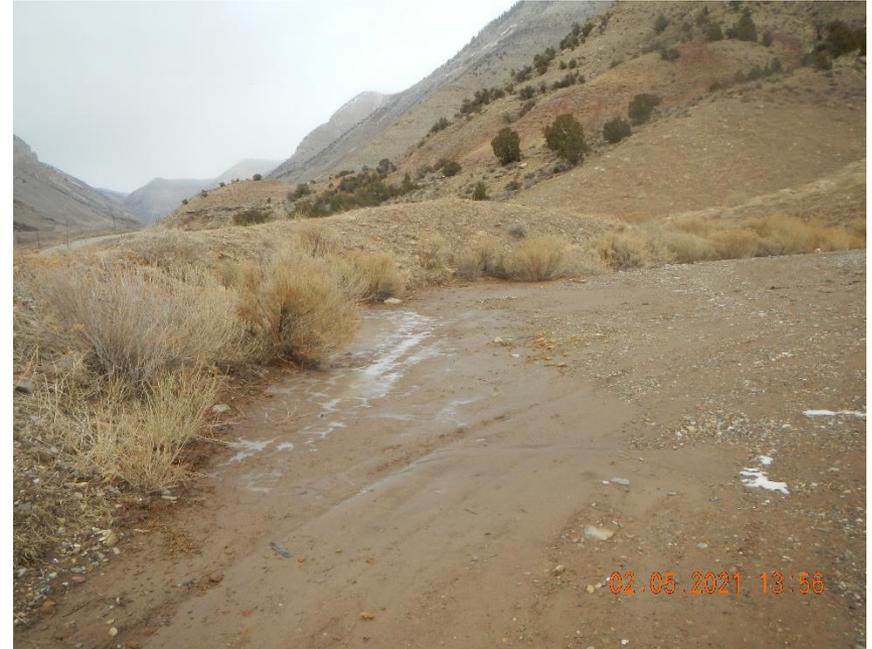
**Sediment build up in ditch**

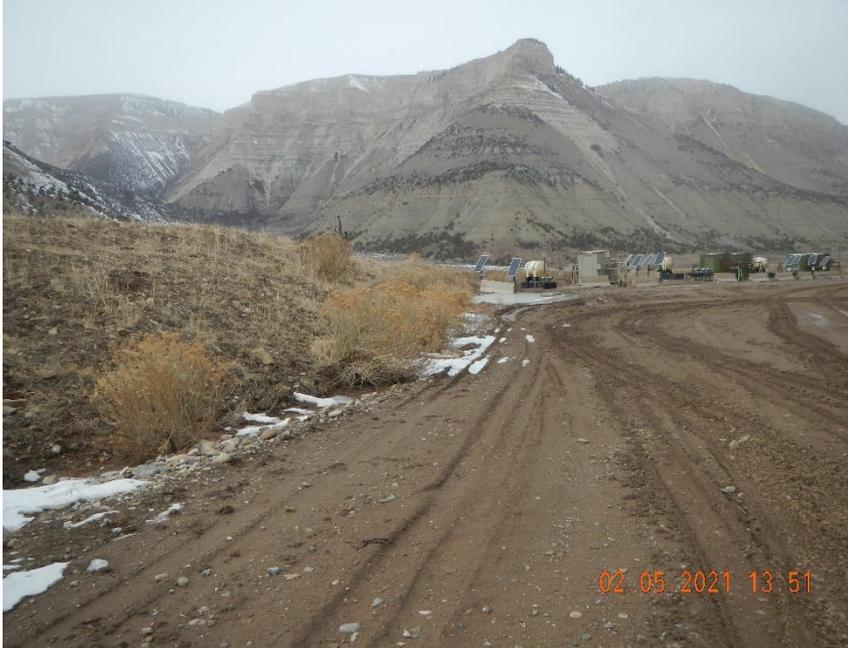
**Location shows signs of lack of stabilization  
BMP's in some areas (rutting is present)**

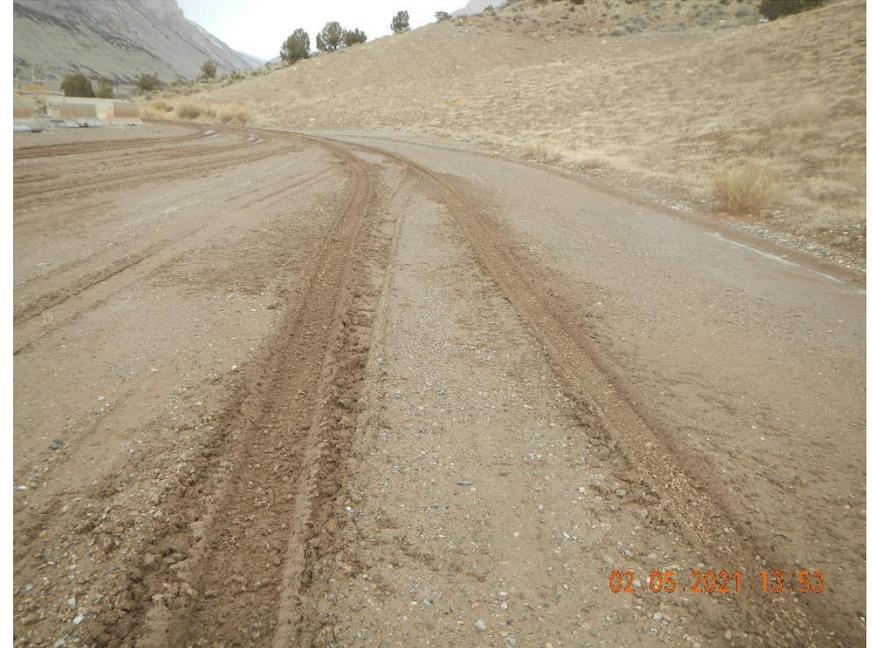
**Location shows signs of lack of stabilization  
BMP's in some areas (rutting is present)**

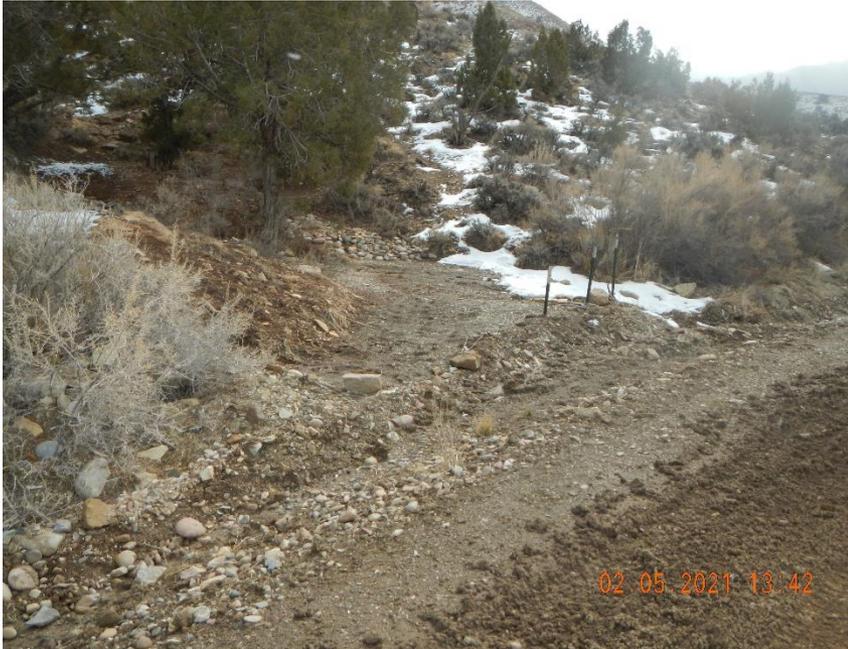
**Drainage merging with road ditch is full of sediment.**

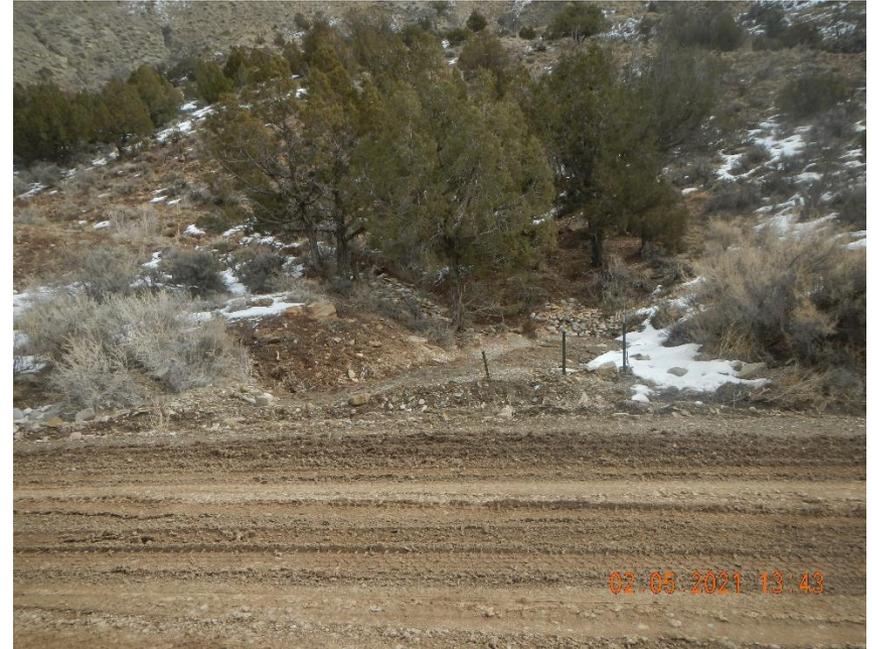
**Drainage merging with road ditch is full of sediment.**

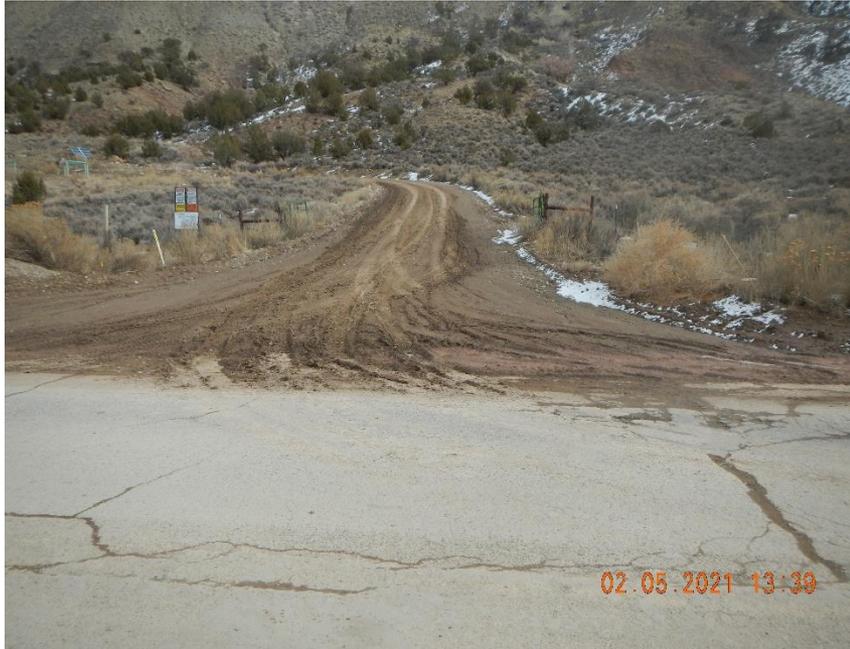
**No evidence of tracking control BMP's**

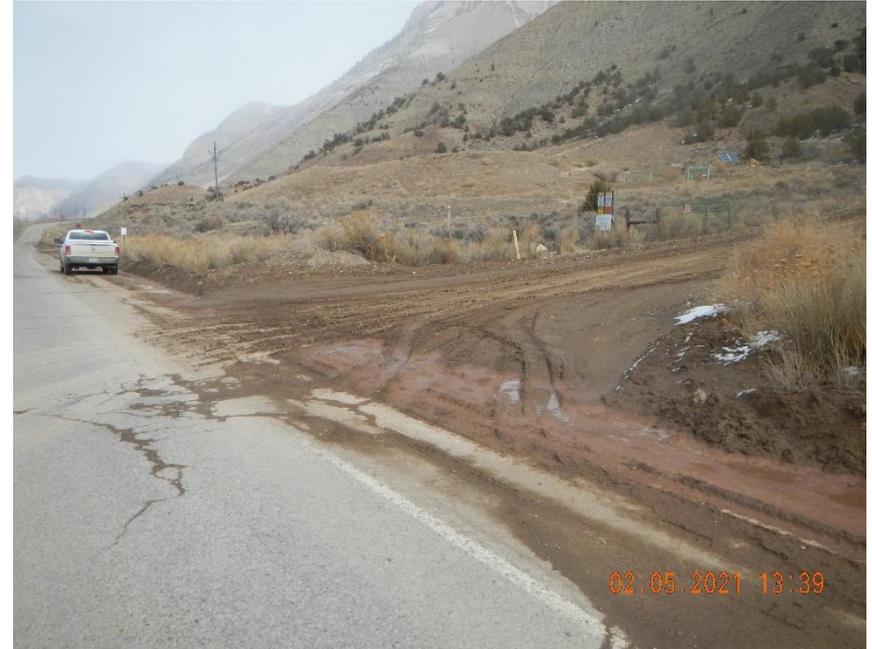
**No evidence of tracking control BMP's**

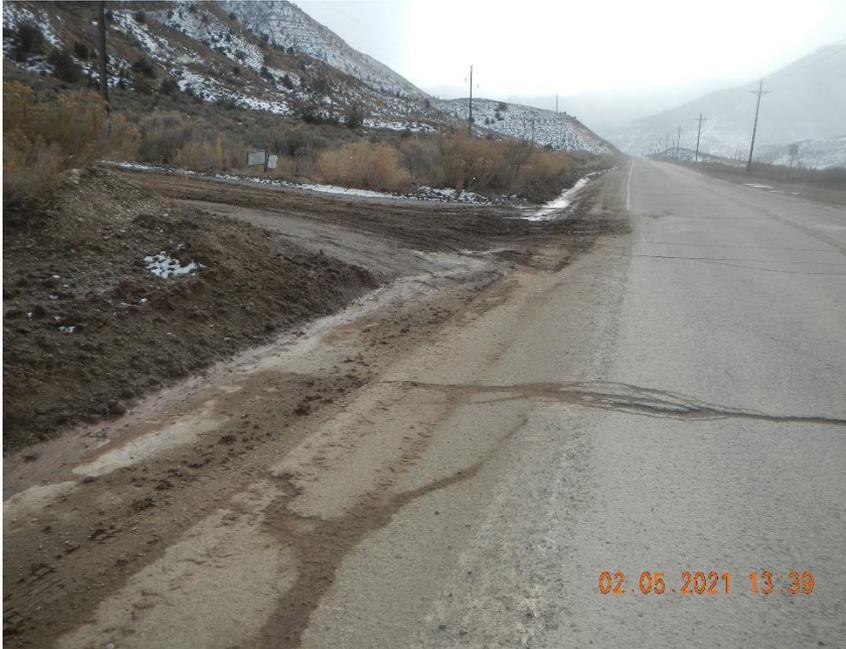
**No evidence of tracking control BMP's**
