Inspection Photos

Location Name: TEP ROCKY MOUNTAIN LLC DIAMOND ELK-66S95W /36SWSE

Location ID: 335029

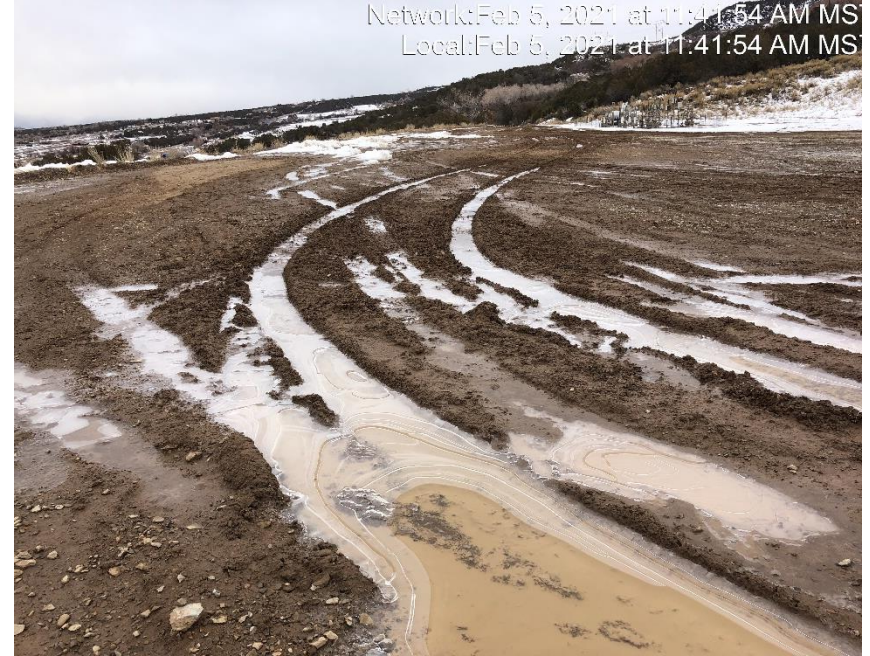
Photo #2821 Rutting present on location due to lack of stabilization.

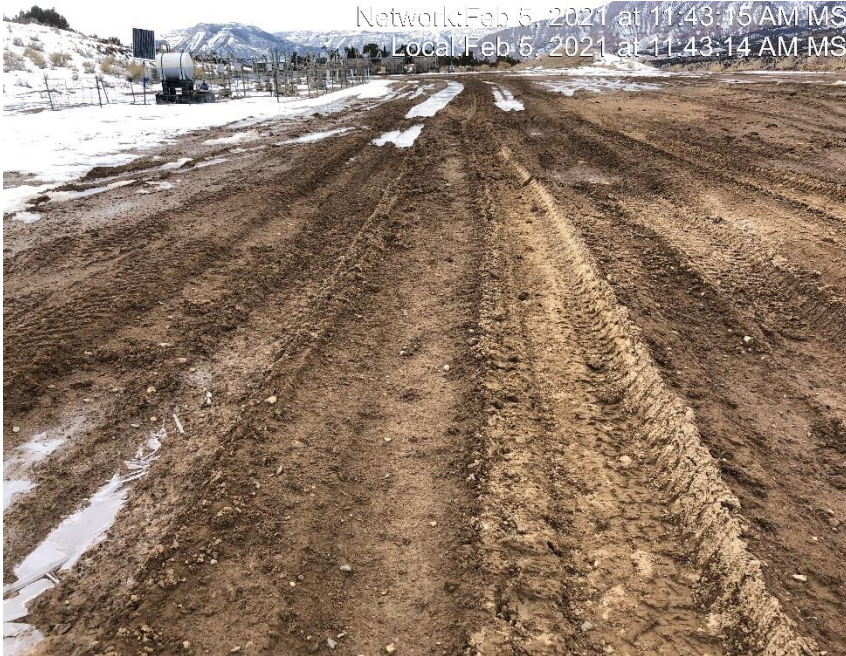
Photo #2822 Rutting present on location due to lack of stabilization.

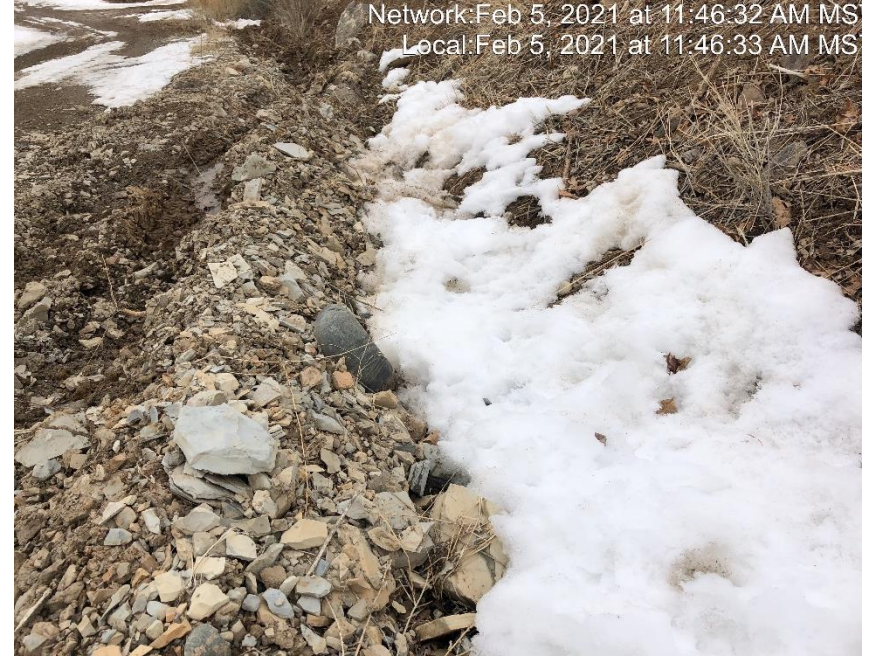
Photo #2823 Ditch has been diverted due to rutting.

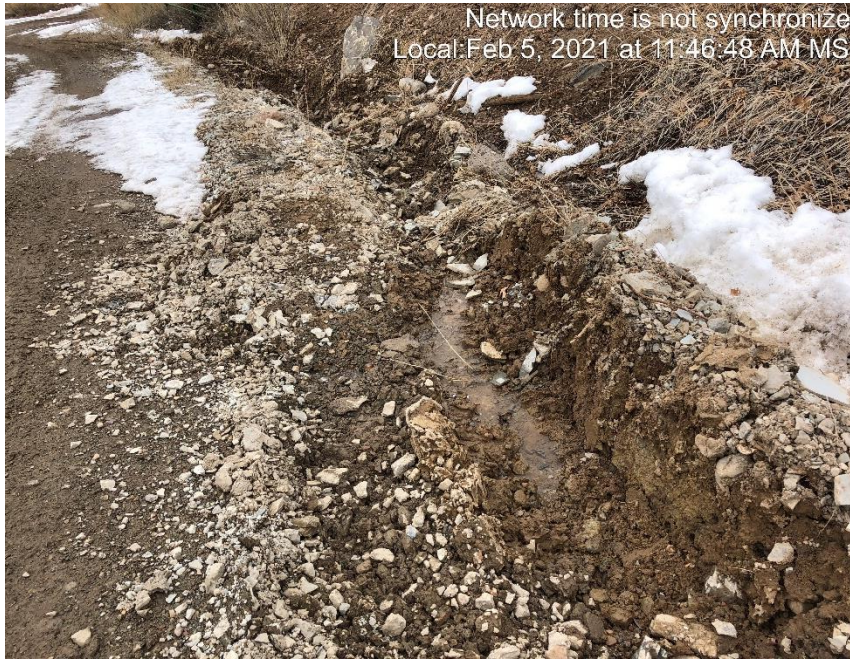
Photo #2824 Ditch has been diverted due to rutting.

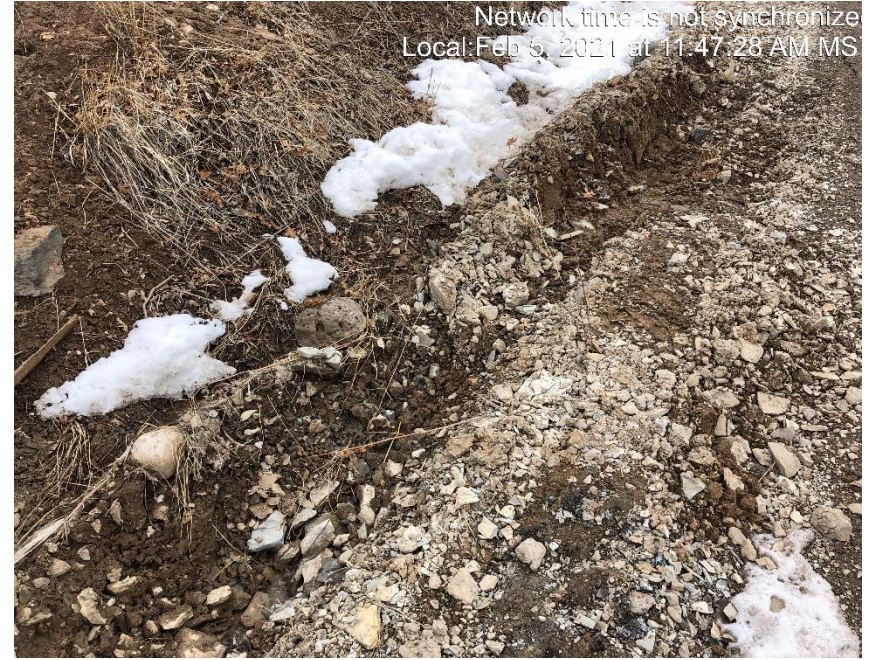
Photo #2825 Ditch has been diverted due to rutting.
