Inspection Photos

Location Name: CAERUS PICEANCE LLC NOCKS-68S96W /2NENE

Location ID: 334078

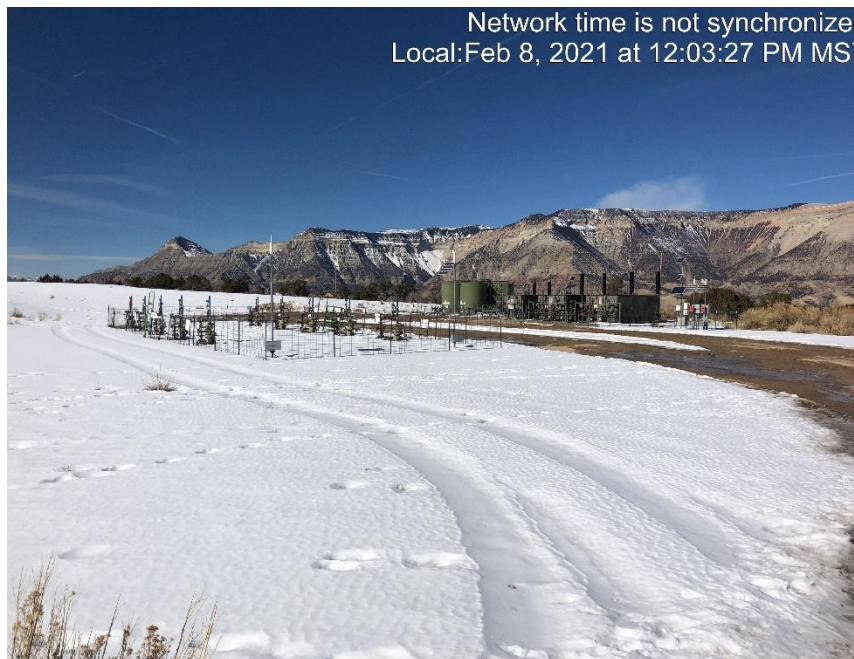
Photo #2838 from entrance to location.

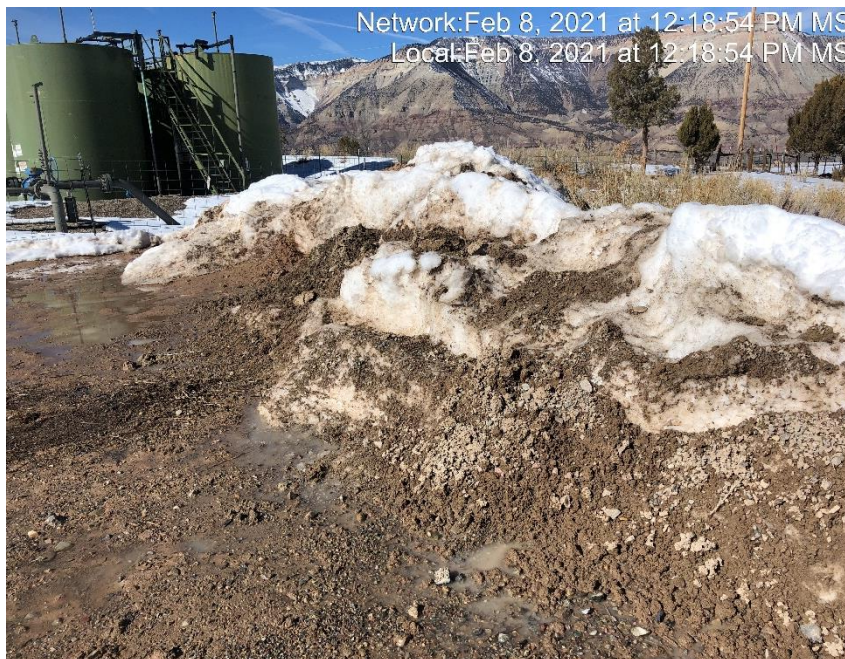
Photo #2839 Front of berm. Sediment has been transported off of location due to snow plowing.

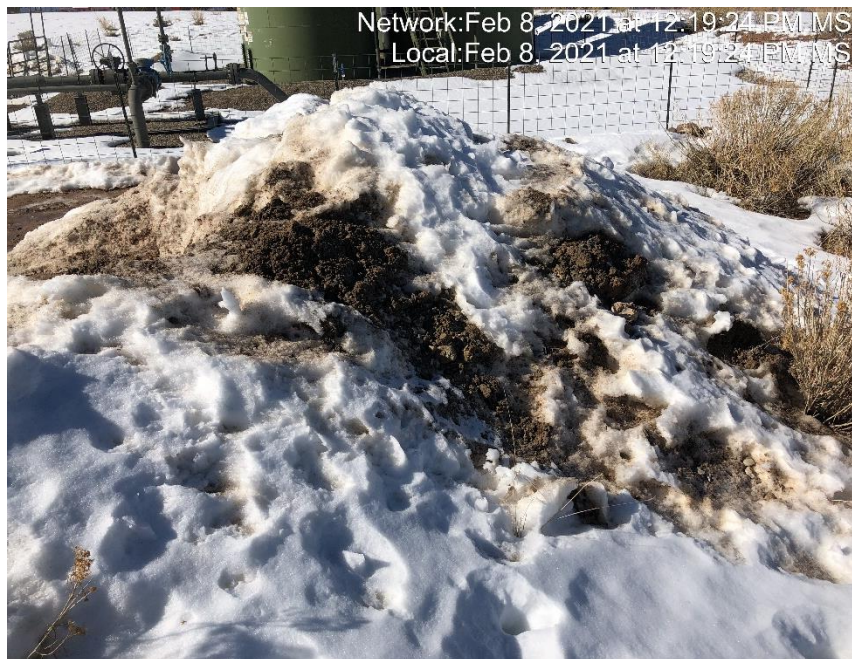
Photo #2840 Back side of berm Sediment has been push over berm.

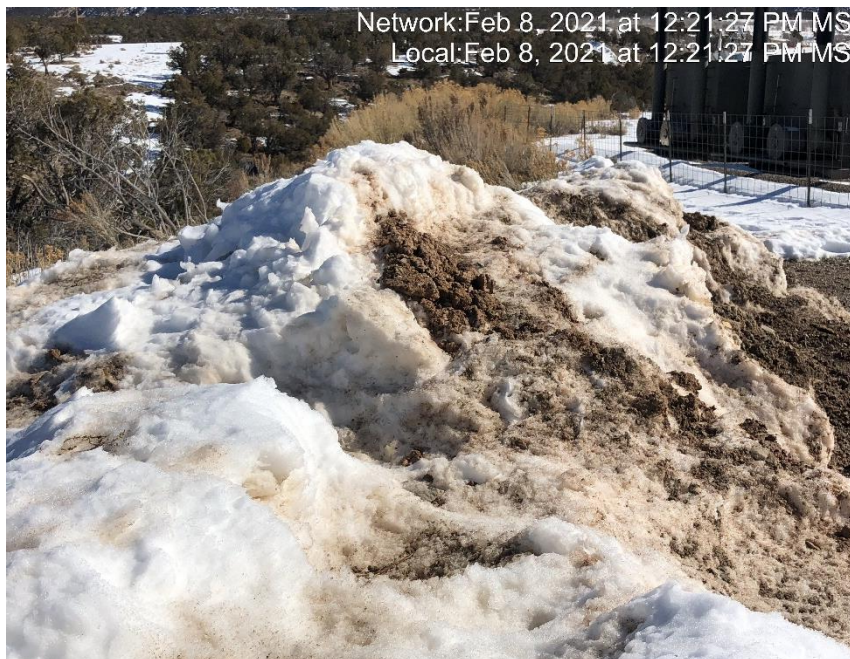
Photo #2841 Back side of berm. Sediment has been push over berm.

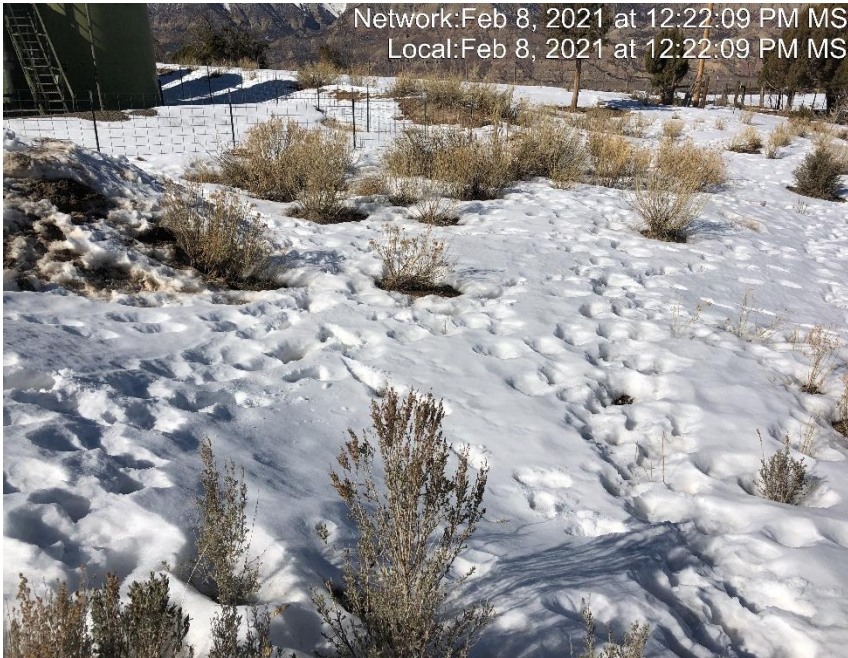
Photo #2842 No BMP's in place to prevent the transportation of sediment from location.

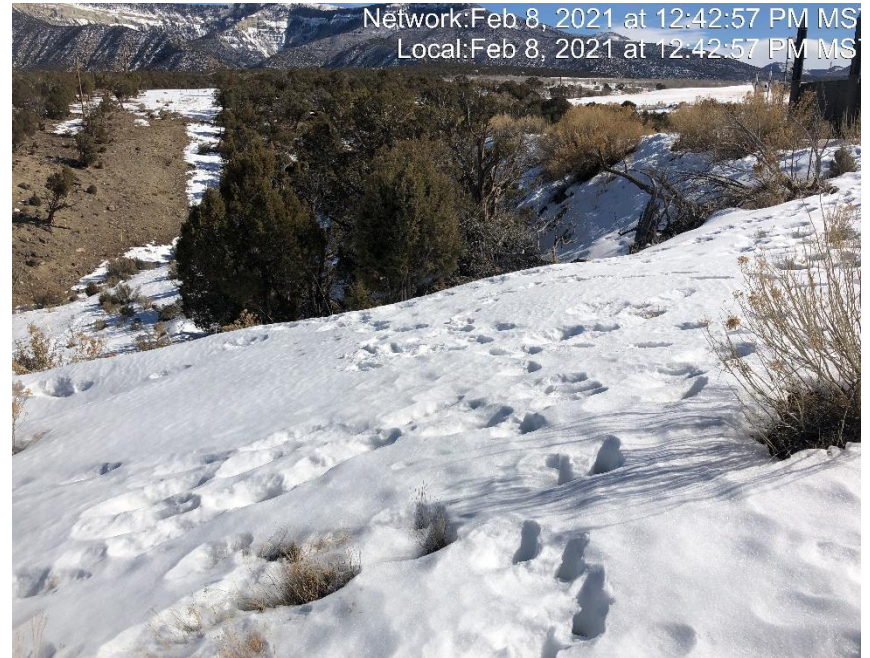
Photo #2843 Pipe line right away.
