Inspection Photos

API: 043-06219

Operator: AUSCO PETROLEUM INC

Inspection Date: 2/9/2021

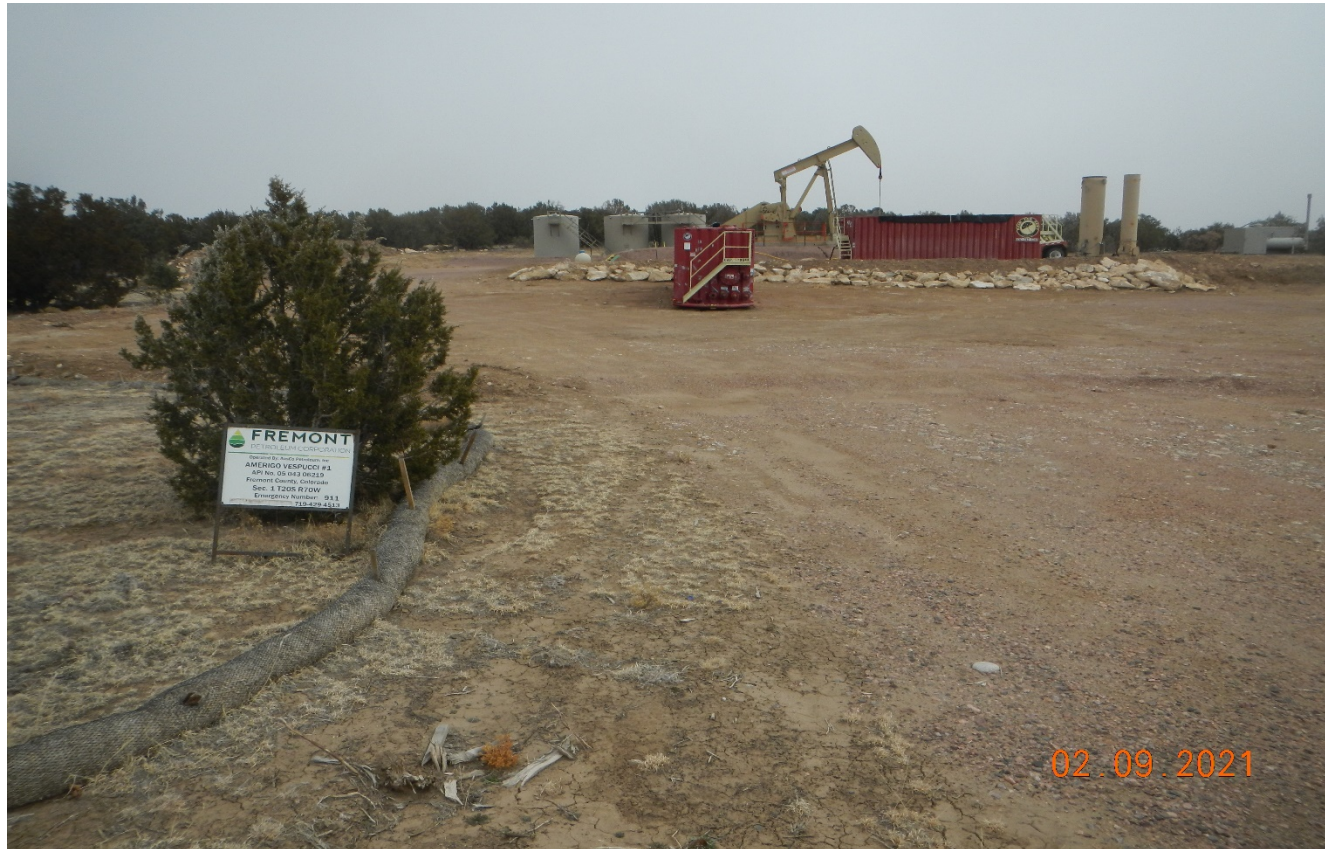
Photo 1. Facing northeast toward the location. Unused equipment has not been removed and interim reclamation has not been performed.

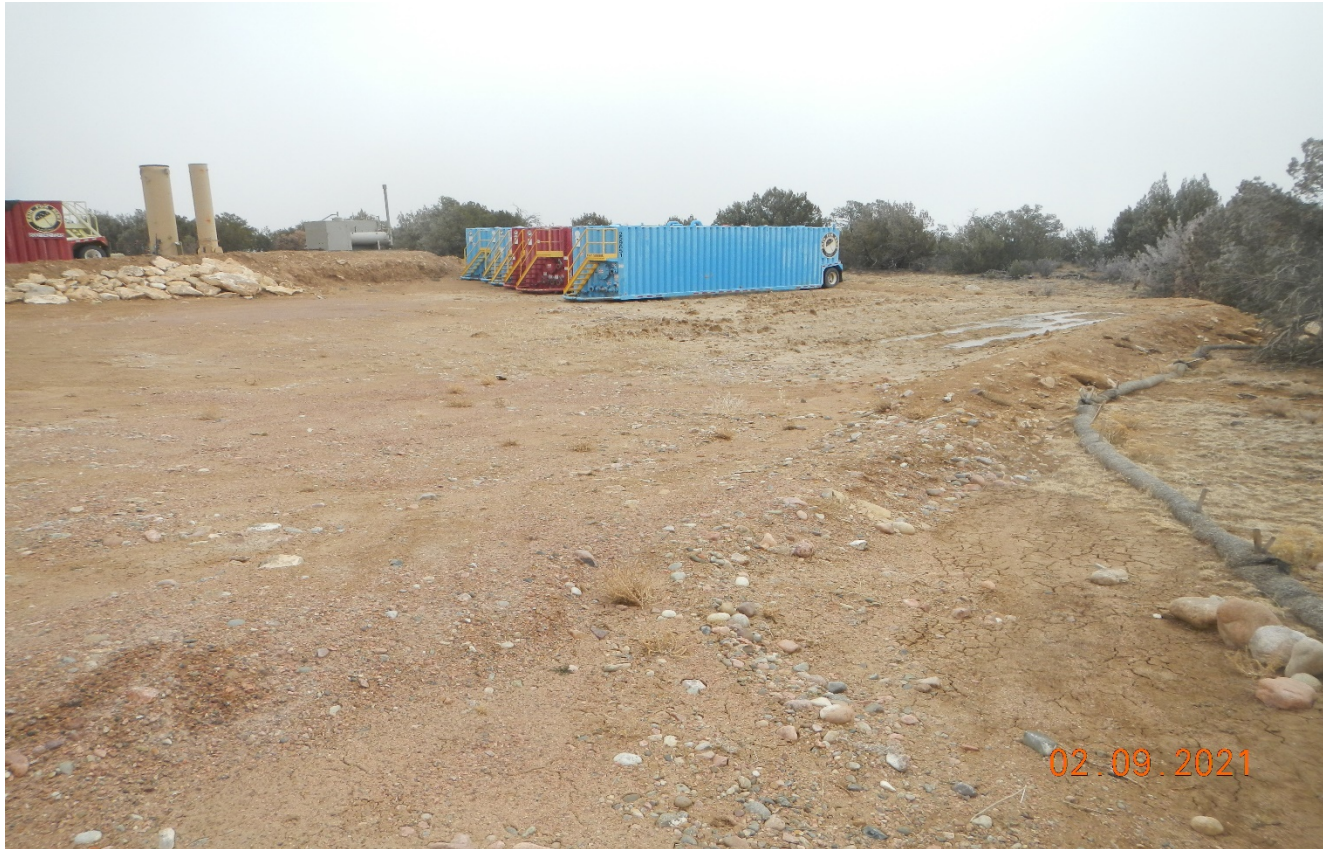
Photo 2. Facing east at the location. There is 5 frac tanks staged that remain. The tanks have not been removed since previous inspection. Previous corrective actions have not been performed.

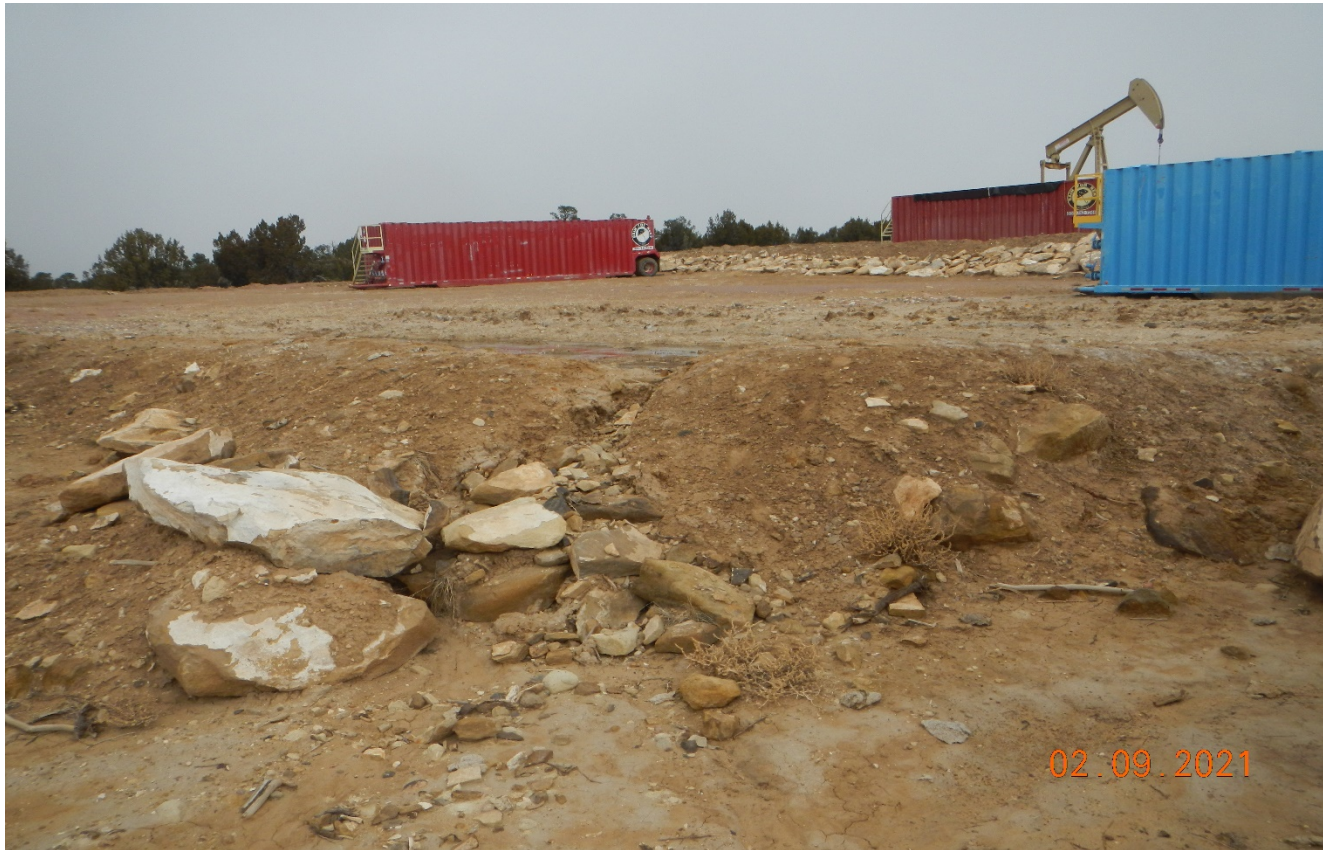
Photo 3. Facing north at the location. There is erosion occurring of the disturbed pad site which is filling in the perimeter wattles. Previous corrective action has not been performed.

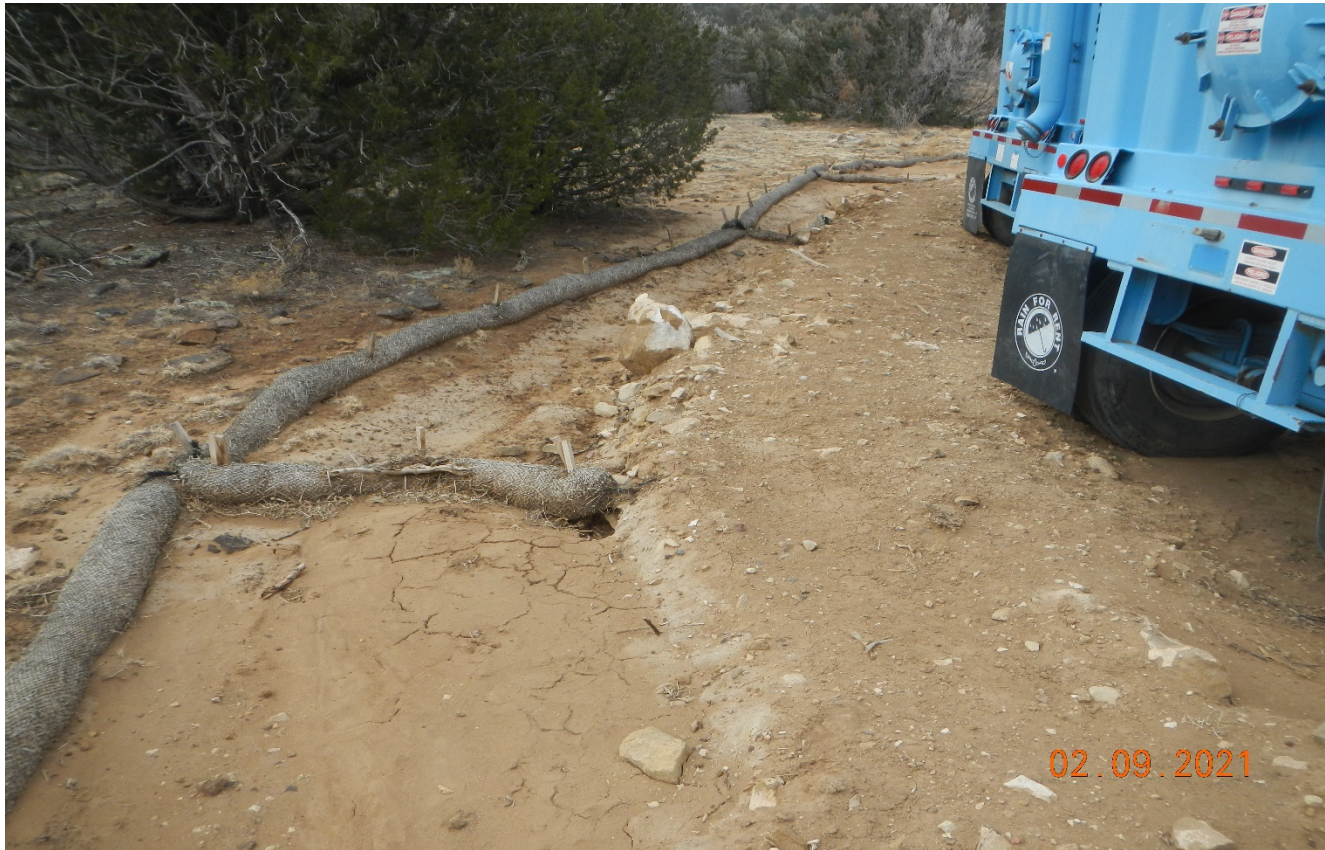
Photo 4. Facing southwest behind the frac tanks. The wattles have filled in with sediment. Previous corrective action has not been performed.

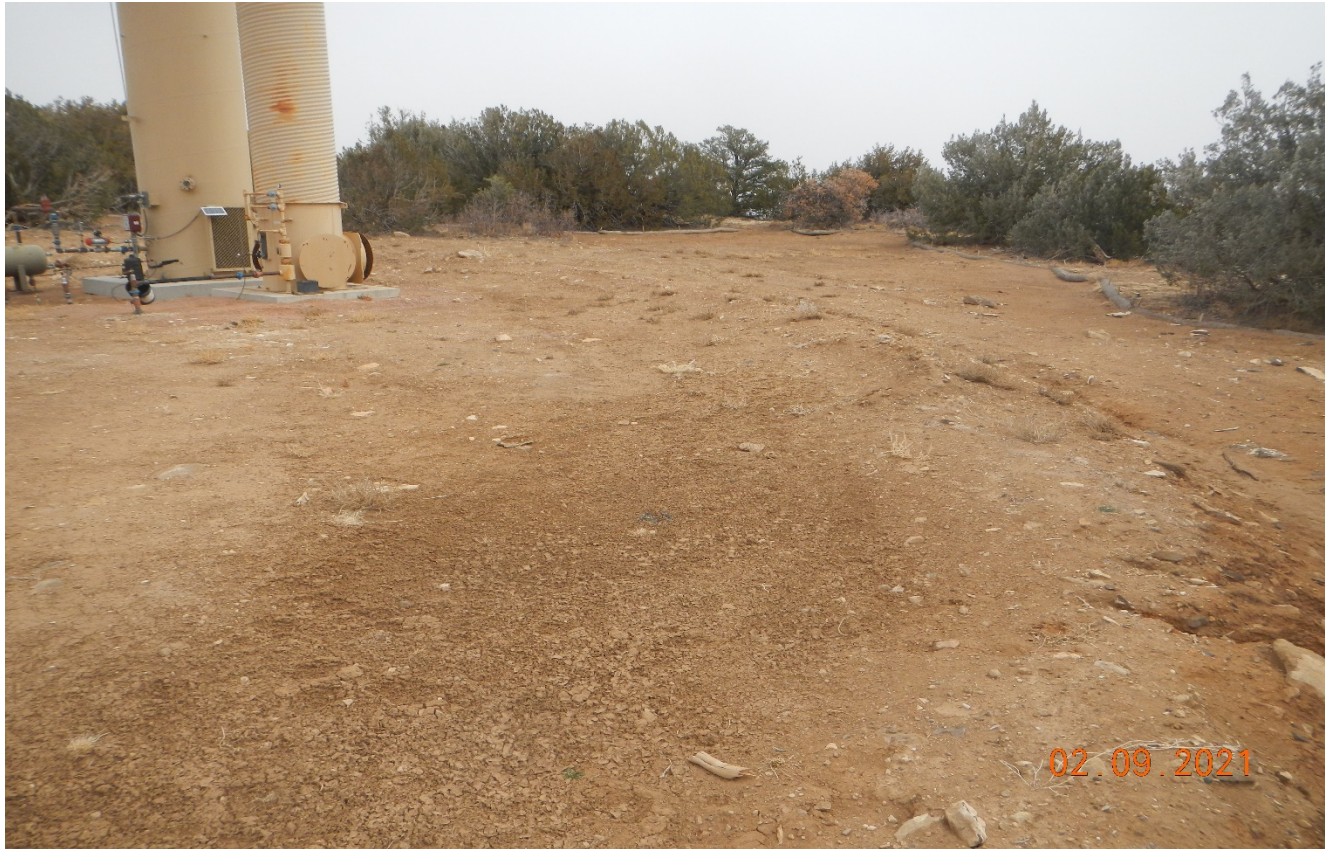
Photo 5. Facing north at the location. Disturbed areas around the location have not been reclaimed and stabilized.

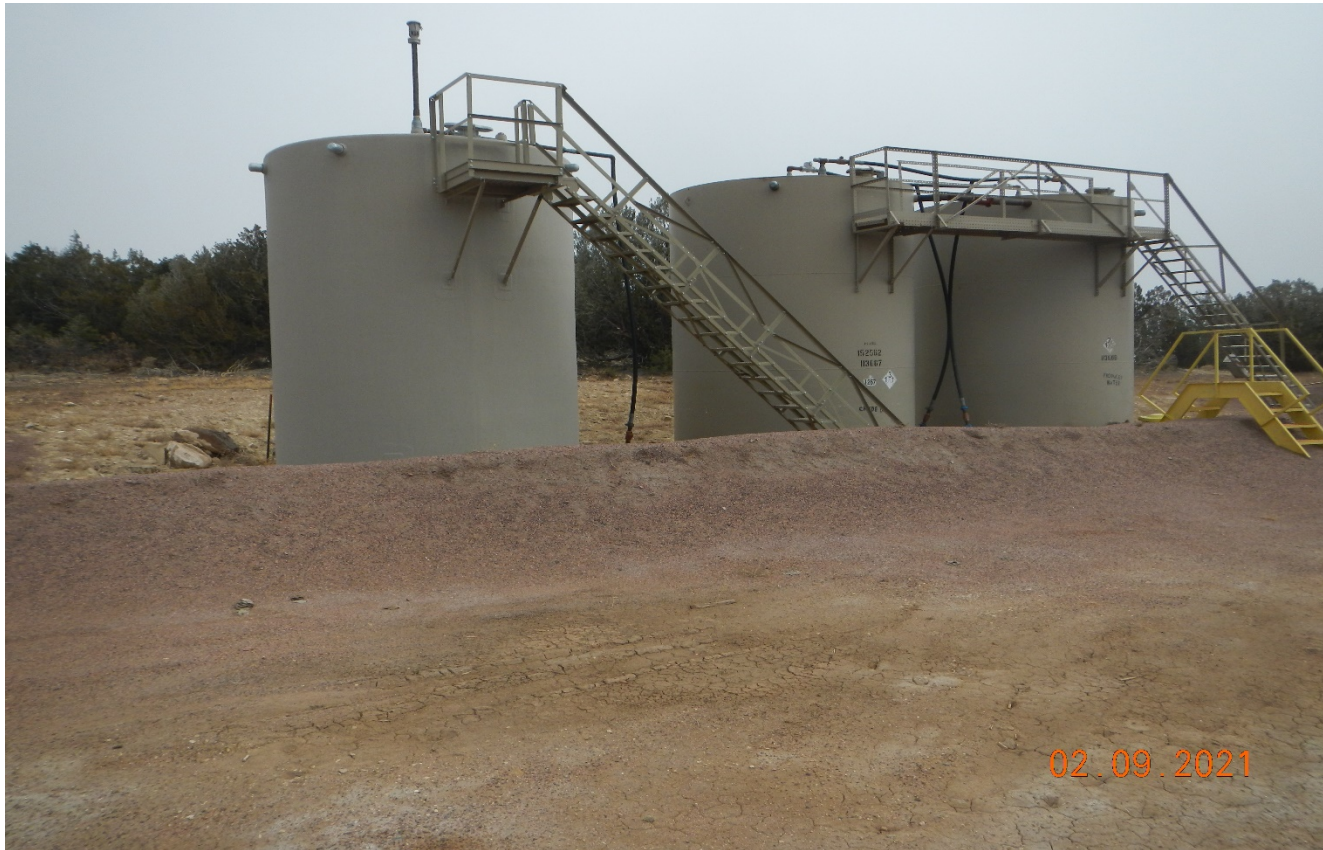
Photo 6. The tanks at north side of the location are not properly labeled.

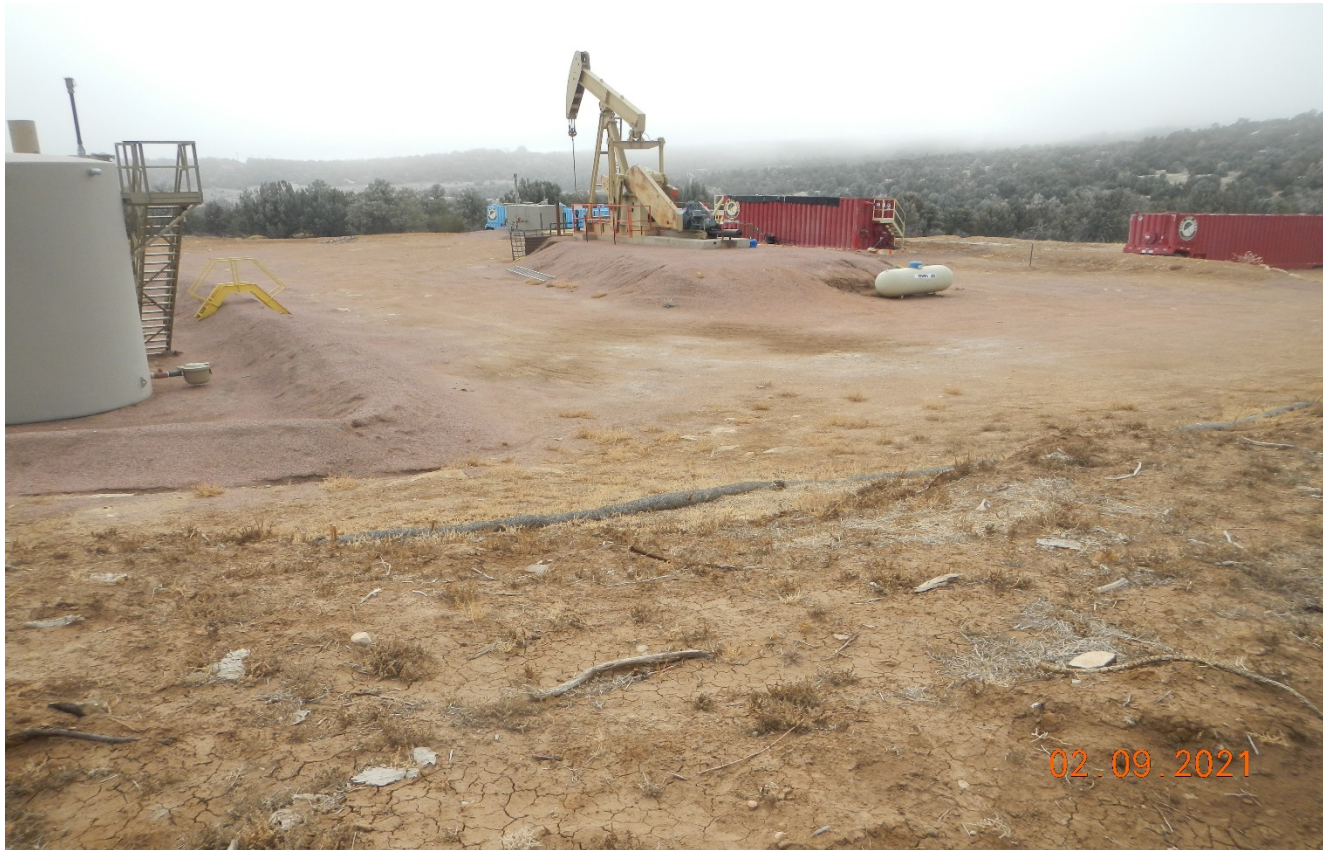
Photo 7. Facing southeast at the location and toward the production equipment.

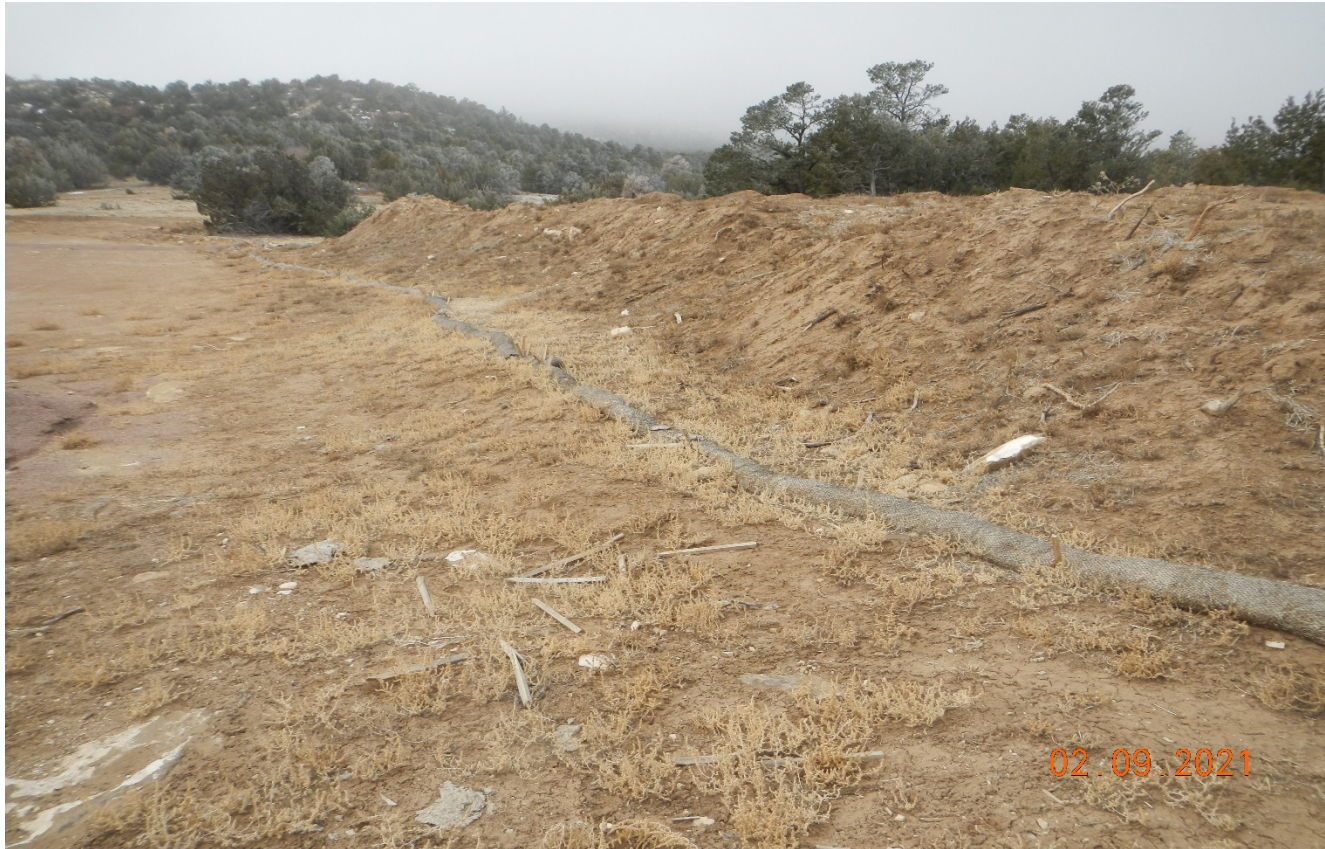
Photo 8. Facing southwest toward the topsoil pile which are not maintained and protected from degradation and weed infestation. Previous corrective action has not been performed.

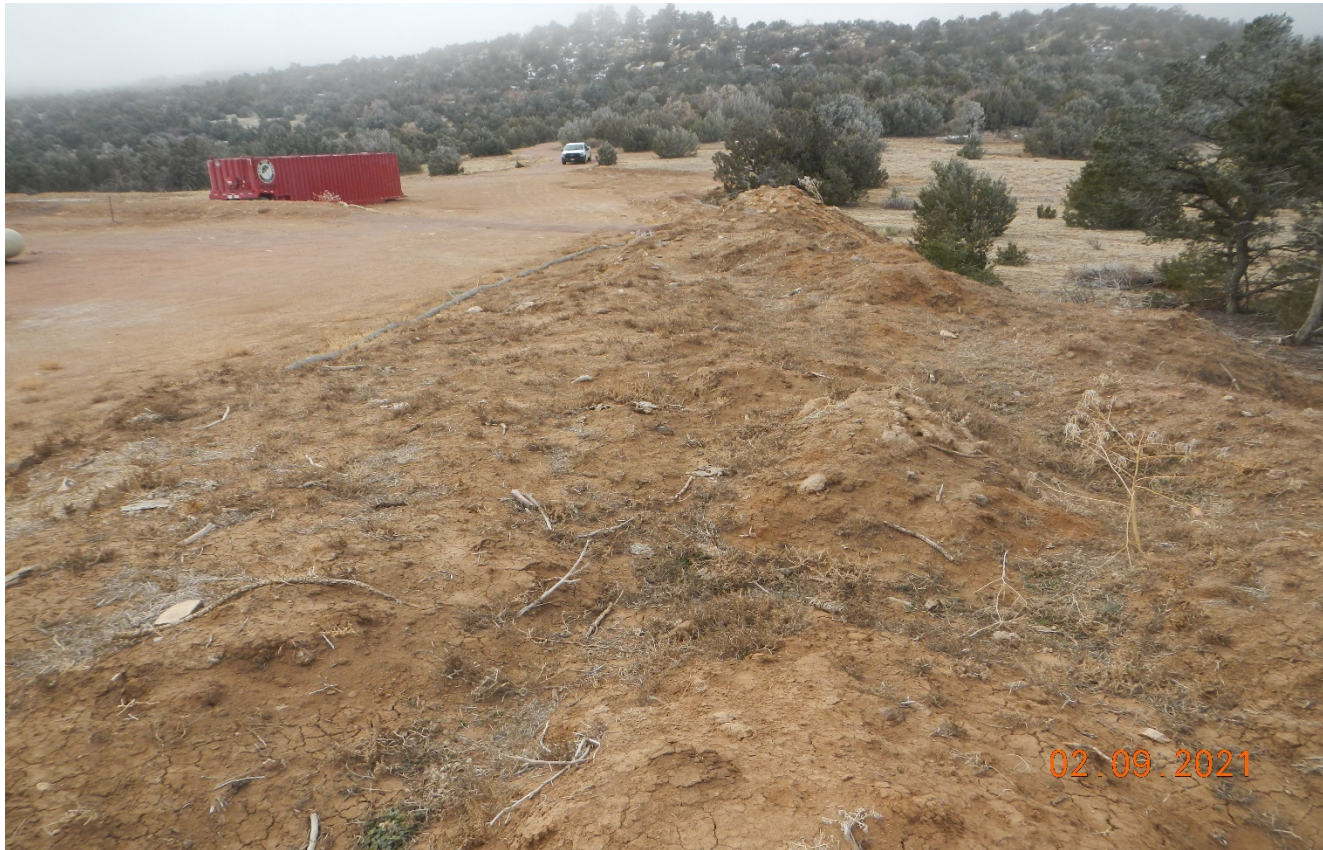
Photo 9. Facing toward the topsoil pile. The topsoil piles are not stabilized and protected. Topsoil piles have not been replaced for interim reclamation.

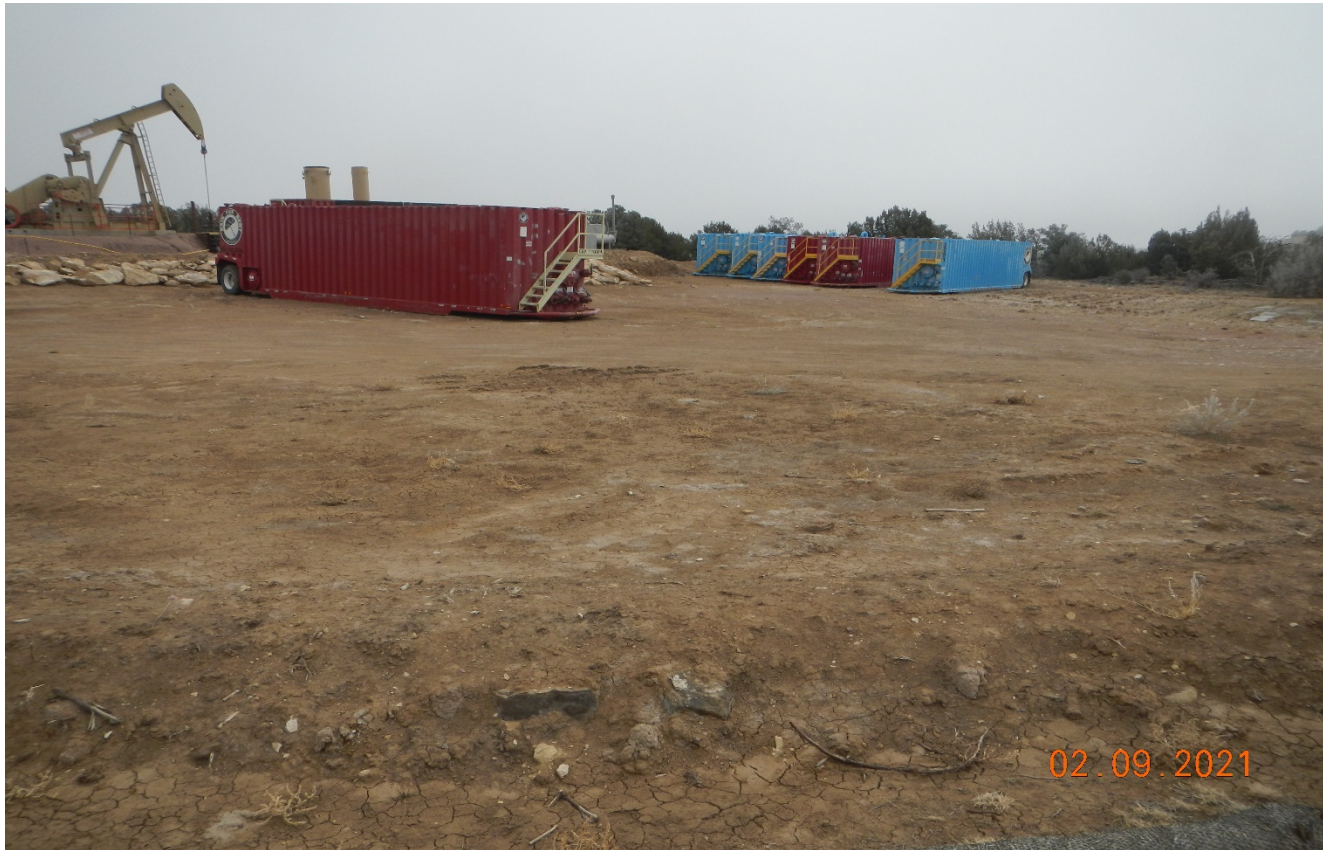
Photo 10. Facing northeast toward the location. The unused tanks need to be removed. This area needs to be recontoured and reclaimed. Previous corrective actions have not been performed.
