# Inspection Photos

2/8/2021

Operator: CAERUS PICEANCE LLC - 10456

Location ID: 323856

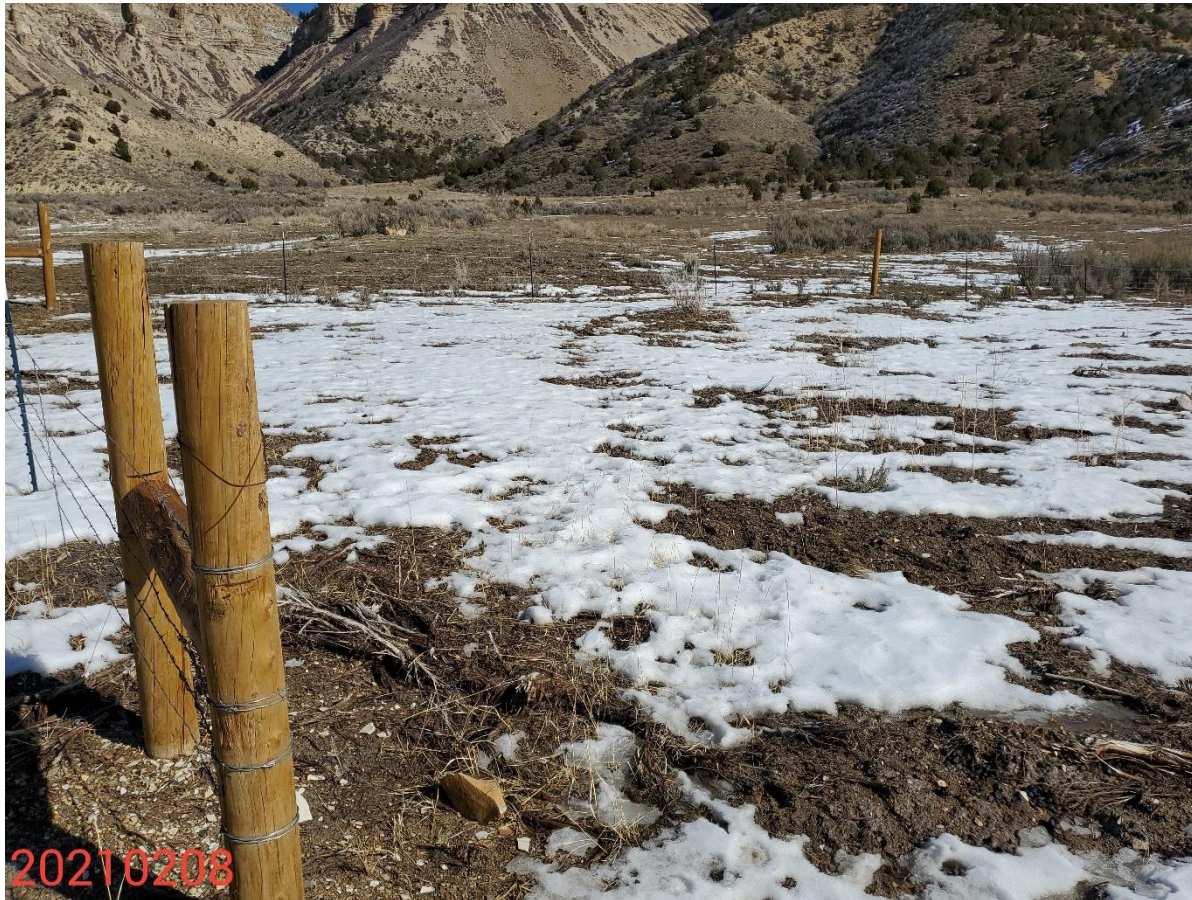
**Photo 1:** Photo taken from the entrance/gate on the northwest end of the Location, facing east. Photos 1-3 provide an overview of the Location from east, southeast to south.

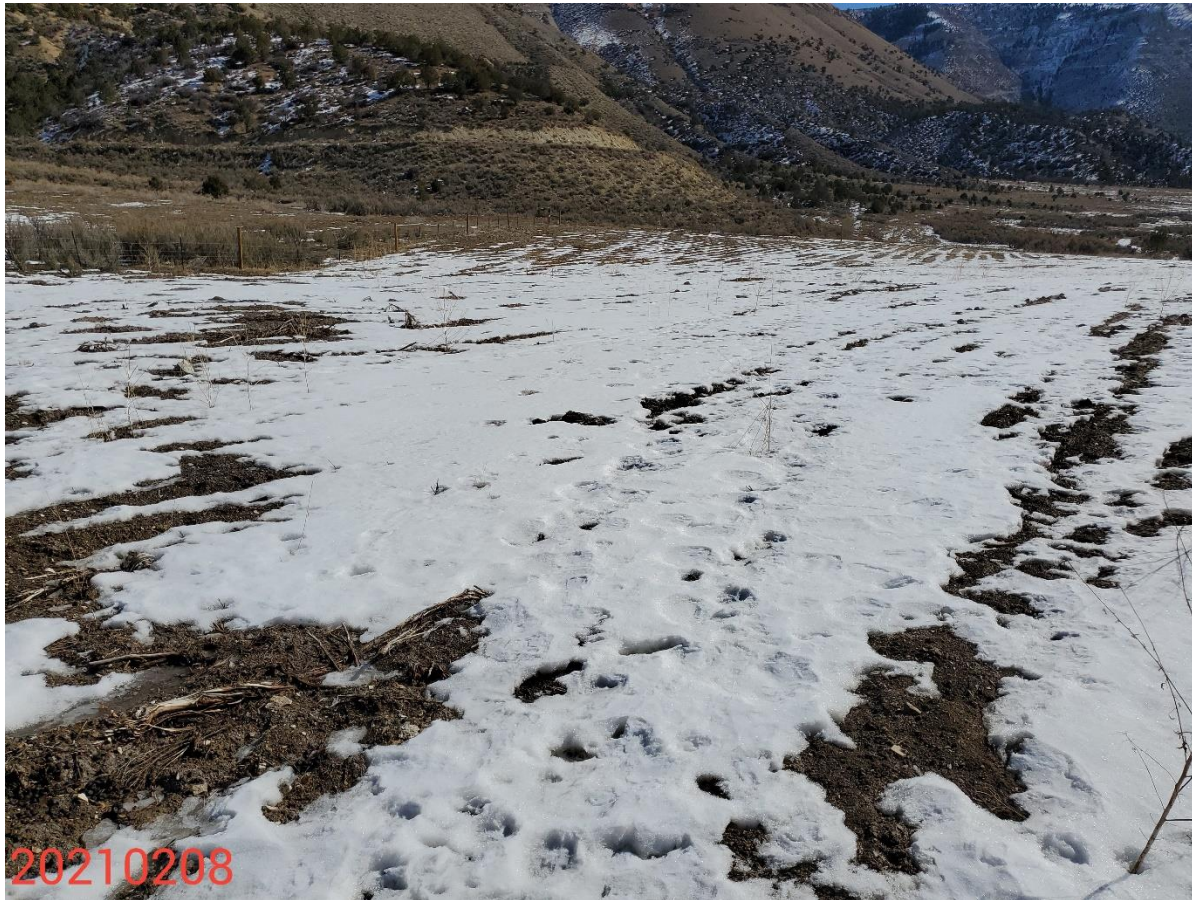
**Photo 2:** See comments under photo 1.

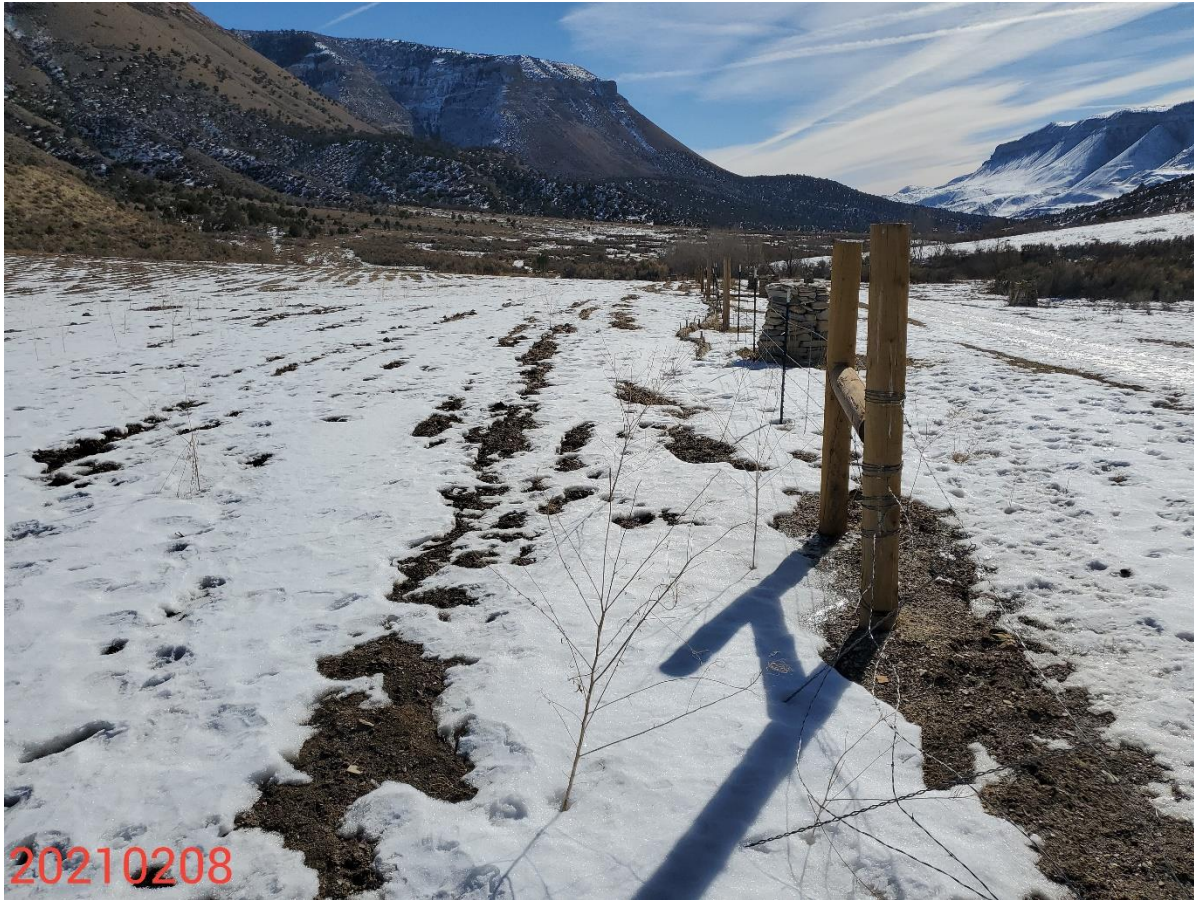
**Photo 3:** See comments under photo 1.

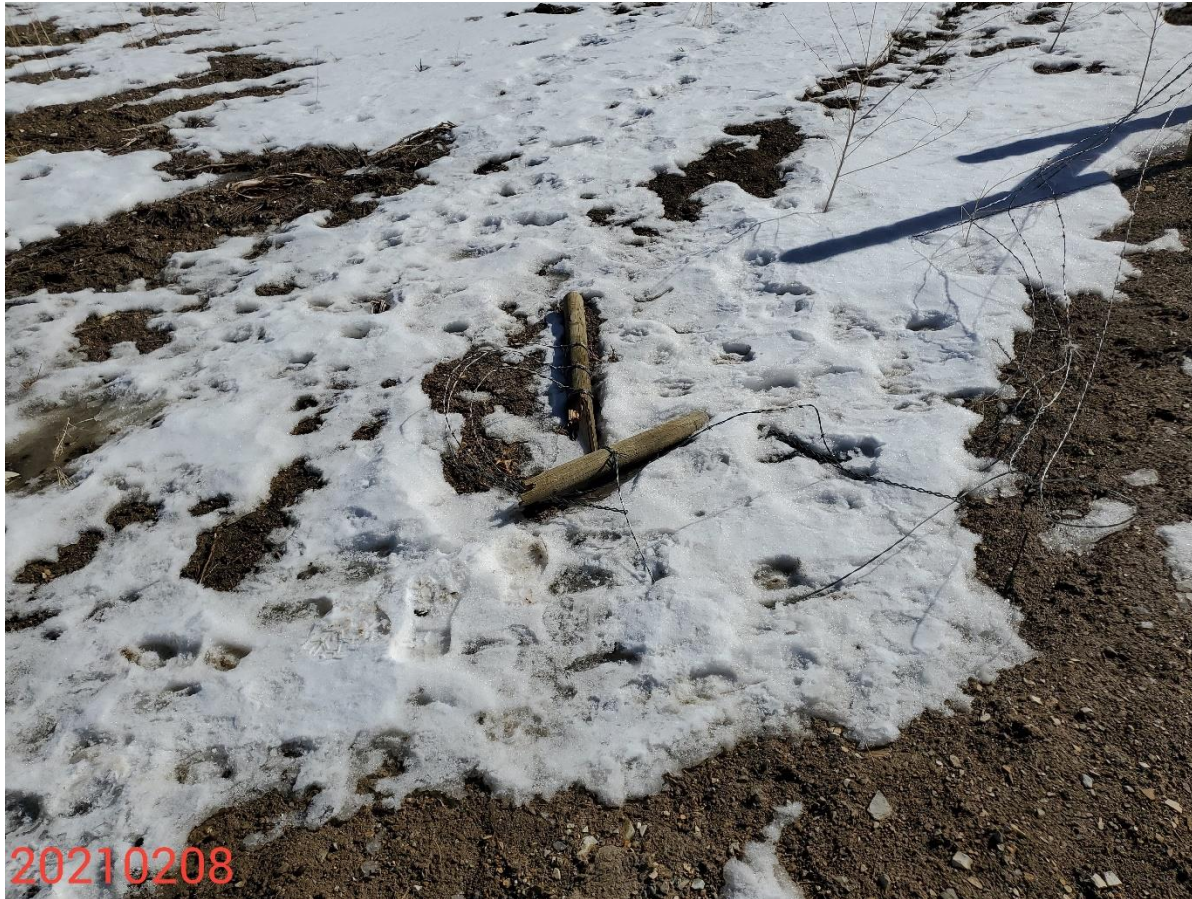
**Photo 4:** Photo shows drop-down gate at the Location entrance is in disrepair.

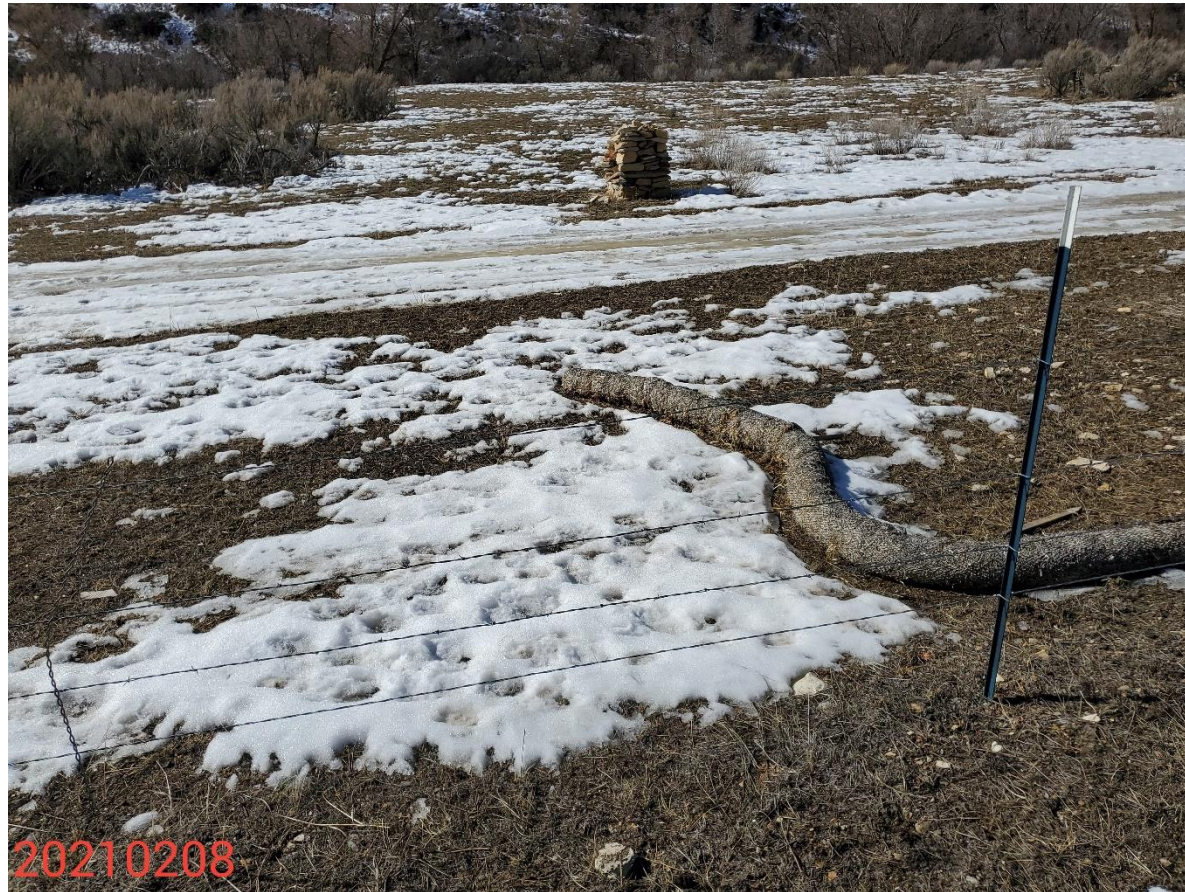
**Photo 5:** Photo shows straw wattle BMP along southwestern perimeter of the Location is in disrepair. Additionally, wattle BMPs do not appear to have been installed in accordance with good engineering practices.

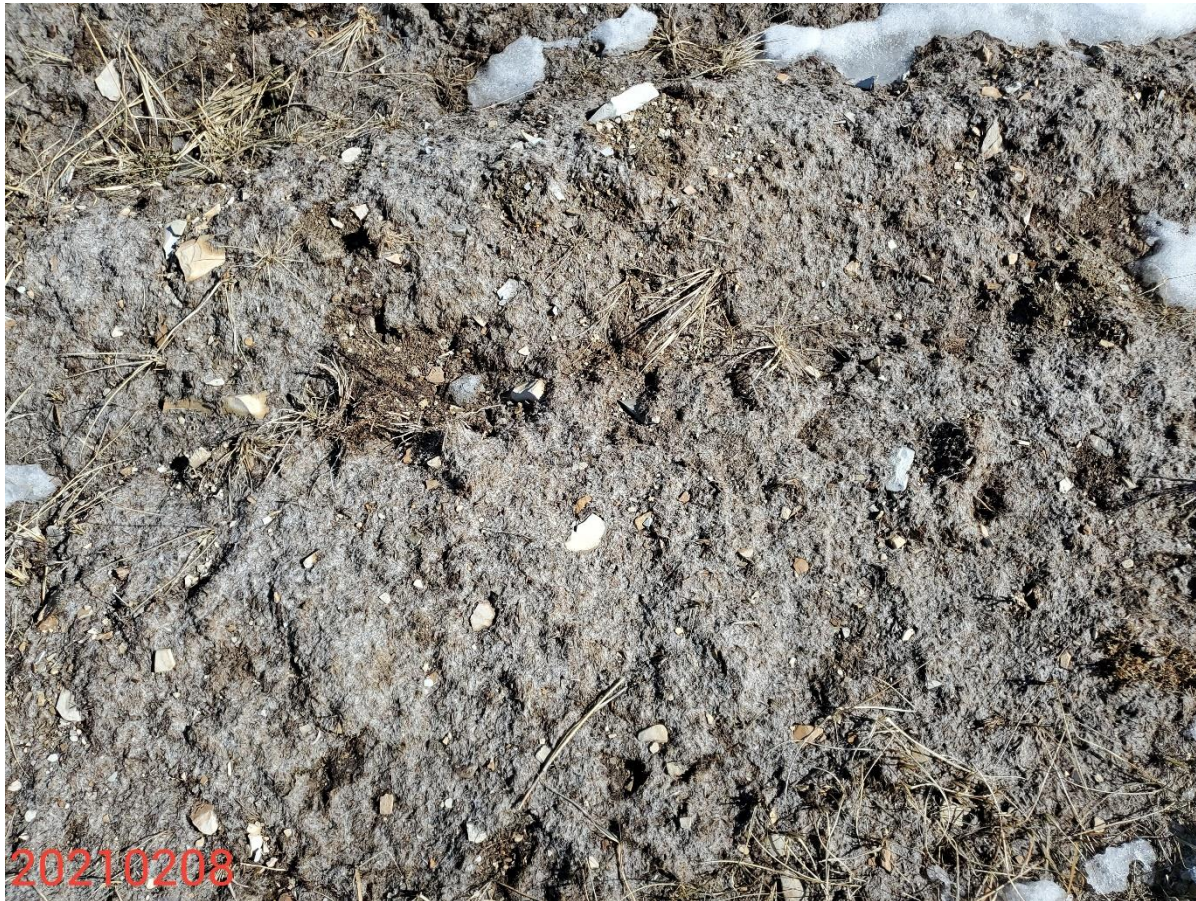
**Photo 6:** Photo shows hydro mulch has been applied to the soil surface of the reclamation area.

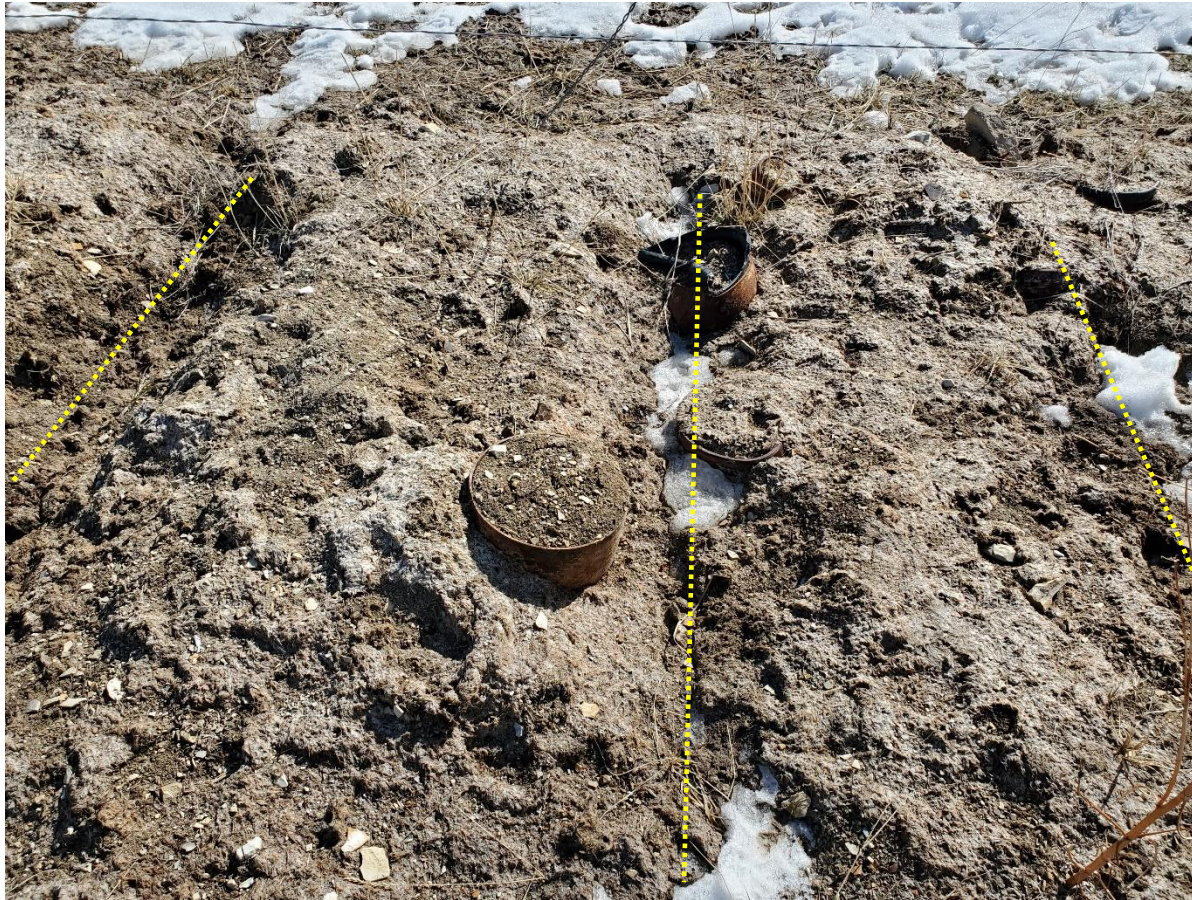
**Photo 7:** Photo taken from the west end of the Location. Photo shows pipe debris remaining. Photo also shows example of ripping marks on the Location. Rule 1004.a requires cross-ripping to a minimum depth of 18 inches; Location appears to have only been ripped in one direction (yellow lines); No indication that areas were cross ripped.

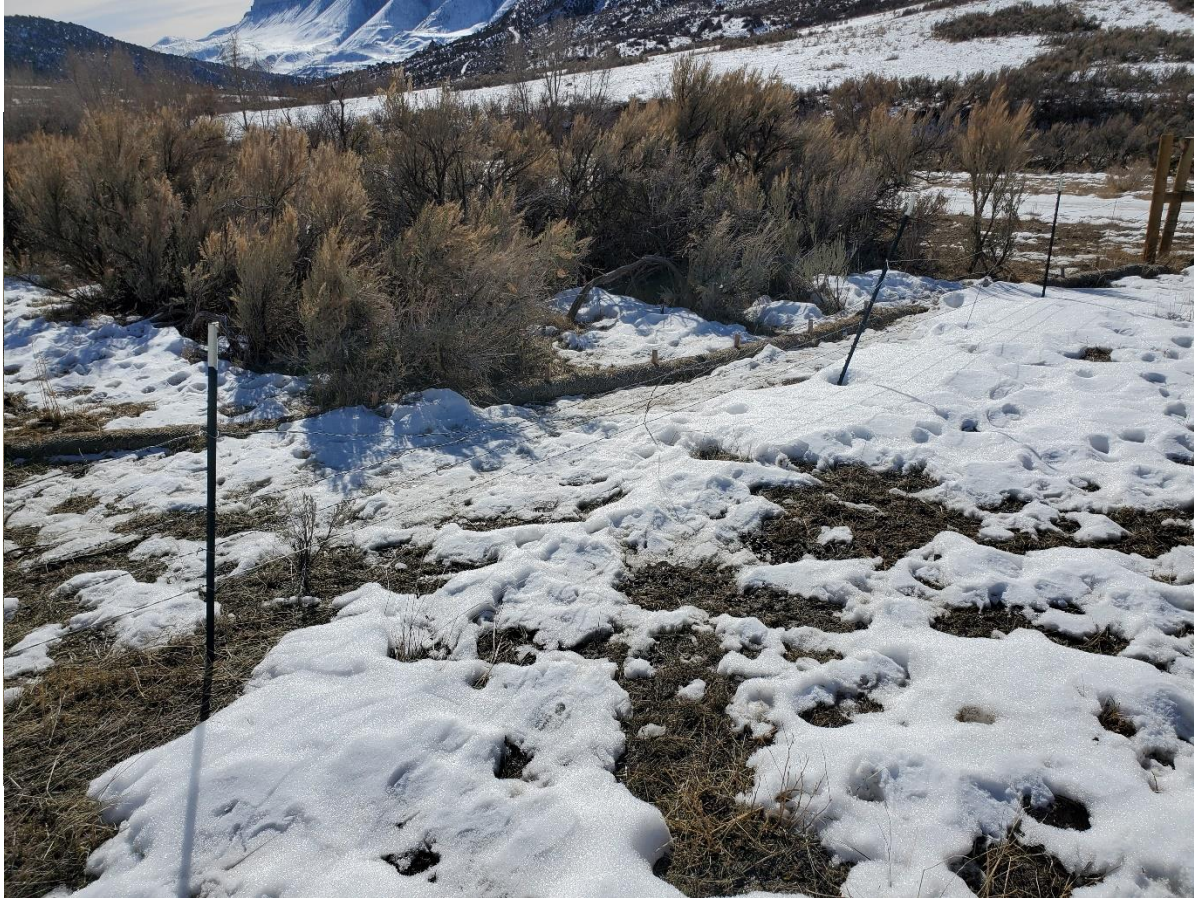
**Photo 8:** Photo shows areas of fence along the east end of the Location where strands appear to have been stretched or broken. Maintenance advised.
