# Inspection Photos

Operator: CHEVRON USA INC #16700

Location ID: 382974

Garfield County, CO

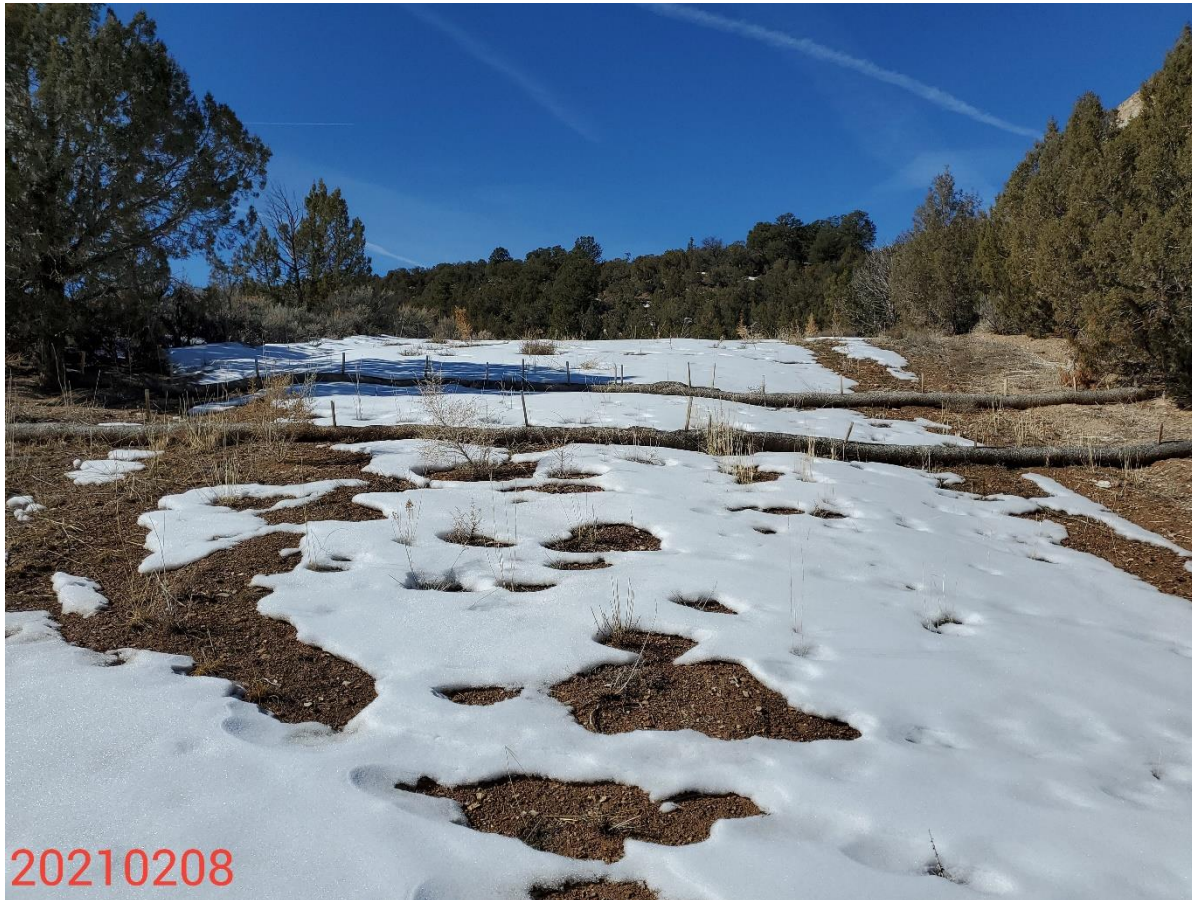
**Photo 1:** Photo taken from the former location/access road entrance on the northeast end of the Location, facing west. Photo shows wattle BMPs at the access road.

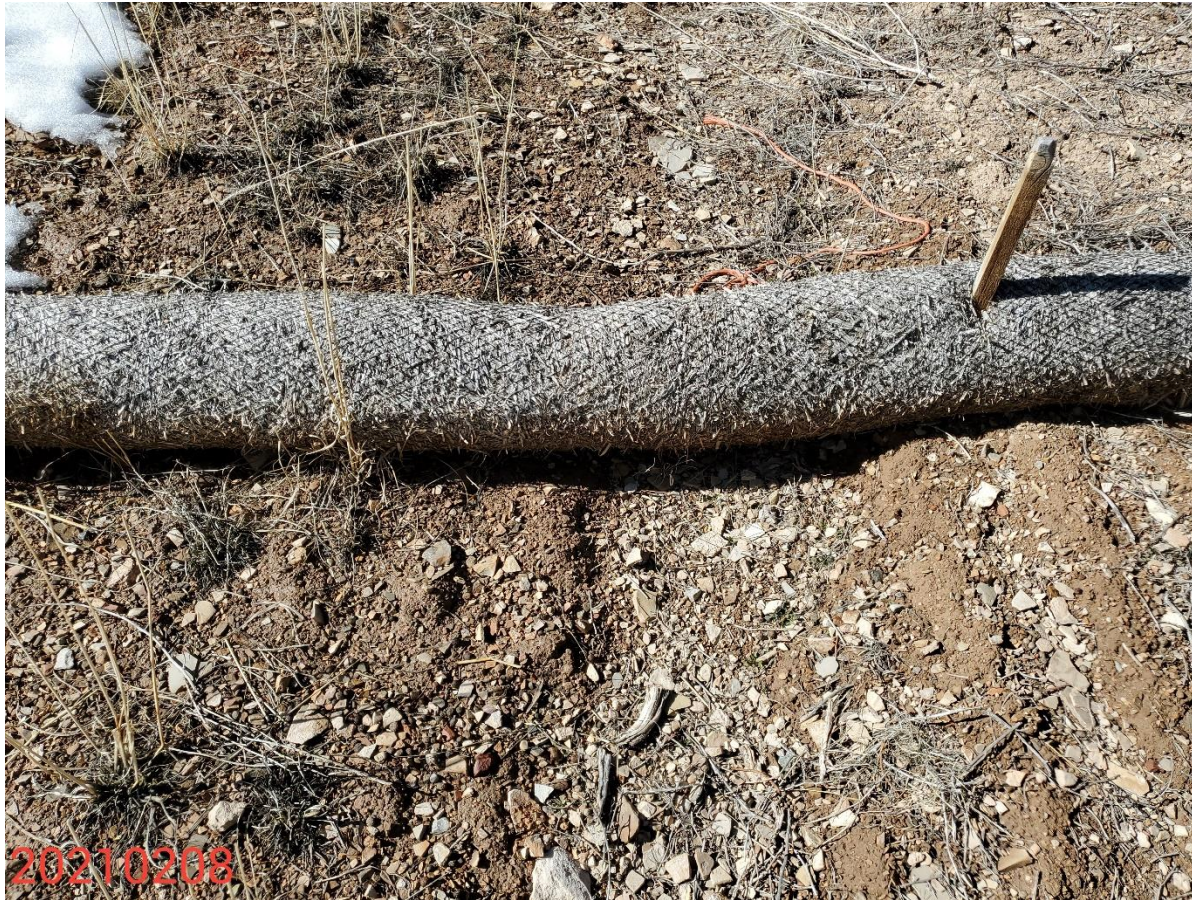
**Photo 2:** Continued from photo 1. Photo shows wattle BMPs on the Location remain improperly installed / not installed in accordance with good engineering practices. BMPs to stabilize the soils have not been installed and remain missing, or insufficient/inadequate.

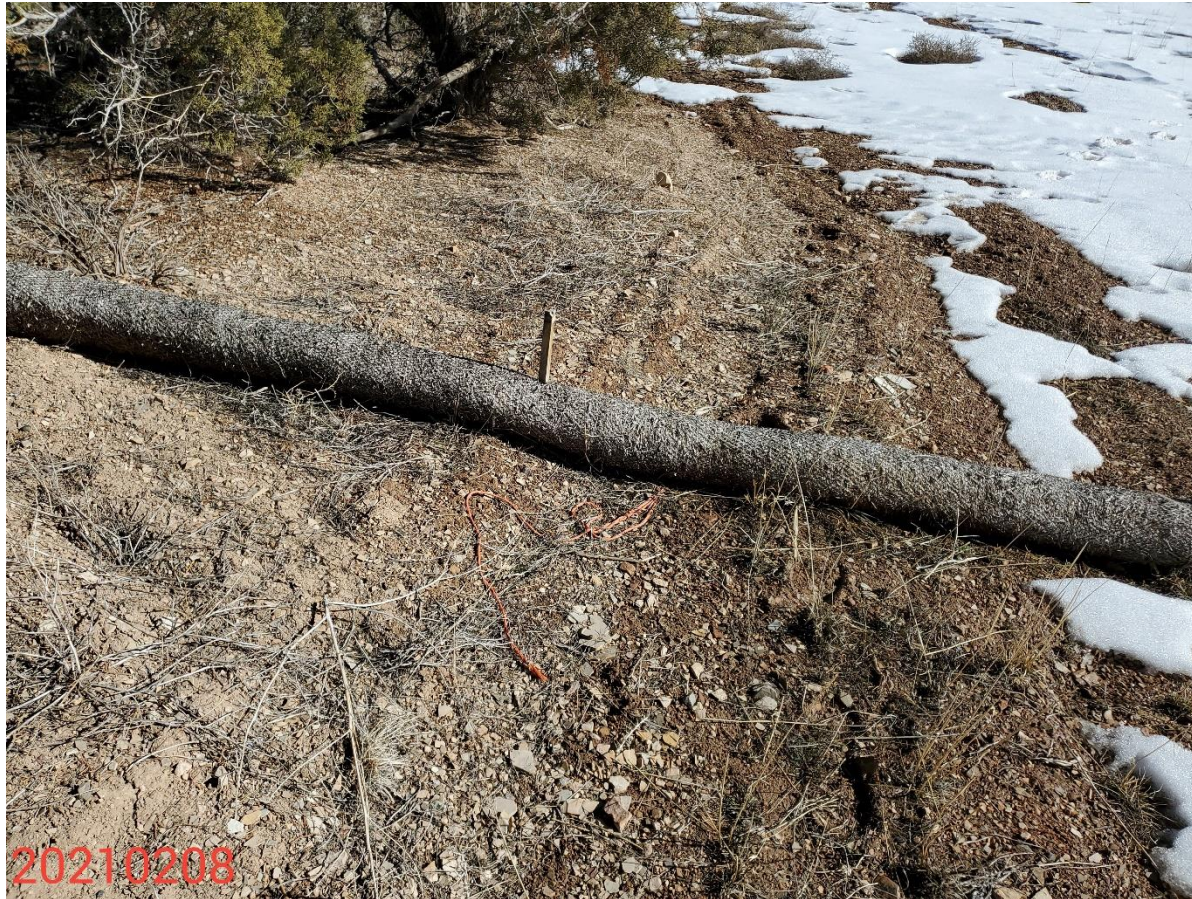
**Photo 3:** Continued from photo 1. Photo shows wattle BMPs on the Location remain improperly installed / not installed in accordance with good engineering practices. BMPs to stabilize the soils have not been installed and remain missing, or insufficient/inadequate.

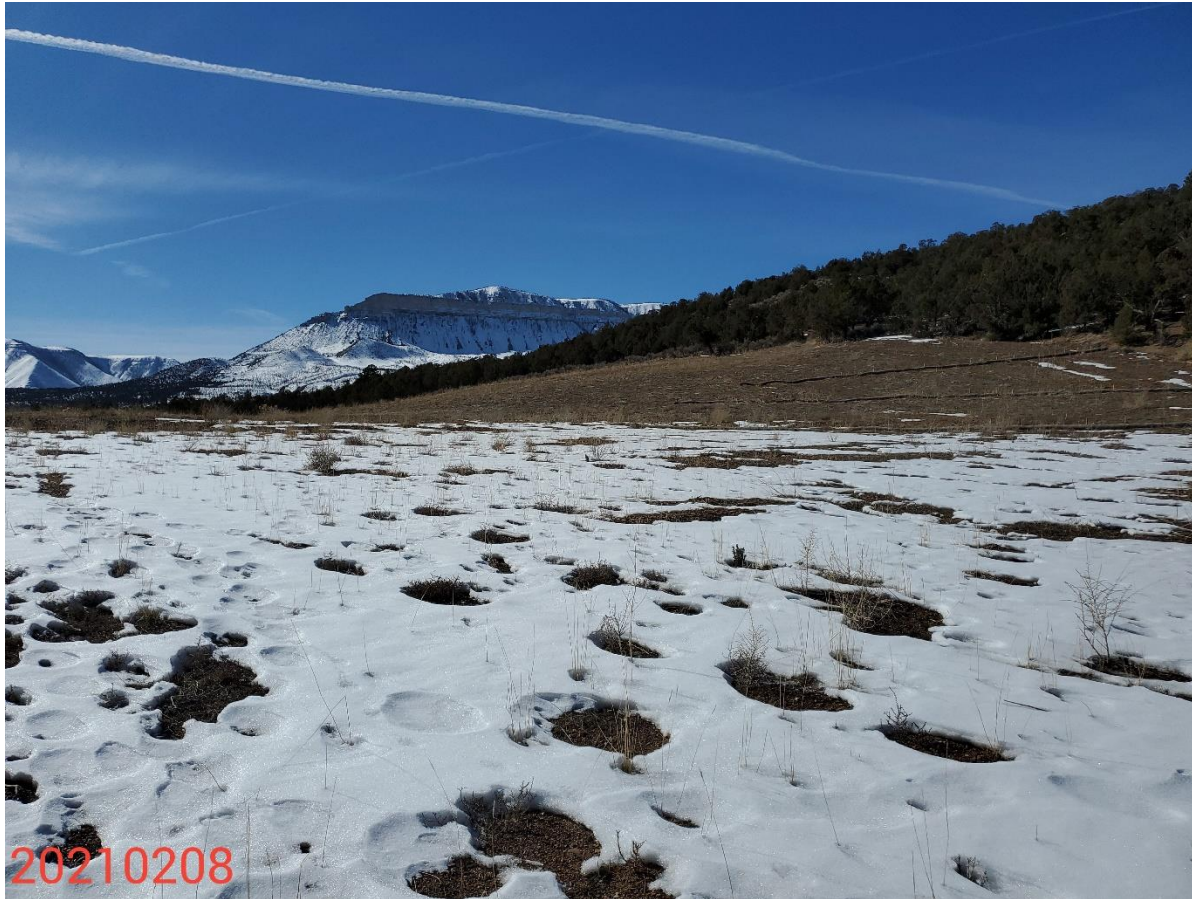
**Photo 4:** Photo taken from the northeast end of the Location, facing southwest. Photo provides an overview of the Location.

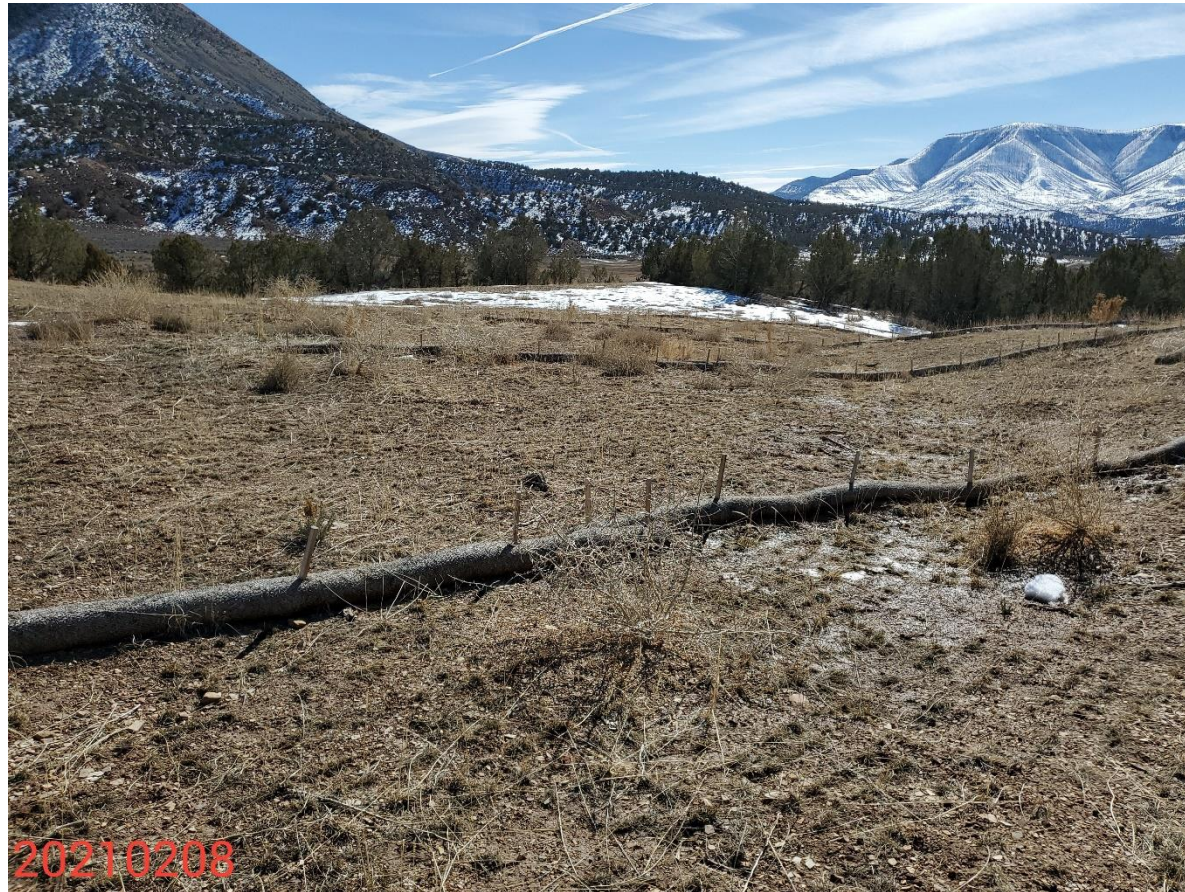
**Photo 5:** Photo shows straw wattle BMP on the Location. Photo shows wattle BMPs on the Location remain improperly installed / not installed in accordance with good engineering practices.

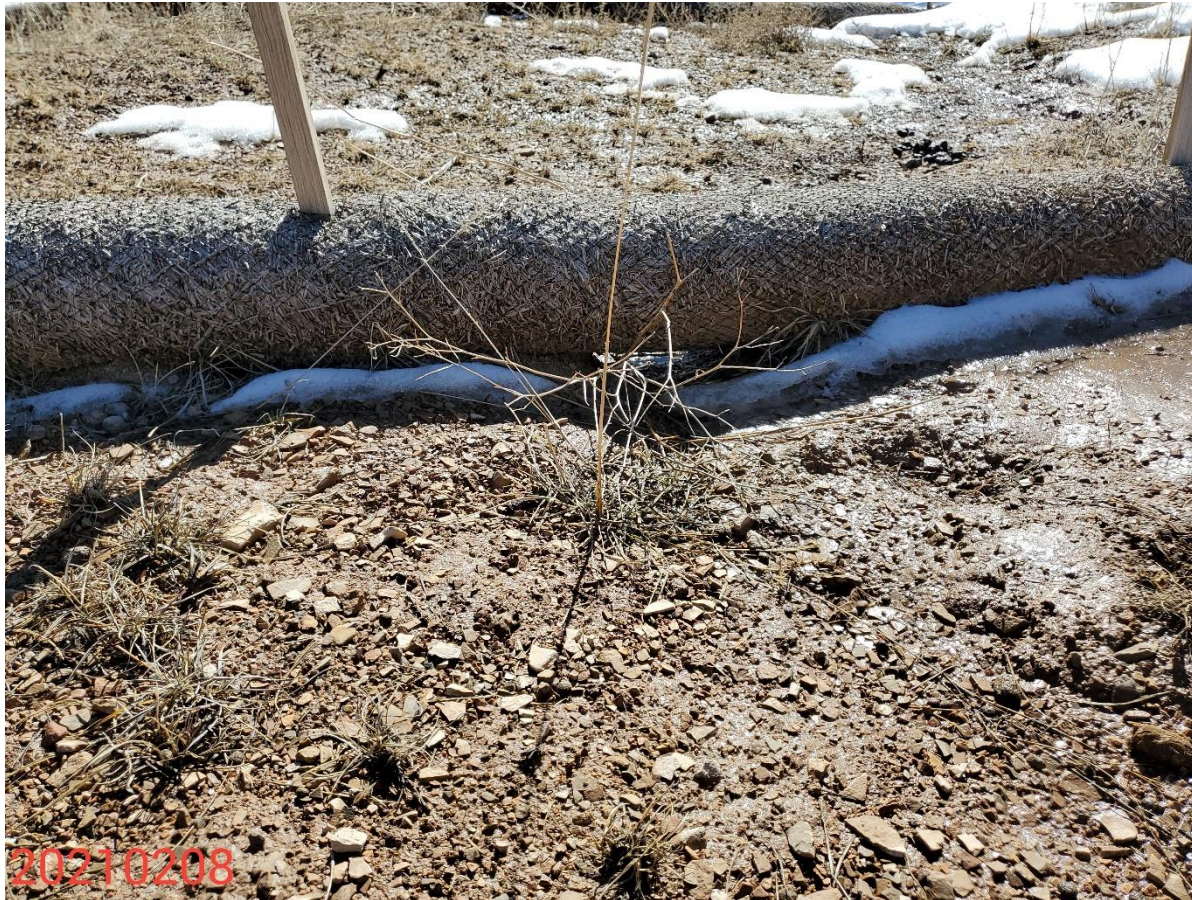
**Photo 6:** Photo shows straw wattle BMP on the Location. Photo shows wattle BMPs on the Location remain improperly installed / not installed in accordance with good engineering practices; Stormwater cutting beneath BMP. BMPs to stabilize the soils have not been installed and remain missing, or insufficient/inadequate.

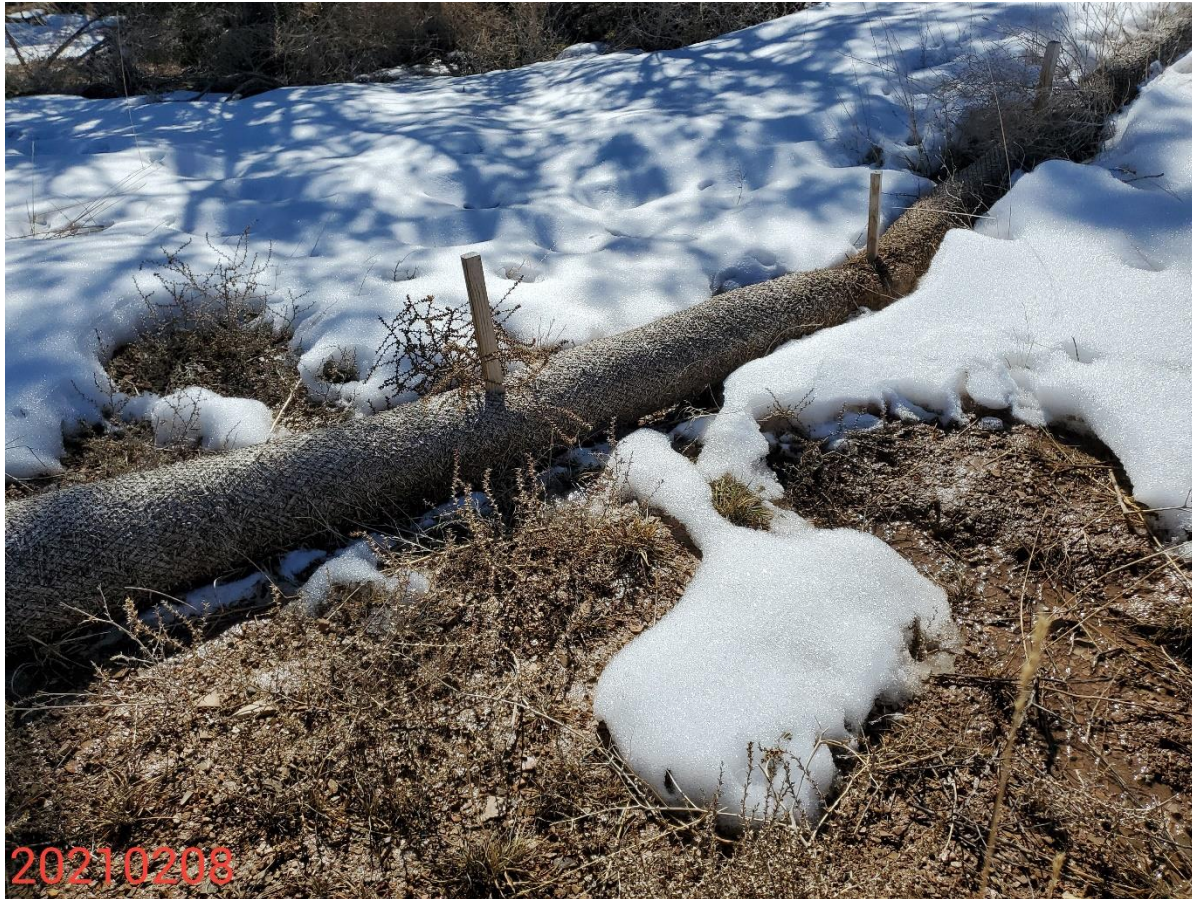
**Photo 7:** Photo shows straw wattle BMP on the Location. Photo shows wattle BMPs on the Location remain improperly installed / not installed in accordance with good engineering practices.

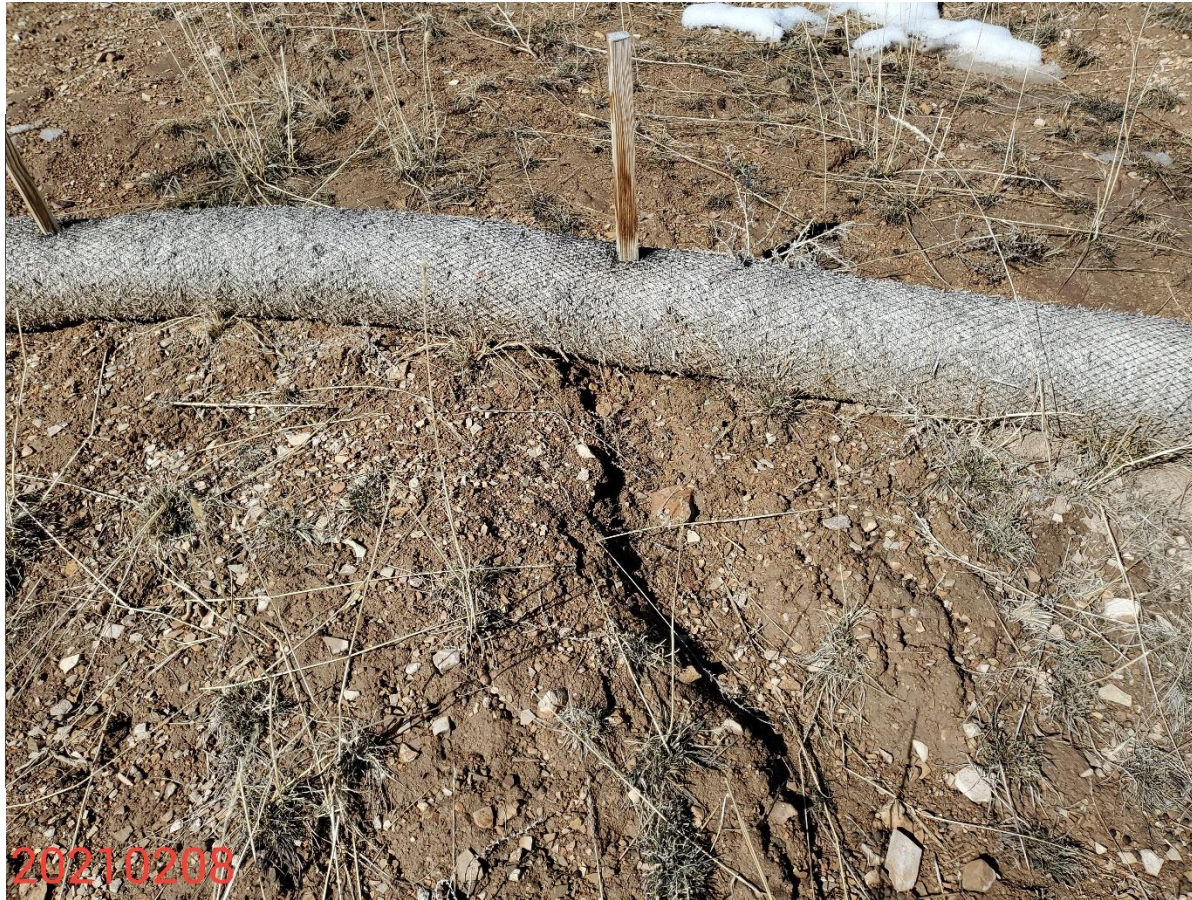
**Photo 8:** Photo shows straw wattle BMP on the Location. Photo shows wattle BMPs on the Location remain improperly installed / not installed in accordance with good engineering practices. BMPs to stabilize the soils have not been installed and remain missing, or insufficient/inadequate.
