**CAERUS PICEANCE LLC**  
**Chevron 42-5D**  
**Location ID: 435733**

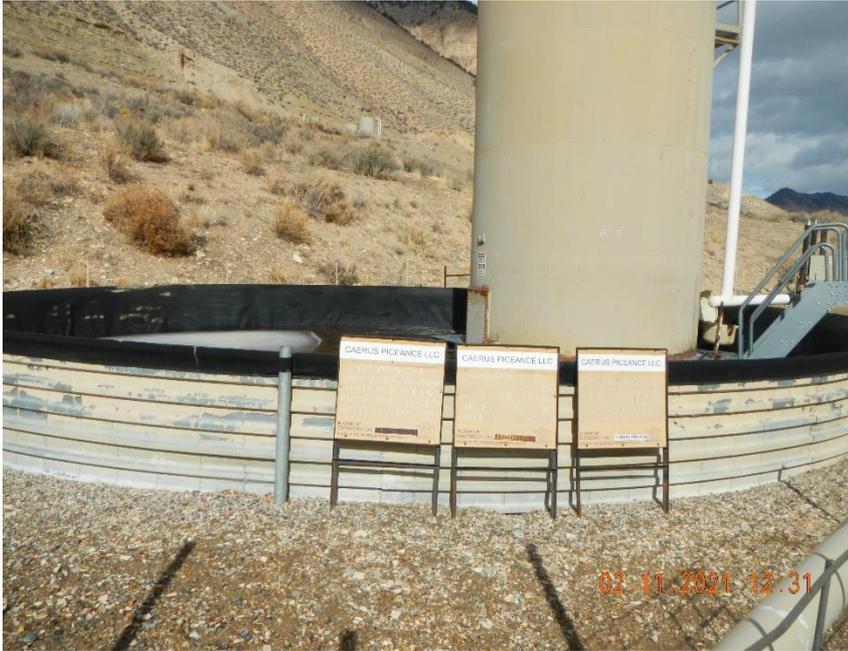
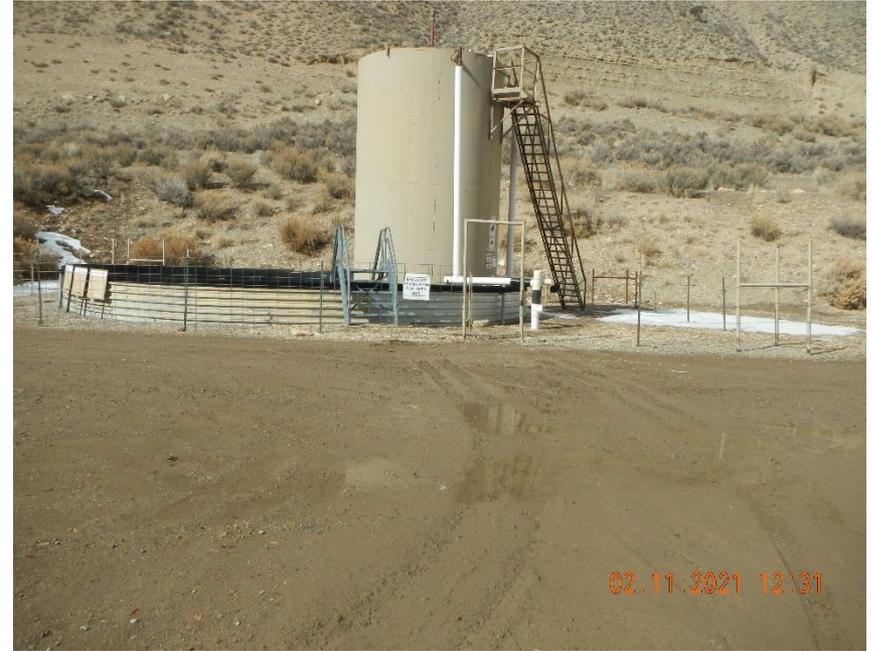
**Location shows signs of lack of stabilization BMP's  
in some areas (rutting is present).**

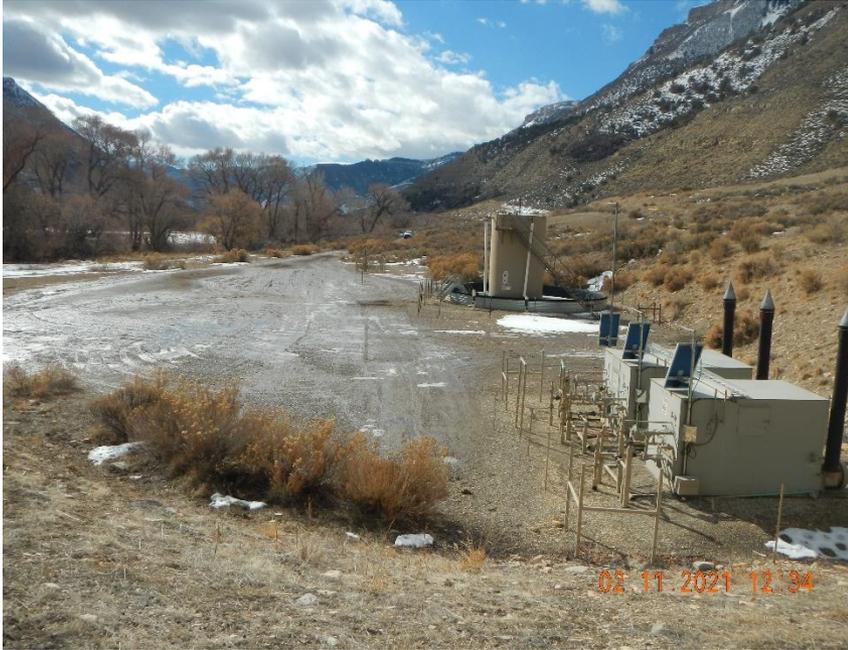
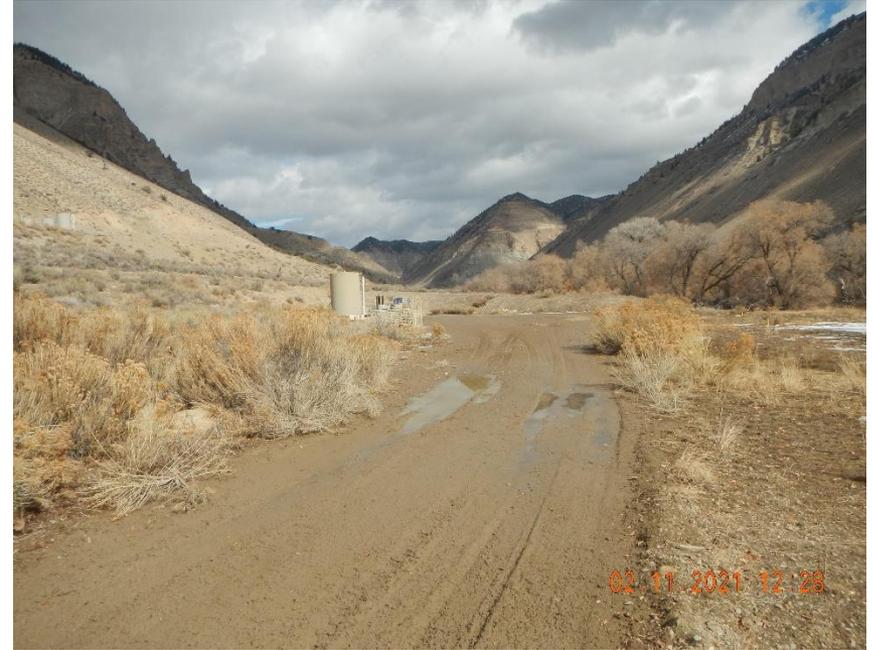
**Access road shows signs of lack of stabilization  
BMP's in some areas (rutting is present).**

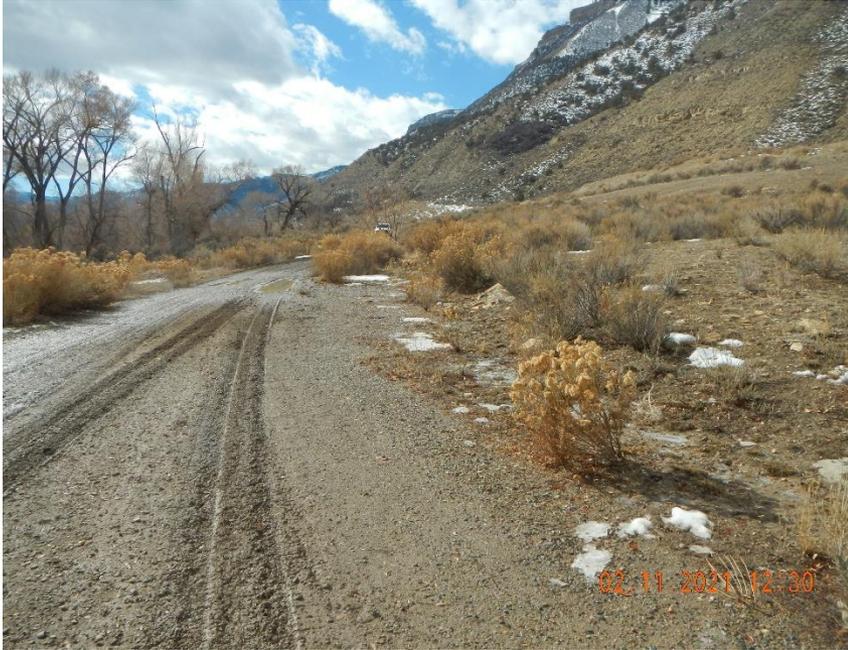
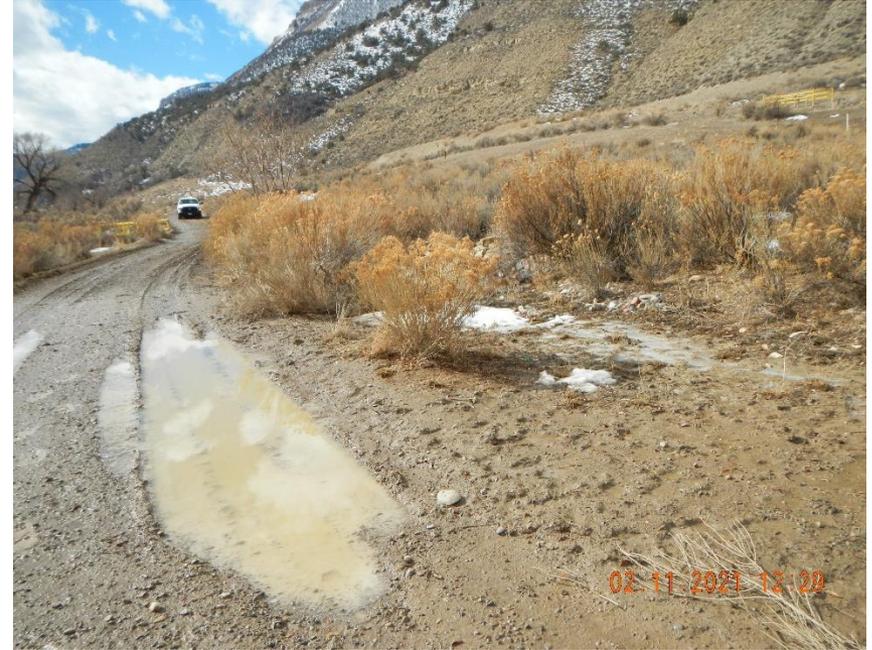
**Storm water not draining to culvert at  
entrance of location.**

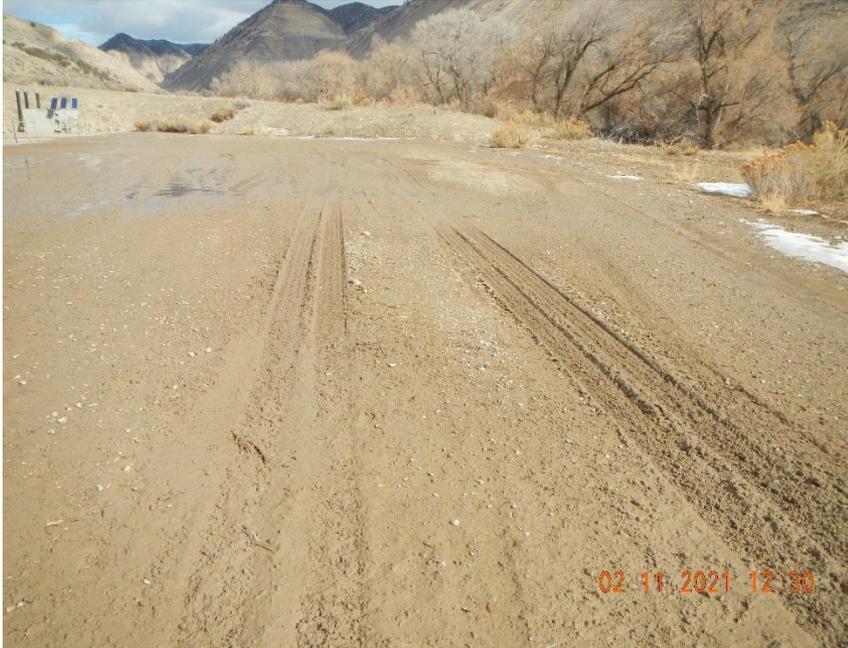
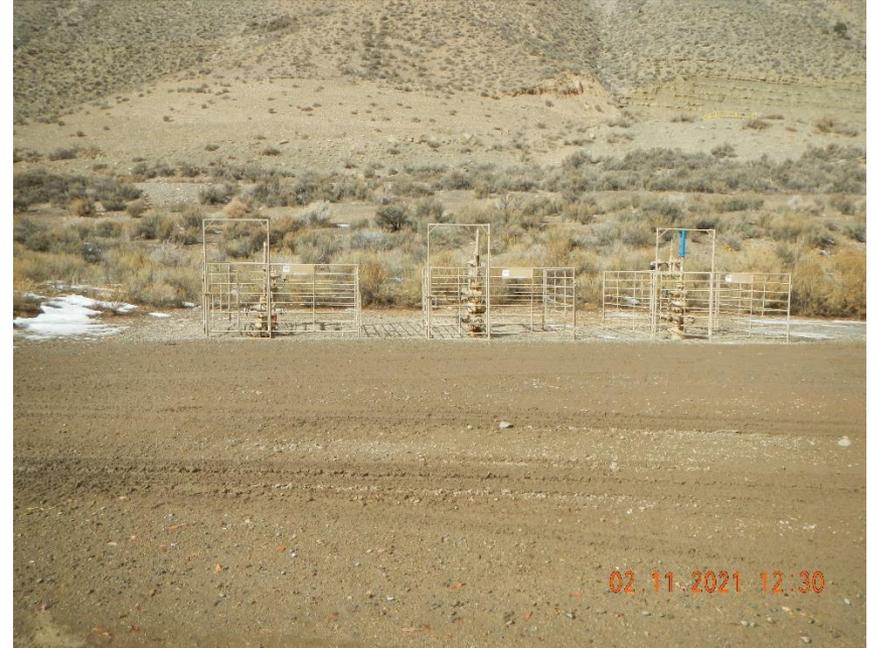
**Location shows signs of lack of stabilization BMP's  
in some areas (rutting is present).**

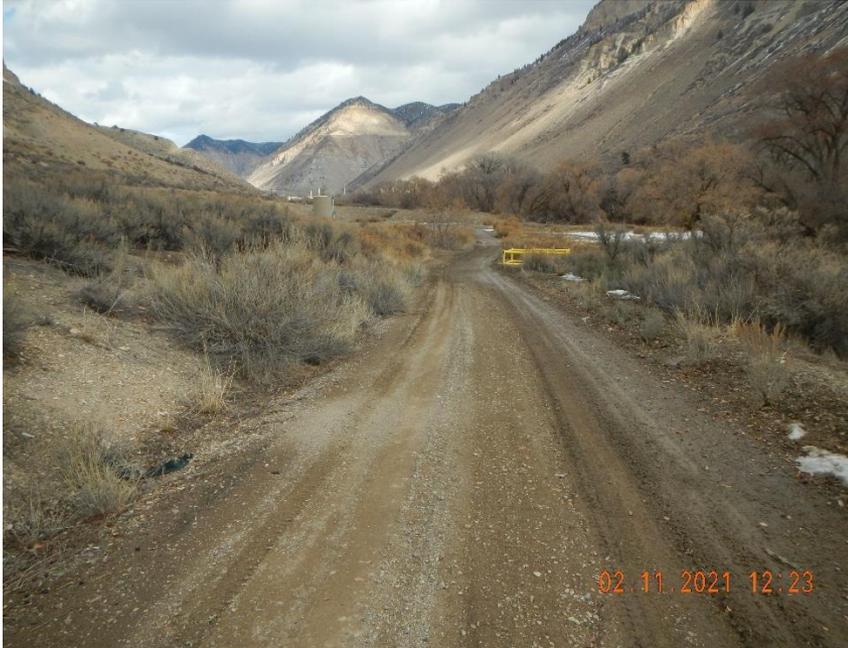
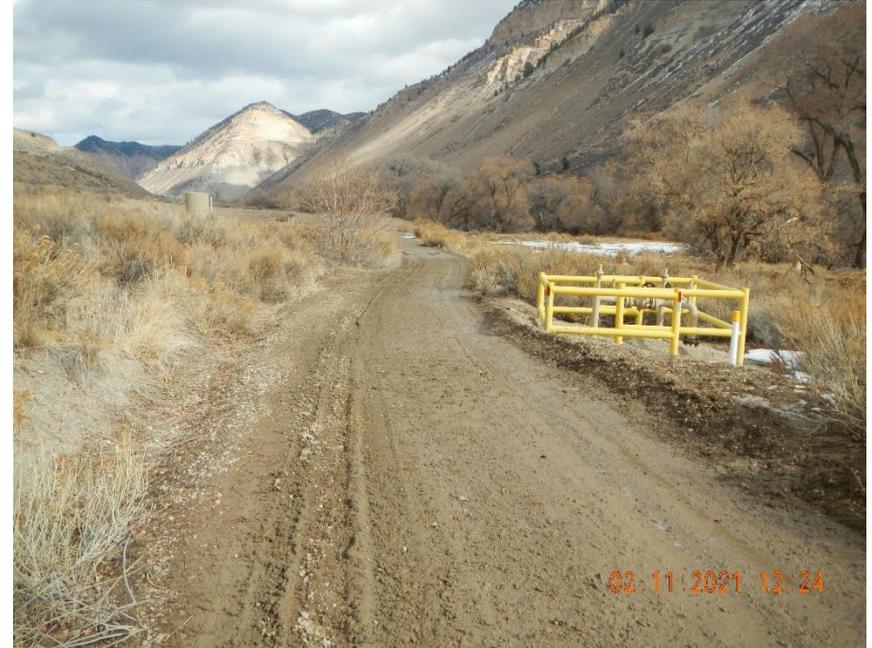
**Access road shows signs of lack of stabilization  
BMP's in some areas (rutting is present).**

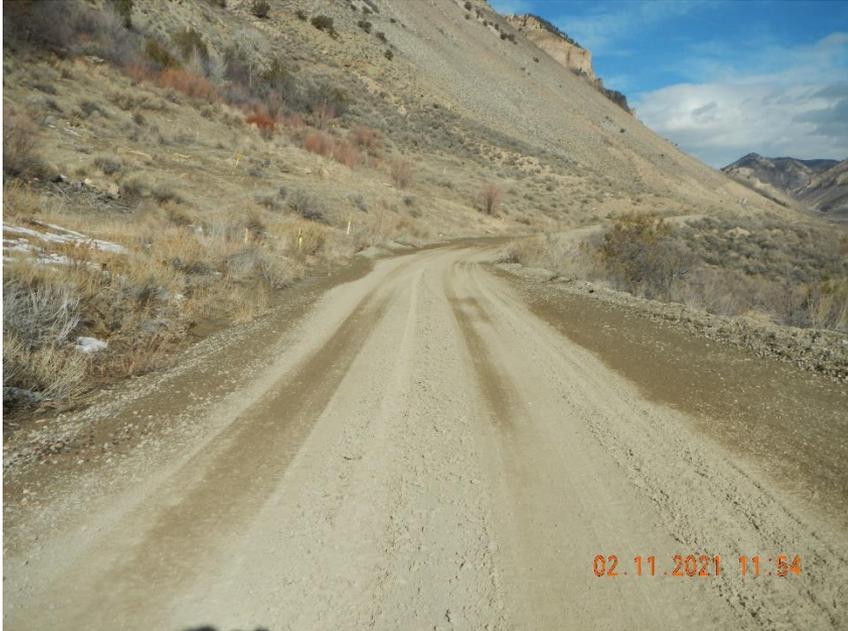
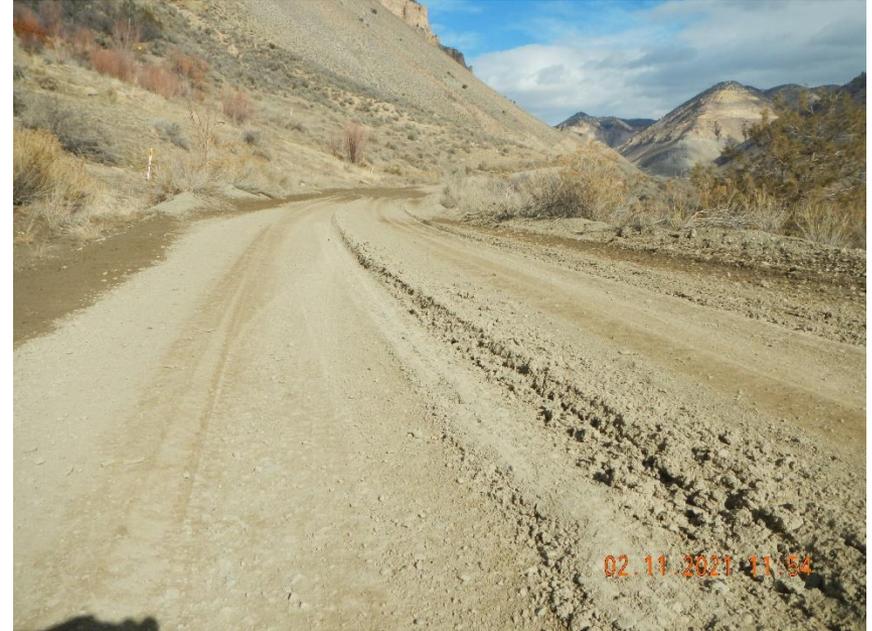
**Access road shows signs of lack of stabilization  
BMP's in some areas (rutting is present).**

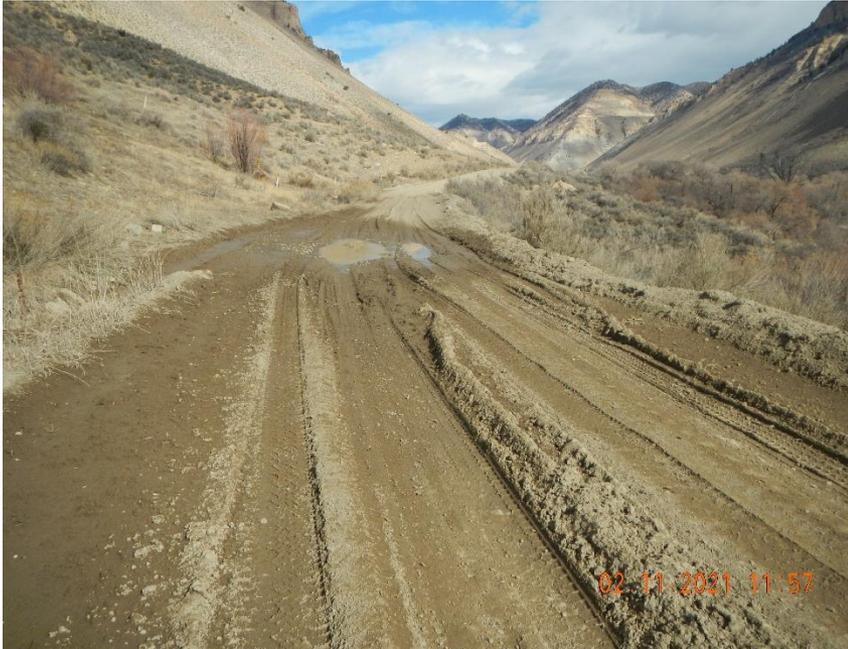
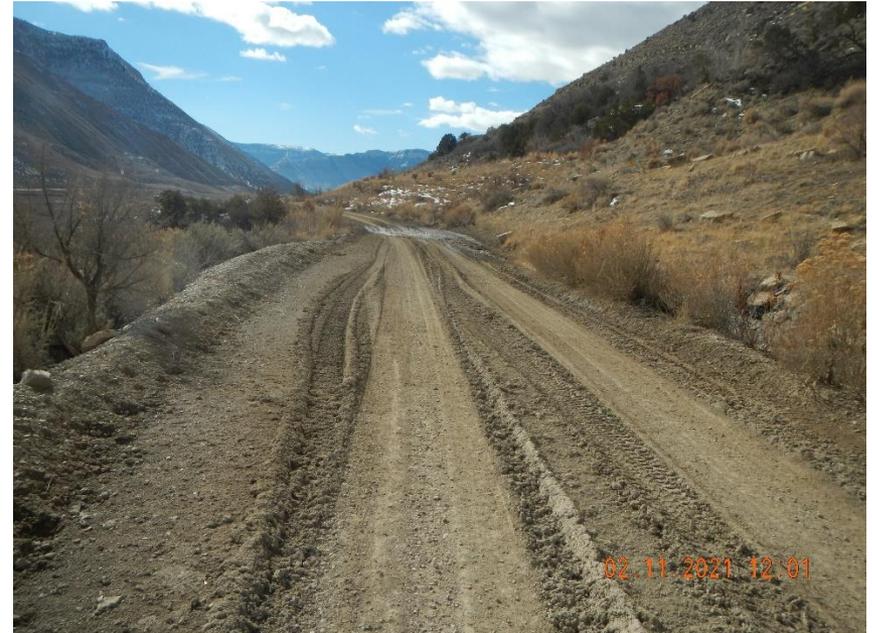
**Access road shows signs of lack of stabilization  
BMP's in some areas (rutting is present).**

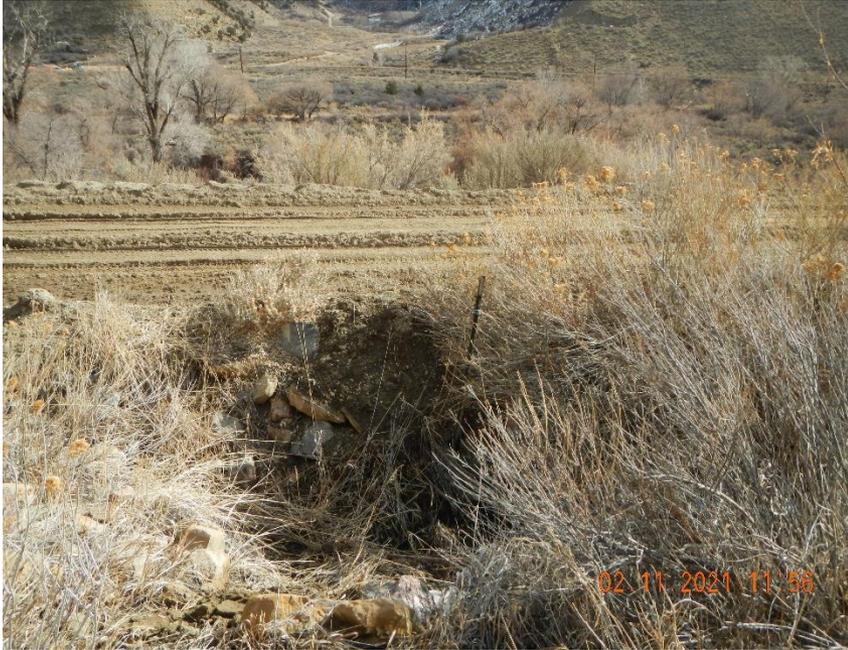
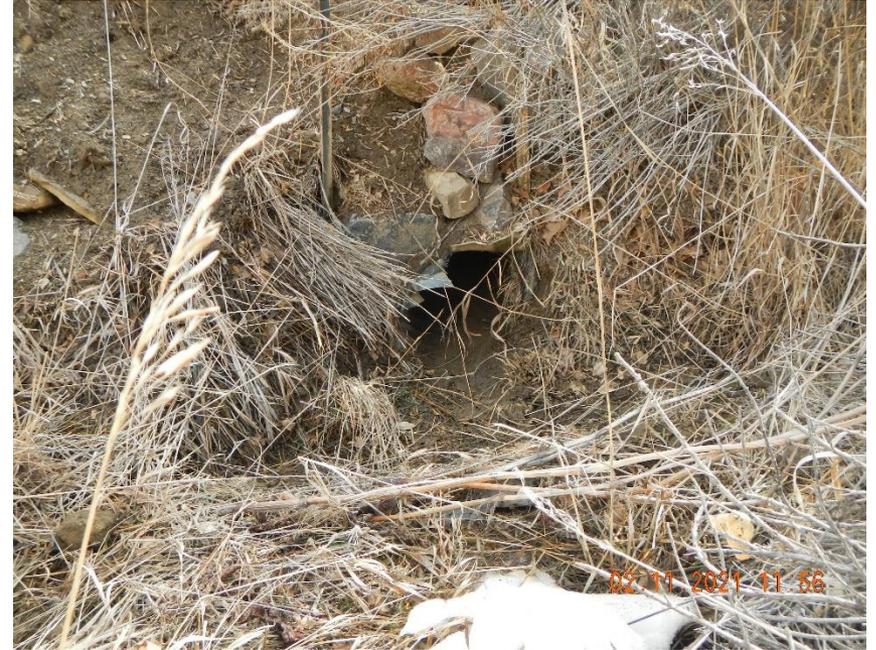
**Culvert basin needs maintained.**

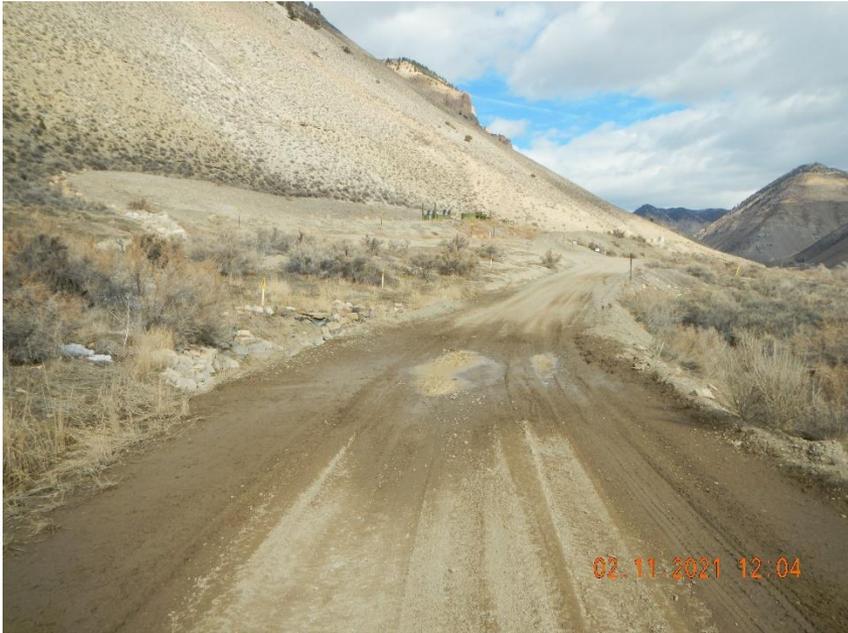
**Water not draining off road.**

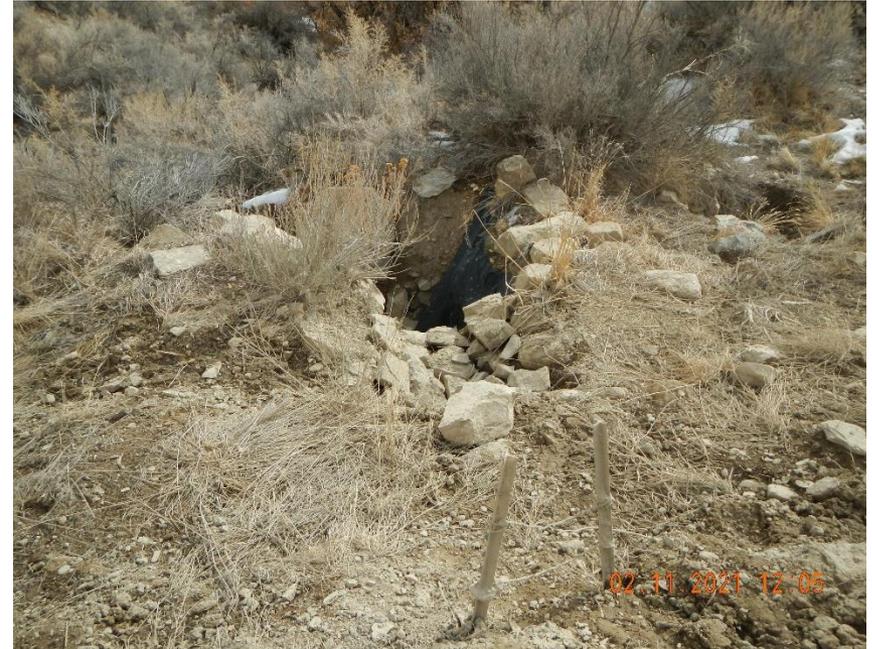
**N39.55348 W-108.11985 Sediment build up in culvert outlet. Erosion damage from culvert outlet**

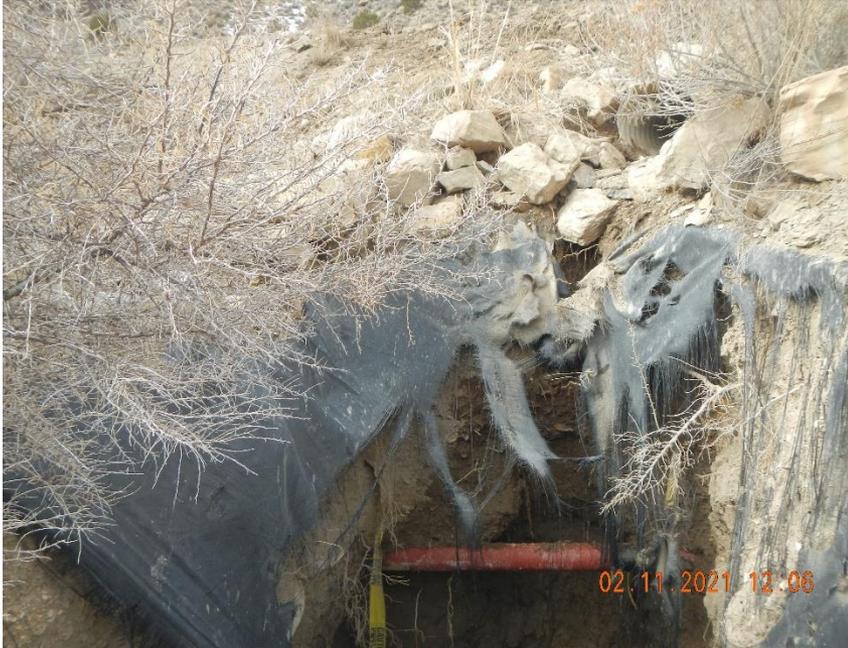
**N39.55348 W-108.11985 Erosion damage from  
culvert outlet.**

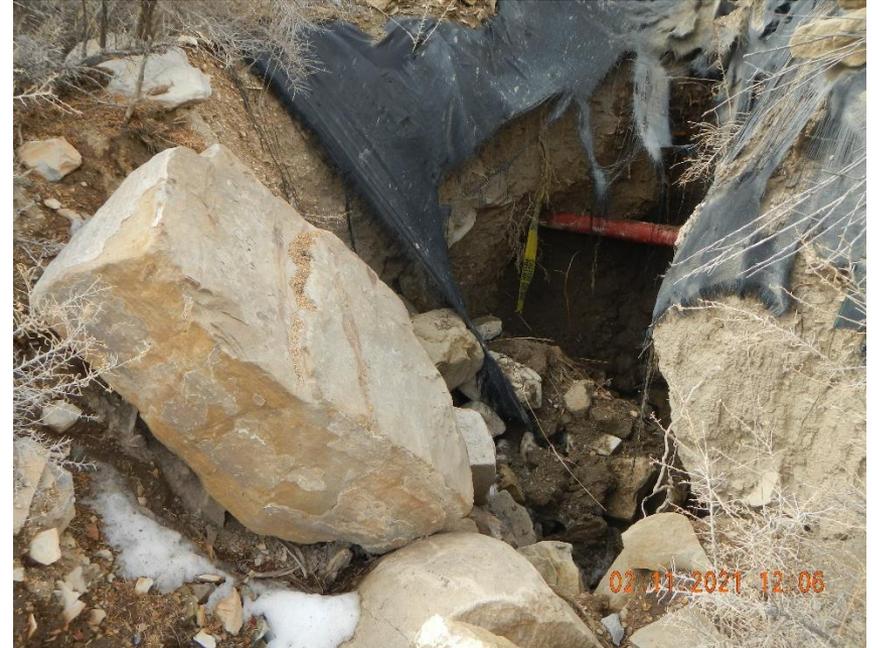
**Erosion has exposed pipe line.**
