Inspection Photos

2/8/2021

Operator: CHEVRON USA INC #16700

Location ID: 323798

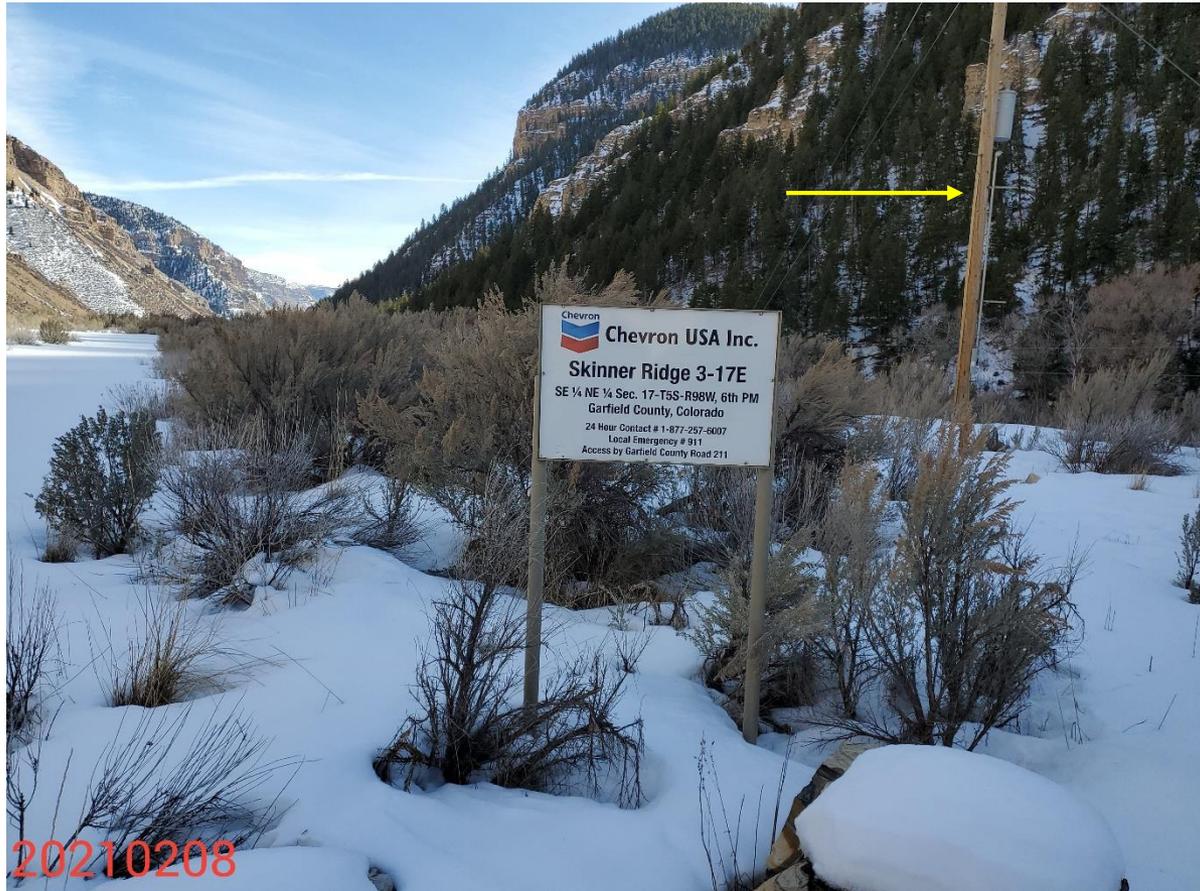
Photo 2: Continued from photo 1. Photo also shows utility equipment remaining on the Location.

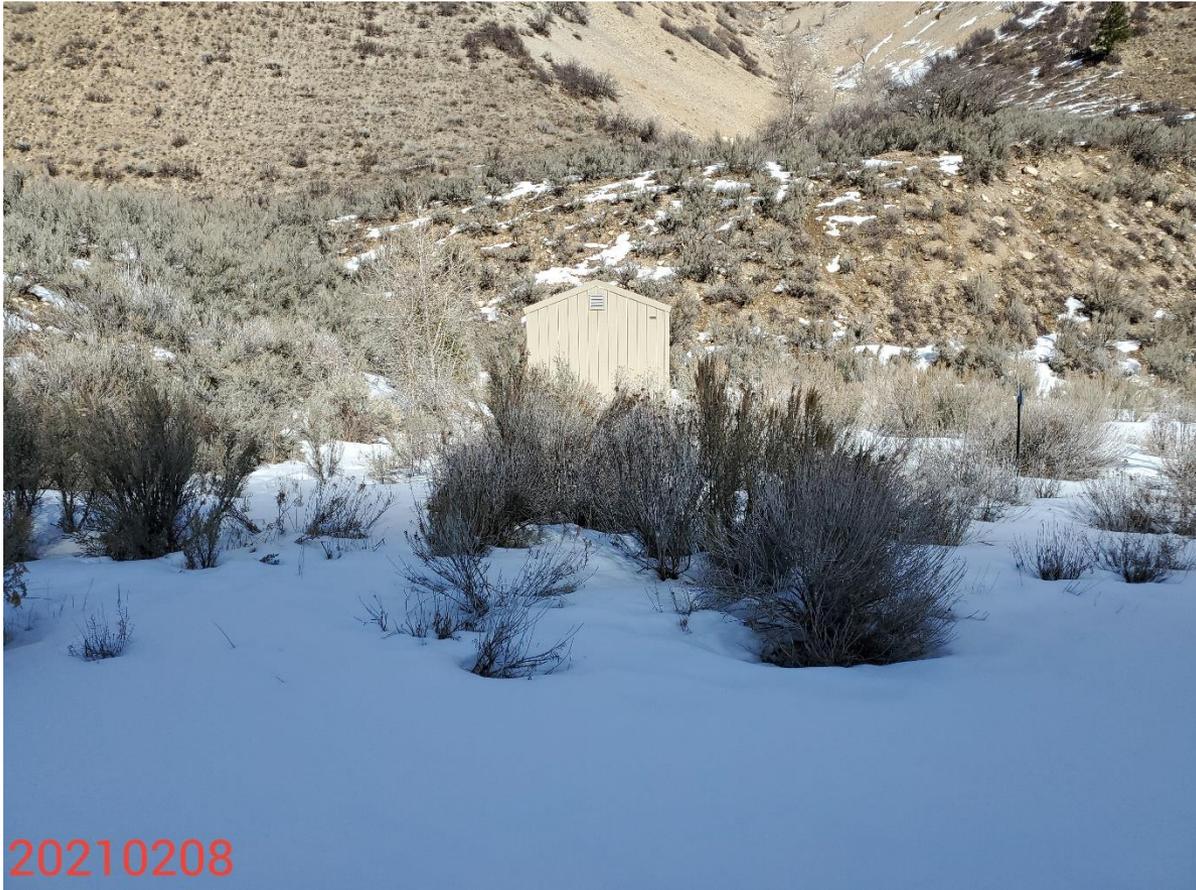
Photo 3: Photo taken from the west end of the Location, facing north. Photos 3-5 provide an overview of the Location from north, east to southeast. Photos show final reclamation (including, but not limited to, removal of equipment/debris, recontouring/regrading, compaction alleviation and revegetation activities) has not been conducted in accordance with 1004 Rules.

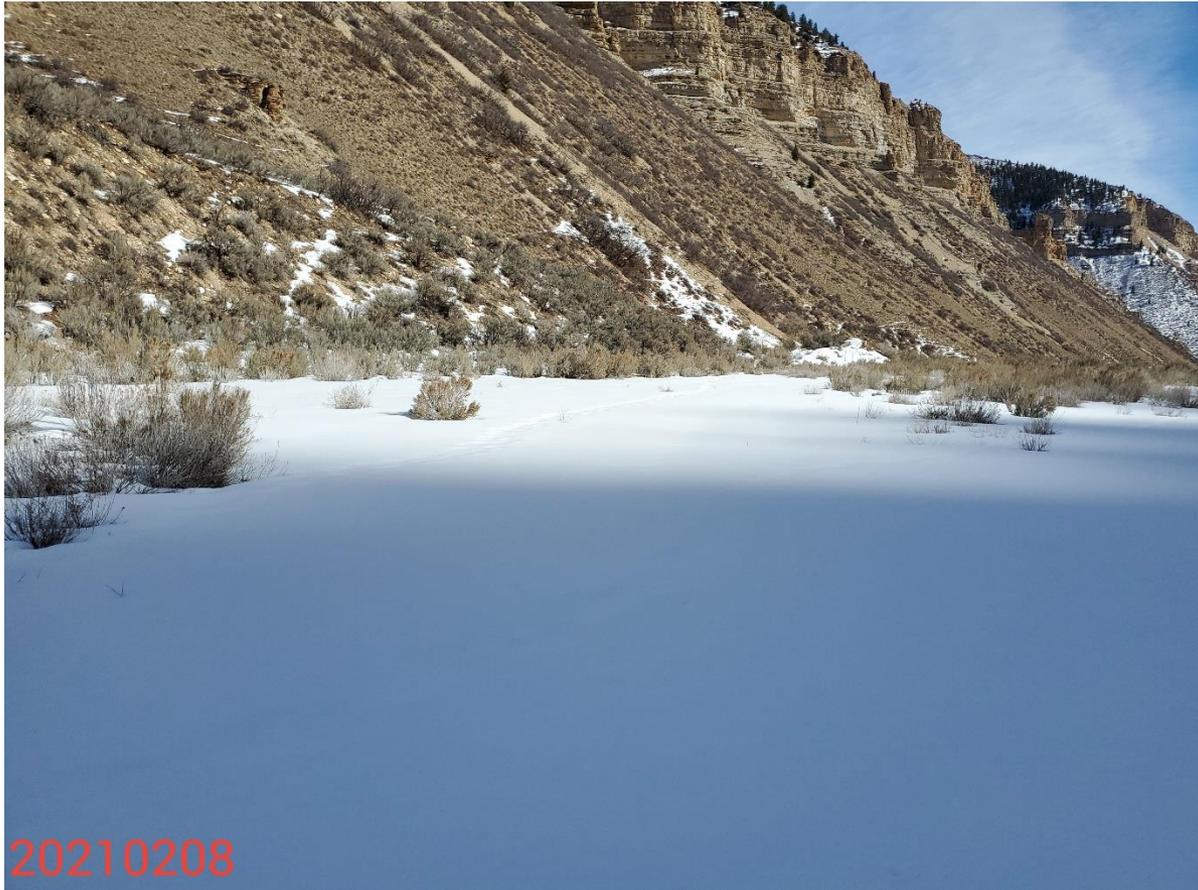
Photo 4: See comments under photo 3.

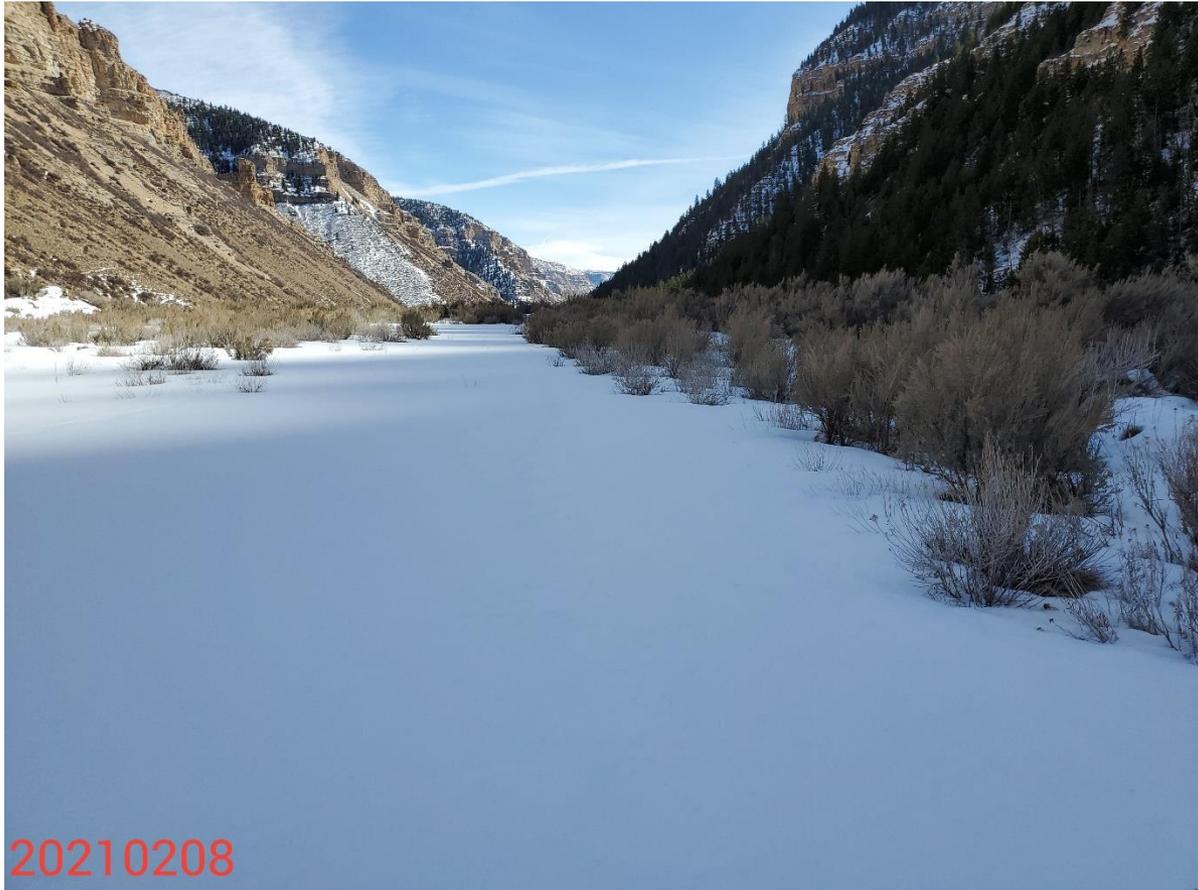
Photo 5: See comments under photo 3.

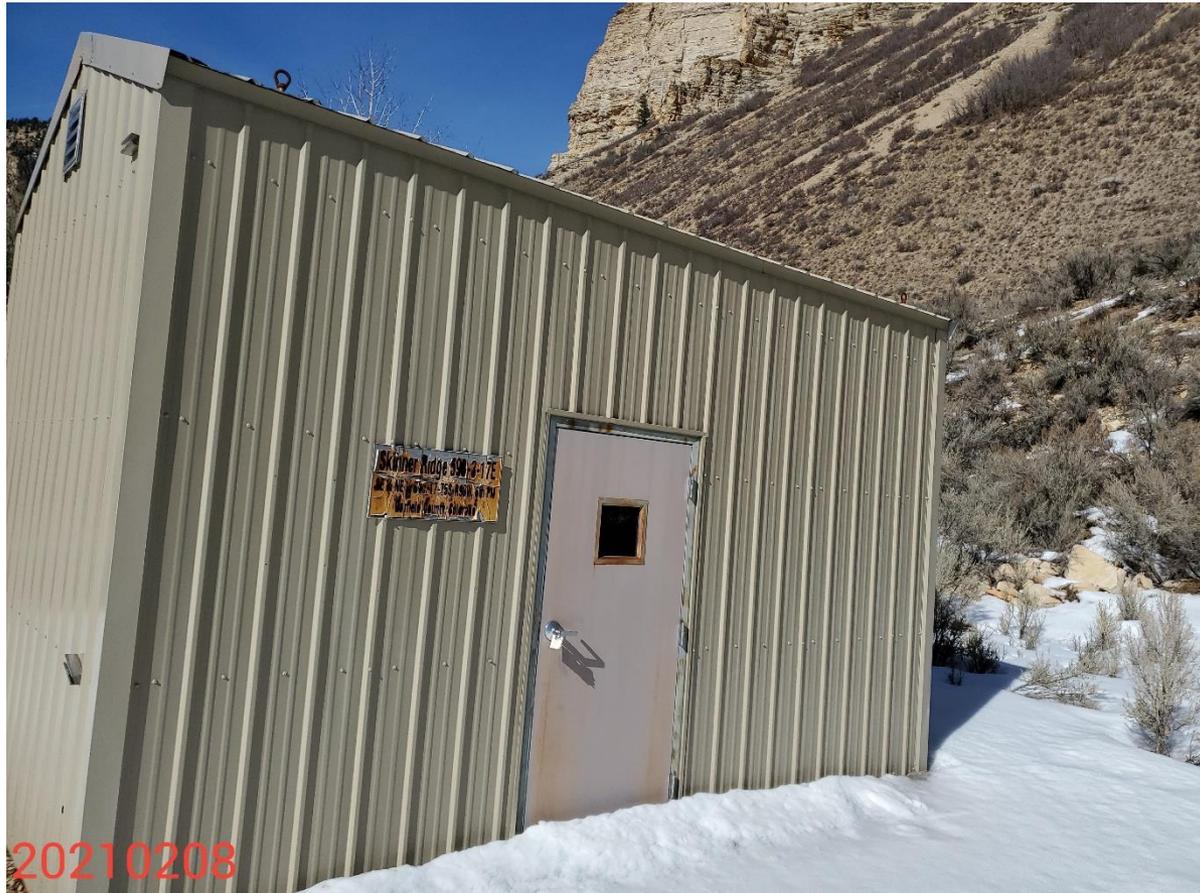
Photo 6: Photo shows shed/equipment remaining on the north end of the Location.

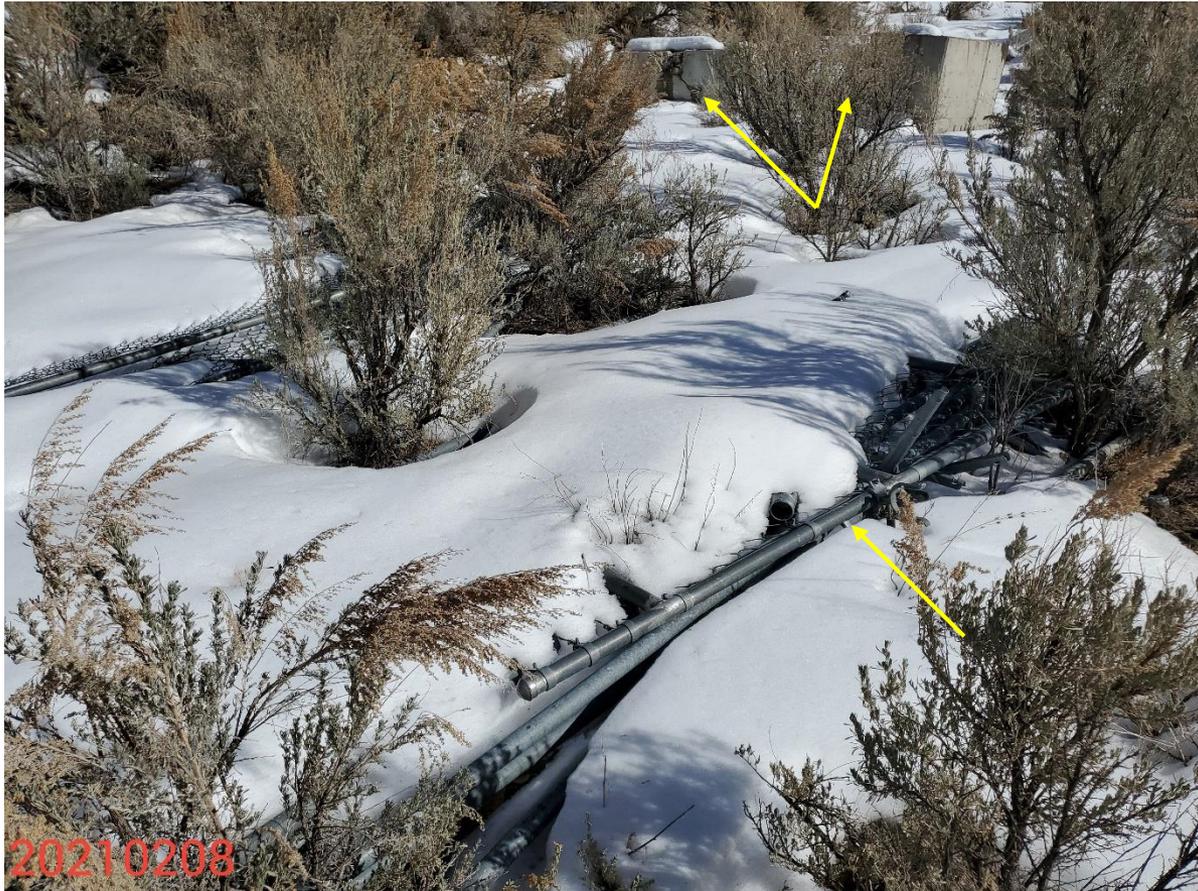
Photo 7: Photo taken from the east end of the Location. Photo shows fence equipment and concrete blocks remaining on the Location.

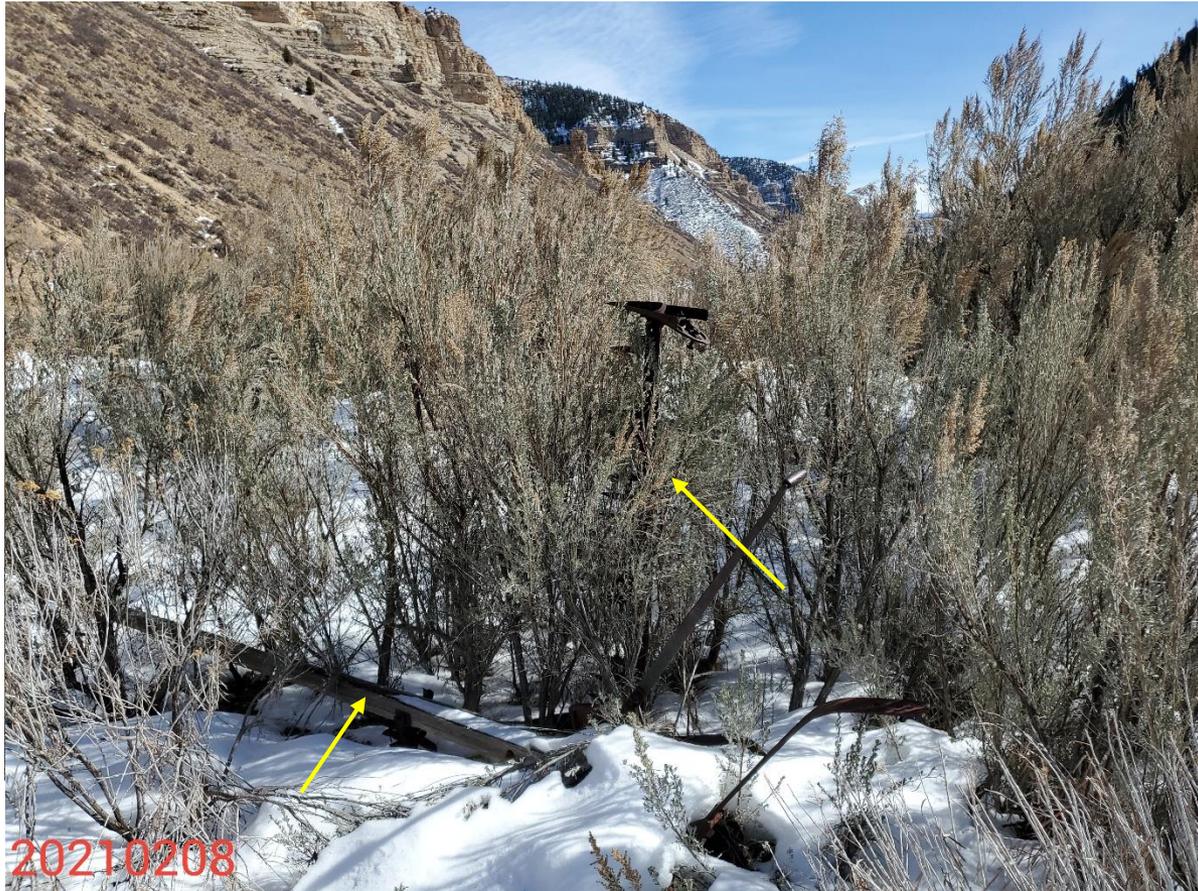
Photo 8: Photo taken from the east end of the Location, facing east. Photo shows various debris or equipment remaining on the Location.

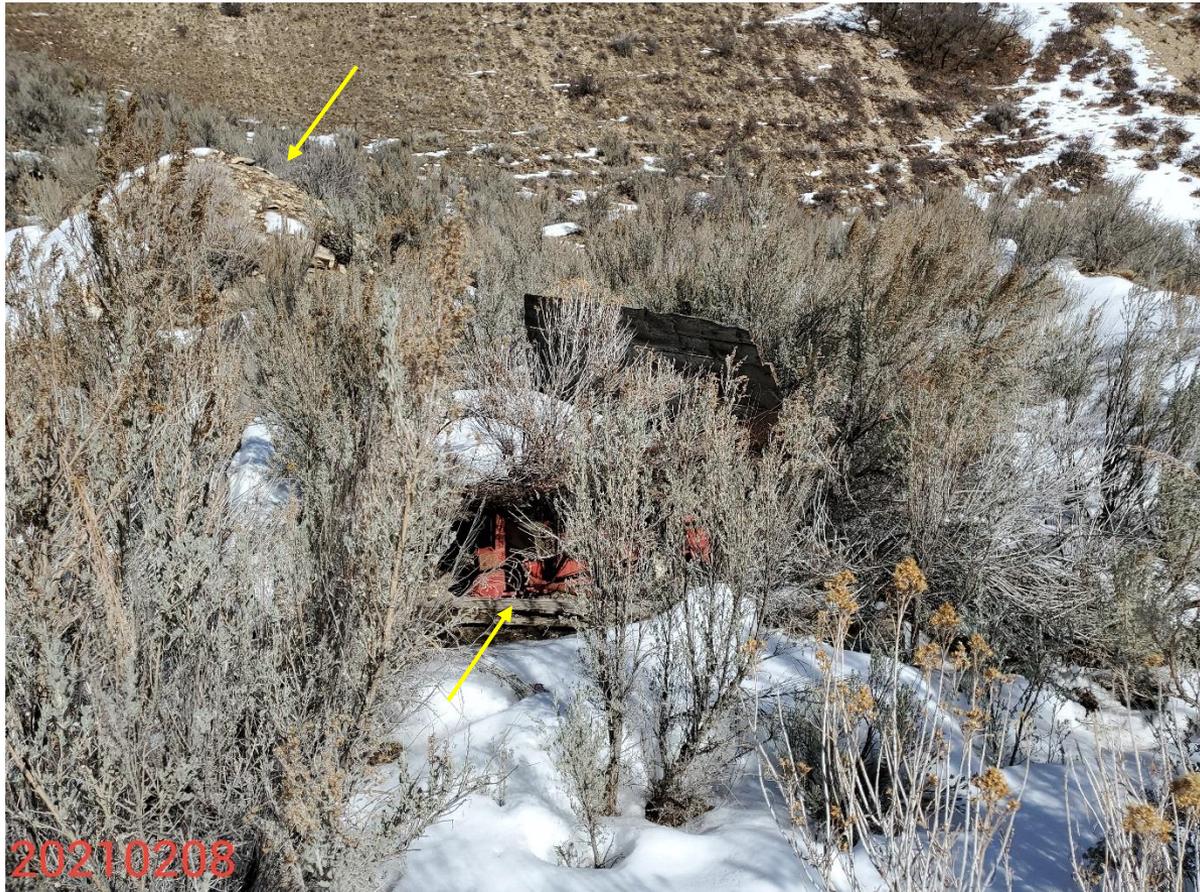
Photo 9: Photo taken from the east end of the Location, facing northeast. Photo shows various debris or equipment remaining on the Location. Photo also shows soil stockpile on the northeast corner of the Location.

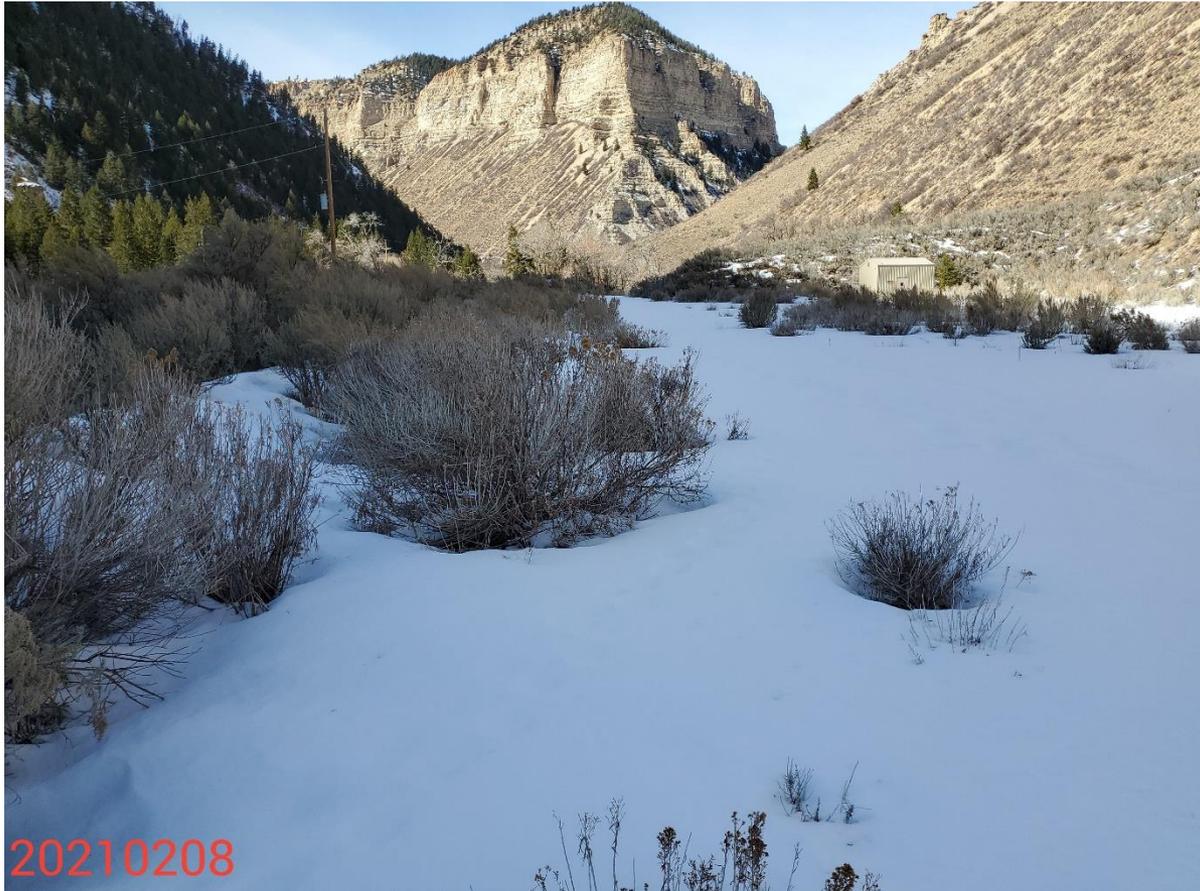
Photo 10: Photo taken from the southeast end of the Location, facing northwest. Photos 10-12 provide an overview of the Location from northwest, north to northeast. Photos show final reclamation (including, but not limited to, removal of equipment/debris, recontouring/regrading, compaction alleviation and revegetation activities) has not been conducted in accordance with 1004 Rules.

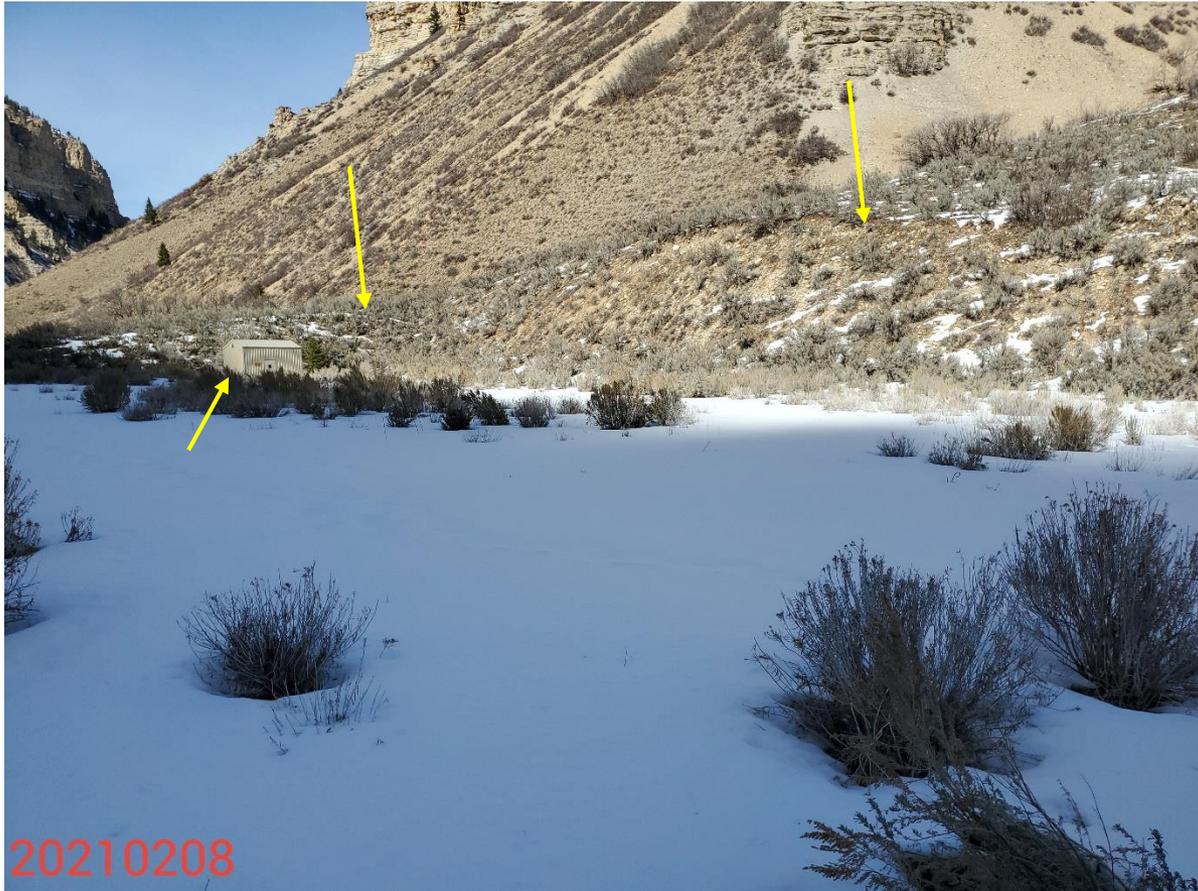
Photo 11: See comments under photo 10. Photo also shows cut-slopes of the Location and equipment remaining. .

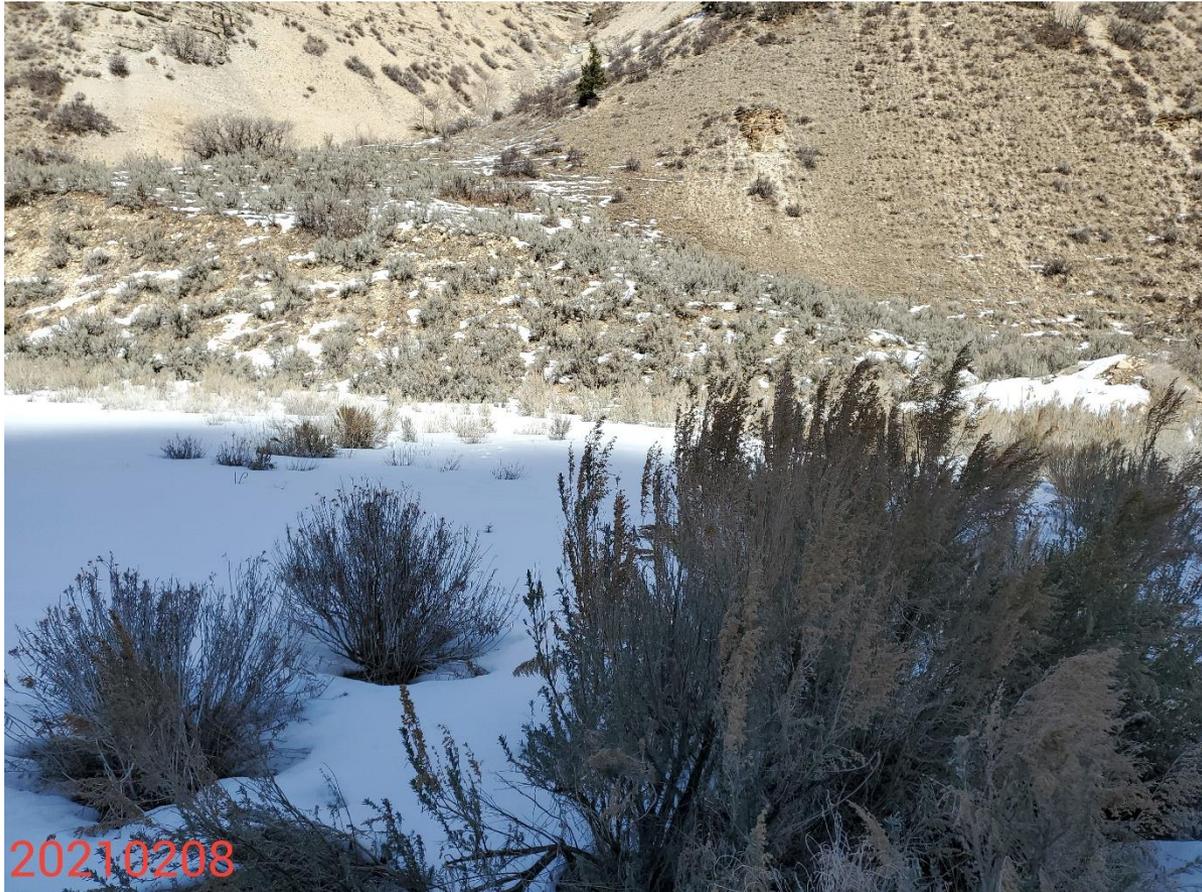
Photo 12: See comments under photo 10.

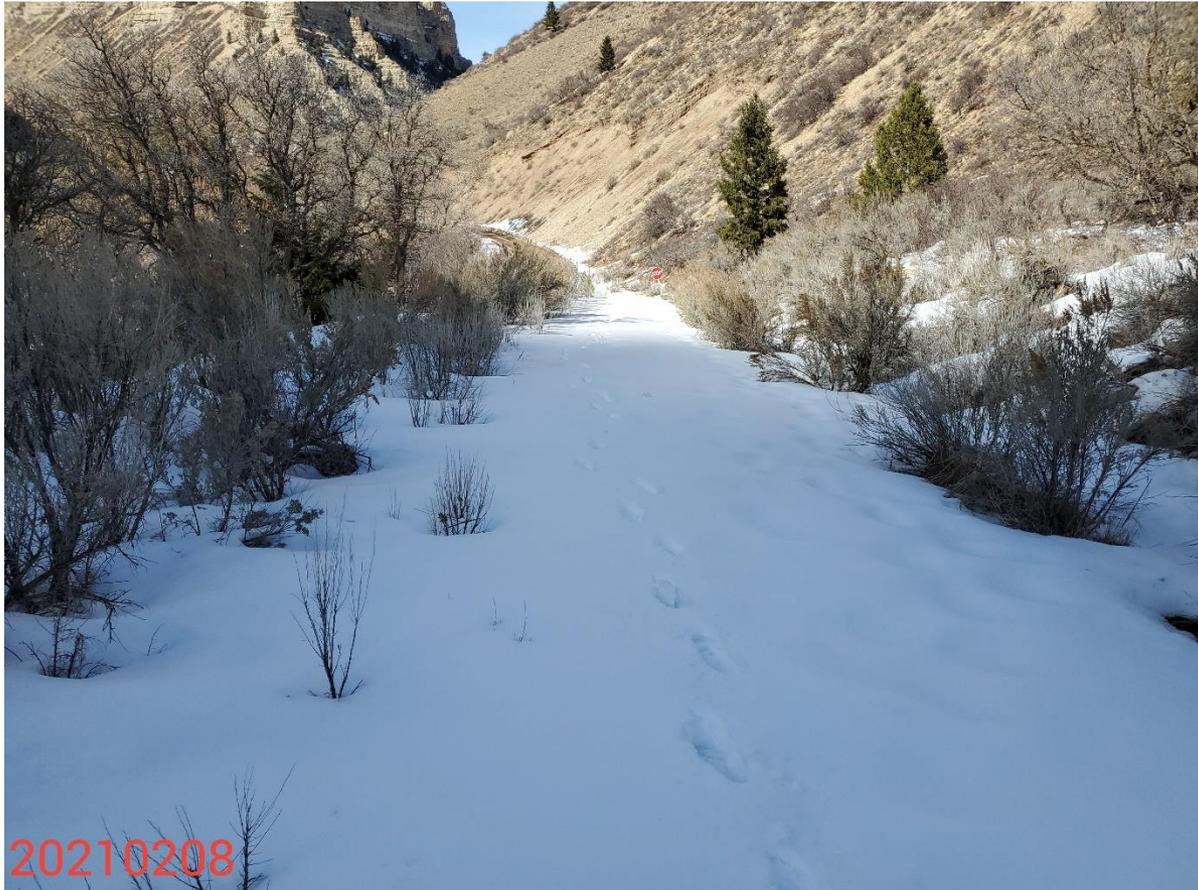
Photo 13: Photo taken from the Location entrance on the northwest end of the site, facing northwest. Photo shows access road has not been recontoured/regraded and reclaimed.

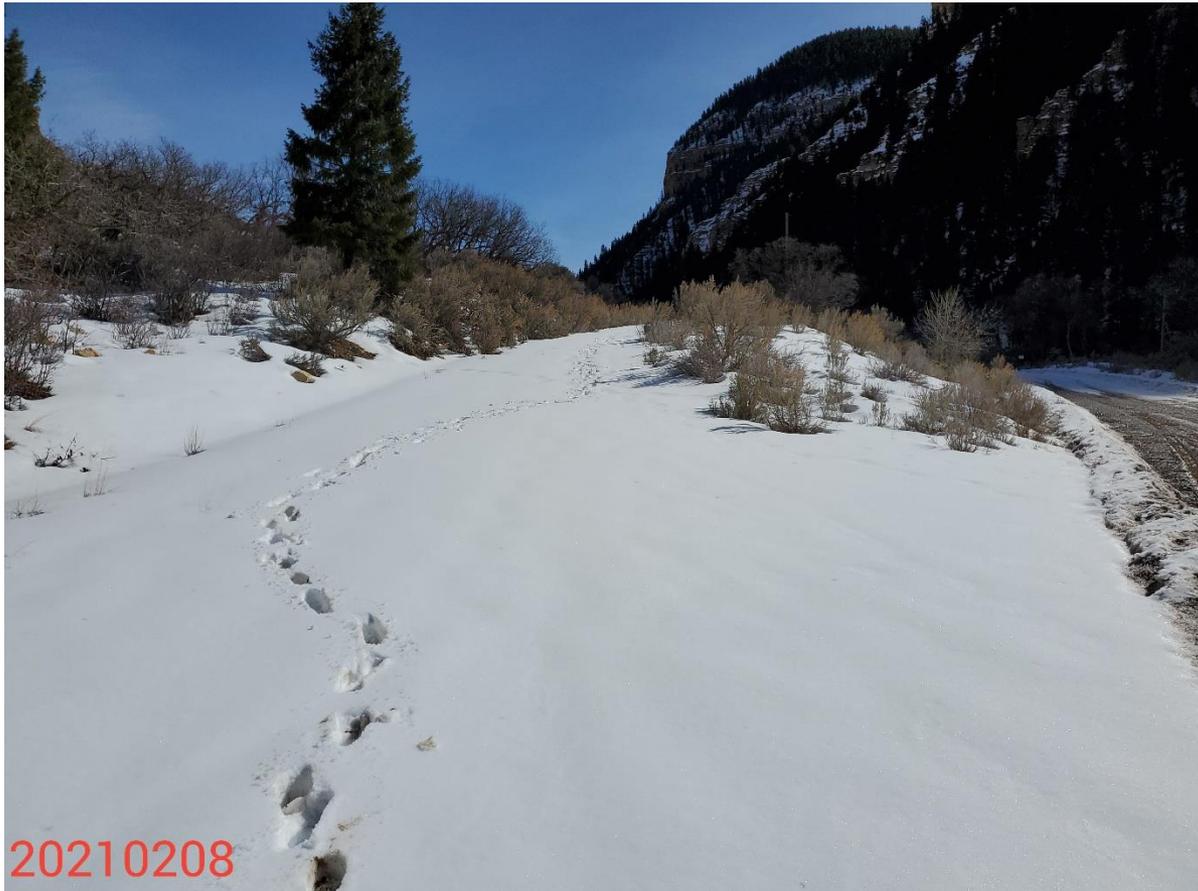
Photo 14: Photo taken from the access road entrance, northwest of the Location, facing southeast. Photo shows access road has not been recontoured/regraded and reclaimed.

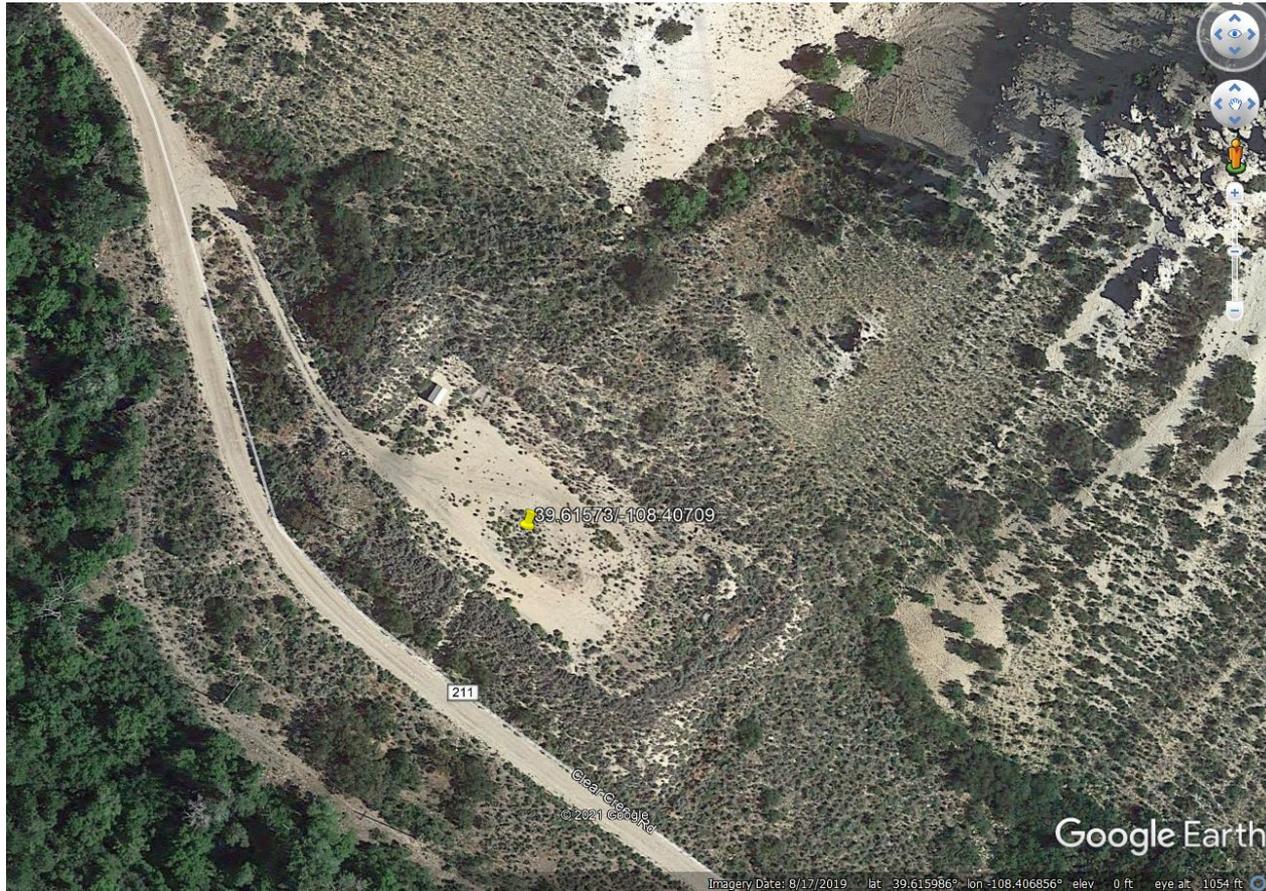
Photo 15: 2019 Google Earth Aerial image. Photo shows overview of the Location. Well PA 11/4/2013, Final Reclamation activities pursuant to Rule 1004.a was required by 11/4/2014.
