COLORADO
Oil & Gas Conservation
Commission
Department of Natural Resources

Arrowhead 9

API: 05-103-05301

Inspection: 700405317

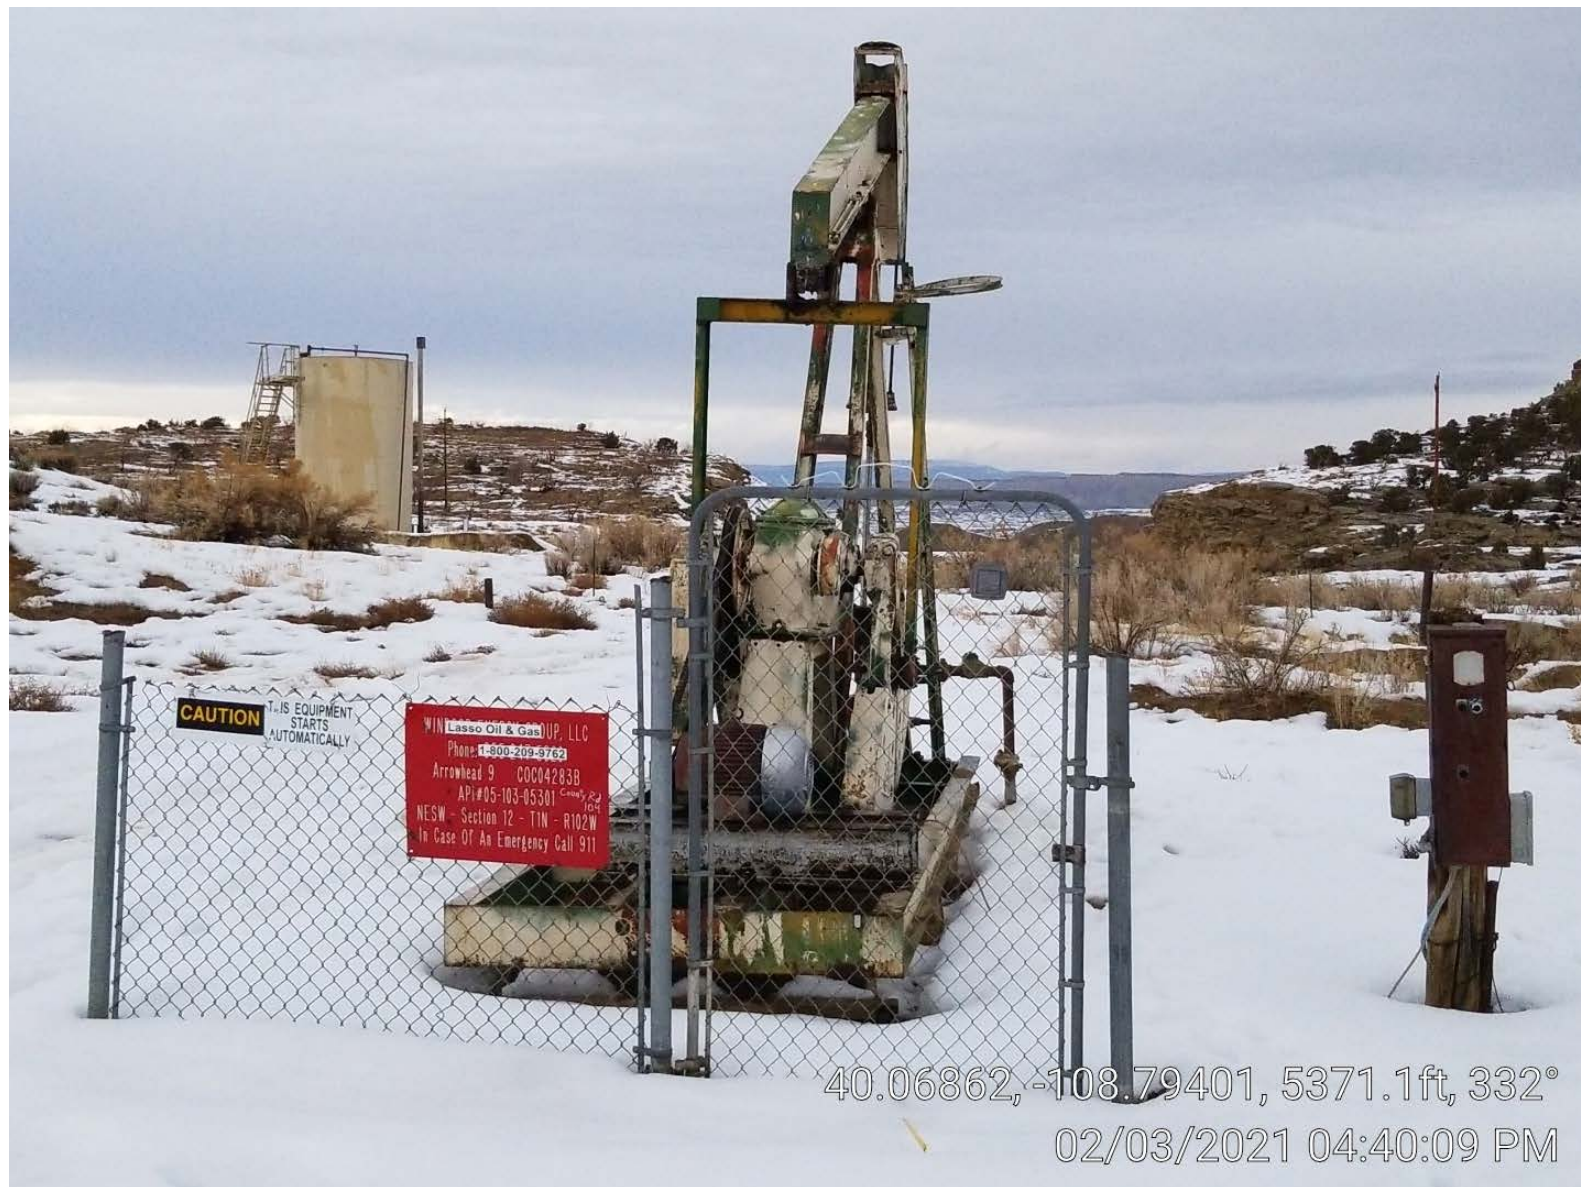
Photo 1. Location.

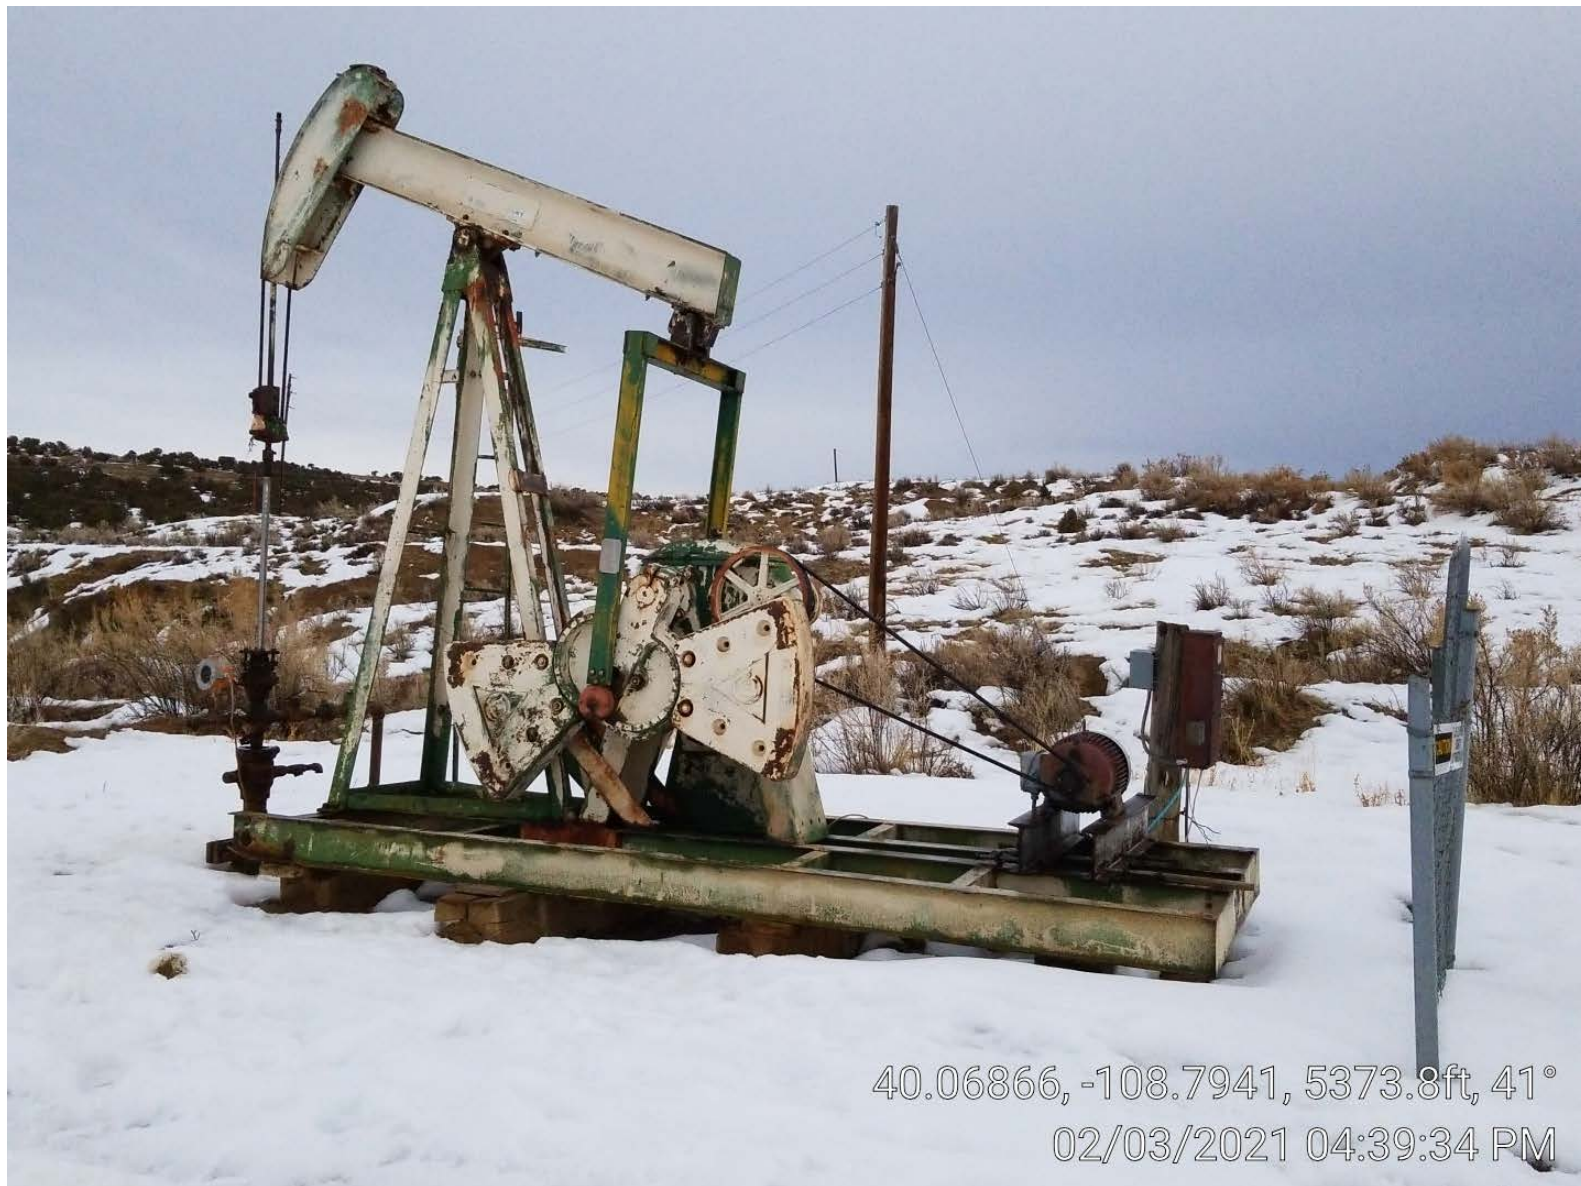
Photo 2. Pump jack.

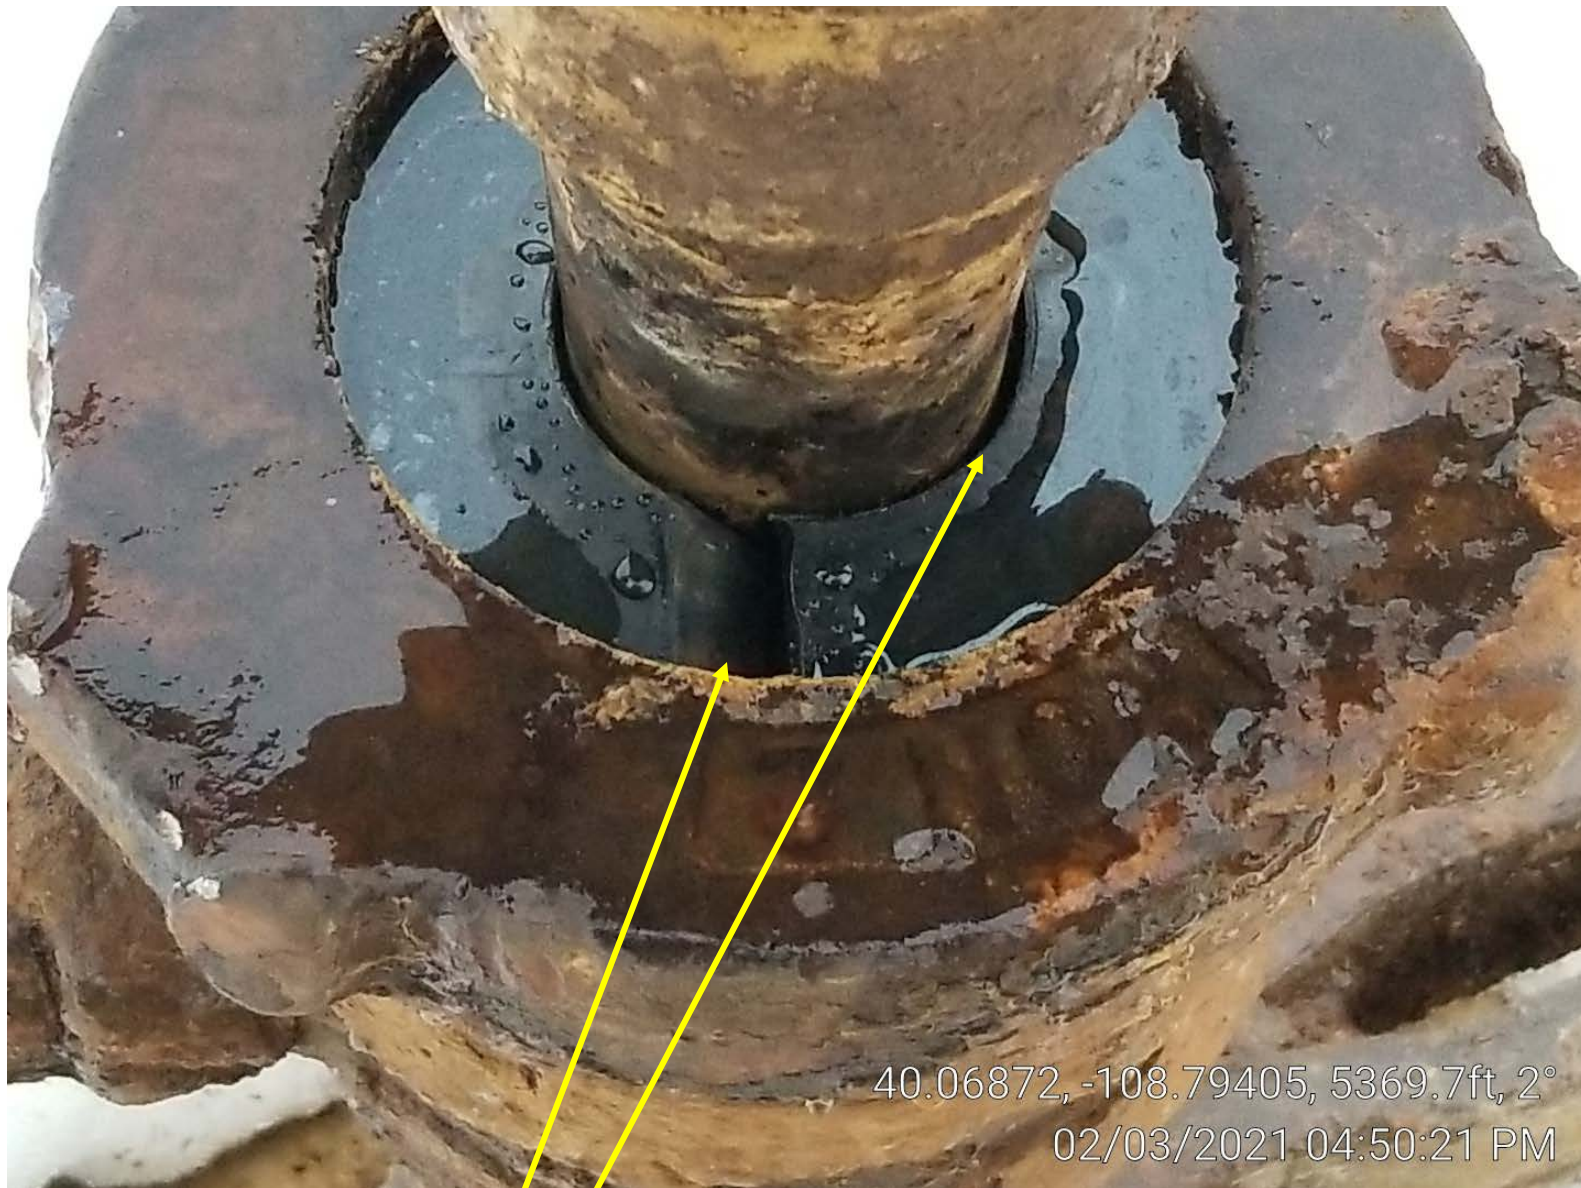
Photo 4. Well with gas leak.

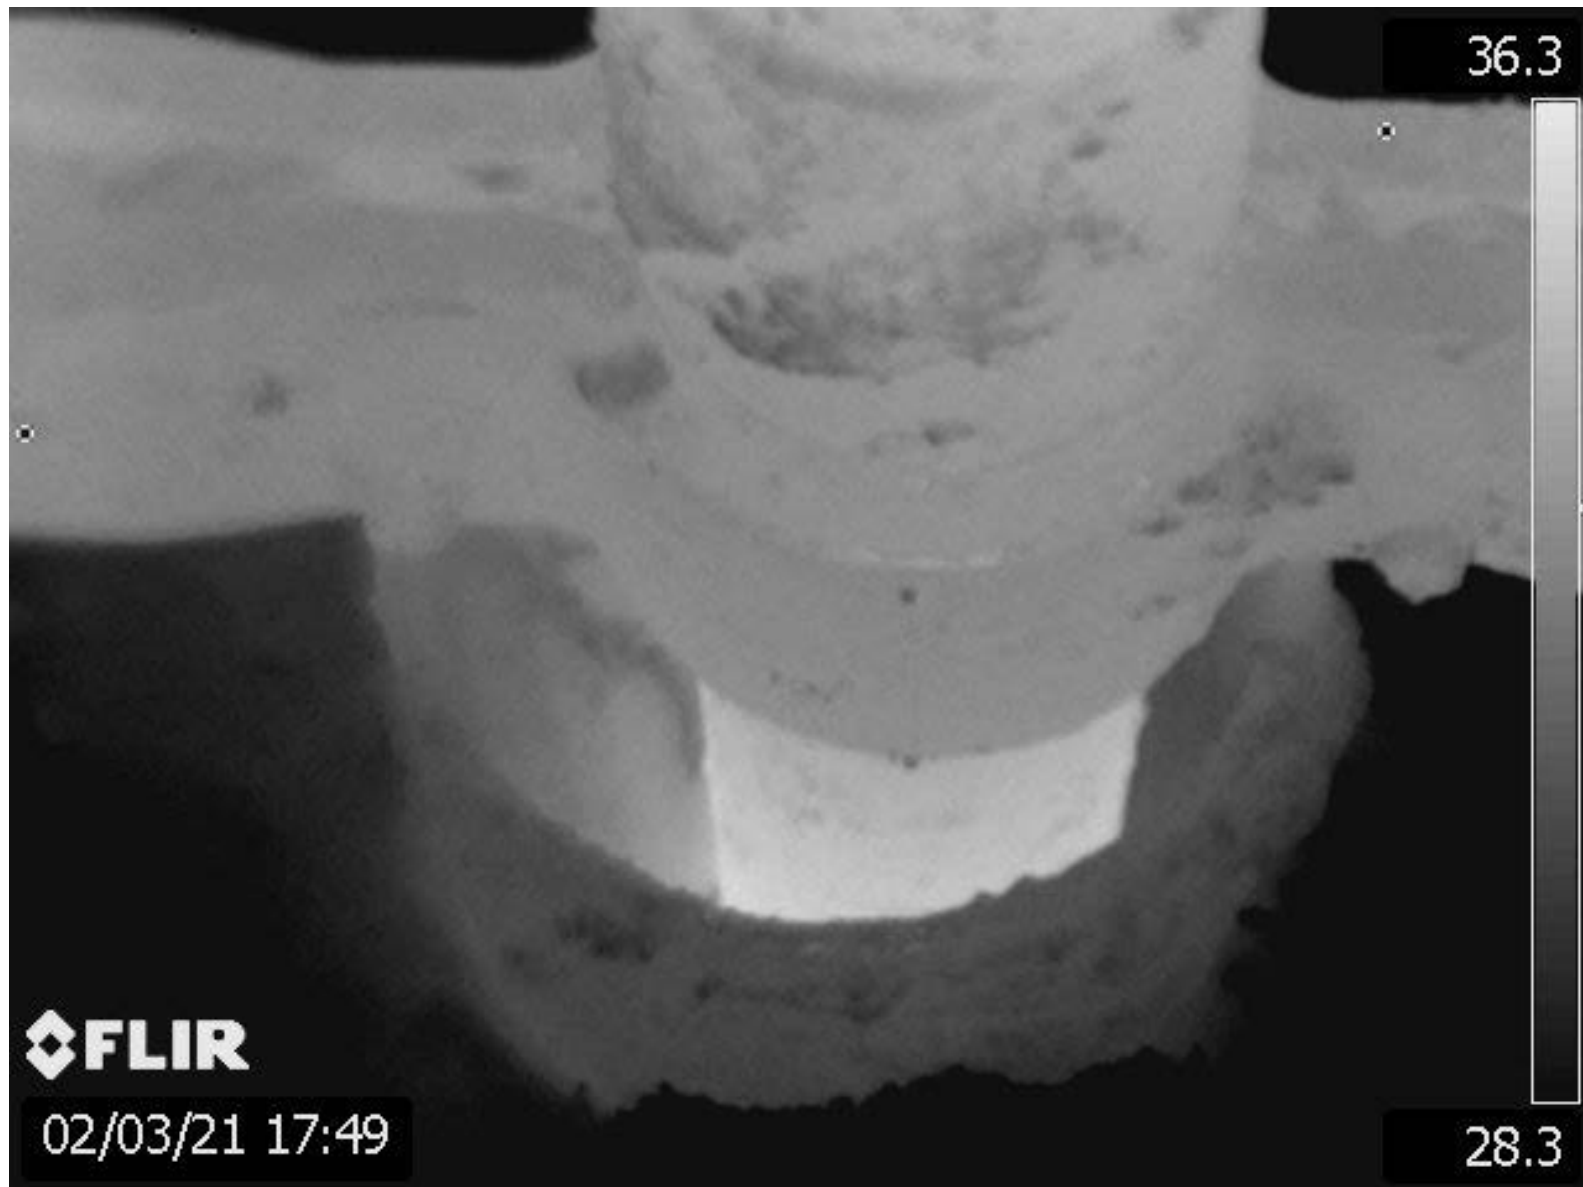
Photo 7. Well at anchor & below.
