Inspection Photos  
Operator: Simcoe  
API: 067-05796  
Date: 2/8/2021

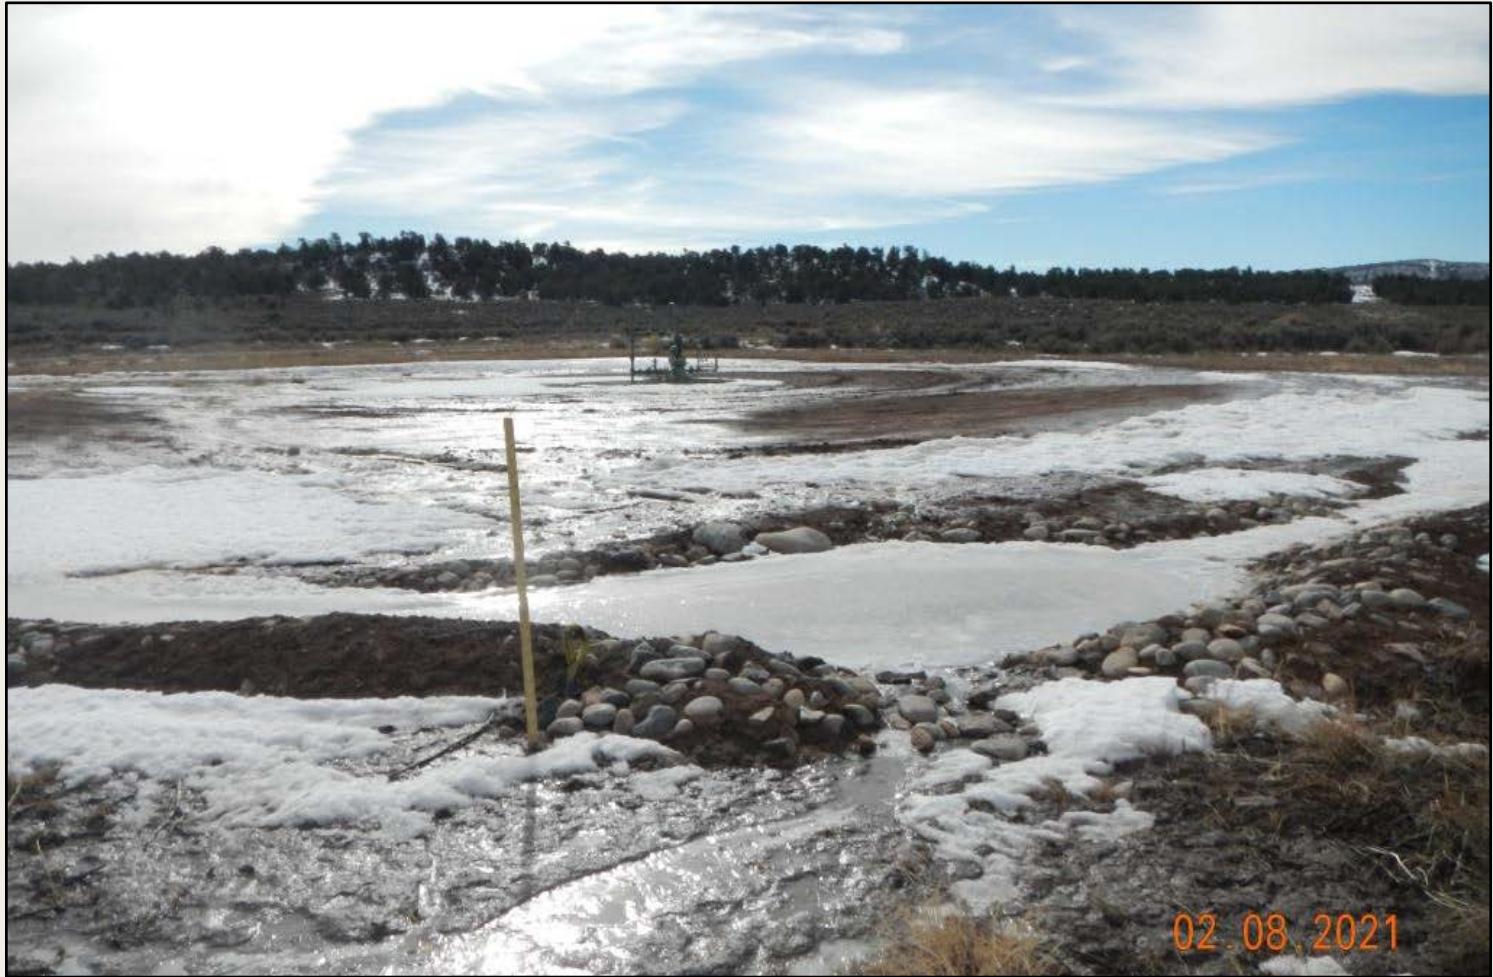
Photo 1. View of the wellhead portion of the project area from the northwestern corner facing center. Silt trap is not adequately sized as it is full and flowing over during a minor runoff event.

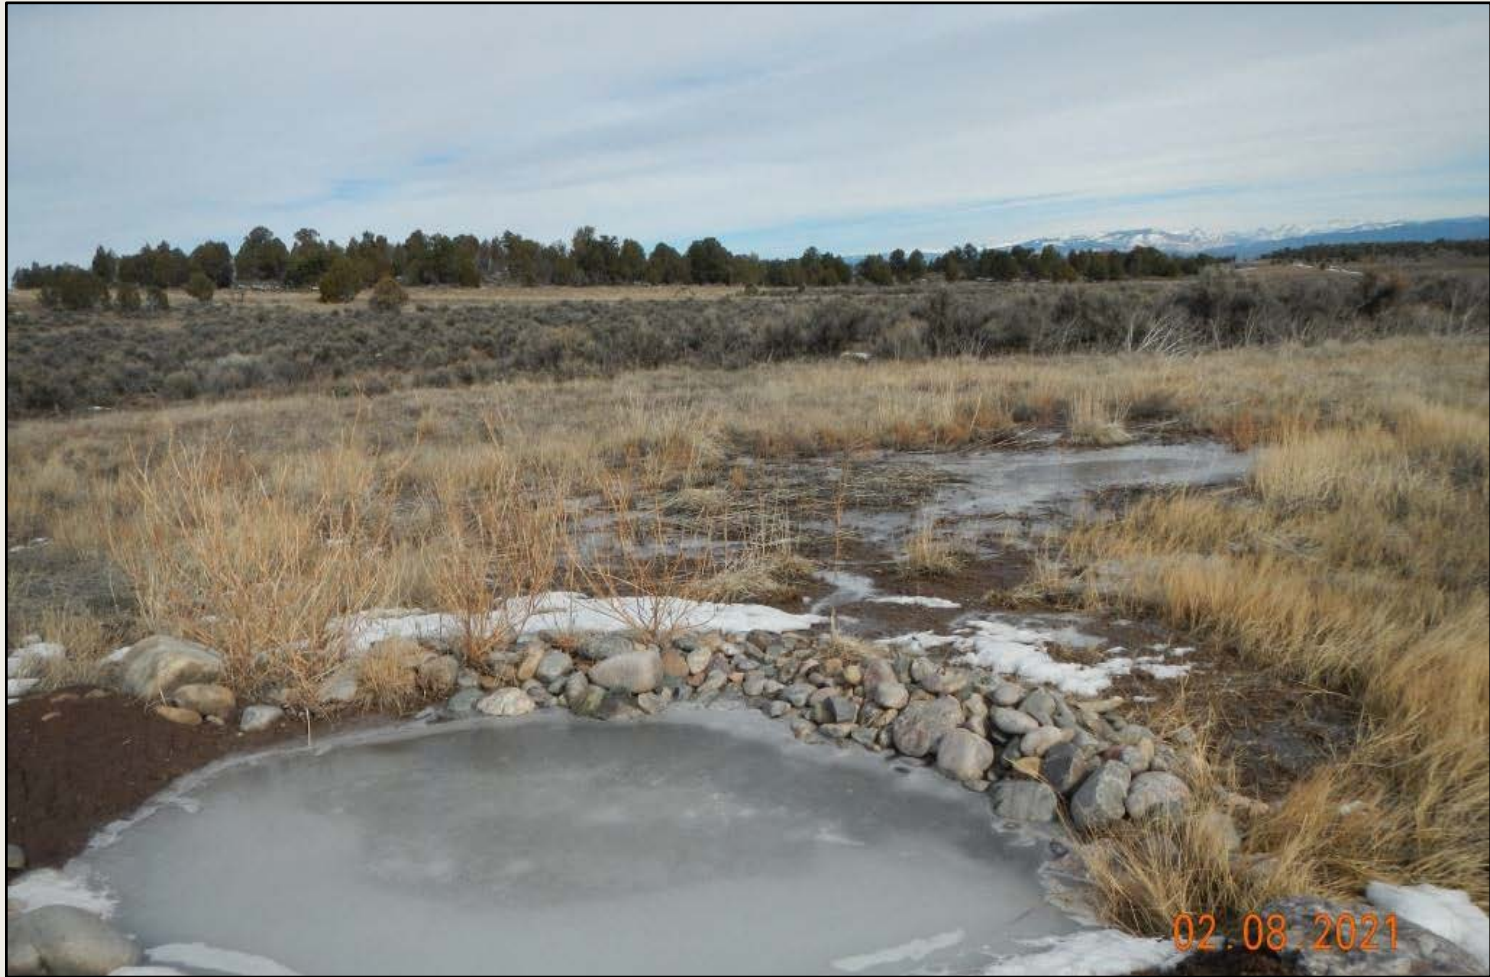
Photo 2. View of silt trap along the northern edge of the project area, is no adequate as it too is overflowing during a minor runoff event. Sediment transport is observed in overflow. Downslope areas need seeding.

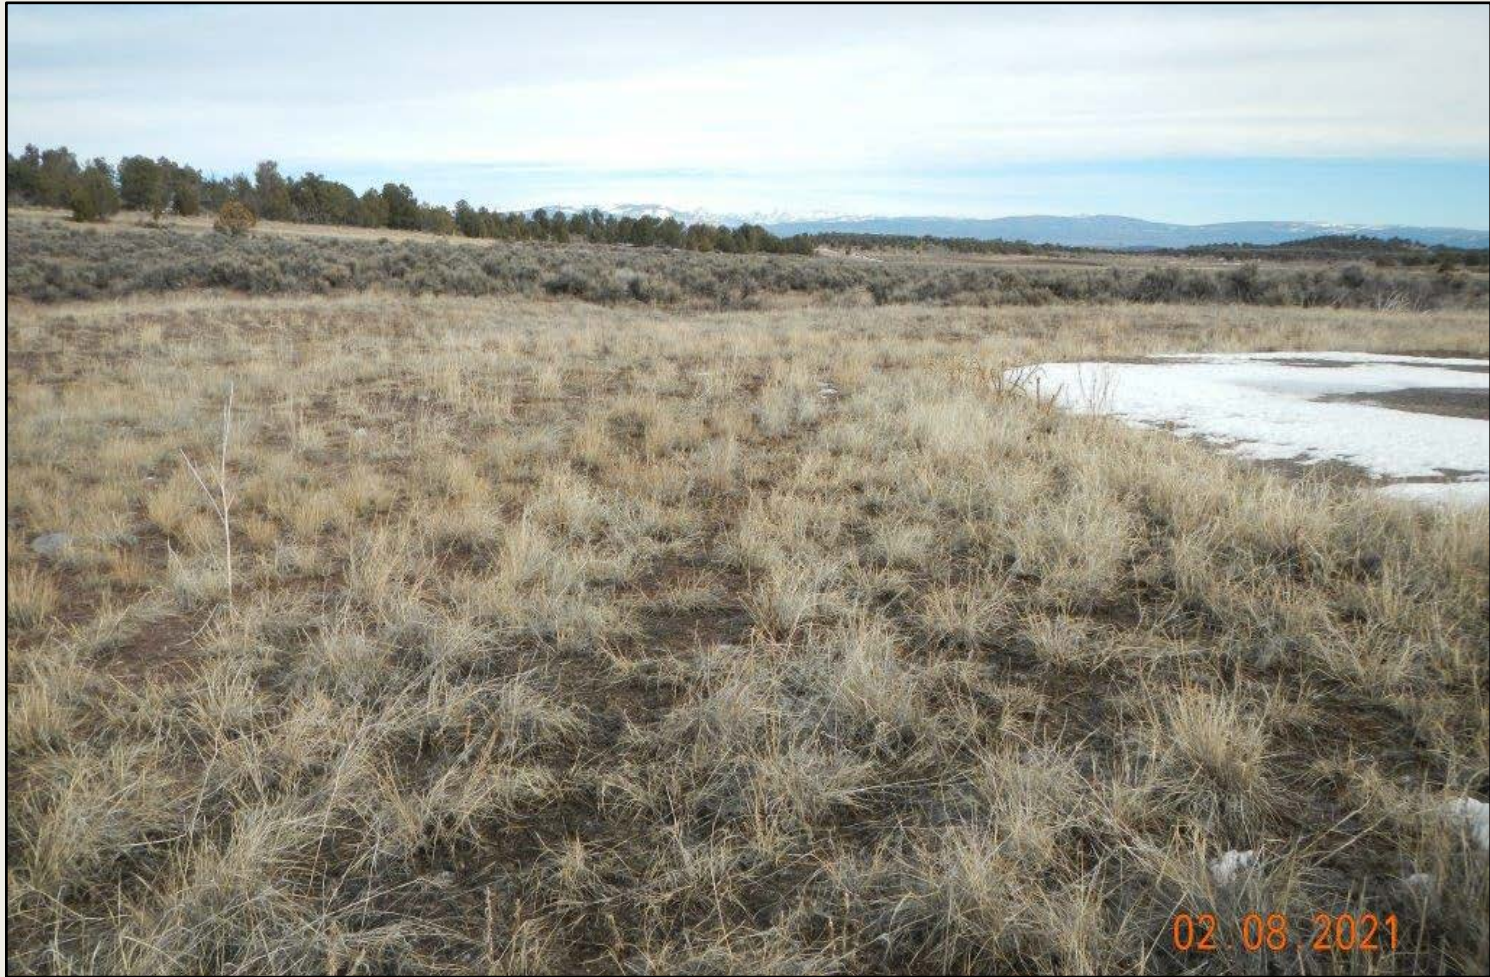
Photo 3. View of the eastern project area facing northward. Revegetation is progressing, largely with western wheatgrass. Reference area (in the background) is comprised of sagebrush shrubland, with grasses such as blue grama and western wheatgrass in the understory.
