Inspection Photos
Operator: Catamount
API: 067-05332
Date: 2/8/2021

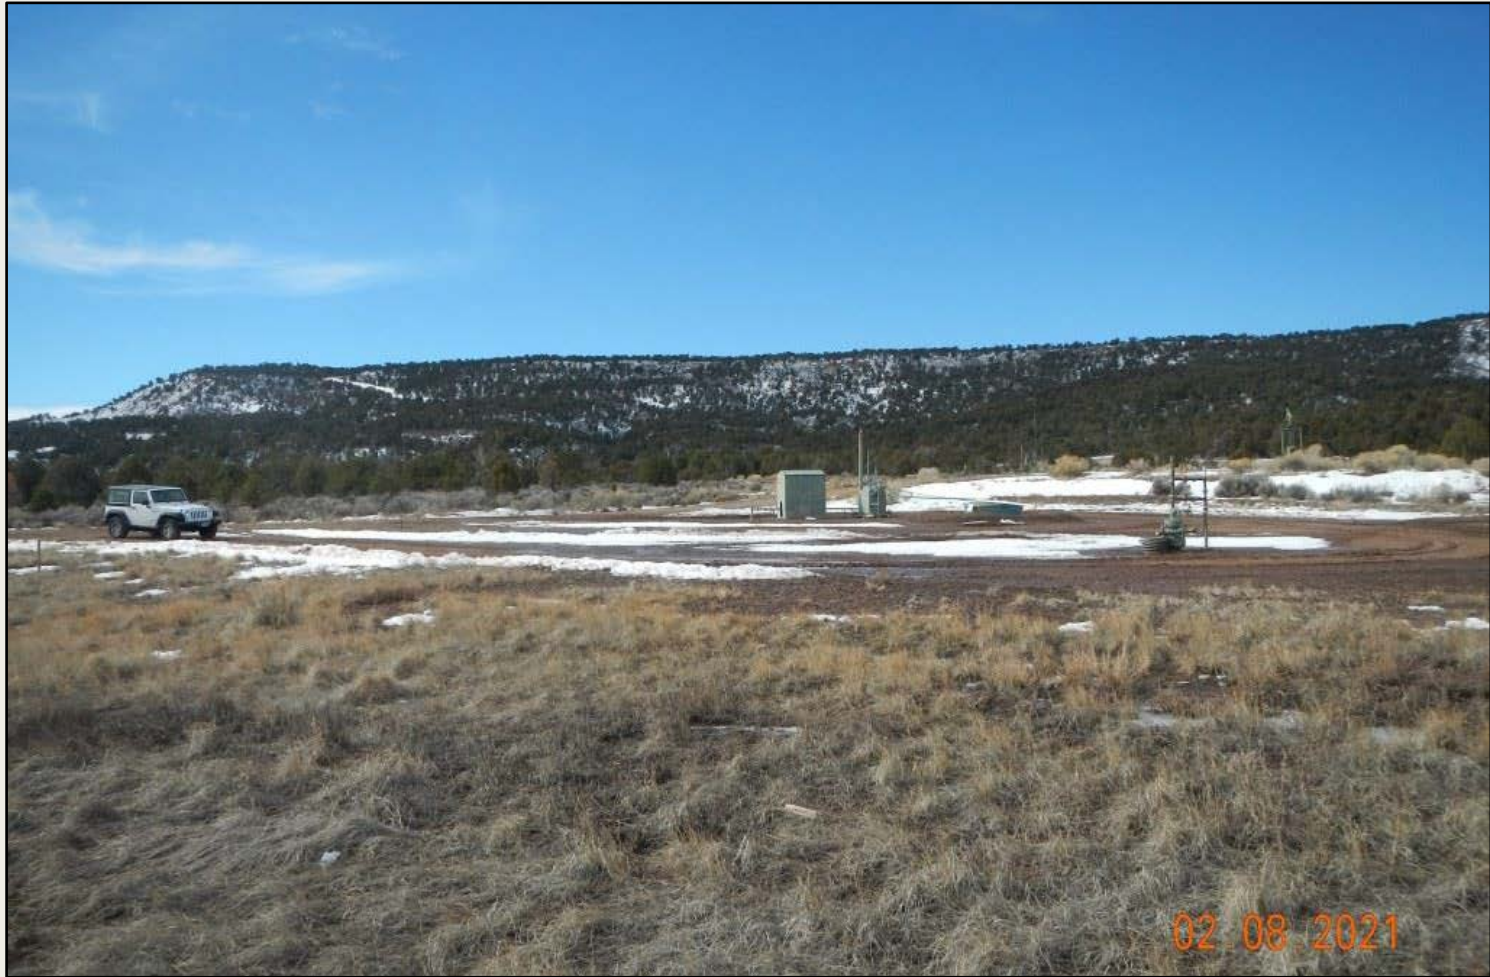
Photo 1. View of the project area from the northeastern corner facing center.

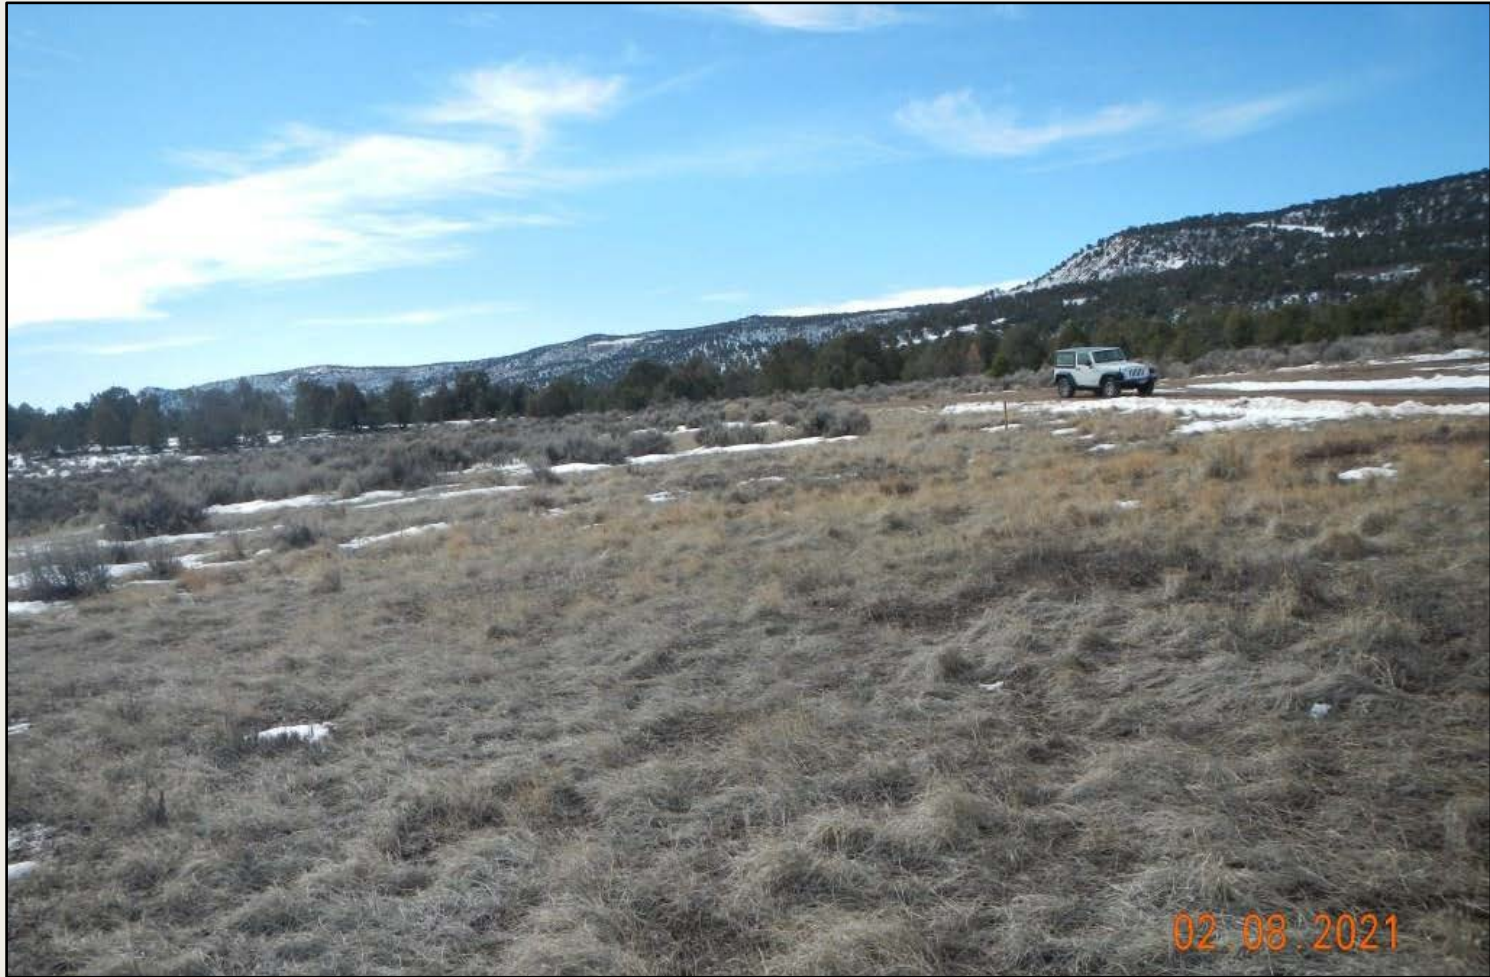
Photo 2. View of the eastern fill slope from the northeastern corner facing southward. Revegetation is progressing, largely with western wheatgrass.

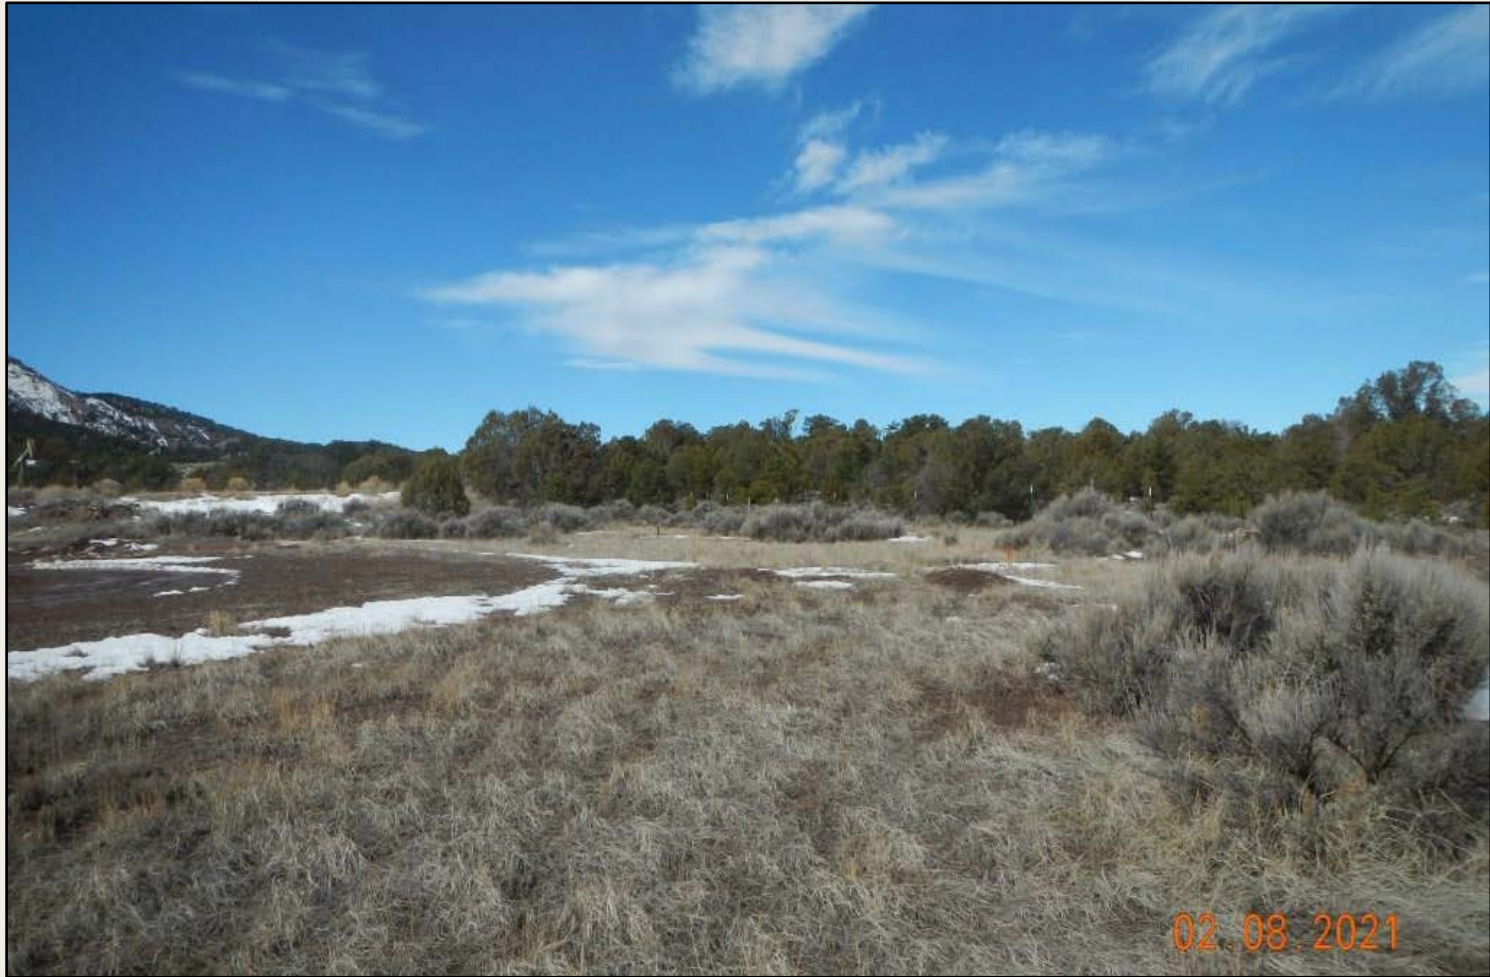
Photo 3. View of the northern project area facing westward.

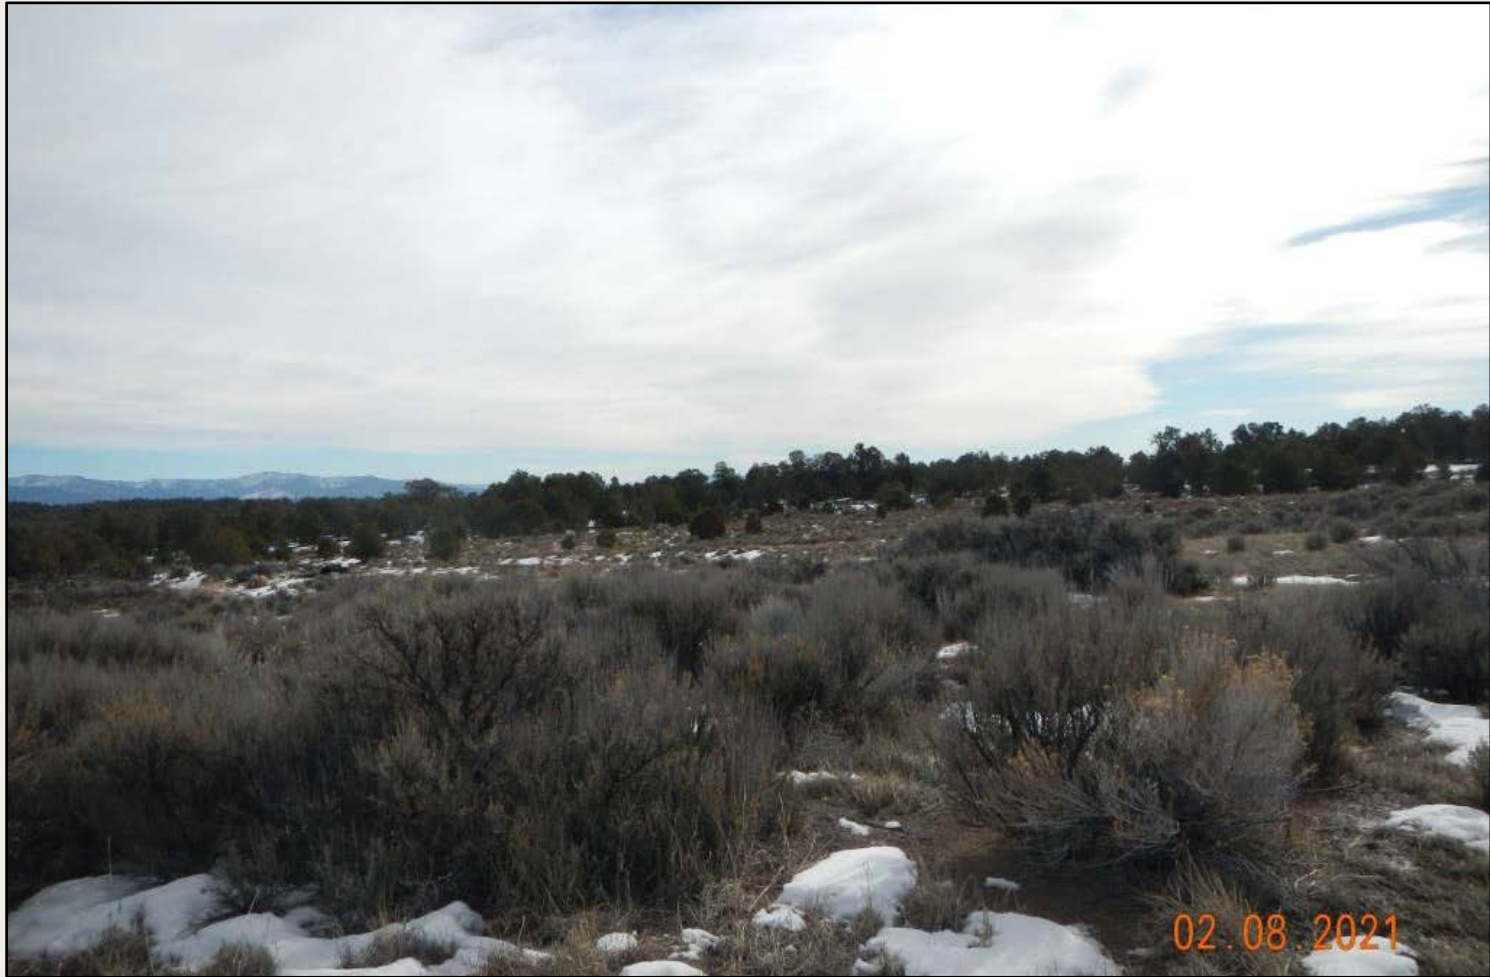
Photo 4. View of the reference area comprised of sagebrush shrubland with understory of grasses and forbs such as western wheatgrass, sand dropseed, and James galleta.
