Inspection Photos
Operator: Logos
API: 067-05297
Date: 2/8/2021

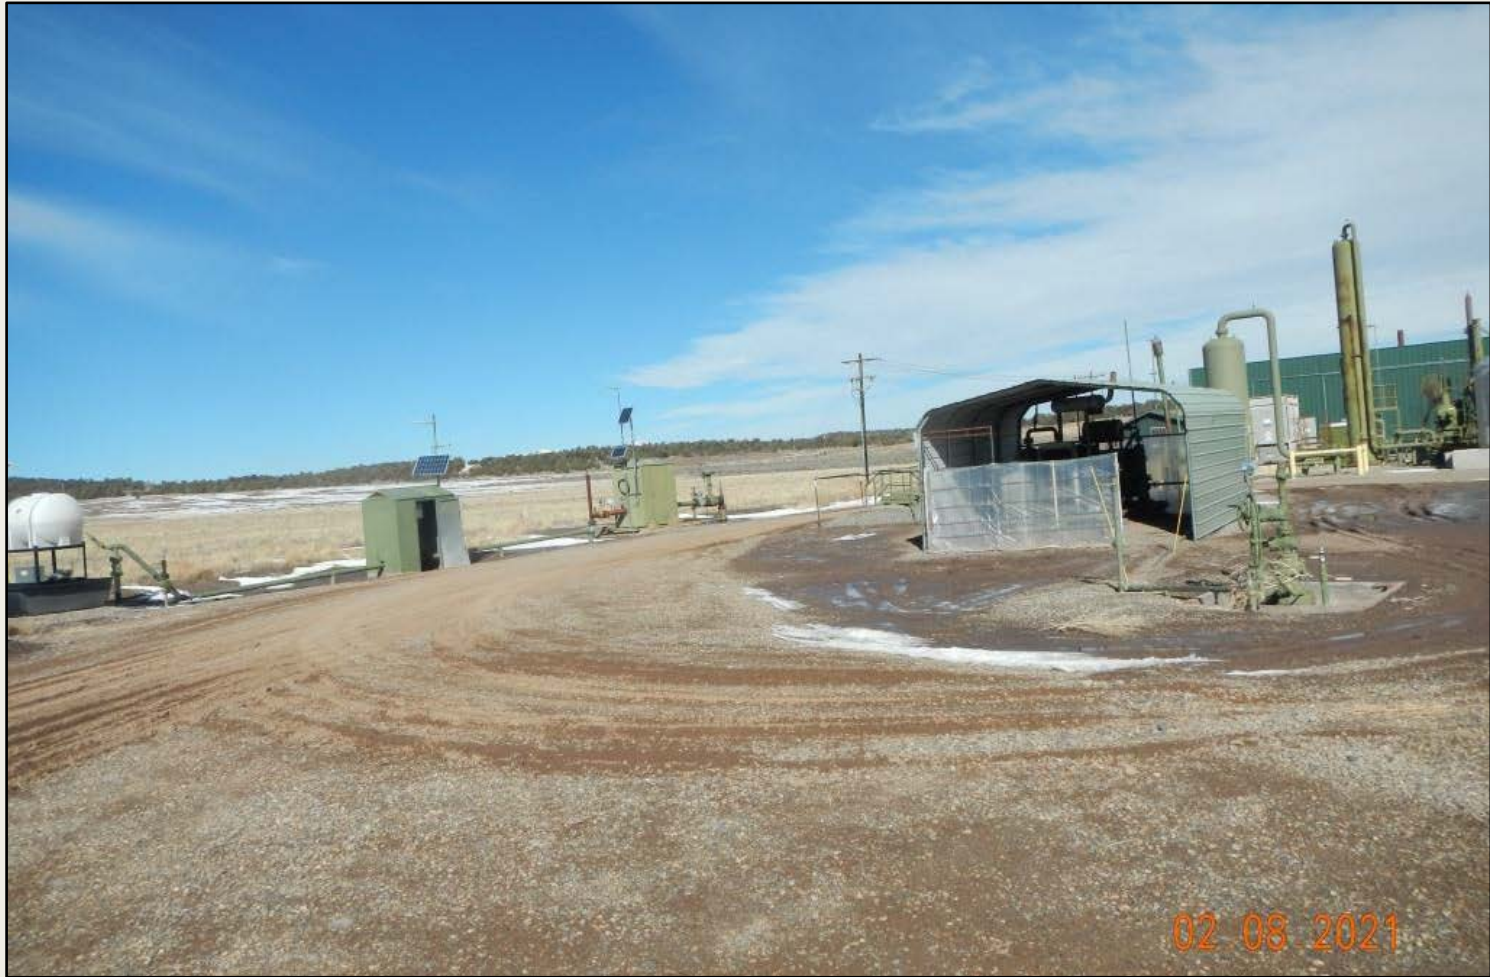
Photo 1. View of the project area from the southeastern corner facing center.

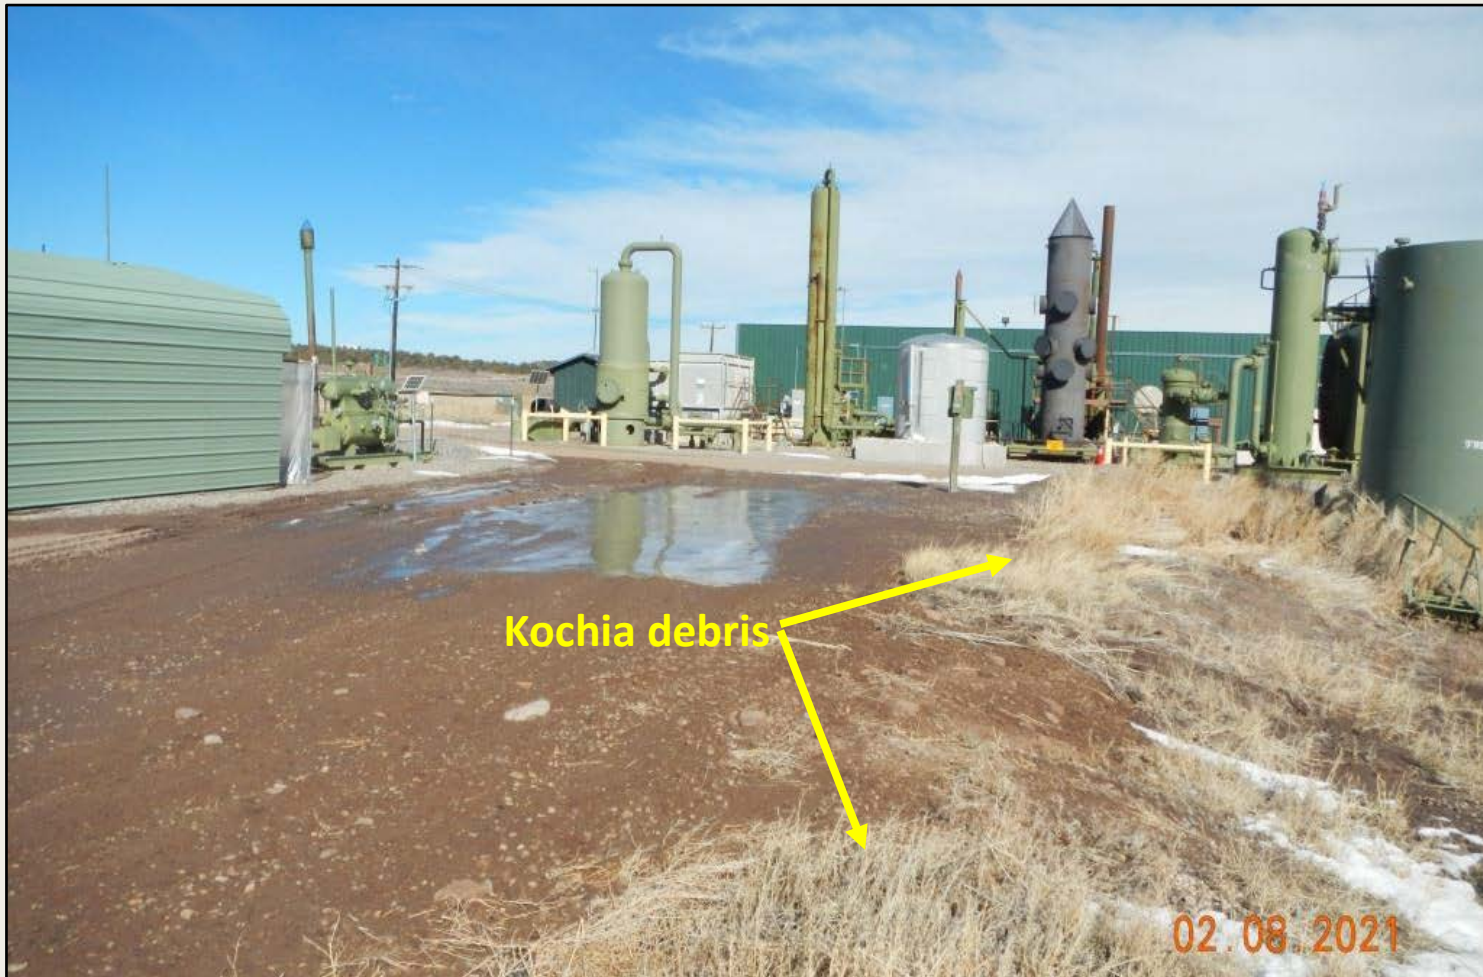
Photo 2. View of the eastern fill slope from the southeastern corner facing northward. Revegetation is progressing, largely with western wheatgrass. Dense kochia observed along the eastern edge of the working area.

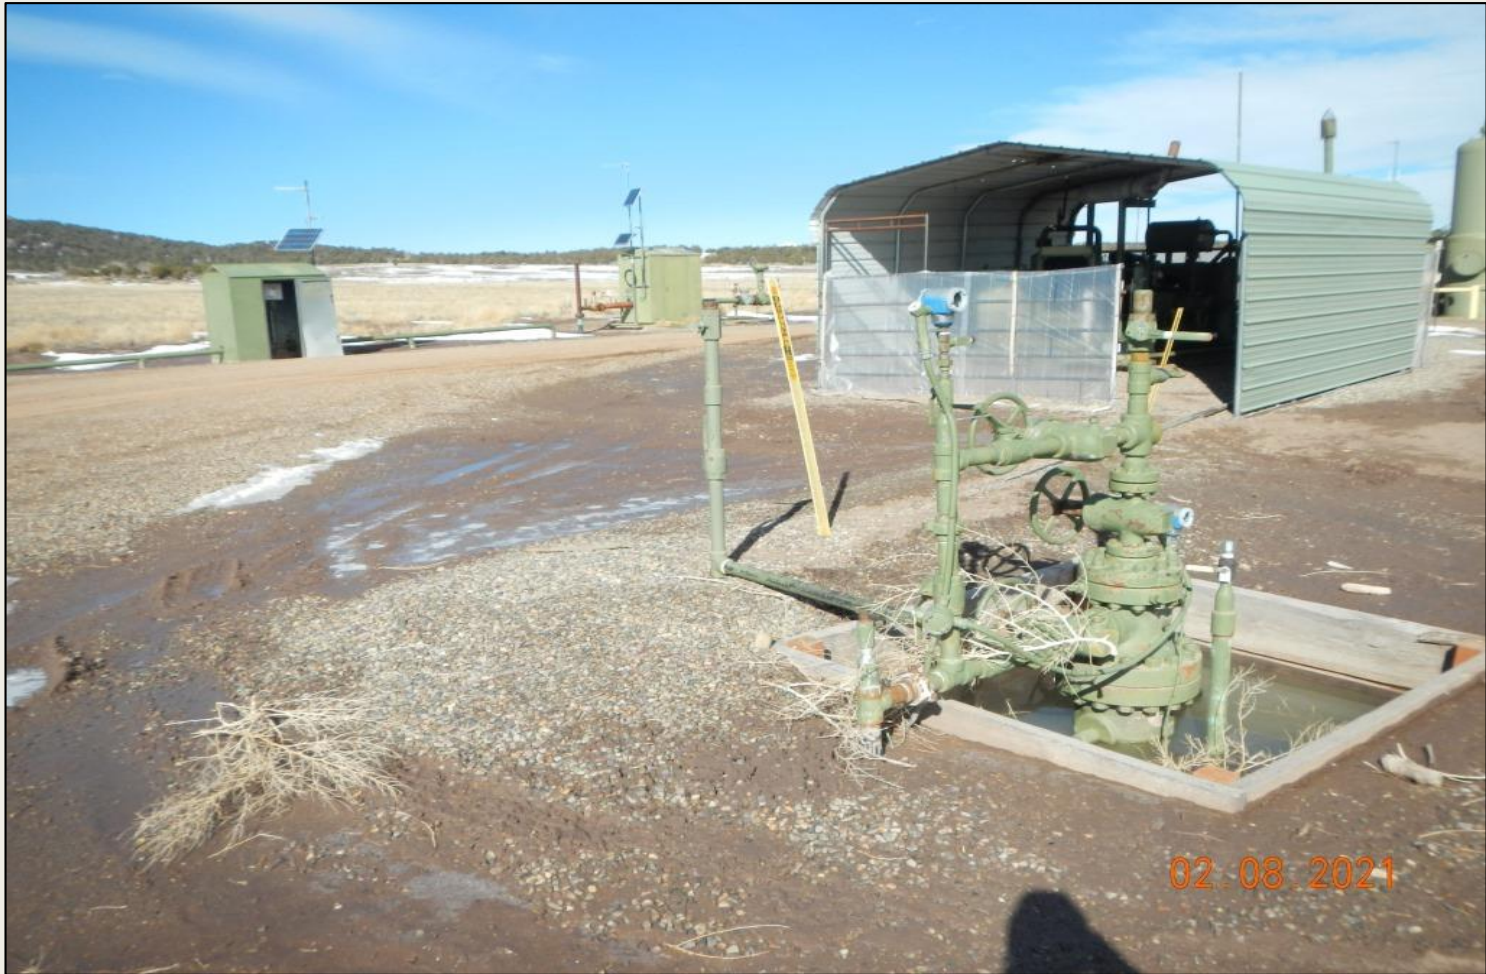
Photo 3. View of kochia debris stuck around wellhead.

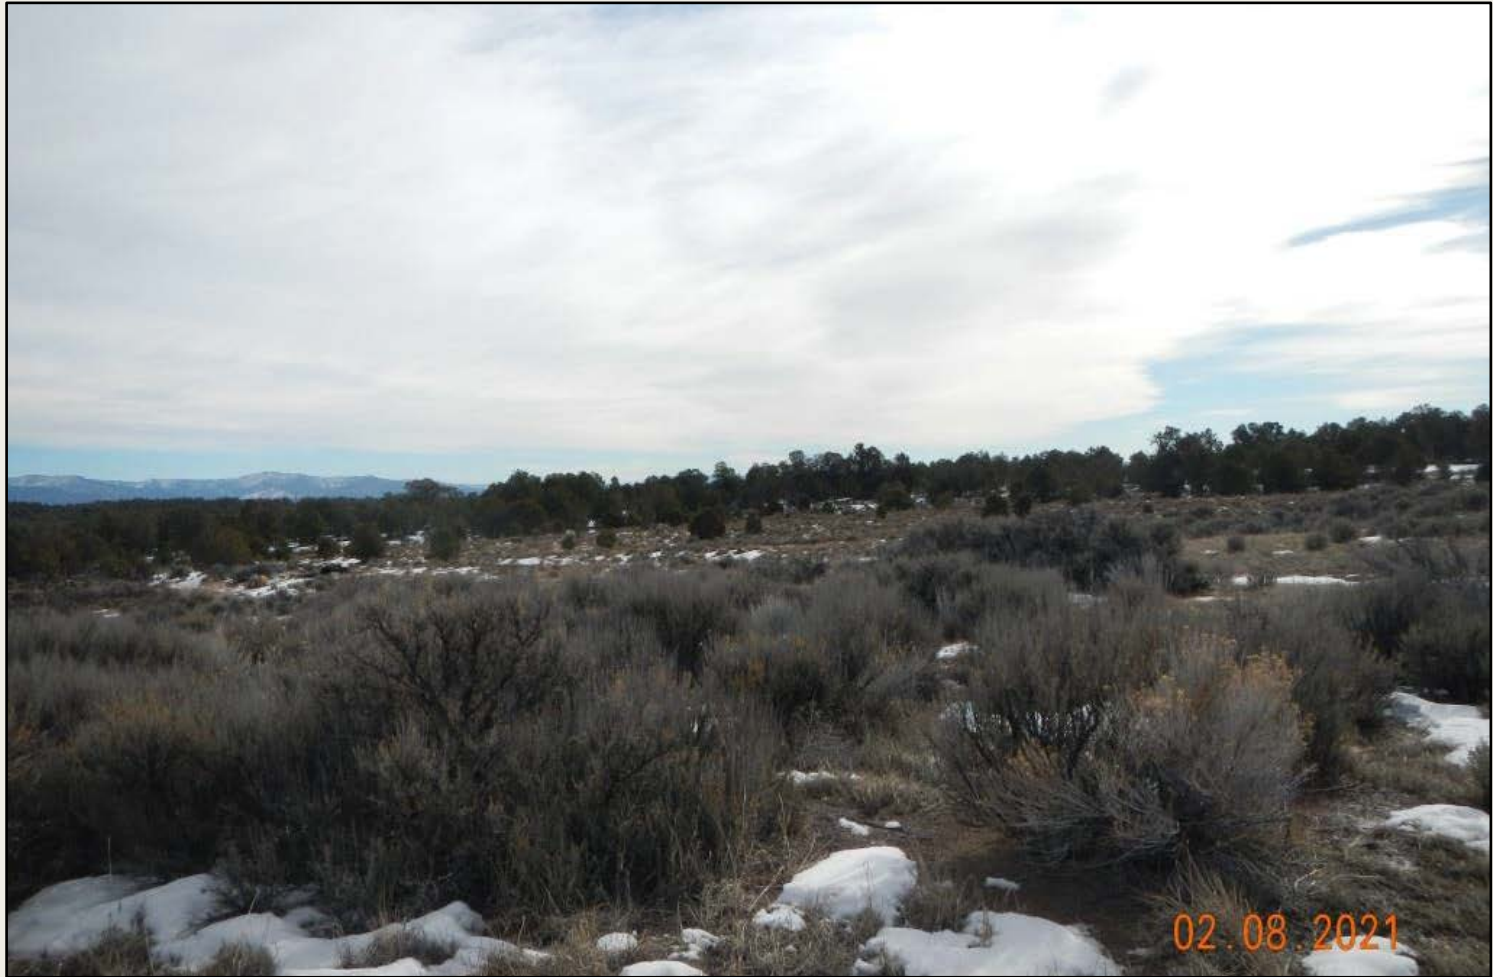
Photo 4. View of the reference area comprised of sagebrush shrubland with understory of grasses and forbs such as western wheatgrass, sand dropseed, and James galleta.
