Inspection Photos

Operator: Logos

API: 067-06249

Date: 2/8/2021

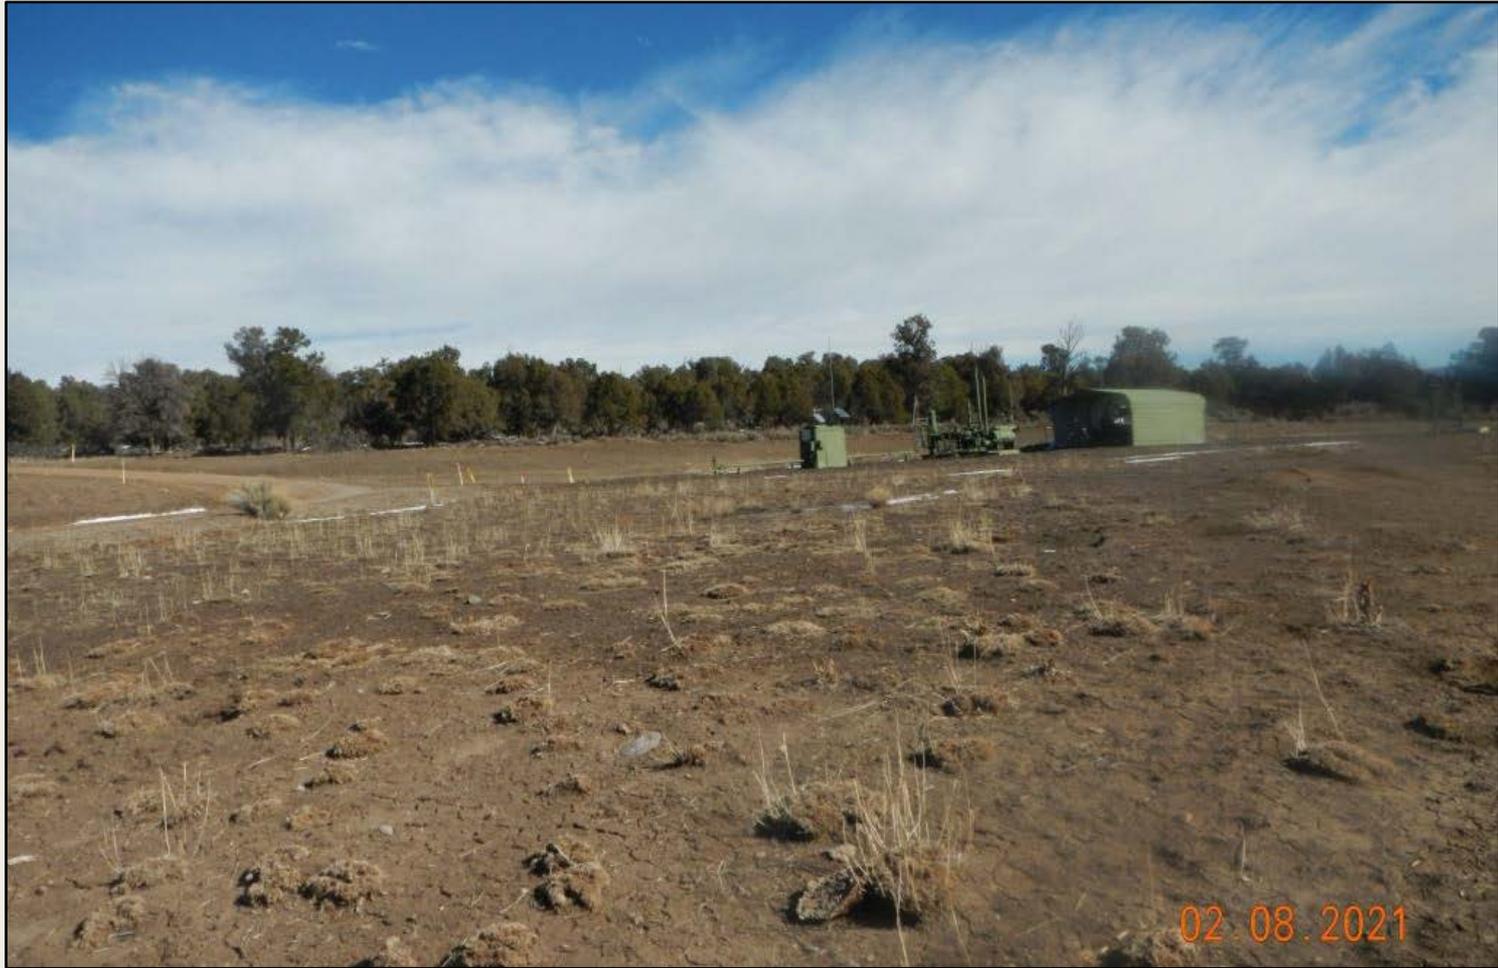
Photo 1. View of the project area from the southwestern corner facing center. Vegetation on the well pad is in a grazed/dormant condition.

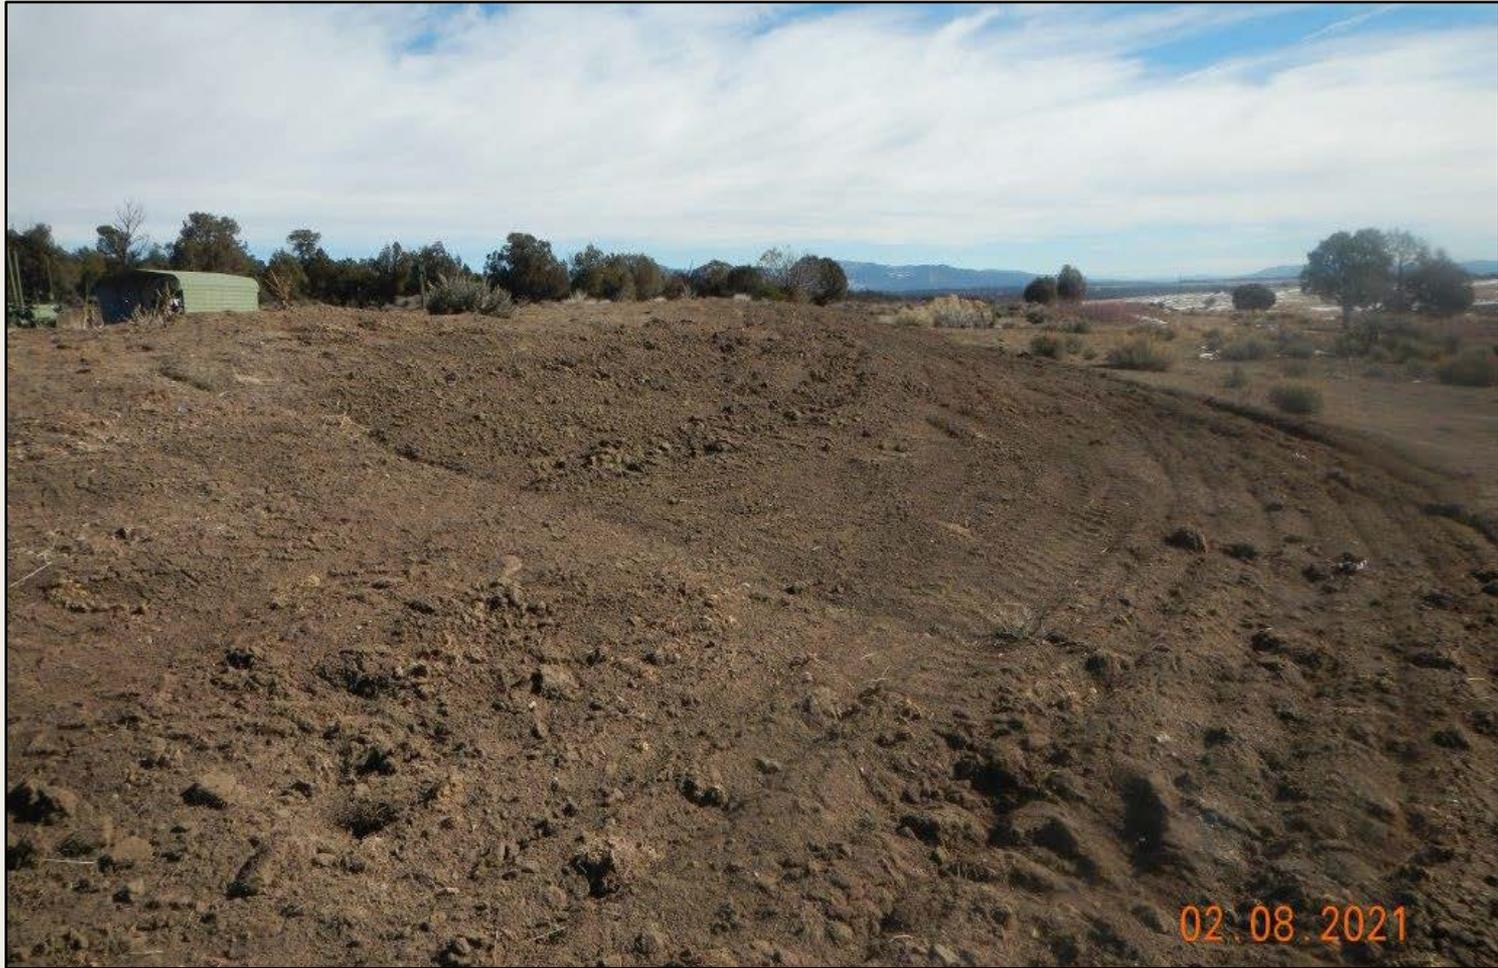
Photo 2. View of the southern fill slope from the southwestern corner facing eastward. Revegetation is conducted. Slopes are tracked. Mulching is not present. Revegetation needs to be monitored. Cattle exclusion is recommended.

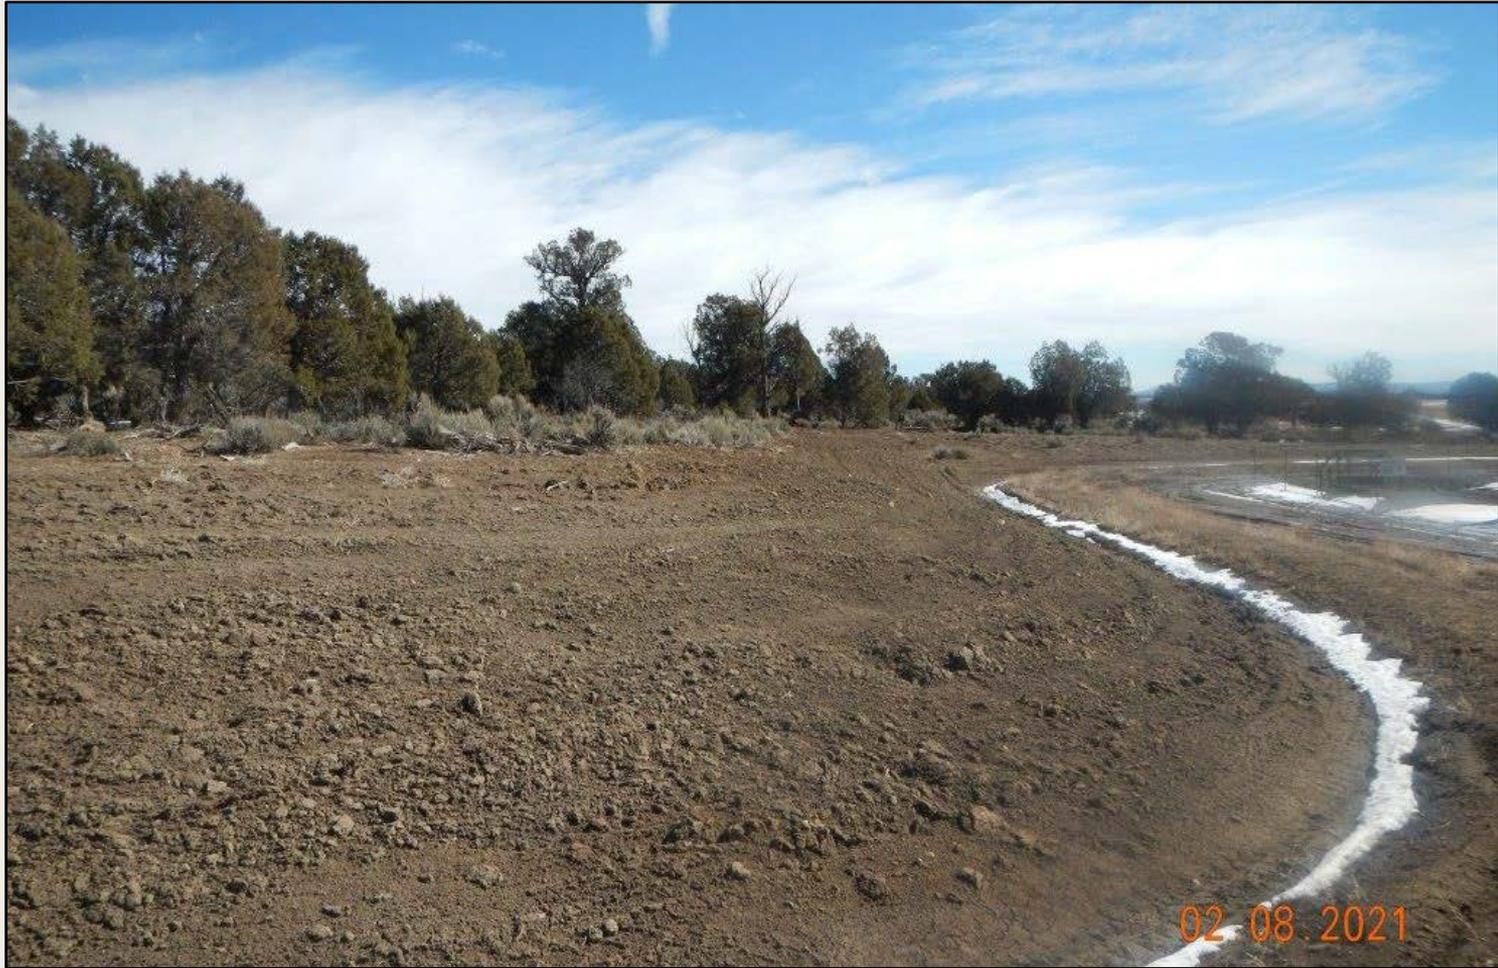
Photo 3. View of the northern cut slope from the northwestern corner facing eastward.

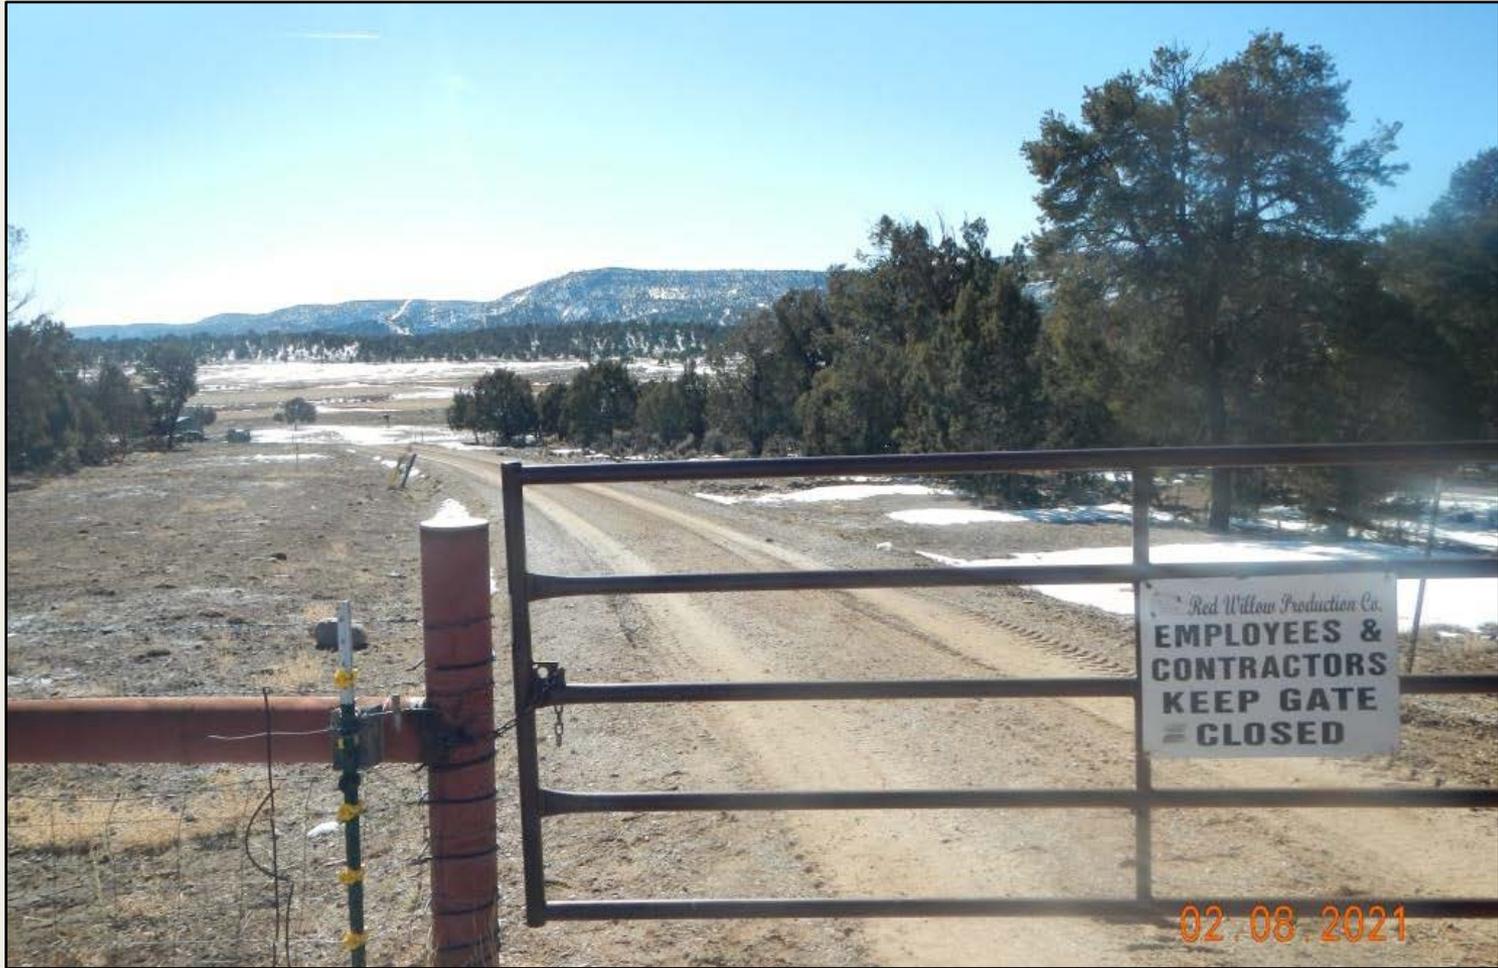
Photo 4. View of closed gate after leaving location.

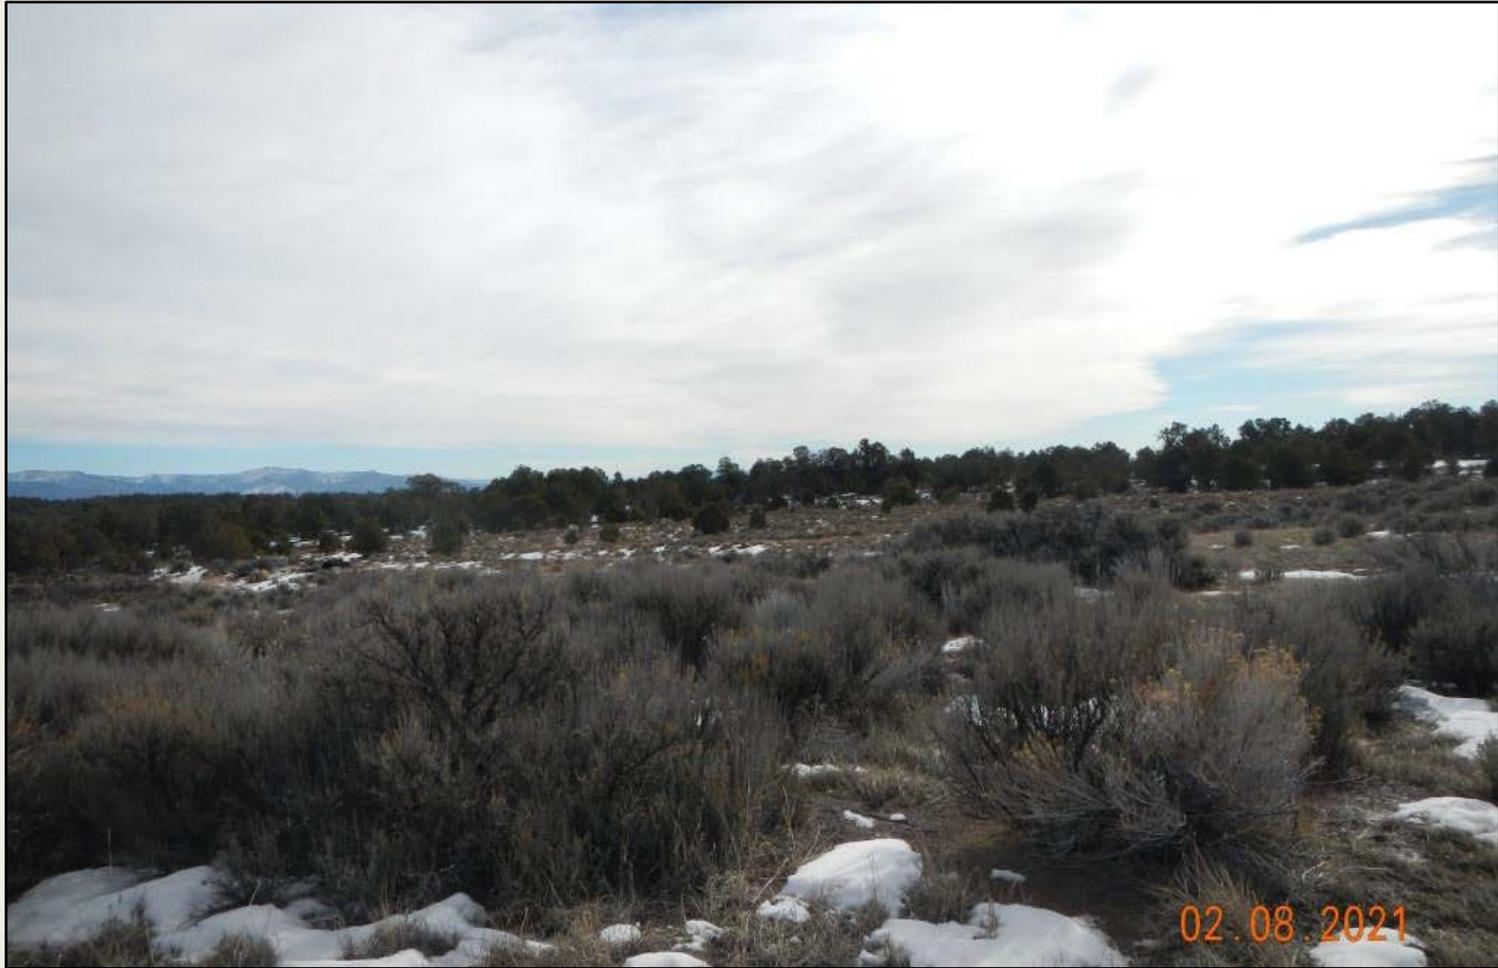
Photo 5. View of the reference area comprised of sagebrush shrubland with understory of grasses and forbs such as western wheatgrass, sand dropseed, and James galleta.
