**COLORADO**  
Oil & Gas Conservation  
Commission  
Department of Natural Resources

**Tranco 5A     API: 05-103-05320**  
**Inspection: 700405325**

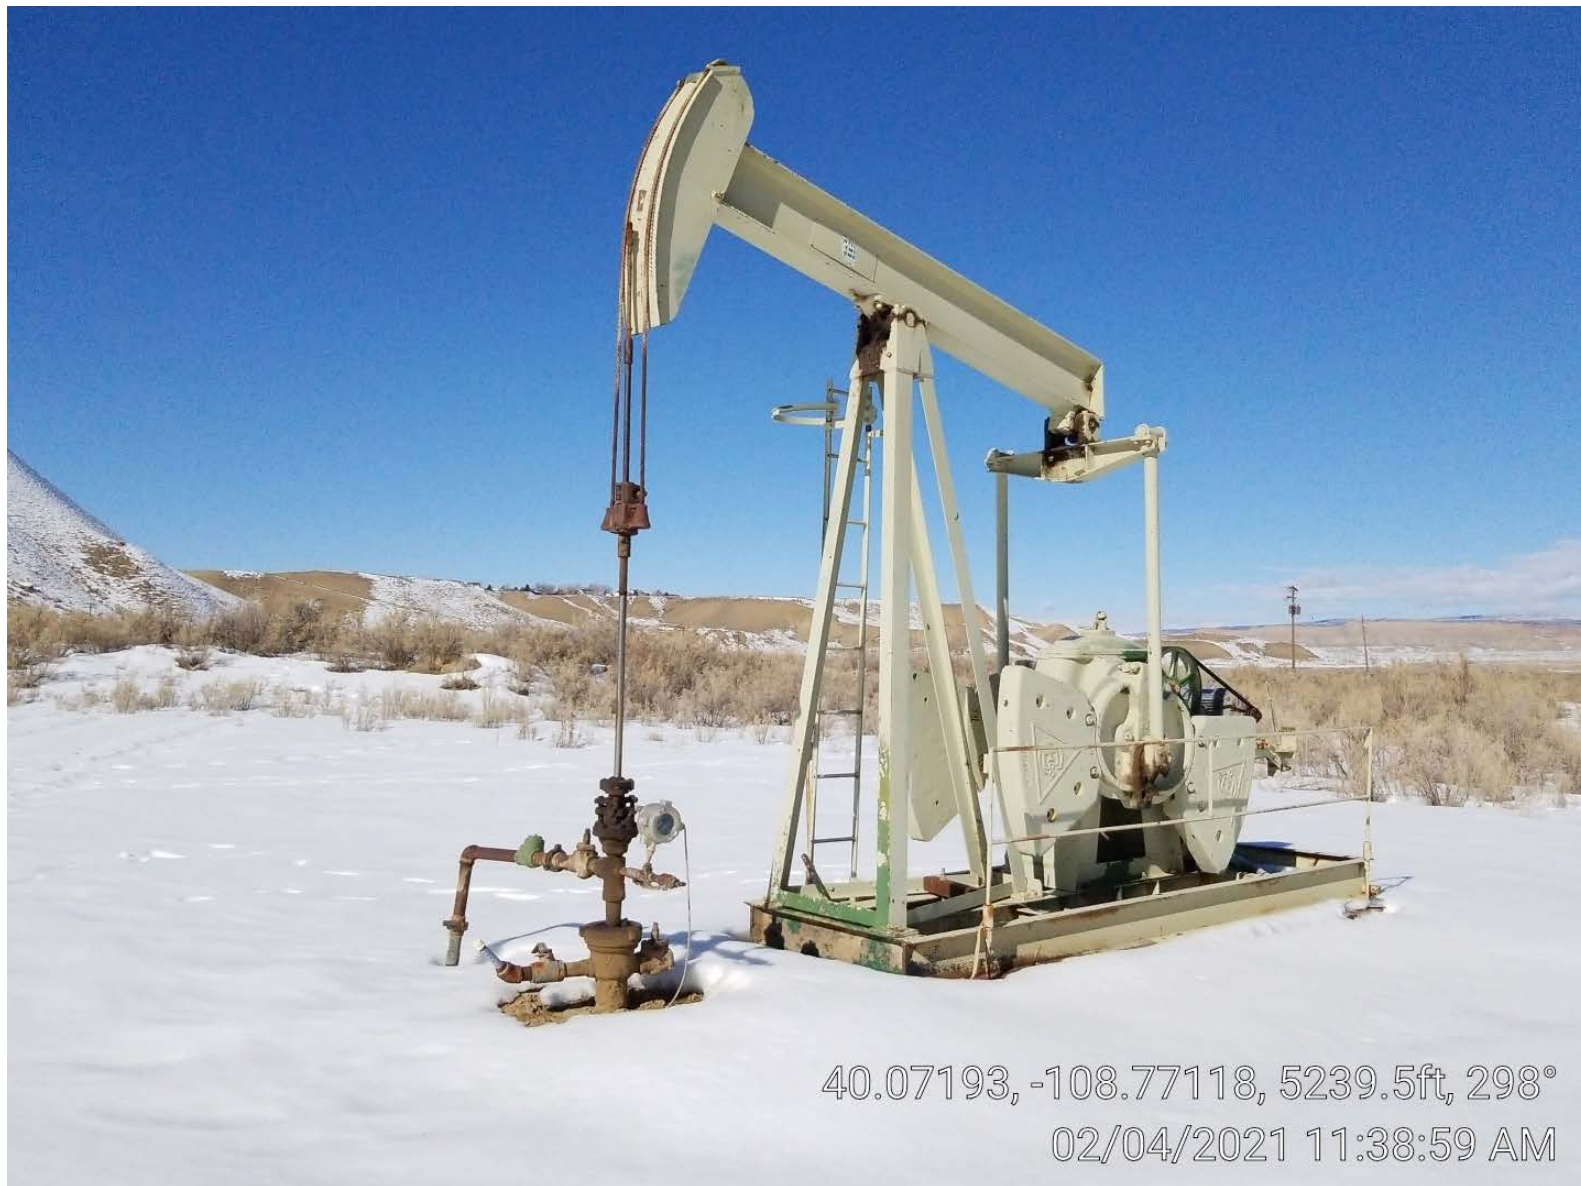
**Photo 1. Pump jack.**

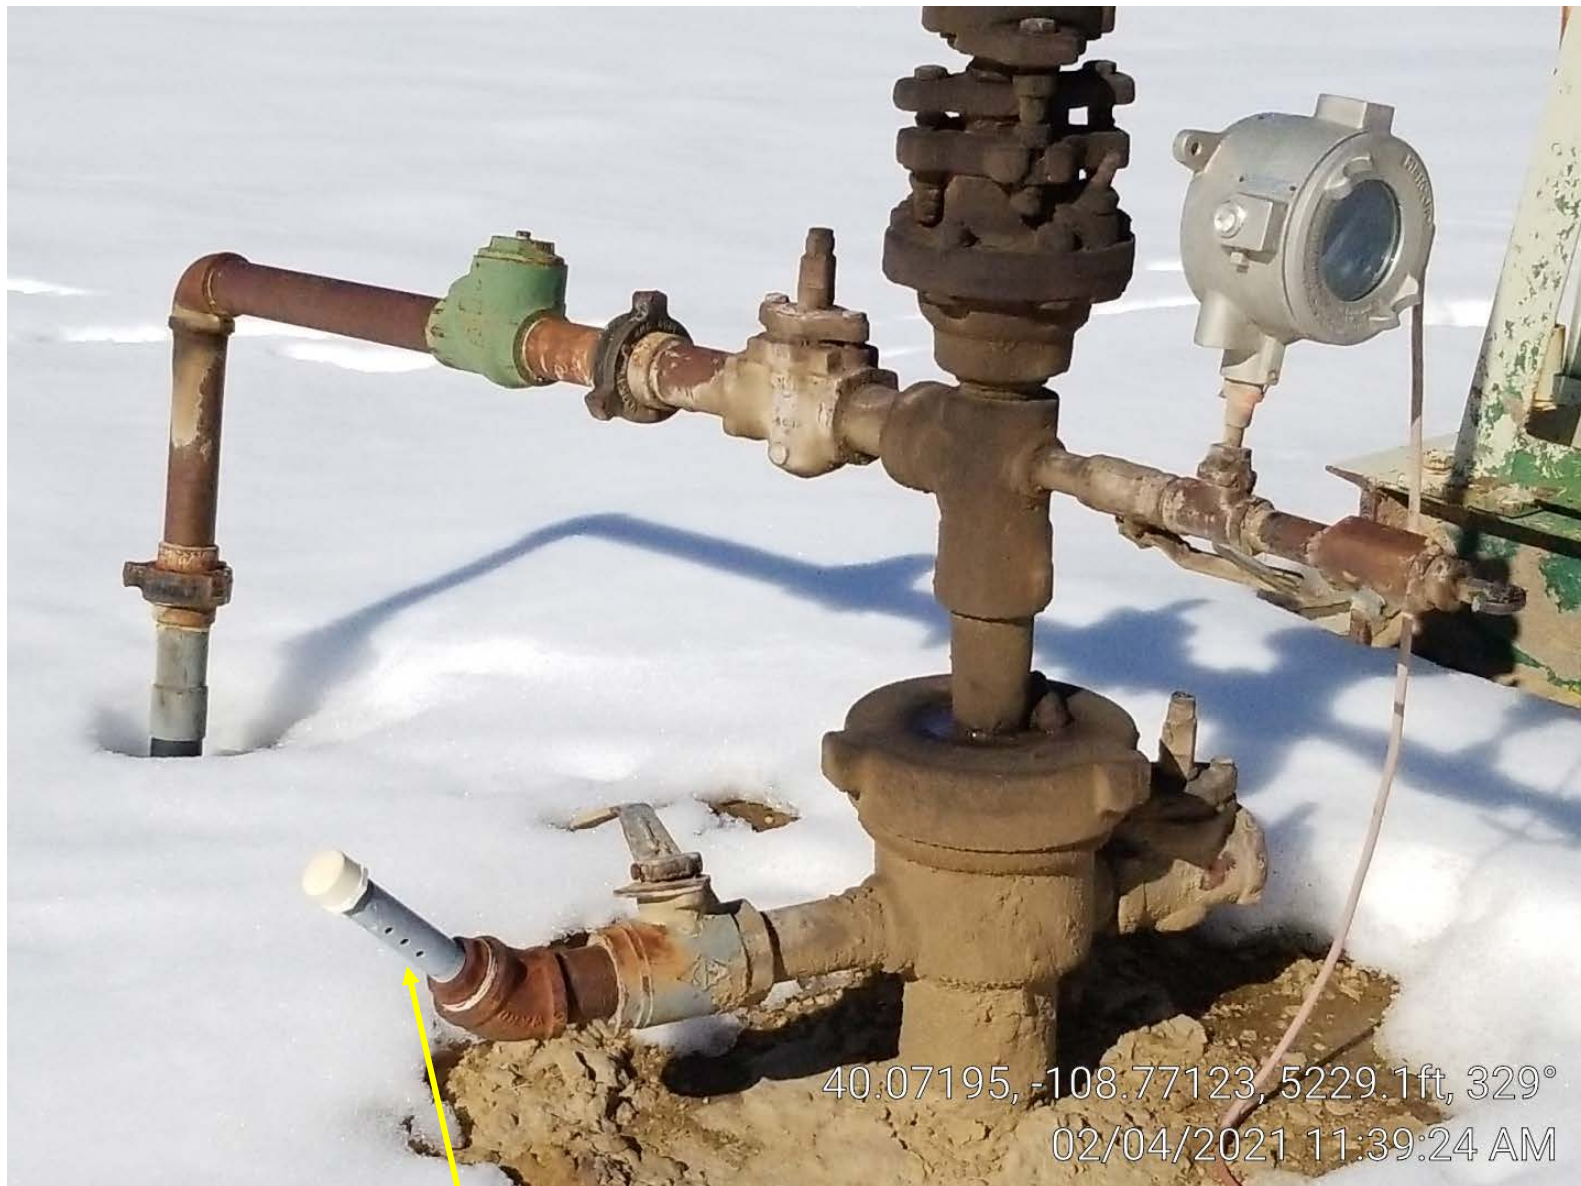
**Photo 2. Well with gas leak.**

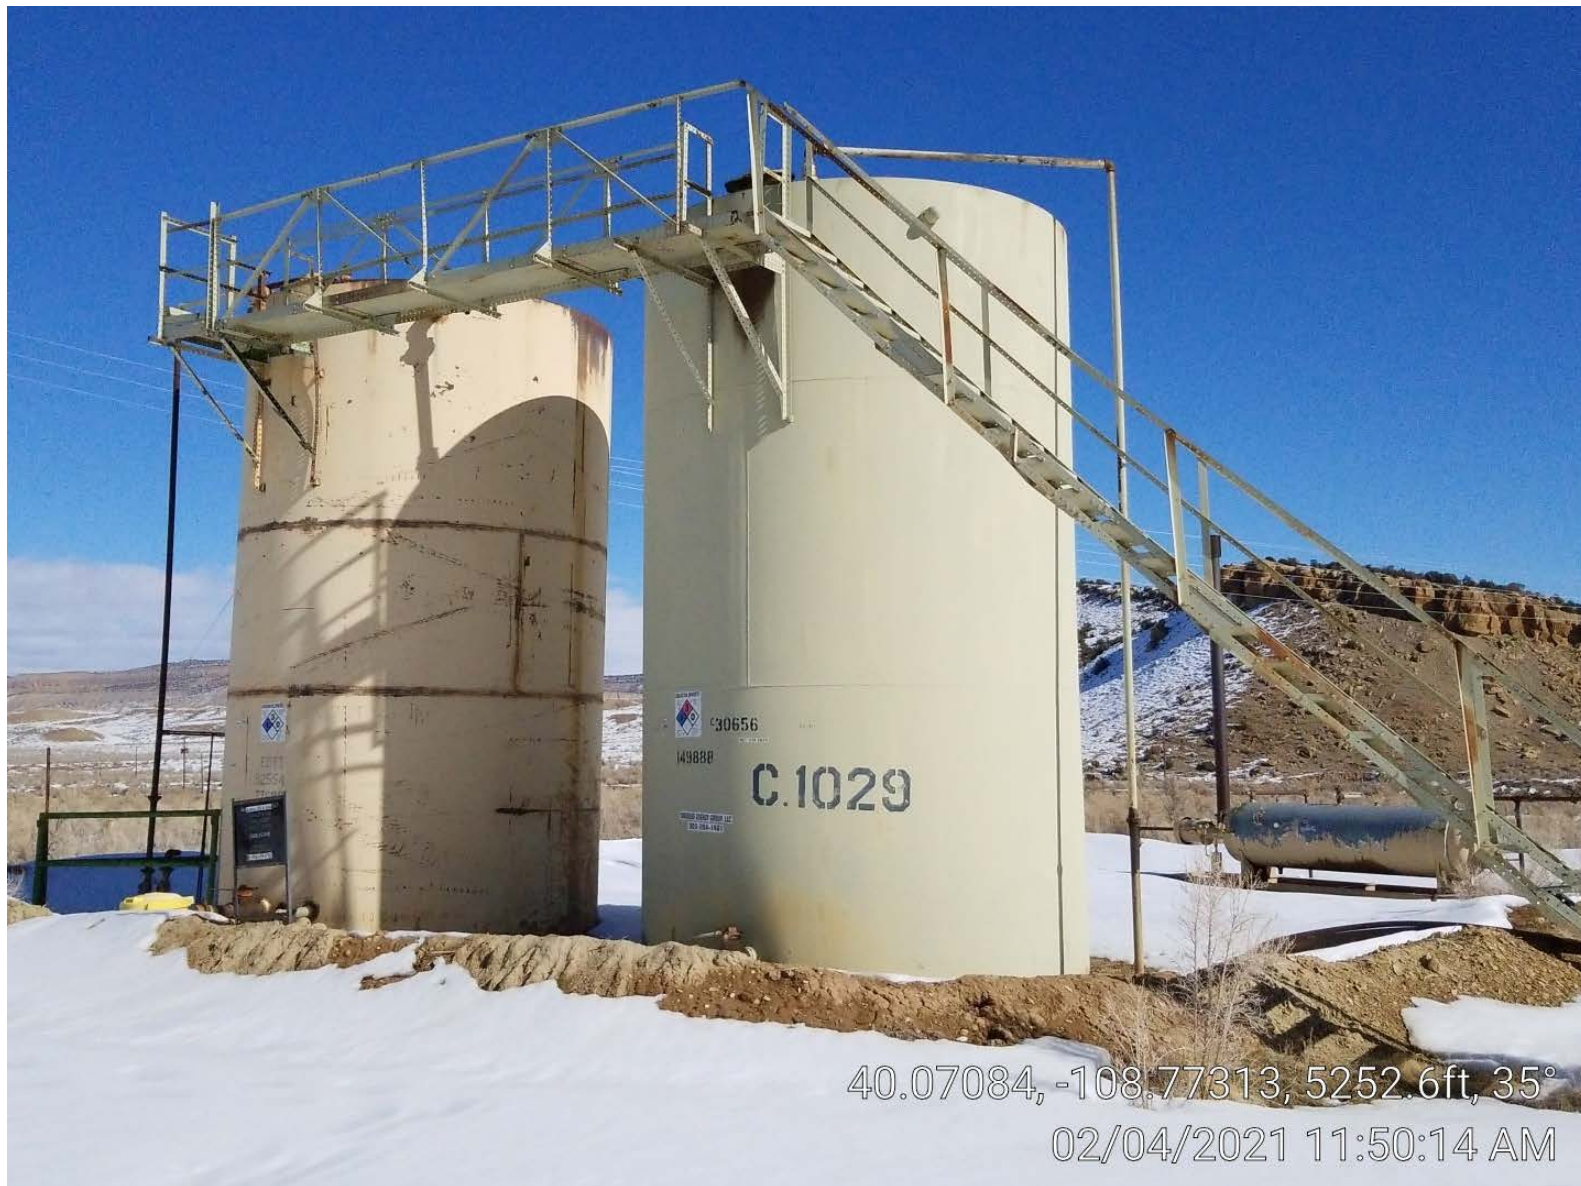
**Photo 4. Tanks.**
