Inspection Photos

API: 071-08925

Operator: EVERGREEN NATURAL RESOURCES

Inspection Date: 2/12/2021

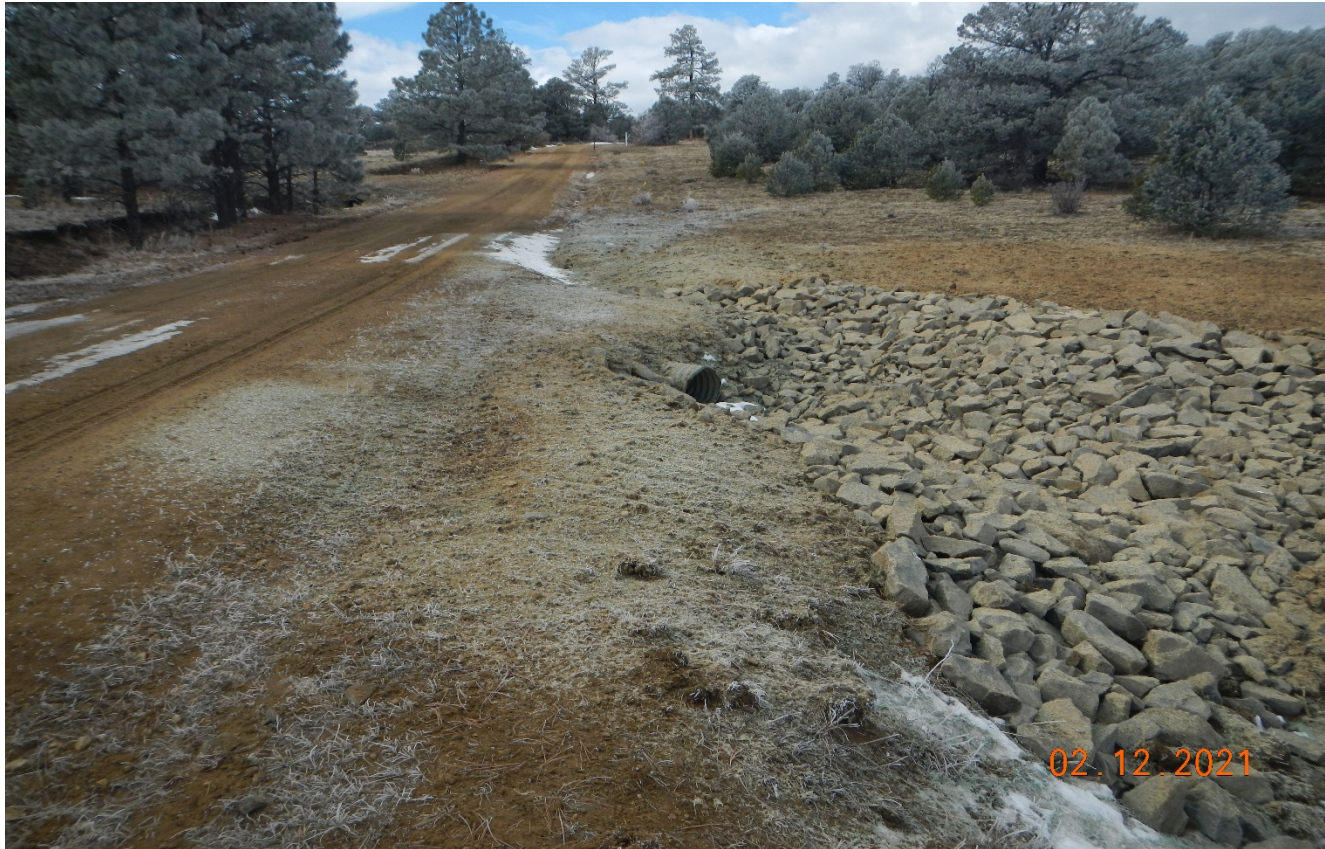
Photo 1. Facing west along the access road. Outlet protection was installed at the culvert. Rock rip/rap is installed where gully erosion was identified.

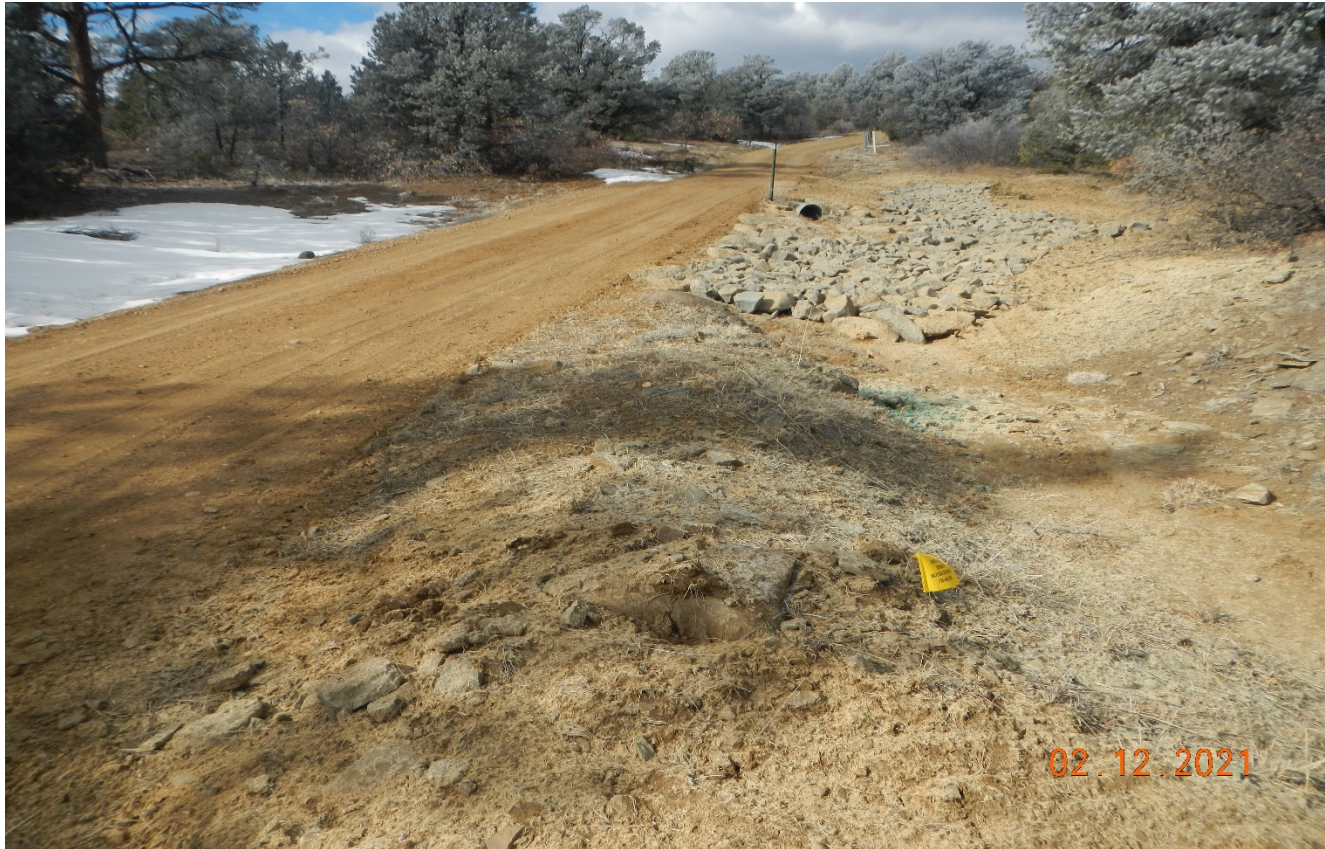
Photo 2. Facing west along the access road. Outlet protection was installed at the culvert.

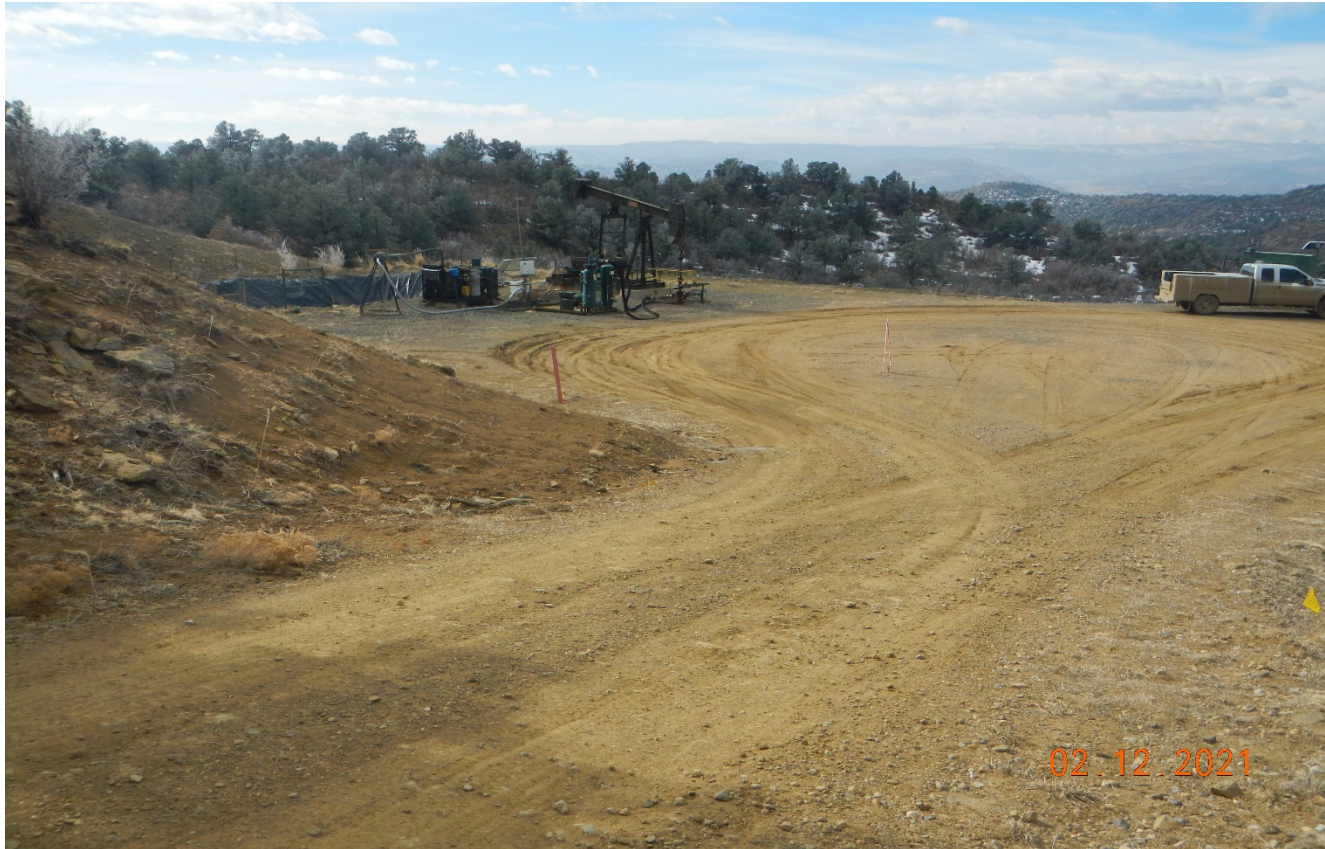
Photo 3. Facing southwest toward the location.
