Inspection Photos
Operator: Simcoe
API: 067-09354
Date: 2/11/2021

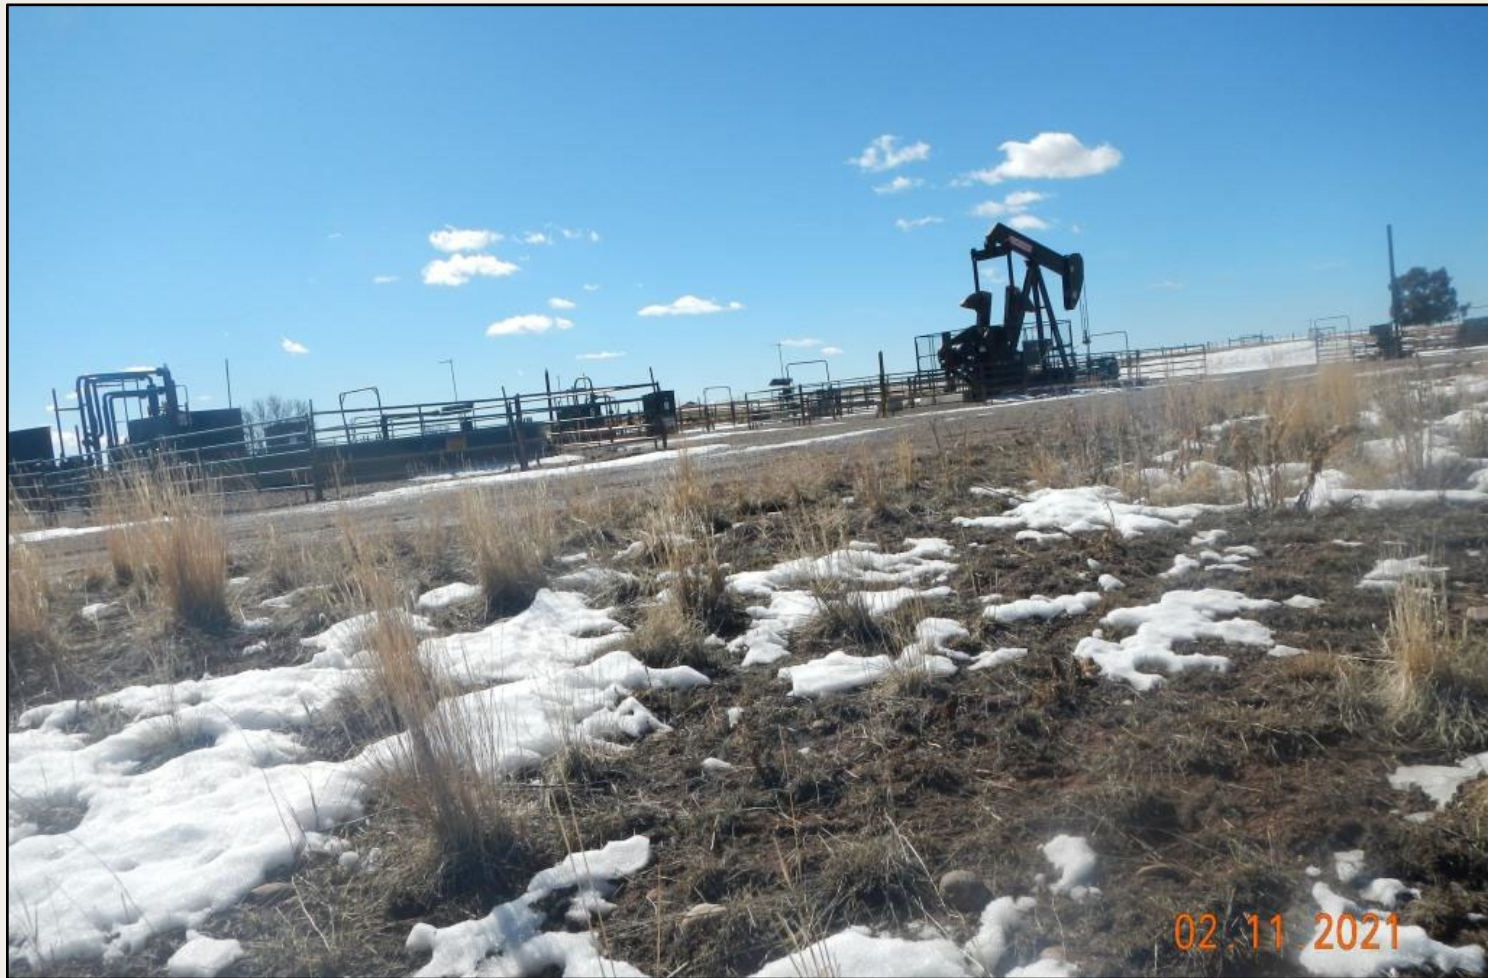
Photo 1. View of the project area from the southeastern corner facing center.

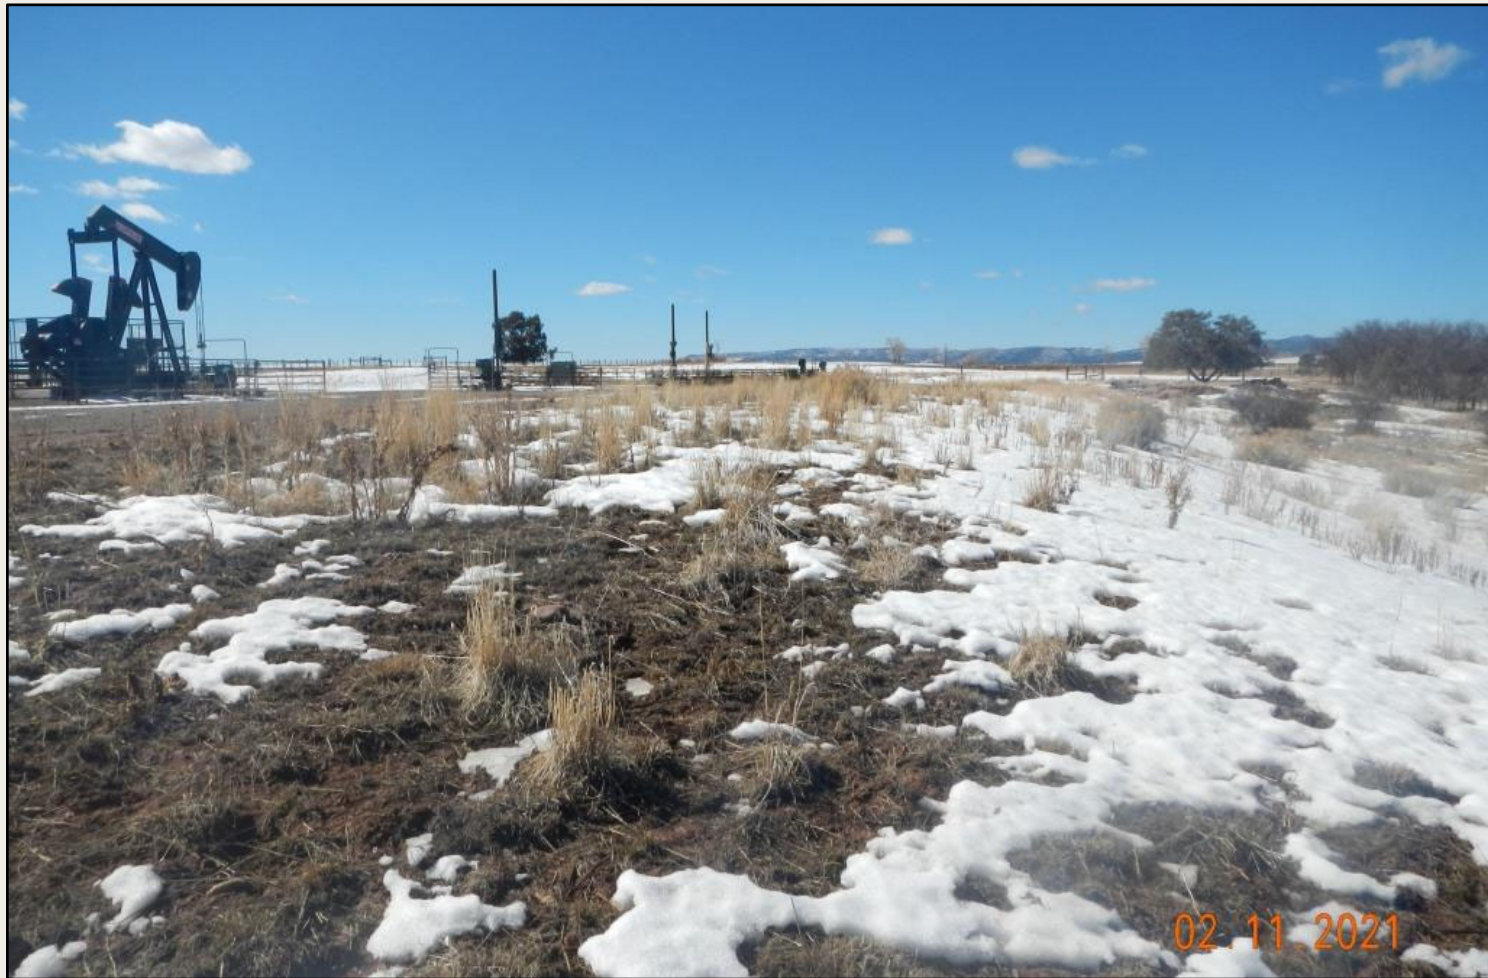
Photo 2. View of the northern fill slope from the northeastern corner facing westward. Revegetation appears to be progressing with crested wheatgrass observable.

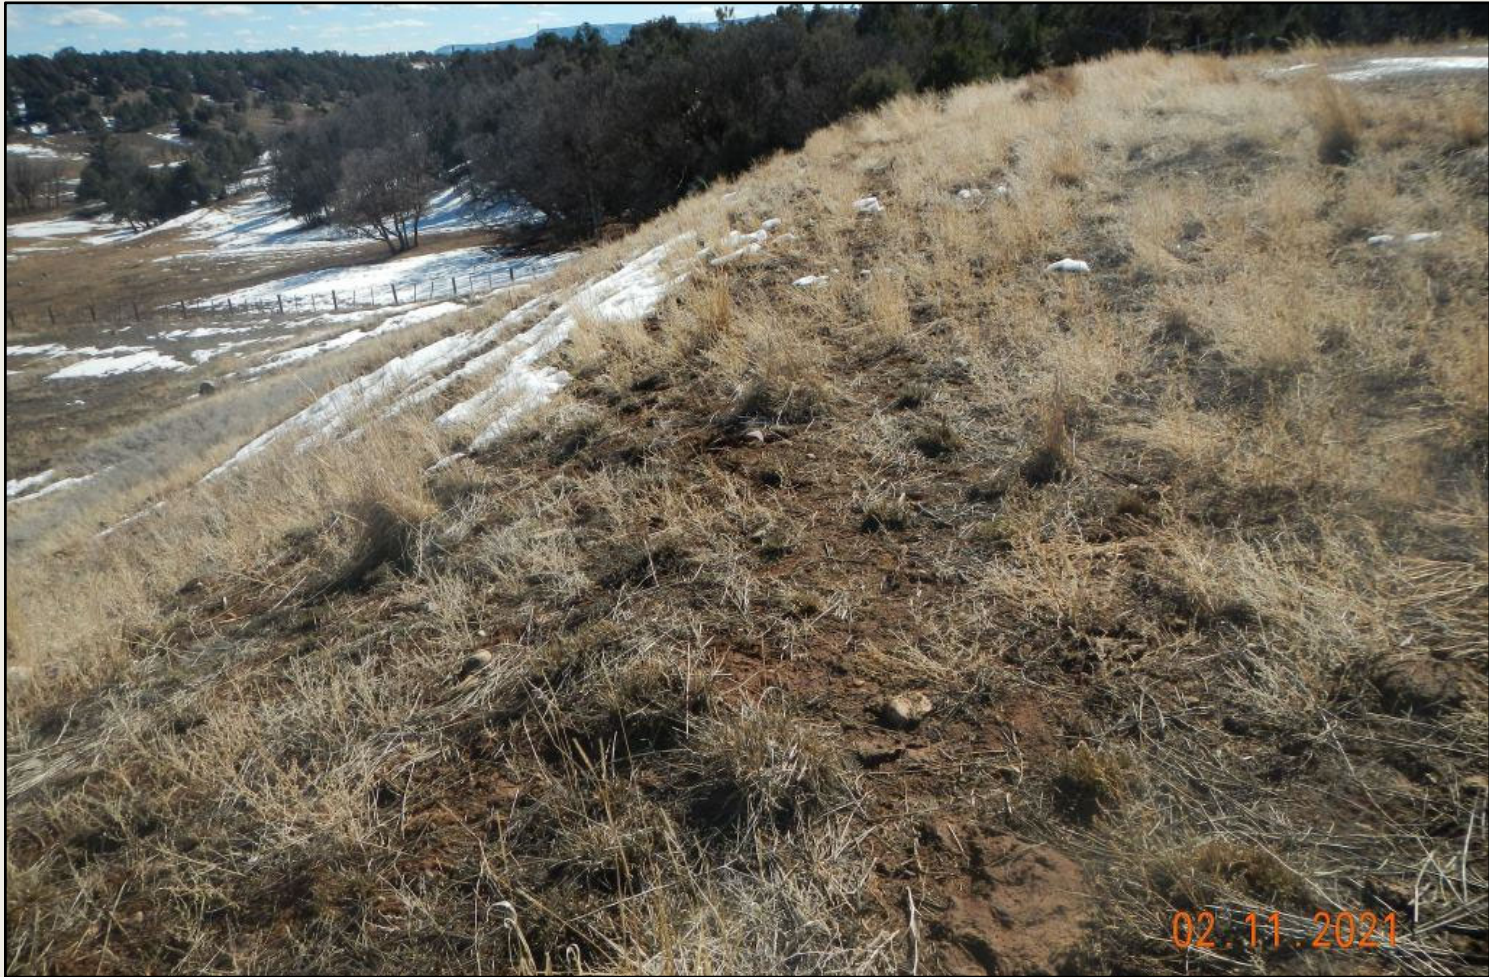
Photos 3. View of the eastern project area from the northeastern corner facing southward.

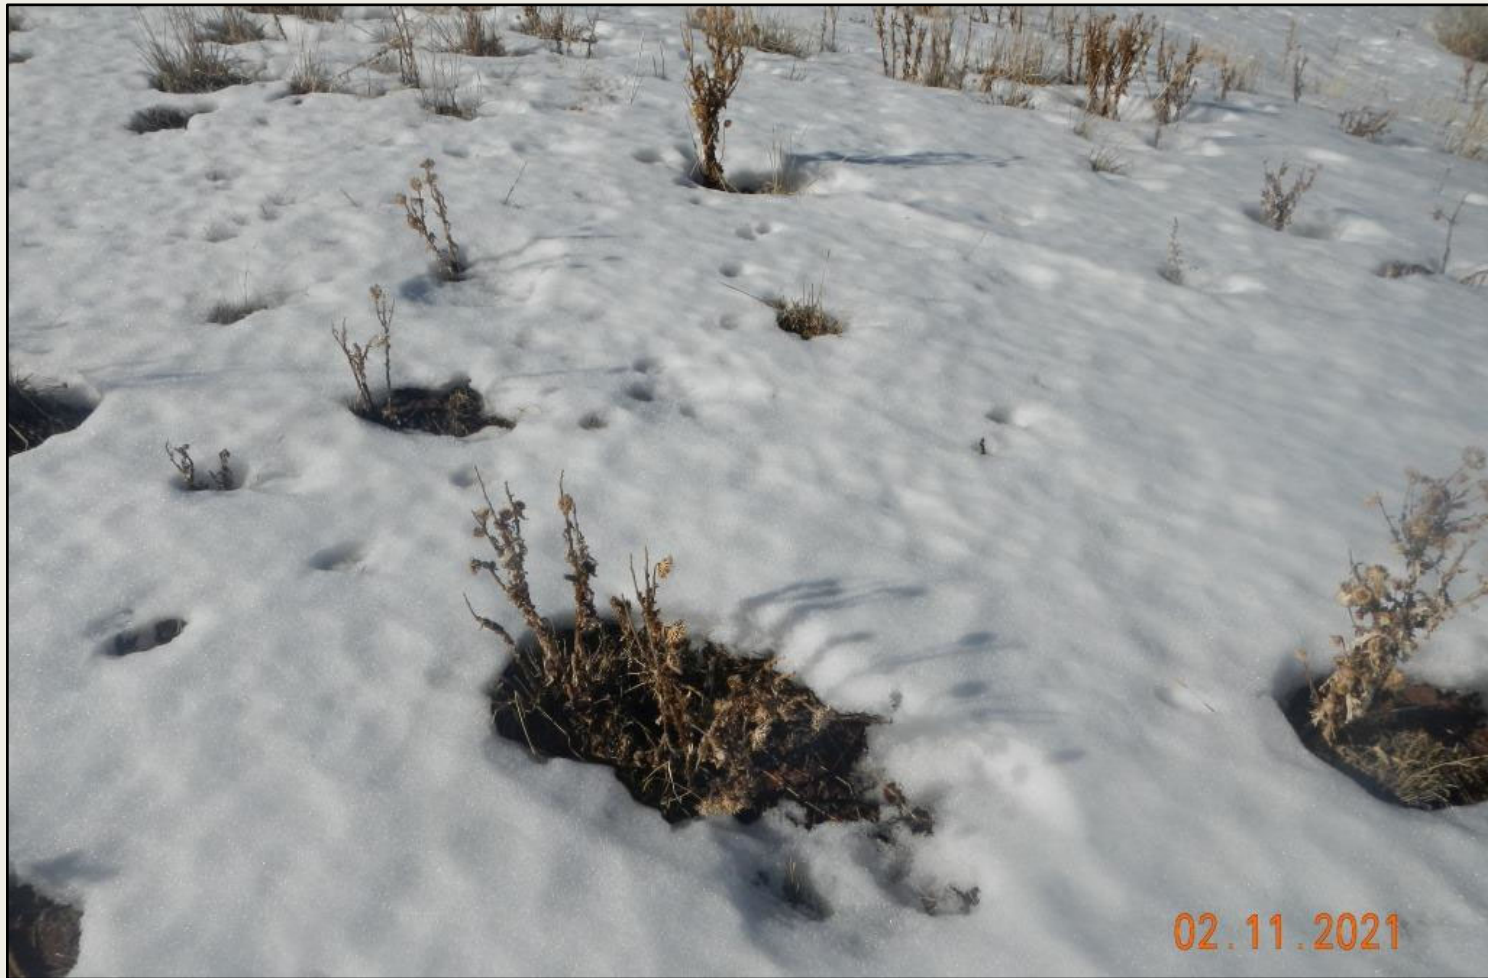
Photo 4 View of musk thistles within the interim reclamation area. Approximately 1000 individuals observed.

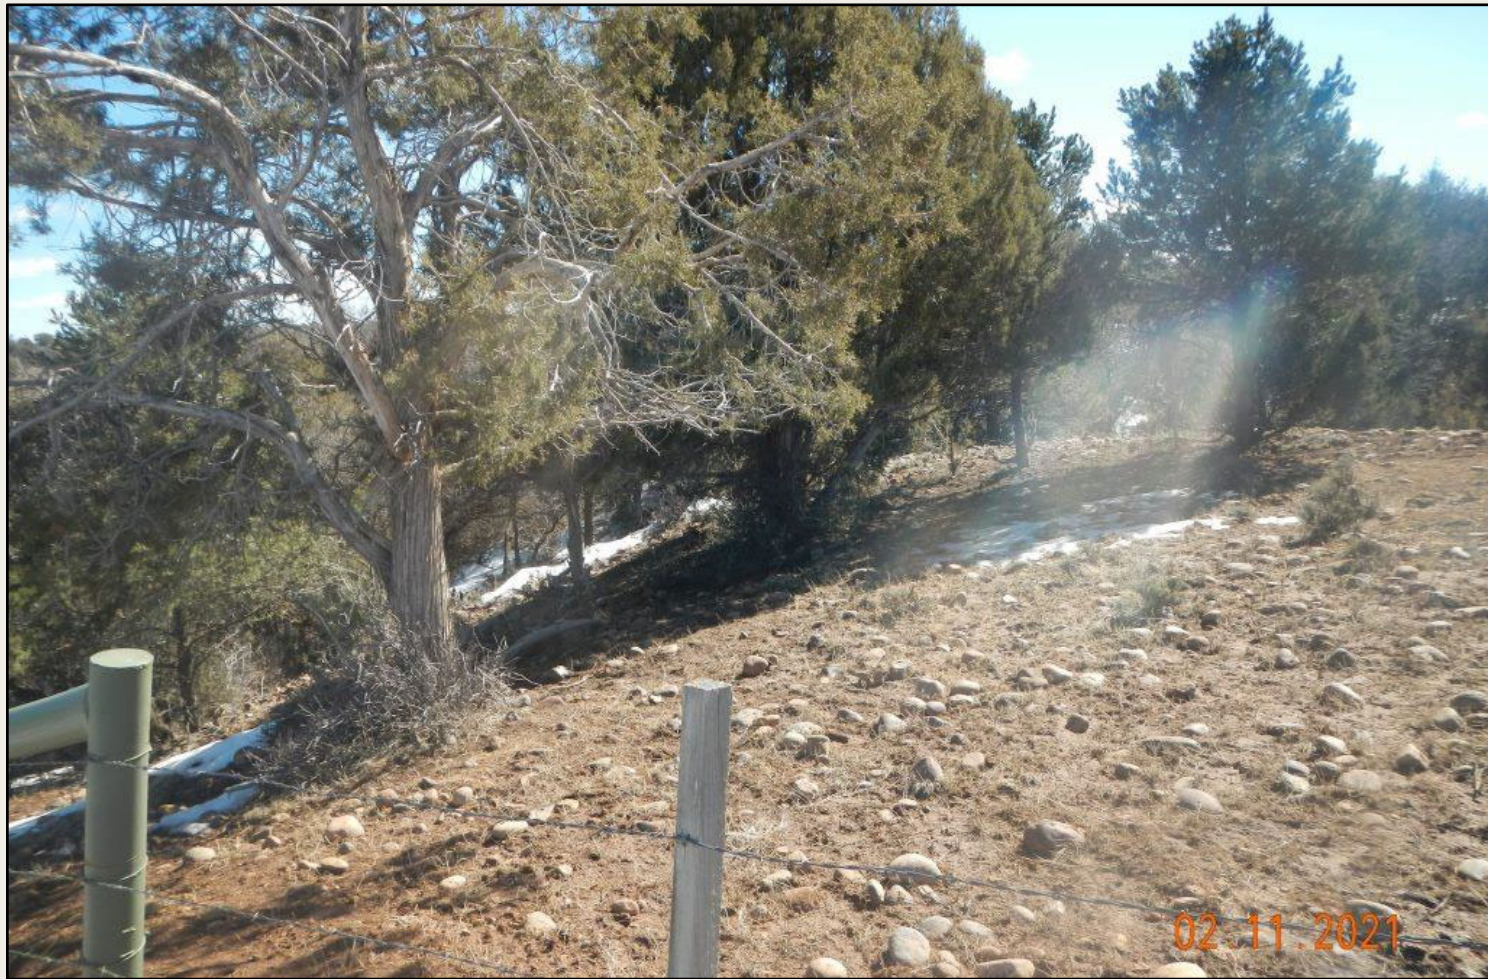
Photo 5. View of the reference area comprised of pinyon/juniper woodland with understory of sagebrush, antelope bitterbrush, gambel oak, and blue grama.
