Inspection Photos
Operator: Simcoe
API: 067-07186
Date: 2/11/2021

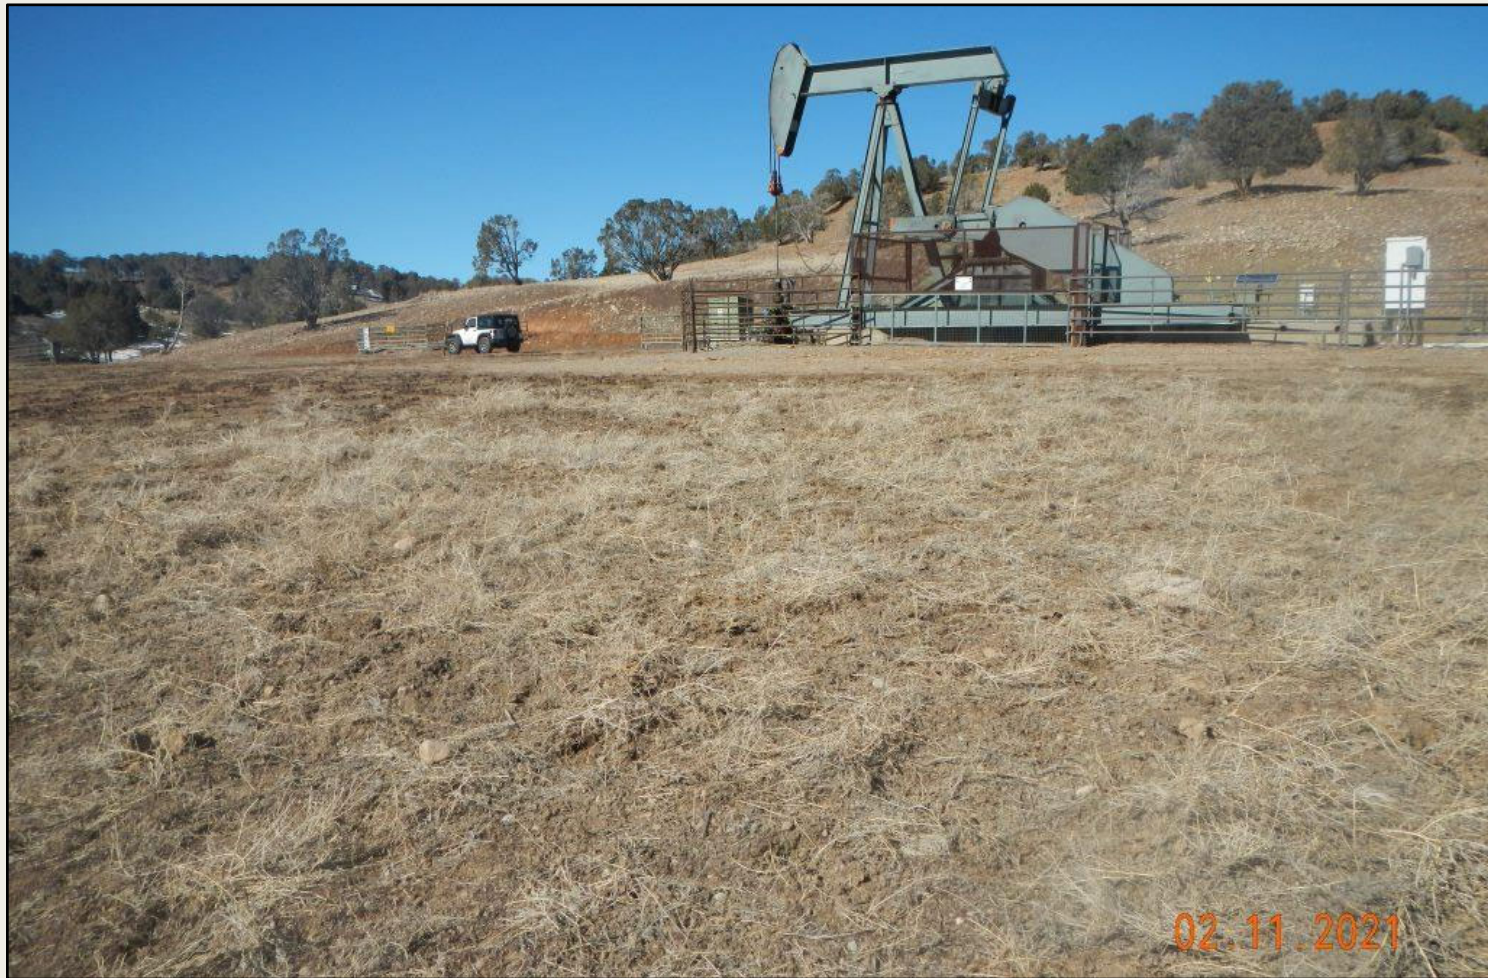
Photo 1. View of the project area from the southeastern corner facing center.

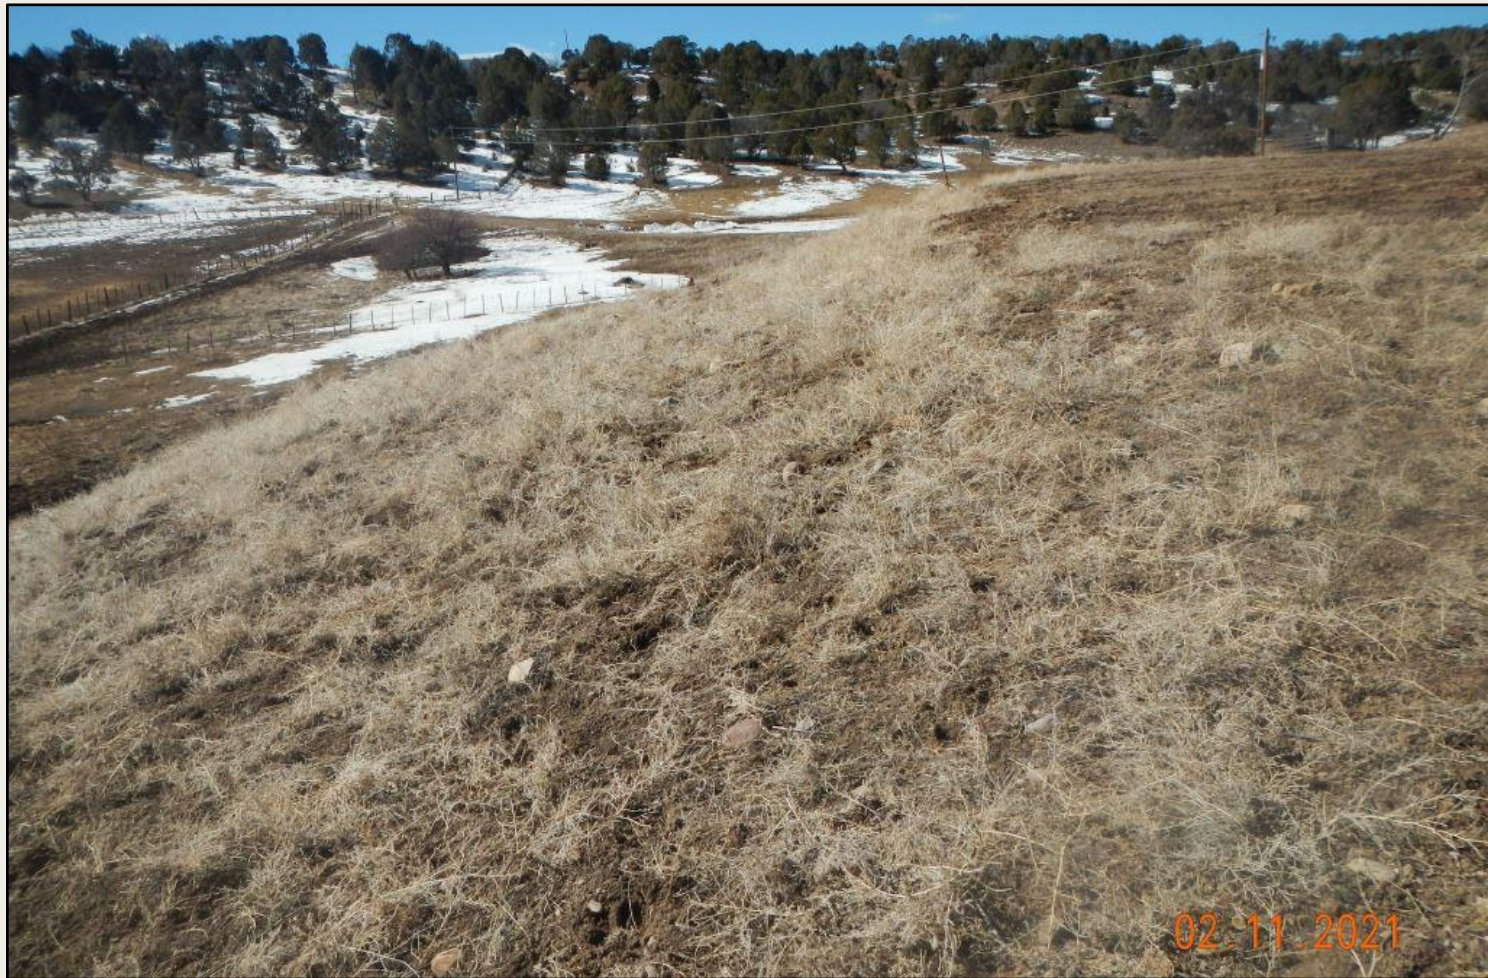
Photo 2. View of the southern fill slope from the southeastern corner facing westward. Vegetation is in a grazed and dormant condition at this time.

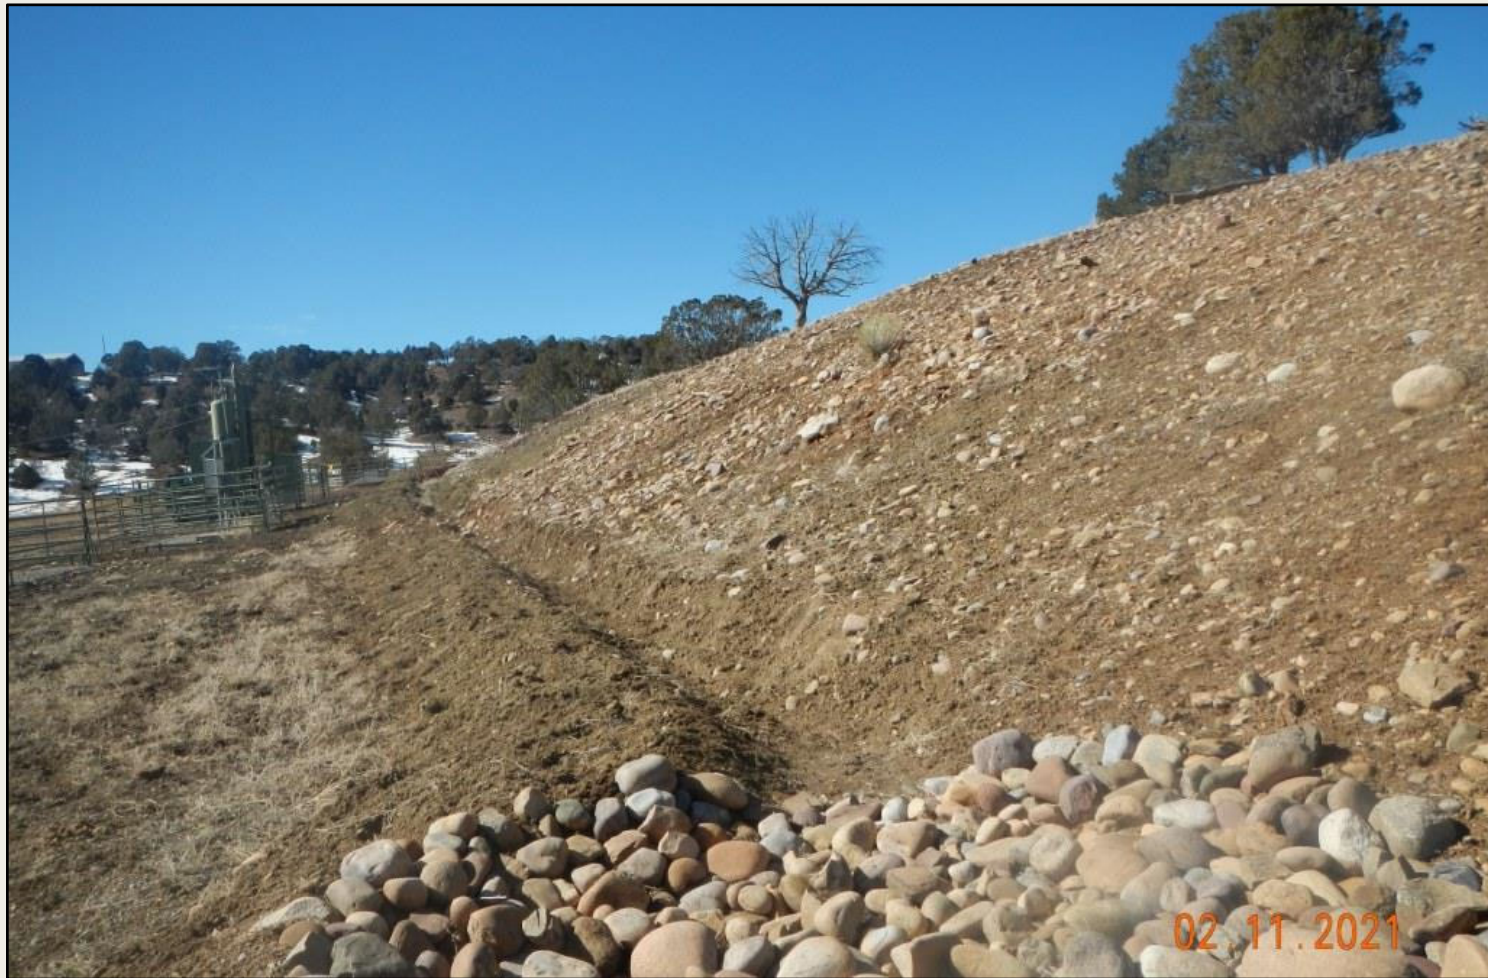
Photos 3. View of the northern project area from the northeastern corner facing westward.
