Inspection Photos
Operator: Simcoe
API: 067-09467
Date: 2/11/2021

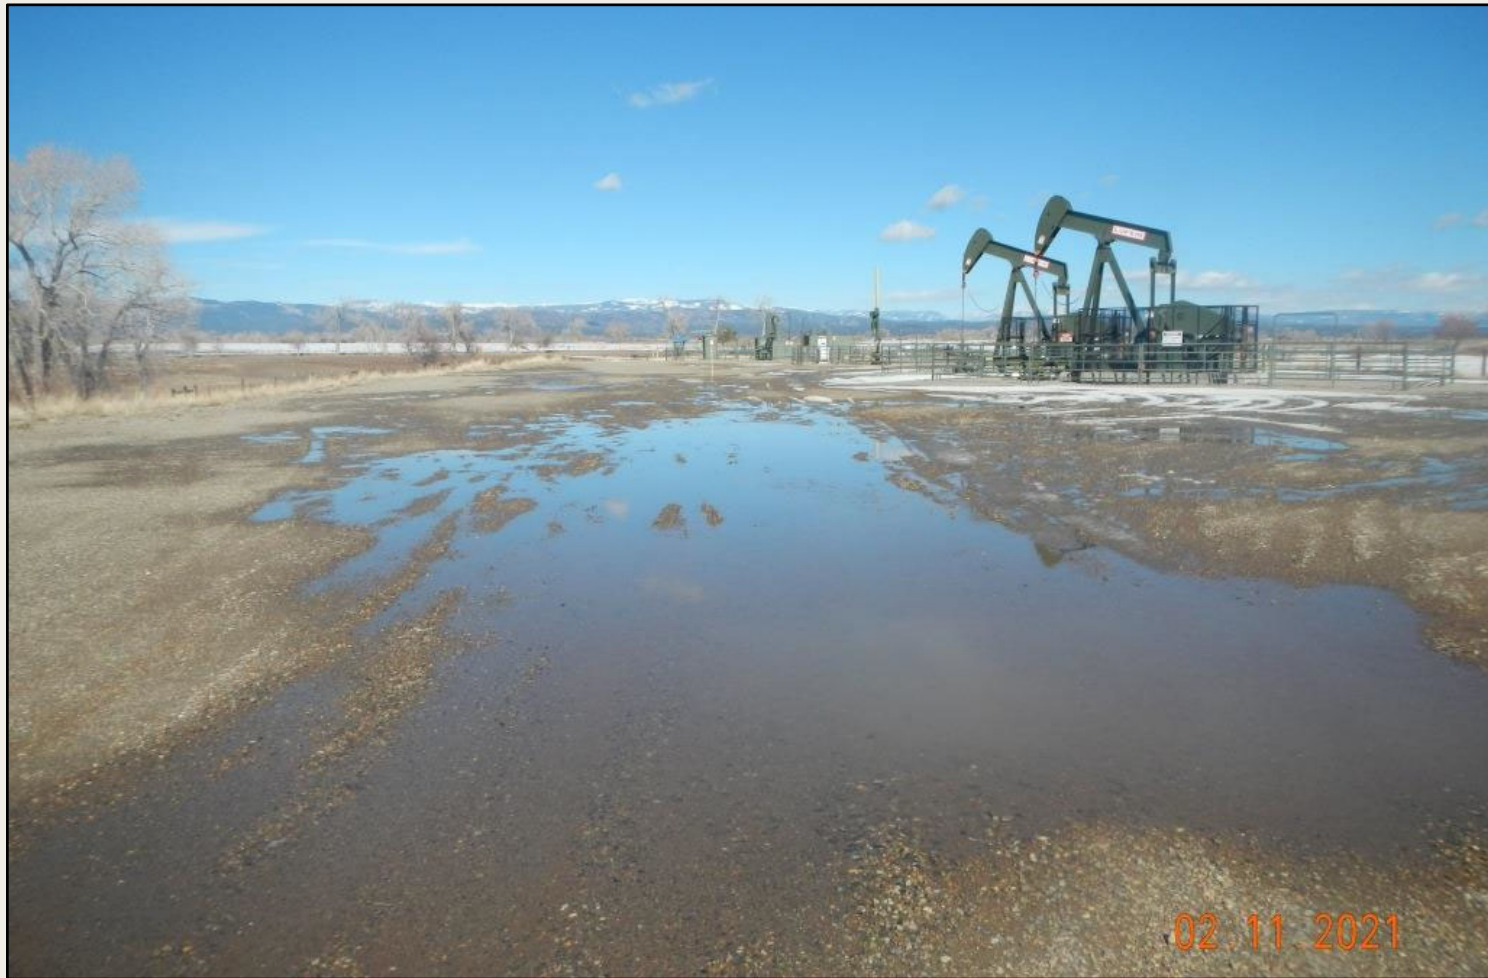
Photo 1. View of the project area from the well pad entrance facing center.

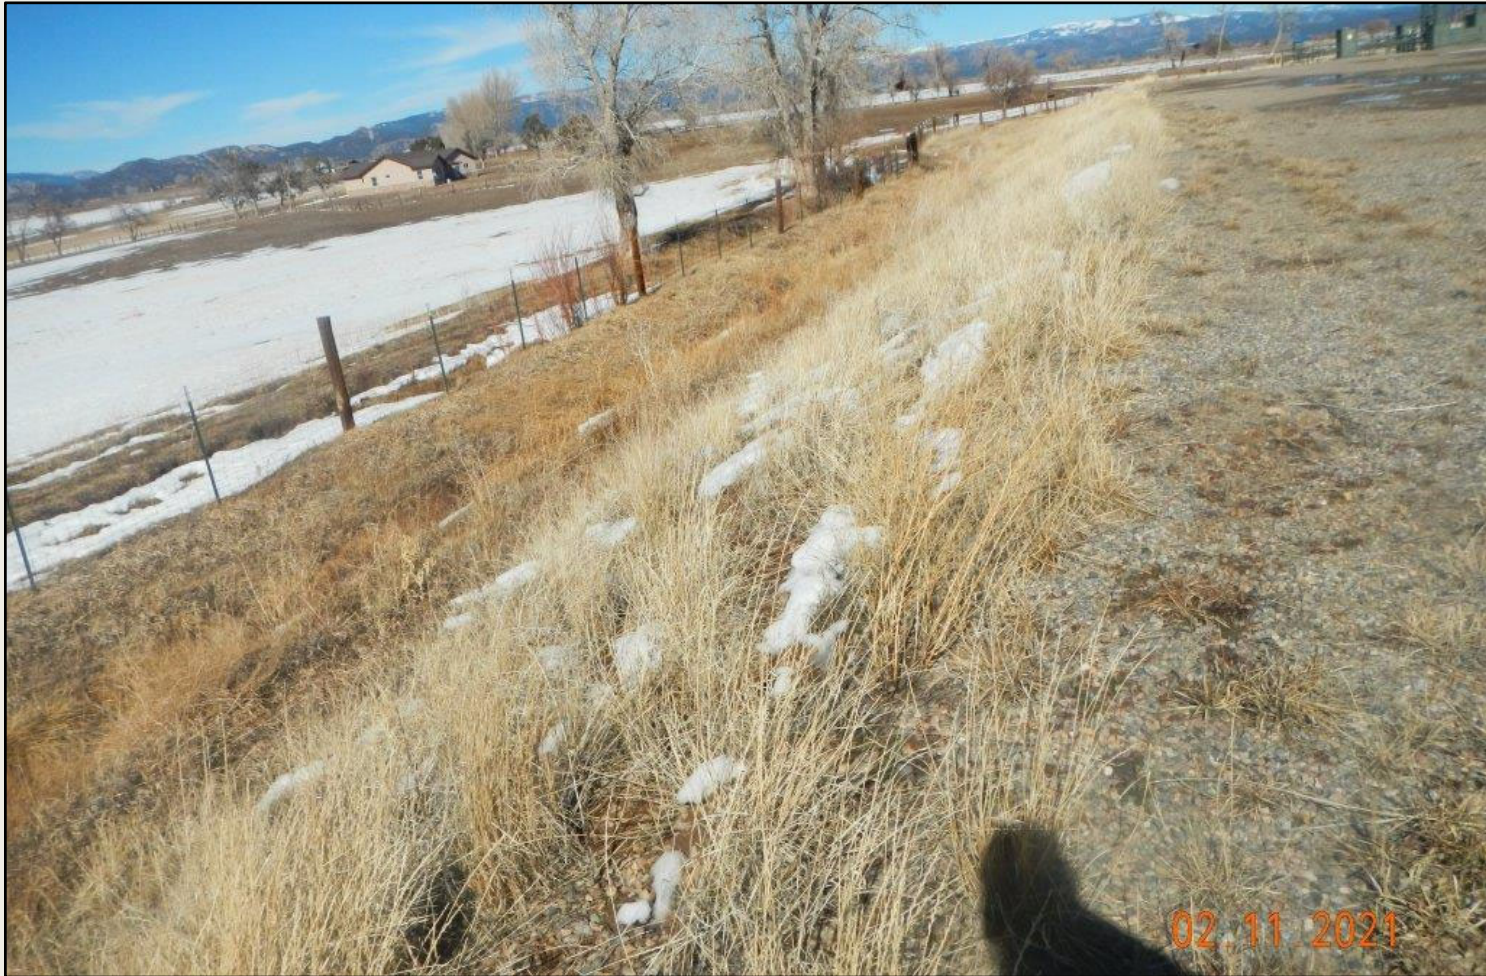
Photo 2. View of the western fill slope from the southwestern corner facing northward. Revegetation is progressing with crested wheatgrass, smooth brome, and western wheatgrass.

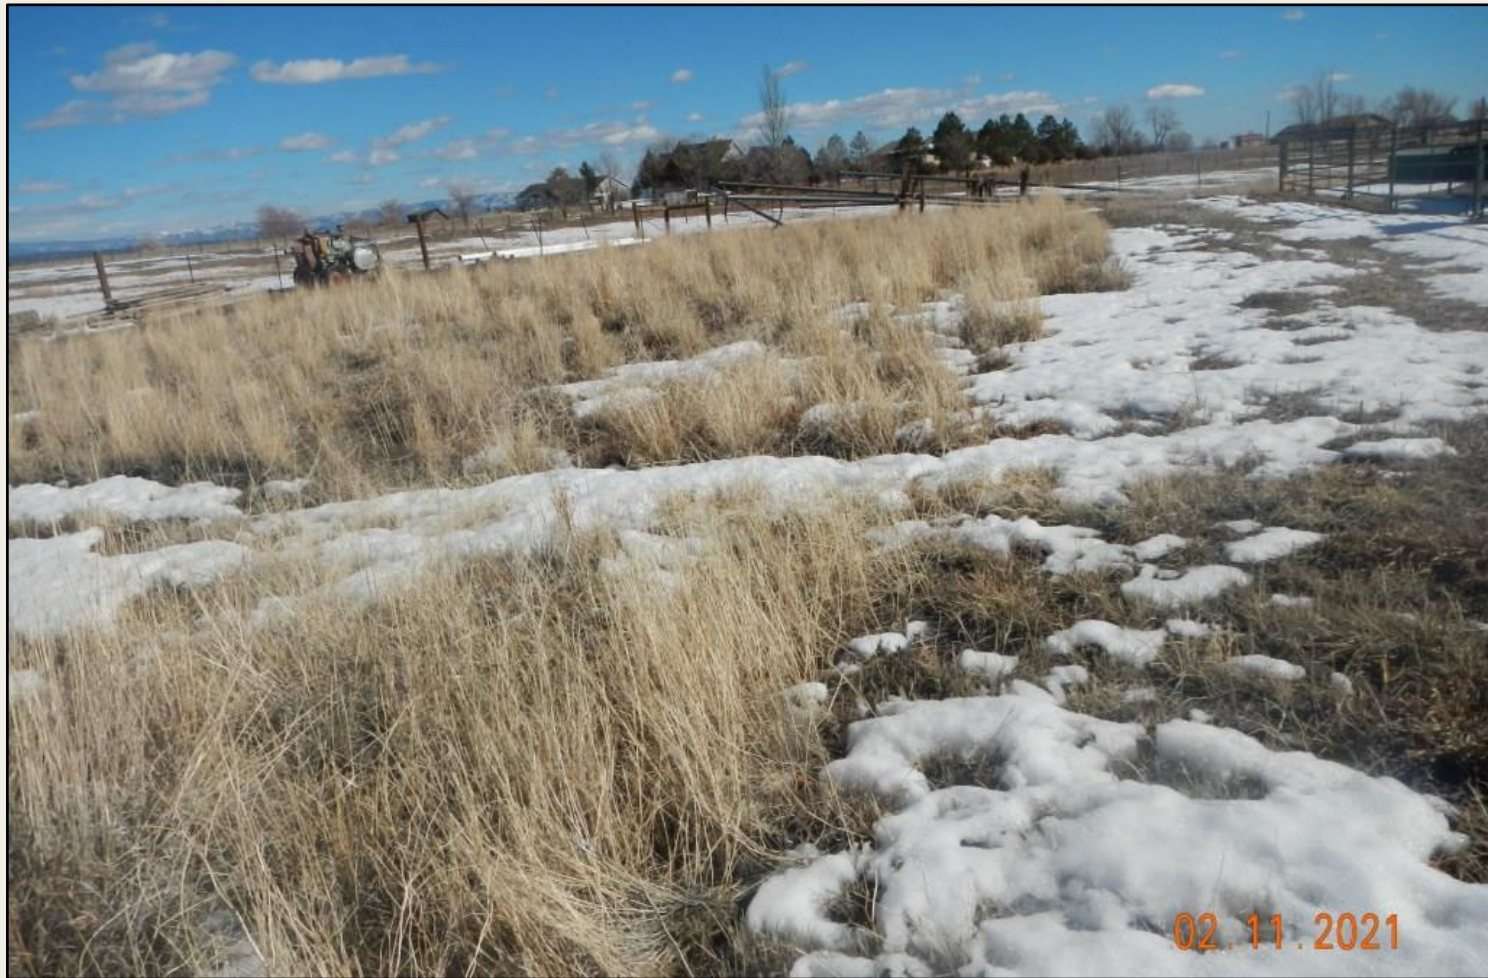
Photos 3. View of the northern project area from the northwestern corner facing eastward.

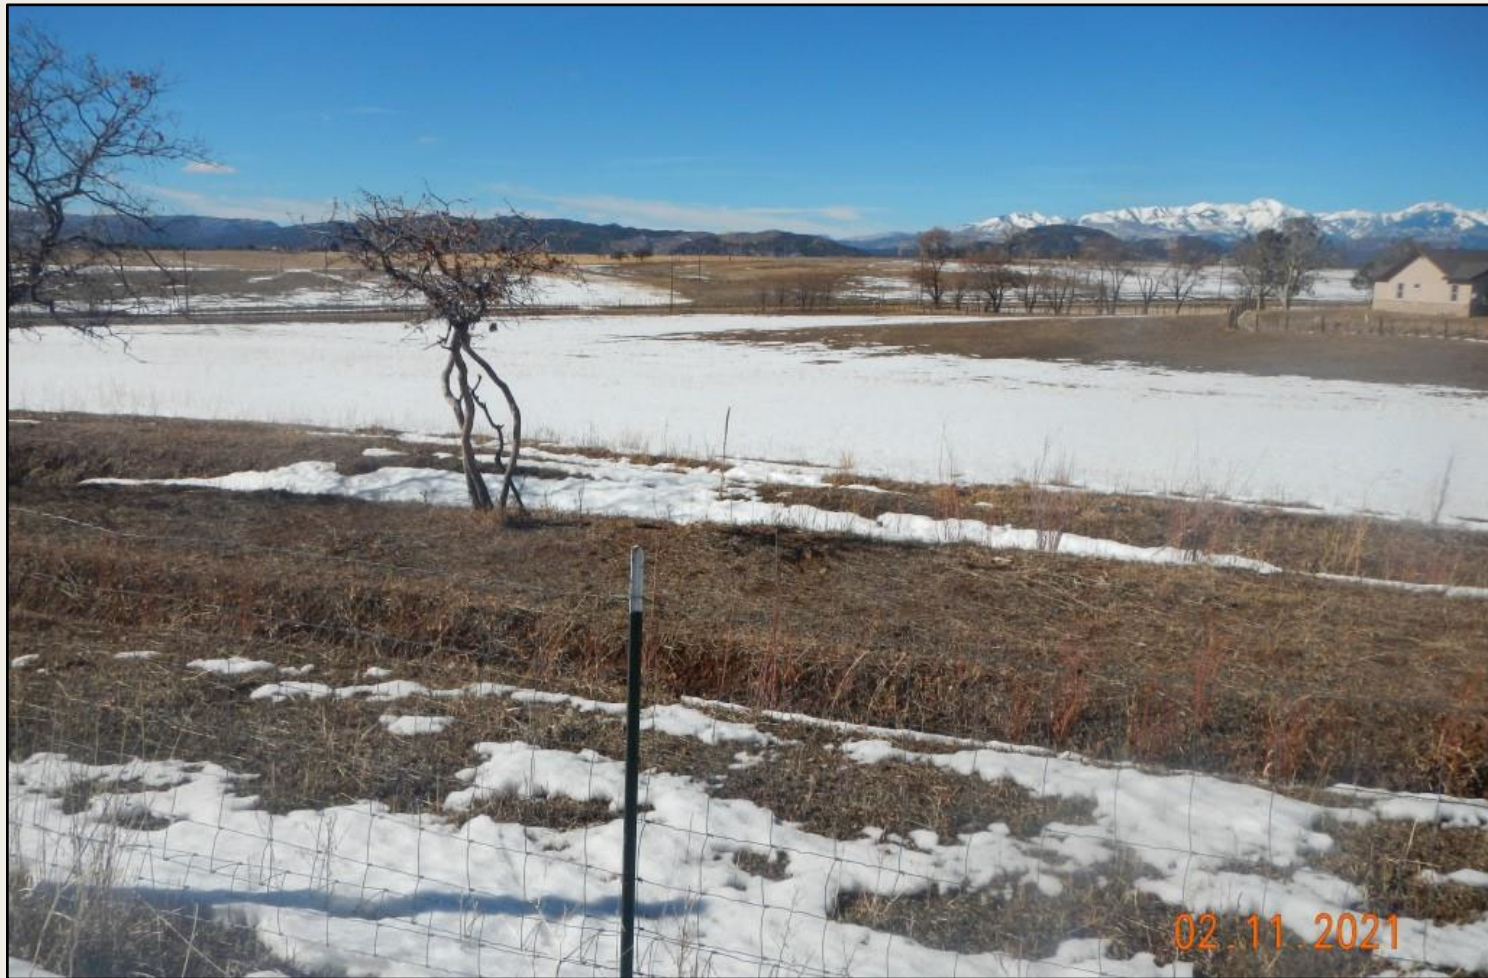
Photo 4 View of the reference area comprised of irrigated grass field in dormant vegetative condition.

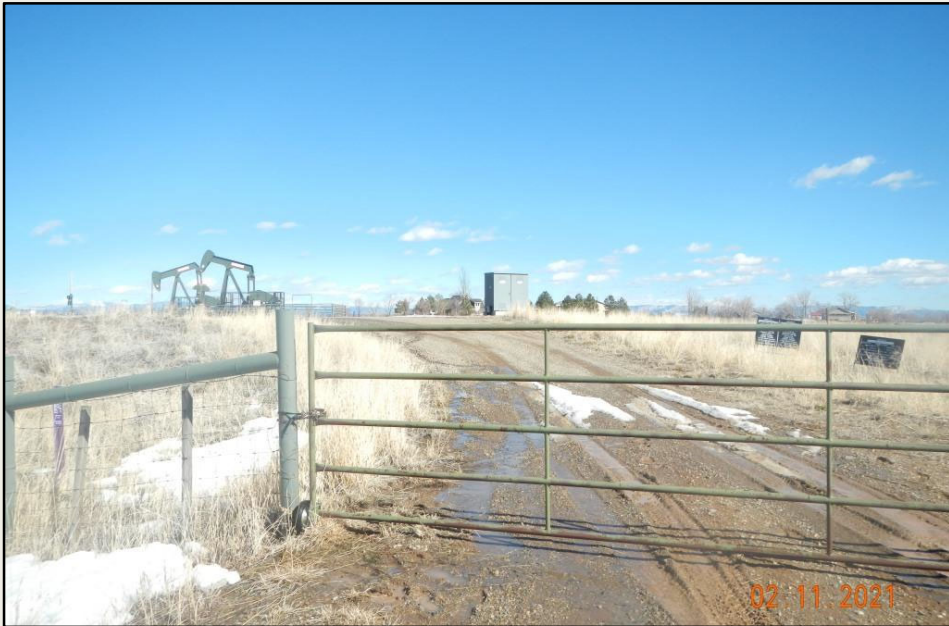
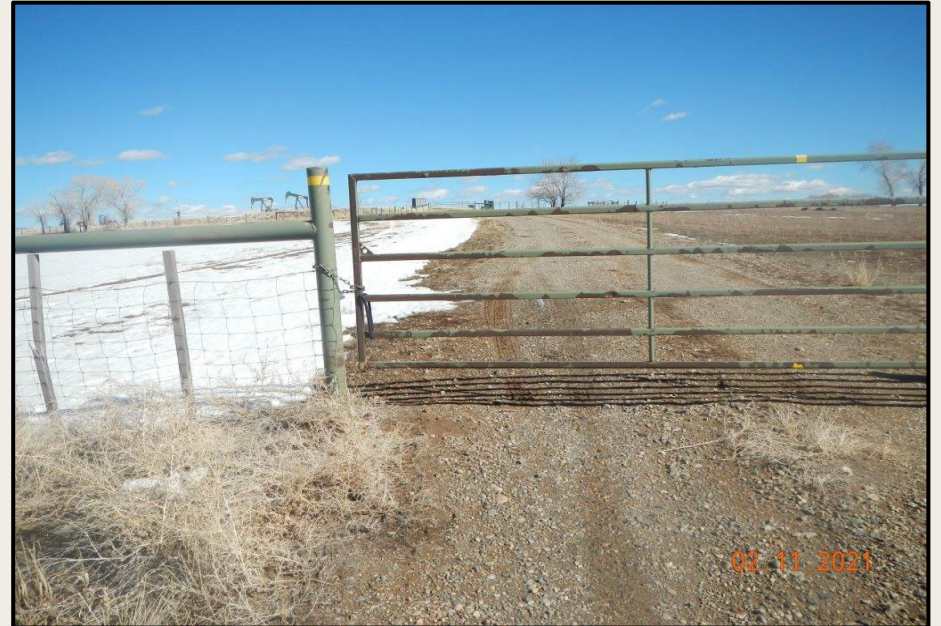
Photos 5/6. View of closed gates after leaving location.
