# *Inspection Photos*

*Loc#3241032*

*Operator: Terra*

*Inspection Number: 692403022*

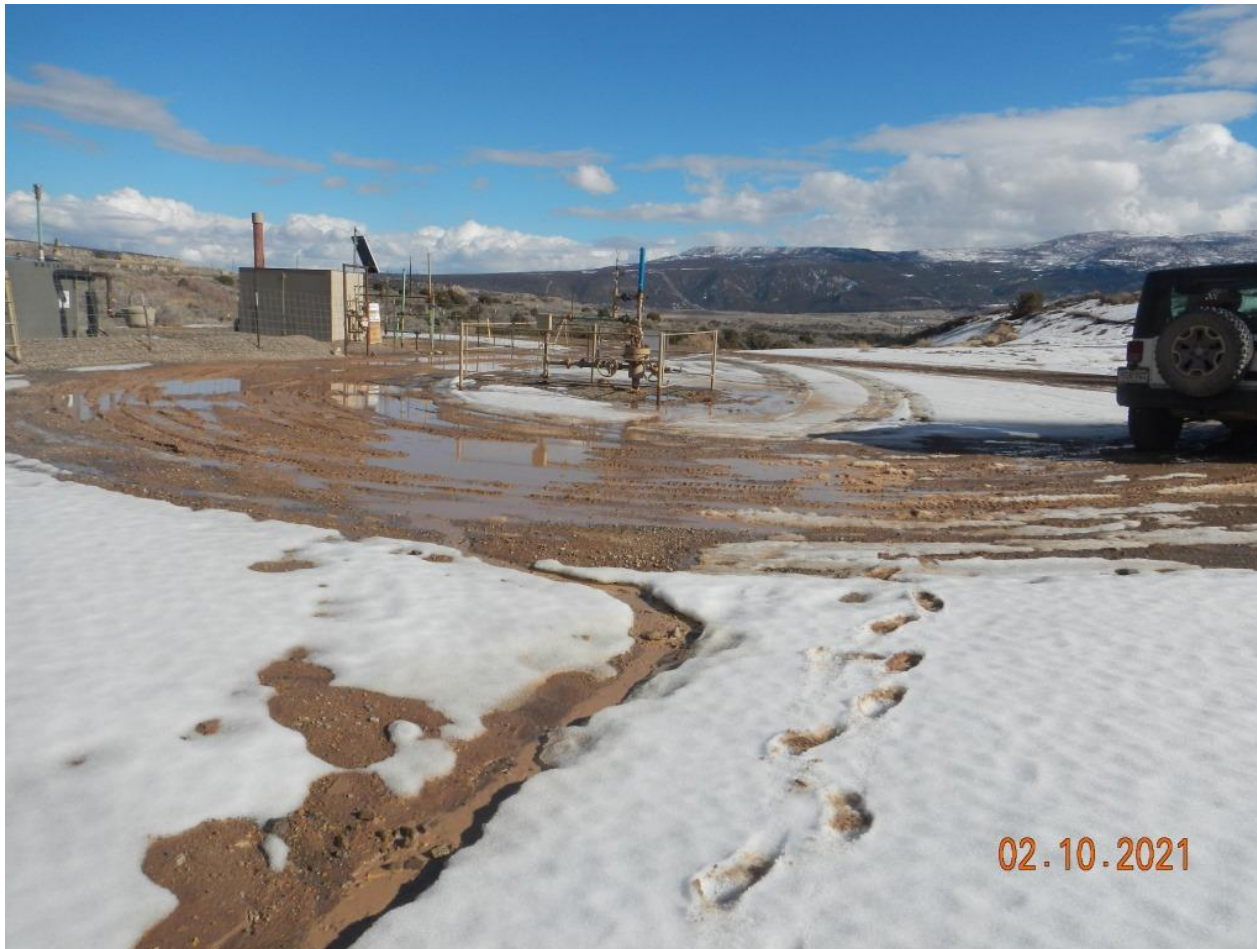
Photo#1:

View over Location to Southeast. Note unchecked stormwater/sediment flow off pad.

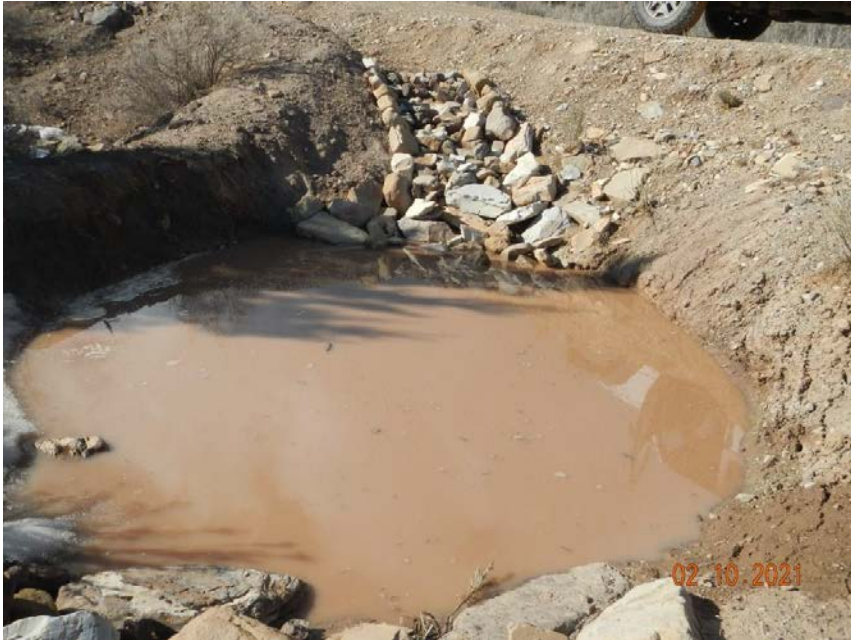
Photo#2:  
Sediment trap.

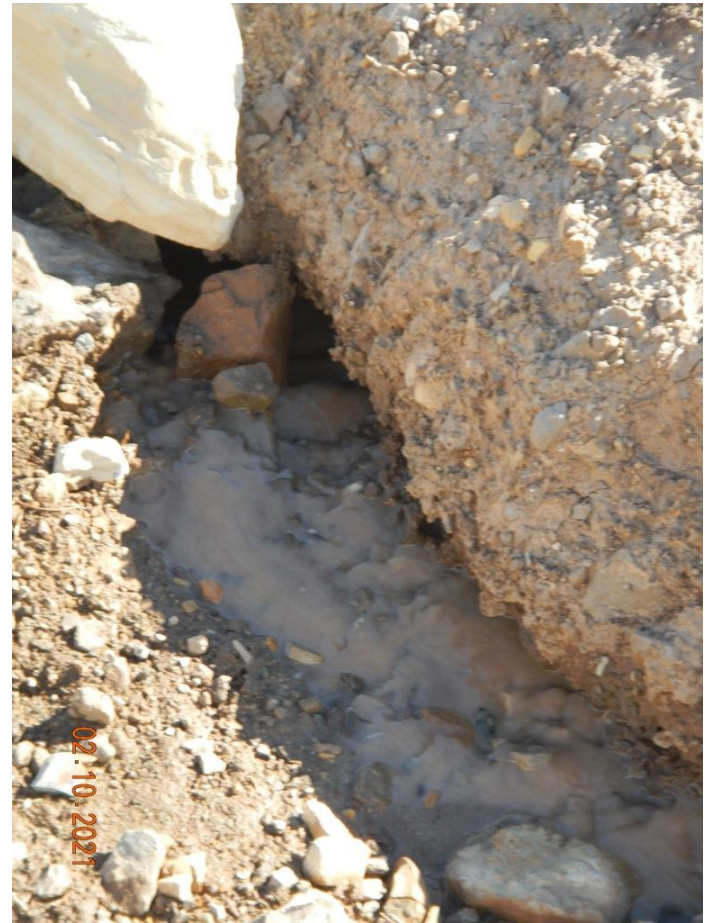
Photo#3:  
BMPs being undercut by stormwater flow.

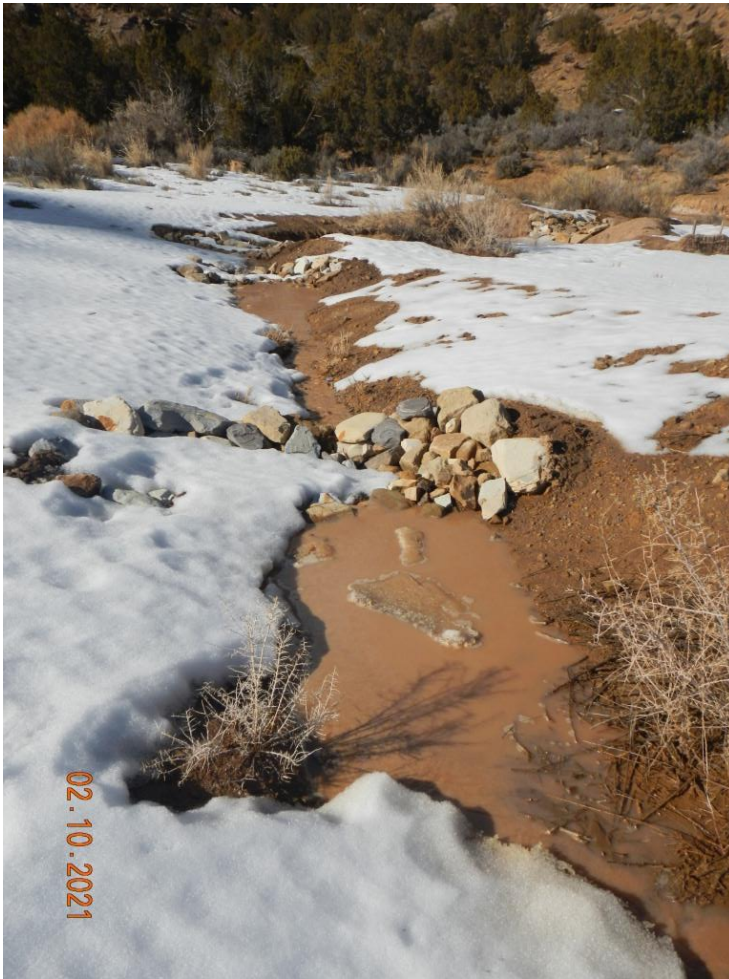
Photo#4:  
BMPs being undercut by stormwater flow.

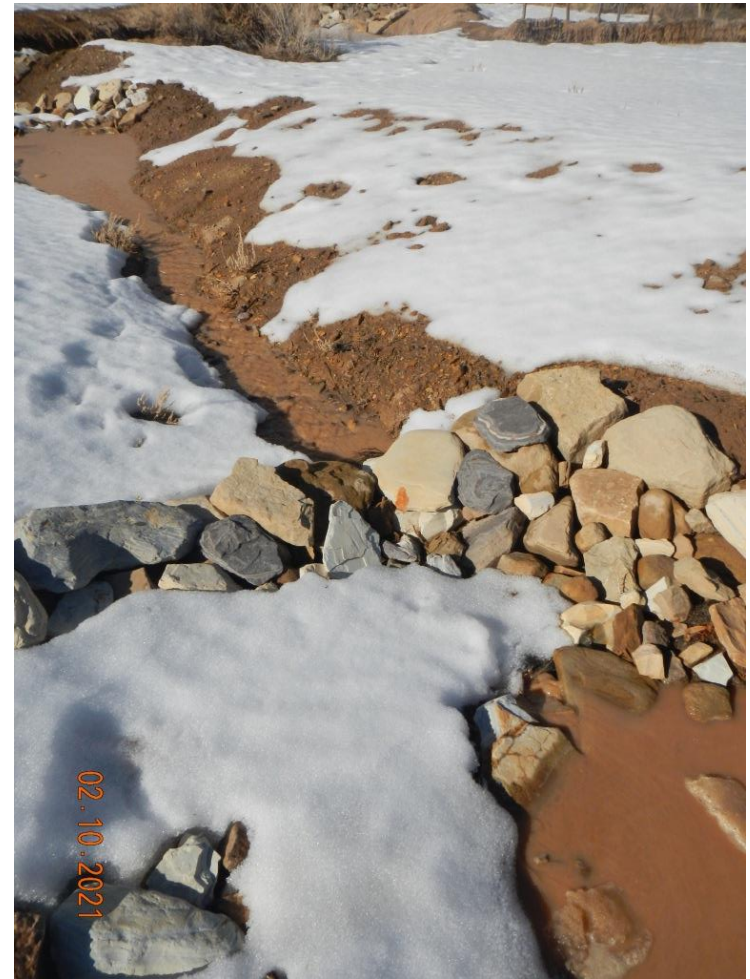
Photo#5:  
BMPs being undercut by stormwater flow.

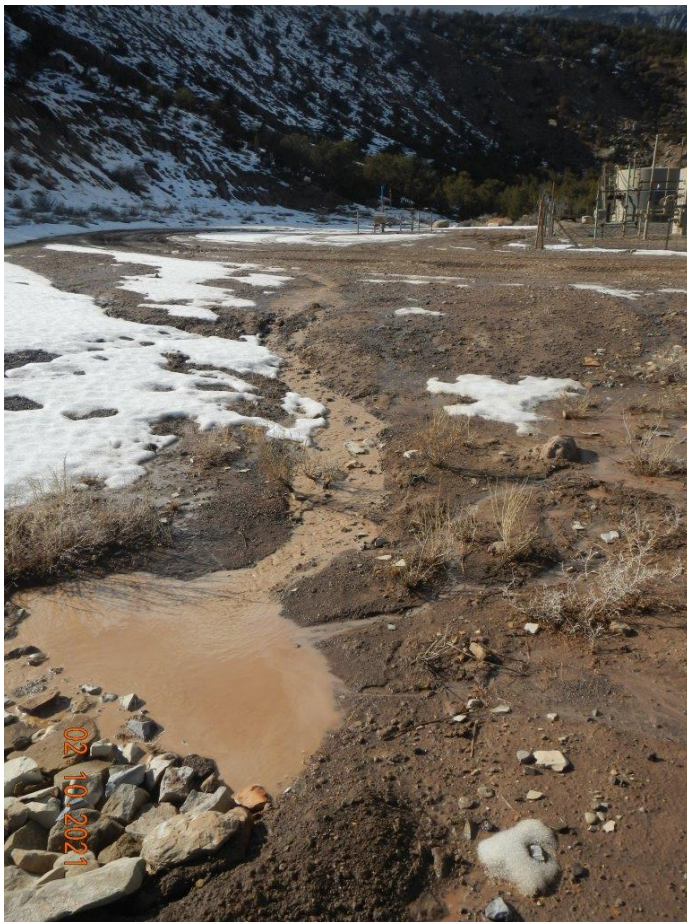
Photo#6:  
BMPs being undercut(scoured/eroded) by stormwater flow.

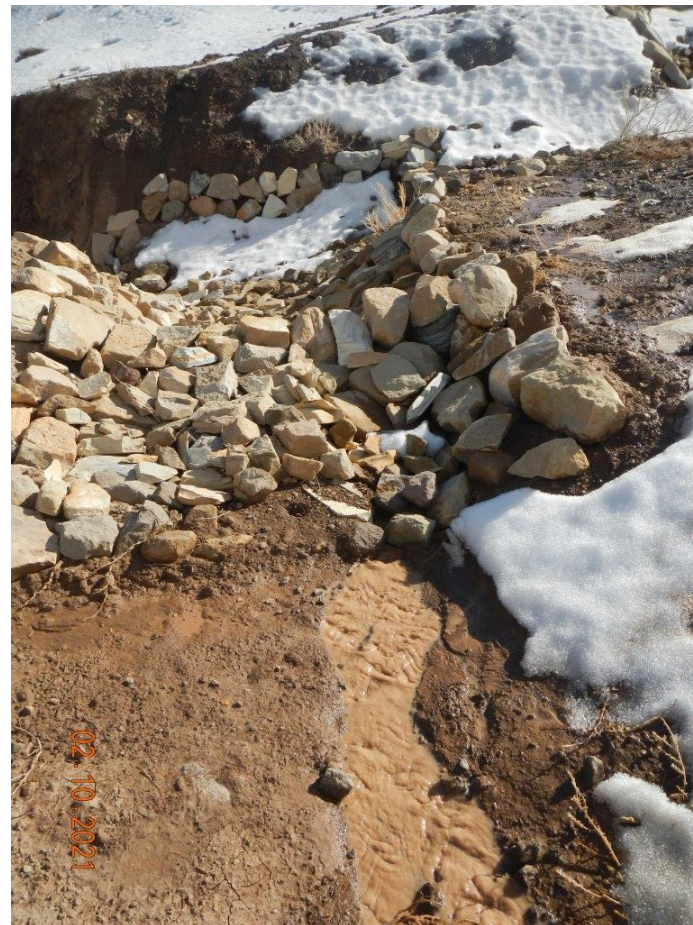
Photo#7:  
BMPs being undercut(scoured/eroded) by stormwater flow.

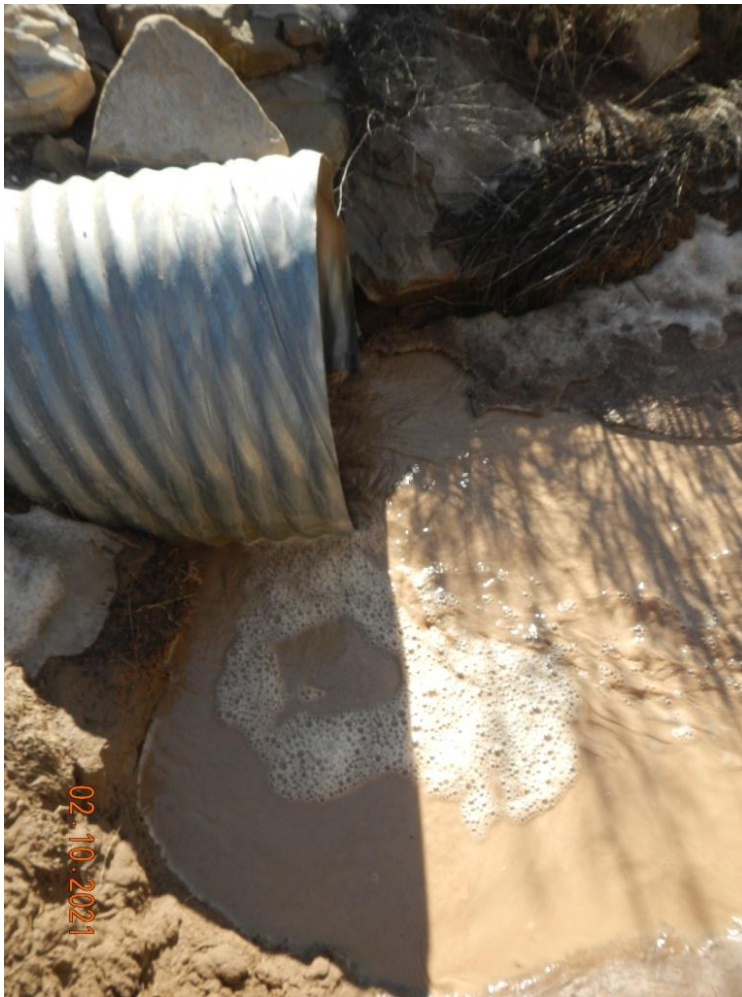
Photo#6:  
Culvert on access road.

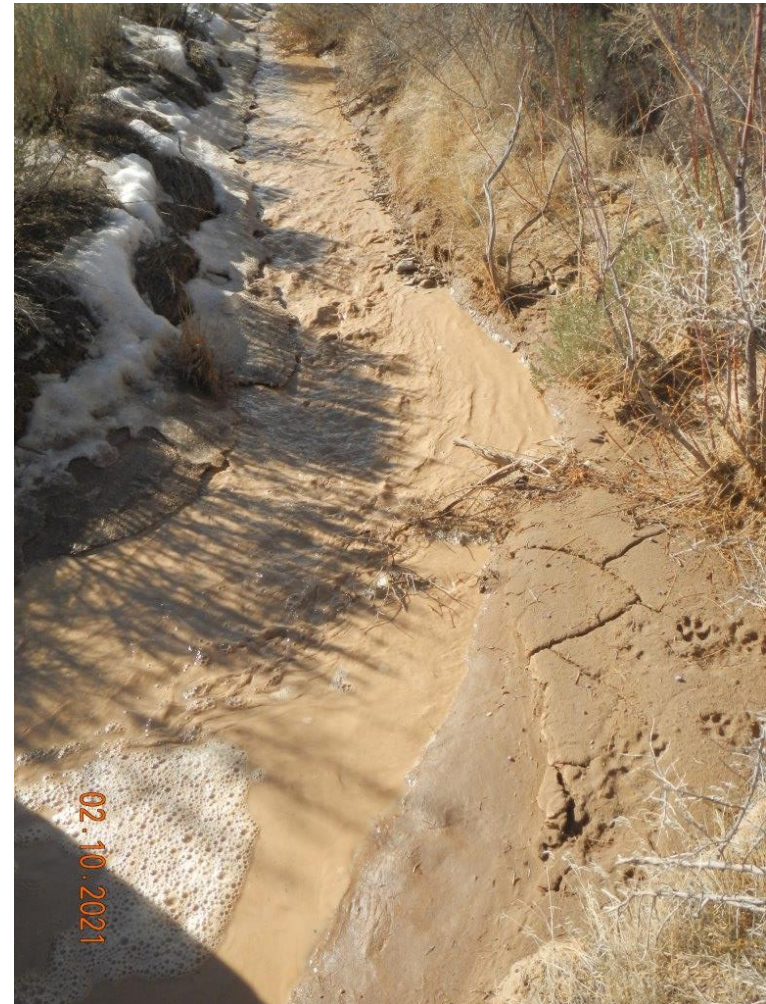
Photo#7:  
Sediment deposition downstream of  
culvert.

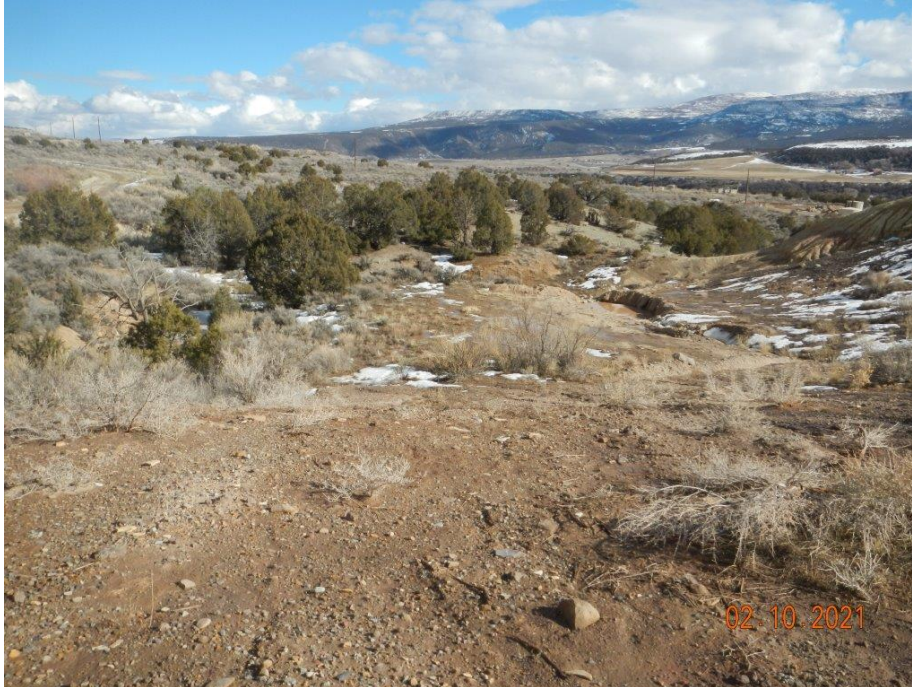
Photo#8:  
Slope that will need to be stabilized.

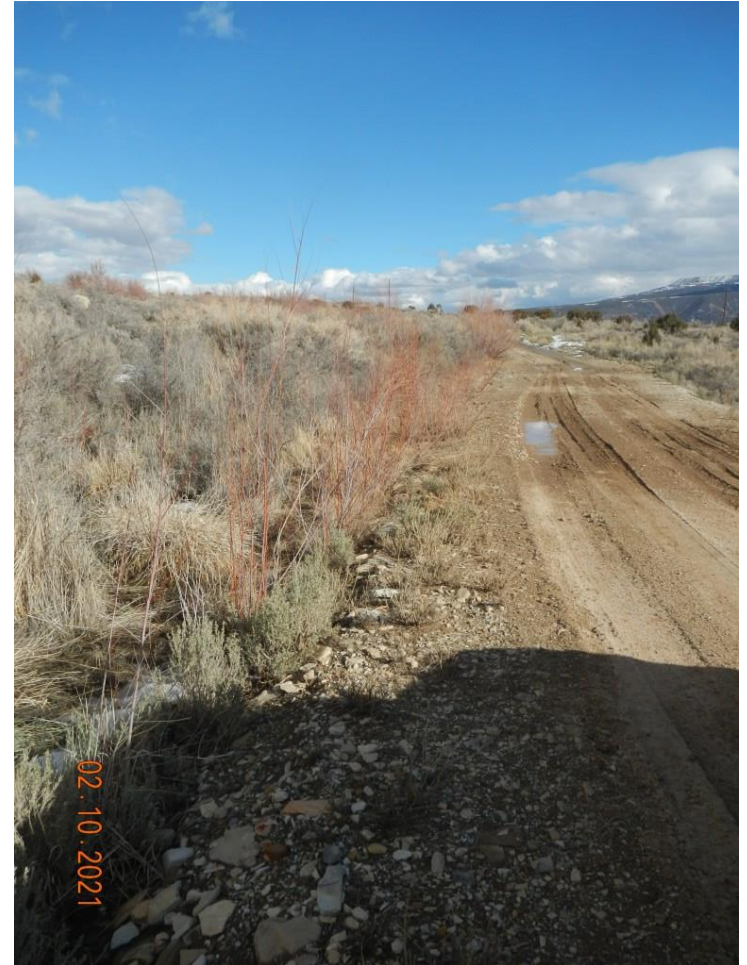
Photo#9:  
Tamarisk along access road.
