CAERUS PICEANCE LLC
CHEVRON-66S96W 4SWNW
Location # 335814

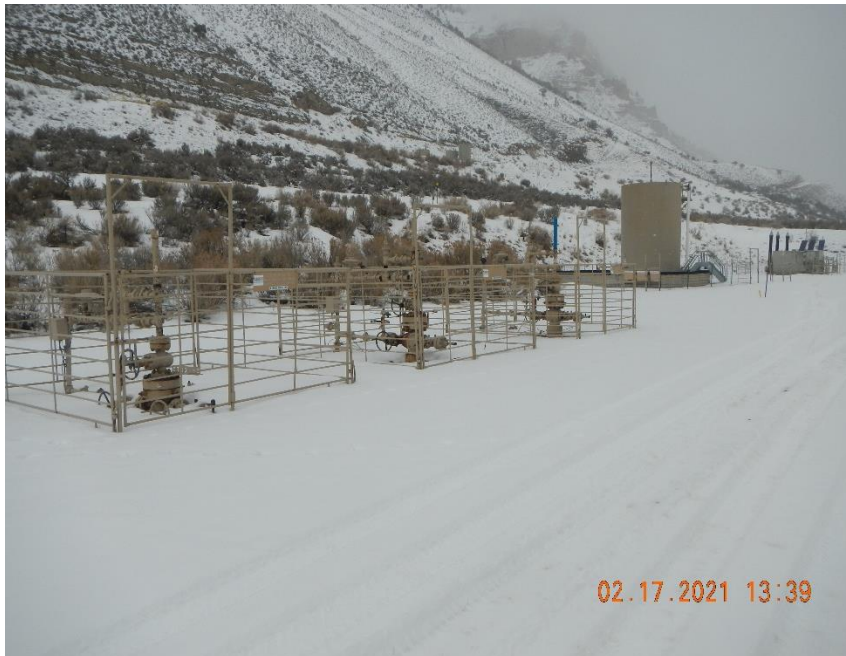
Location shows signs of lack of stabilization BMP's in some areas (rutting is present).

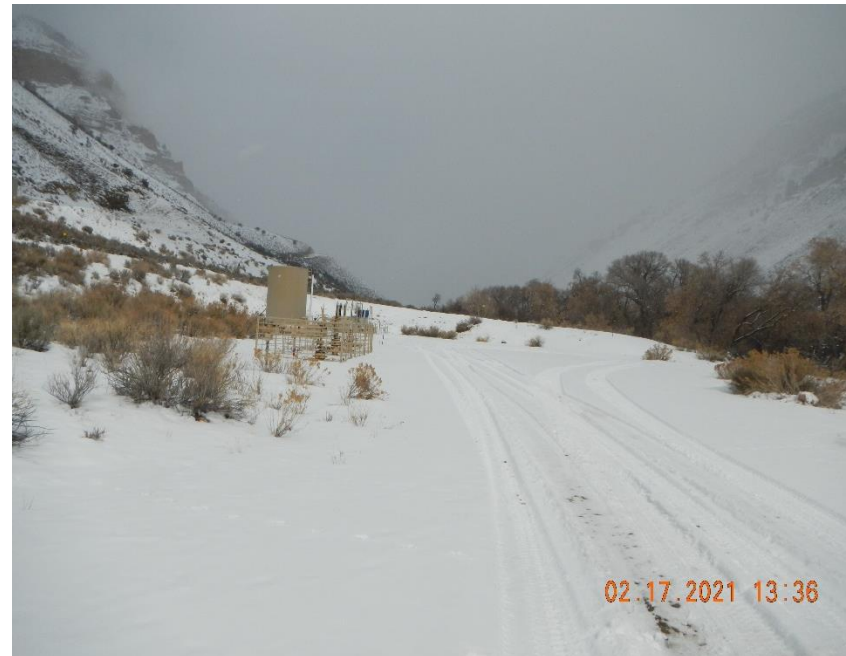
Access road shows signs of lack of stabilization BMP's in some areas (rutting is present).

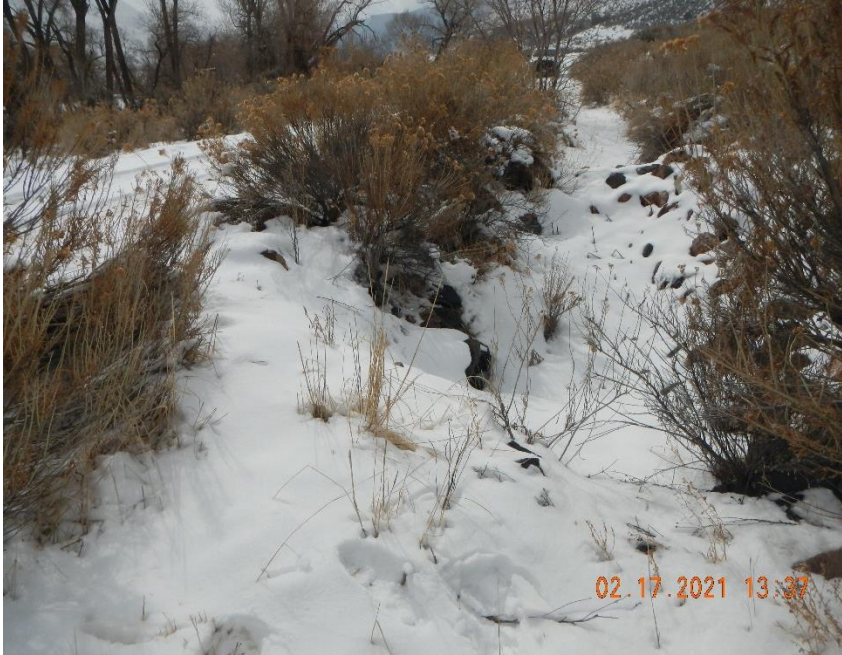
Culvert inlet at entrance of location.

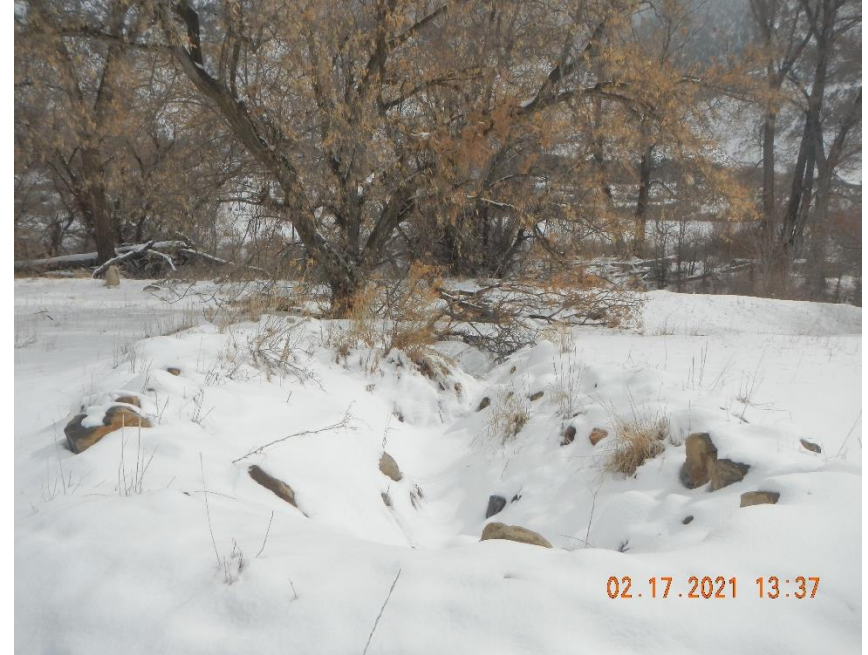
Culvert outlet at entrance of location.

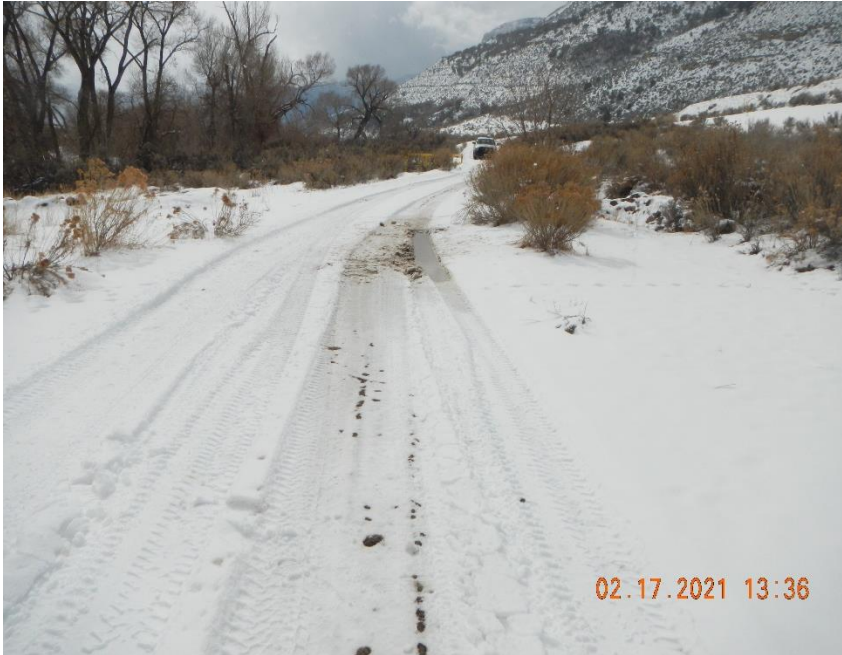
**Storm water not draining to culvert at
entrance of location.**

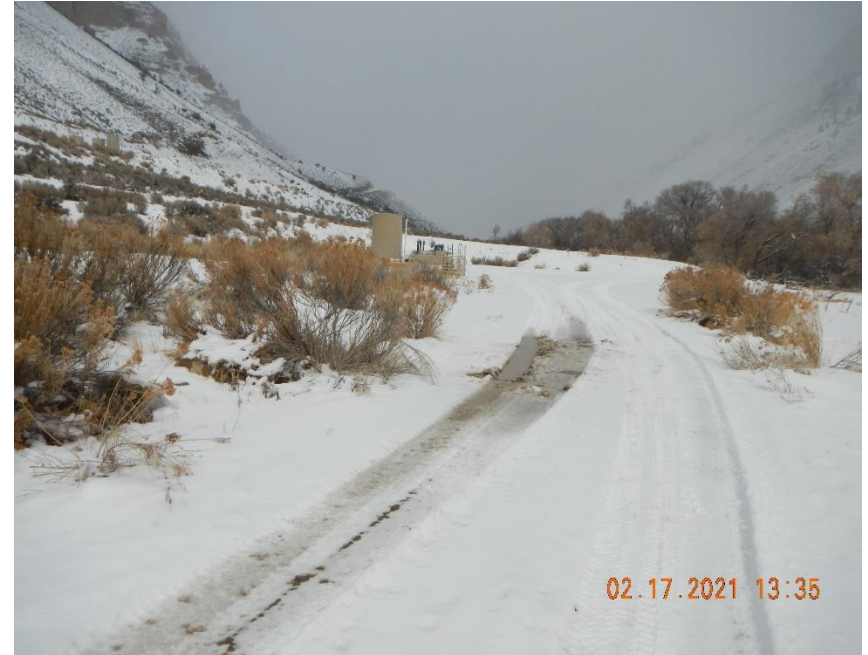
**Storm water not draining to culvert at
entrance of location.**

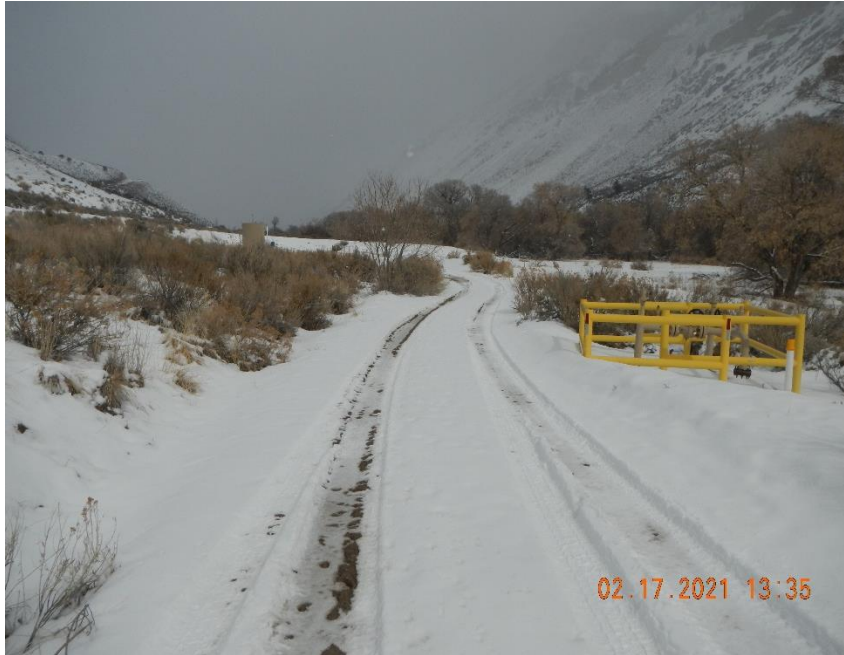
**Access road shows signs of lack of stabilization
BMP's in some areas (rutting is present).**

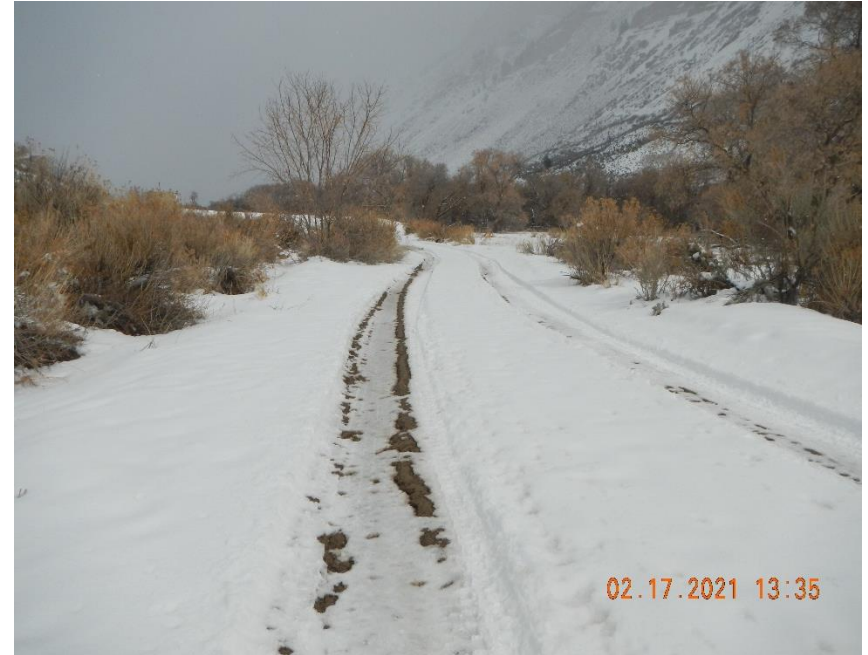
**Access road shows signs of lack of stabilization
BMP's in some areas (rutting is present).**

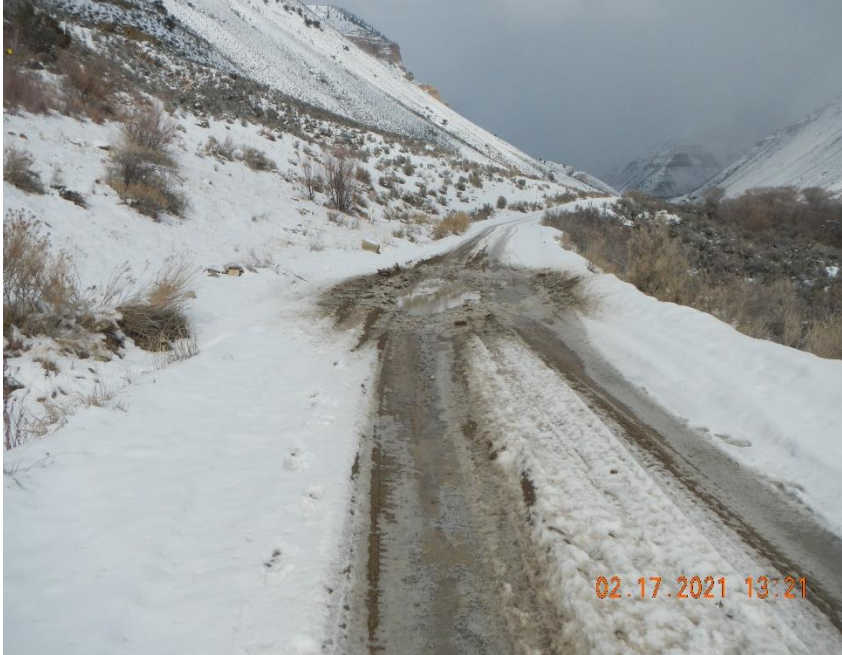
N39.55096 W108.12064

Water not draining off road into culvert or ditch.

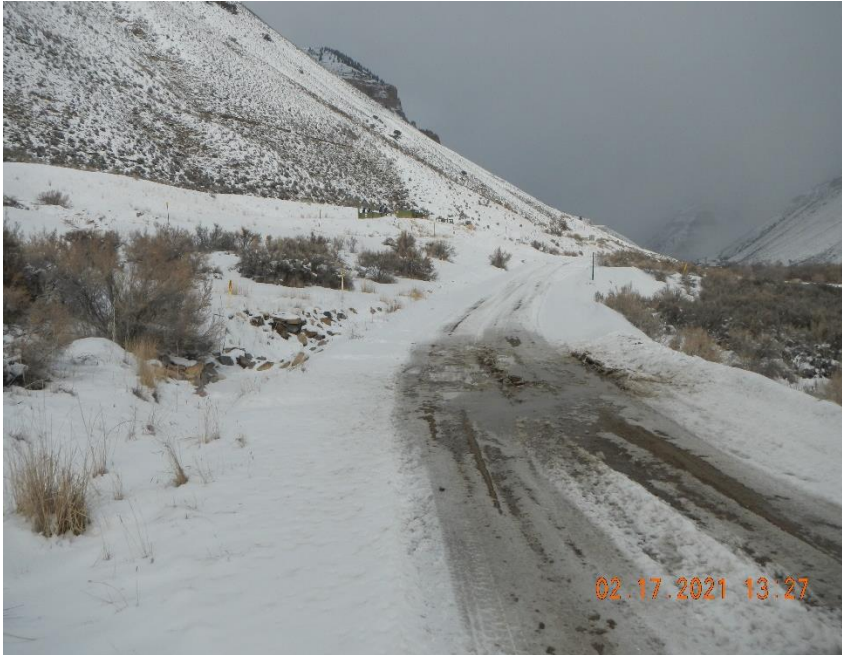
N39.55334 W108.11990

Erosion damage from culvert outlet. Access road shows signs of lack of stabilization BMP's in some areas (rutting is present).

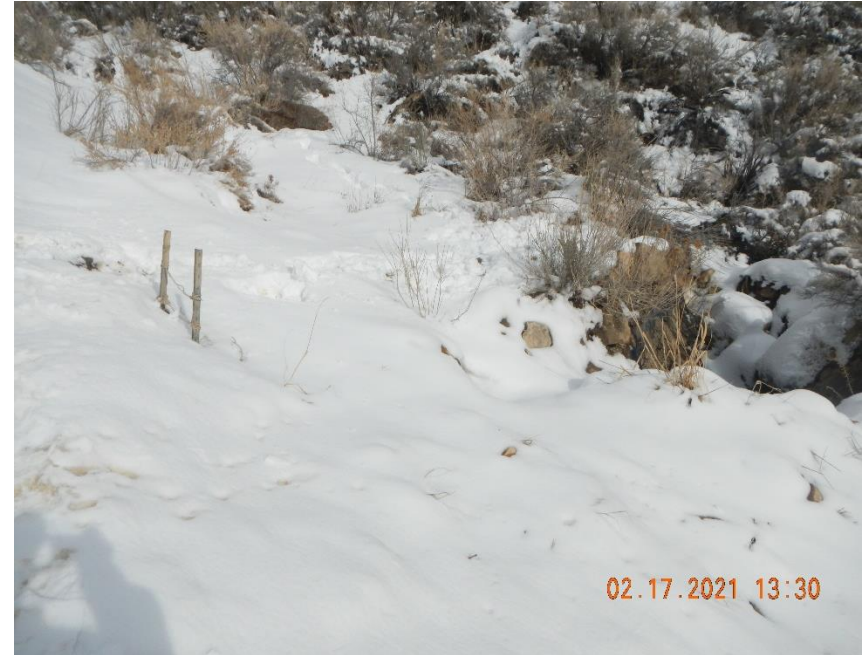
N39.55334 W108.11990

Erosion damage from culvert outlet.
