COLORADO
Oil & Gas Conservation
Commission
Department of Natural Resources

McLaughlin SR 6

API: 05-103-05500

Inspection: 700405446

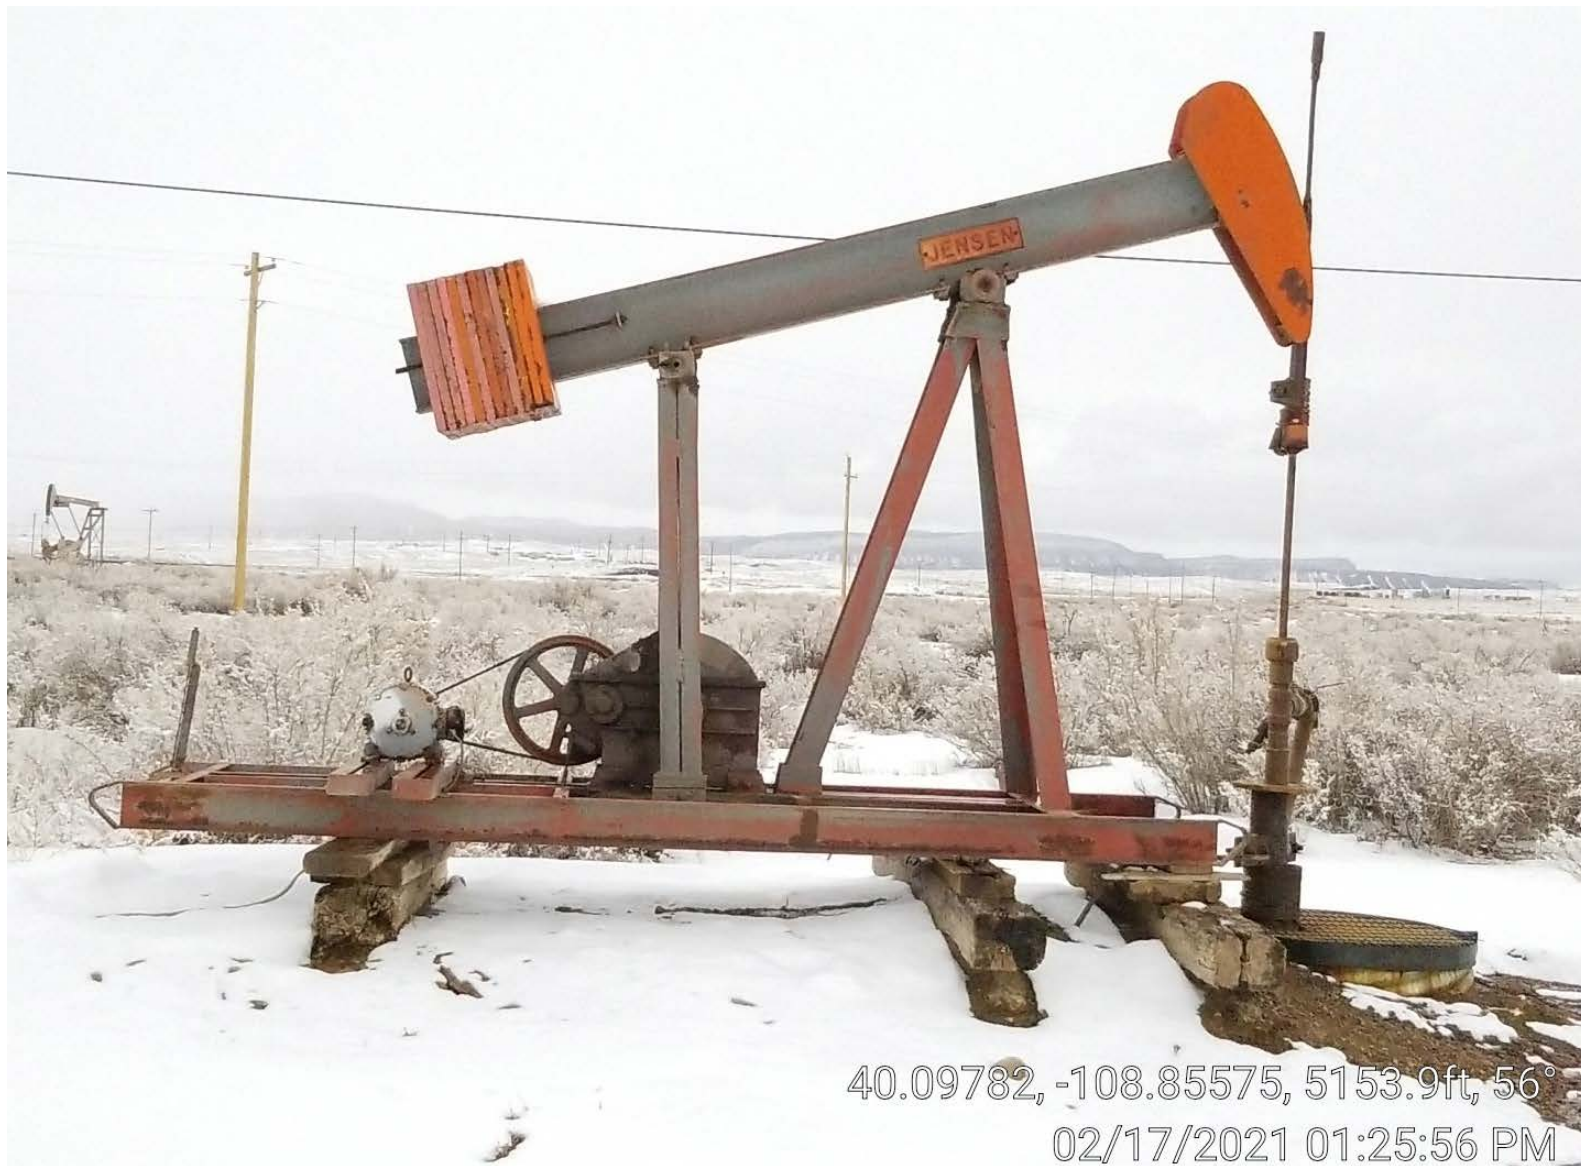
Photo 1. Pump jack.

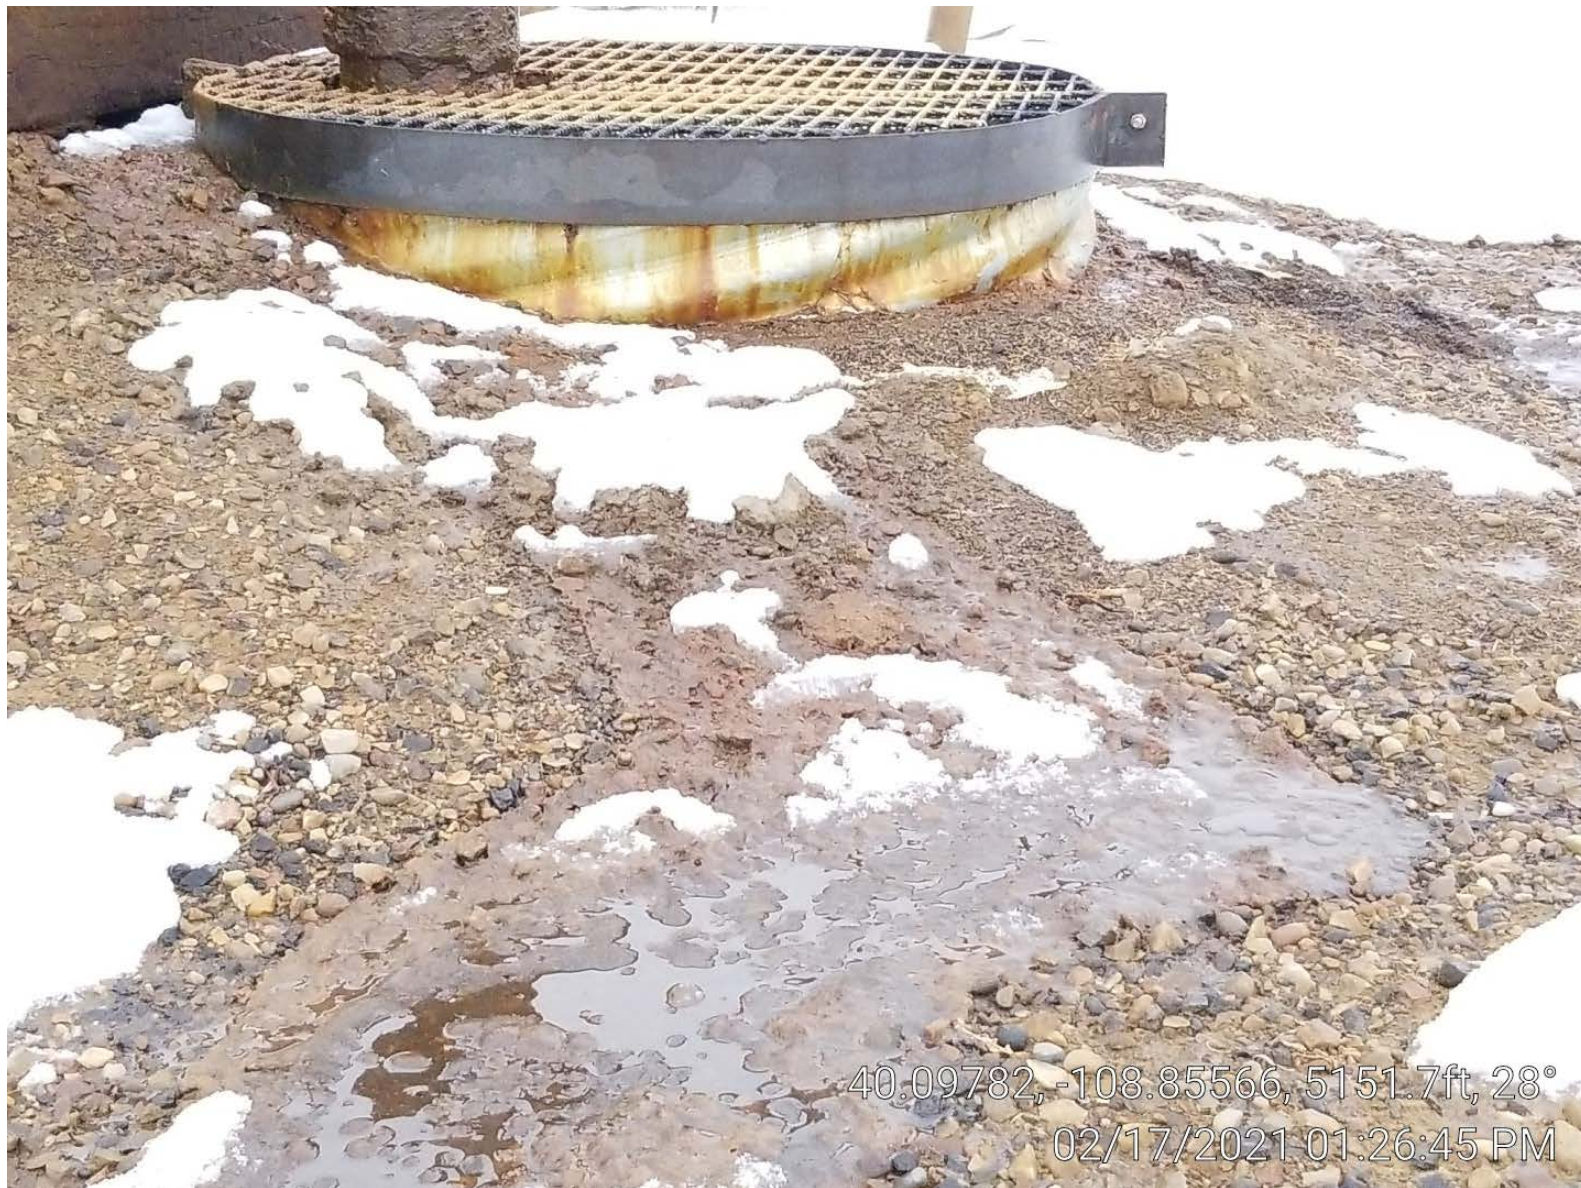
Photo 3. Oil spill.

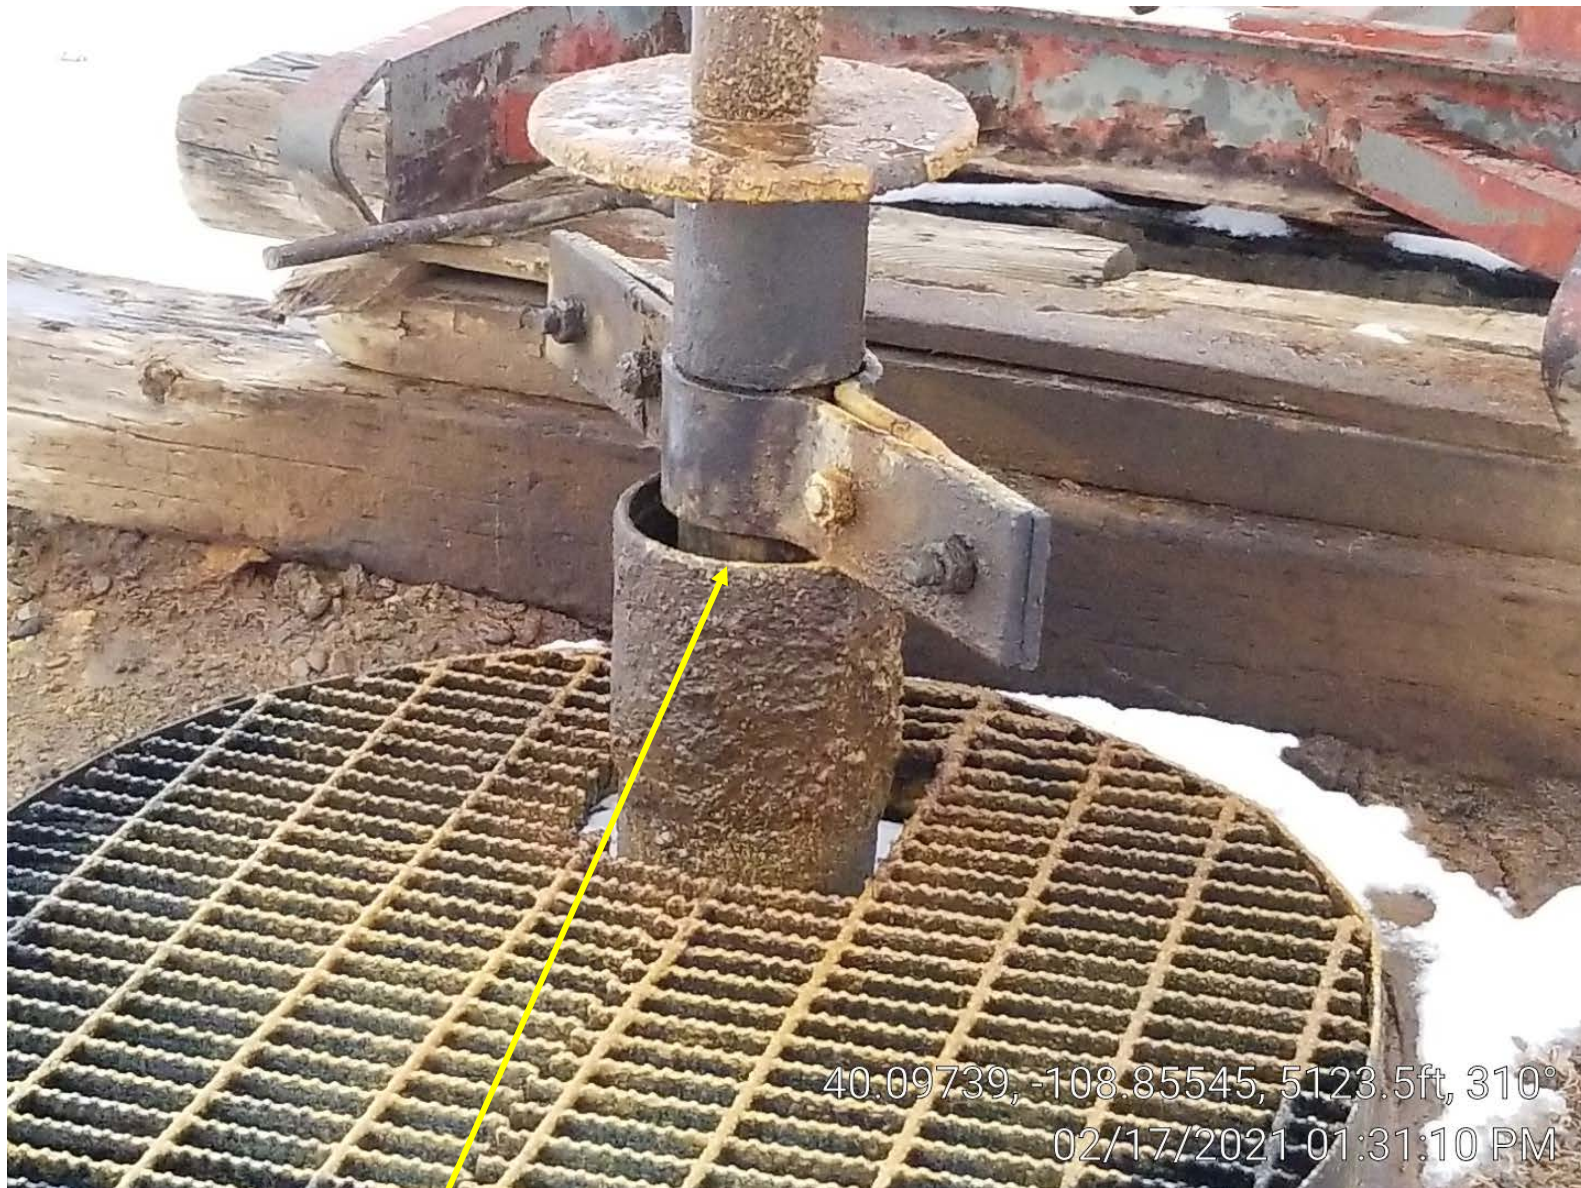
Photo 5. Venting.
