COLORADO
Oil & Gas Conservation
Commission
Department of Natural Resources

Arrowhead 9

API: 05-103-05301

Inspection: 700405450

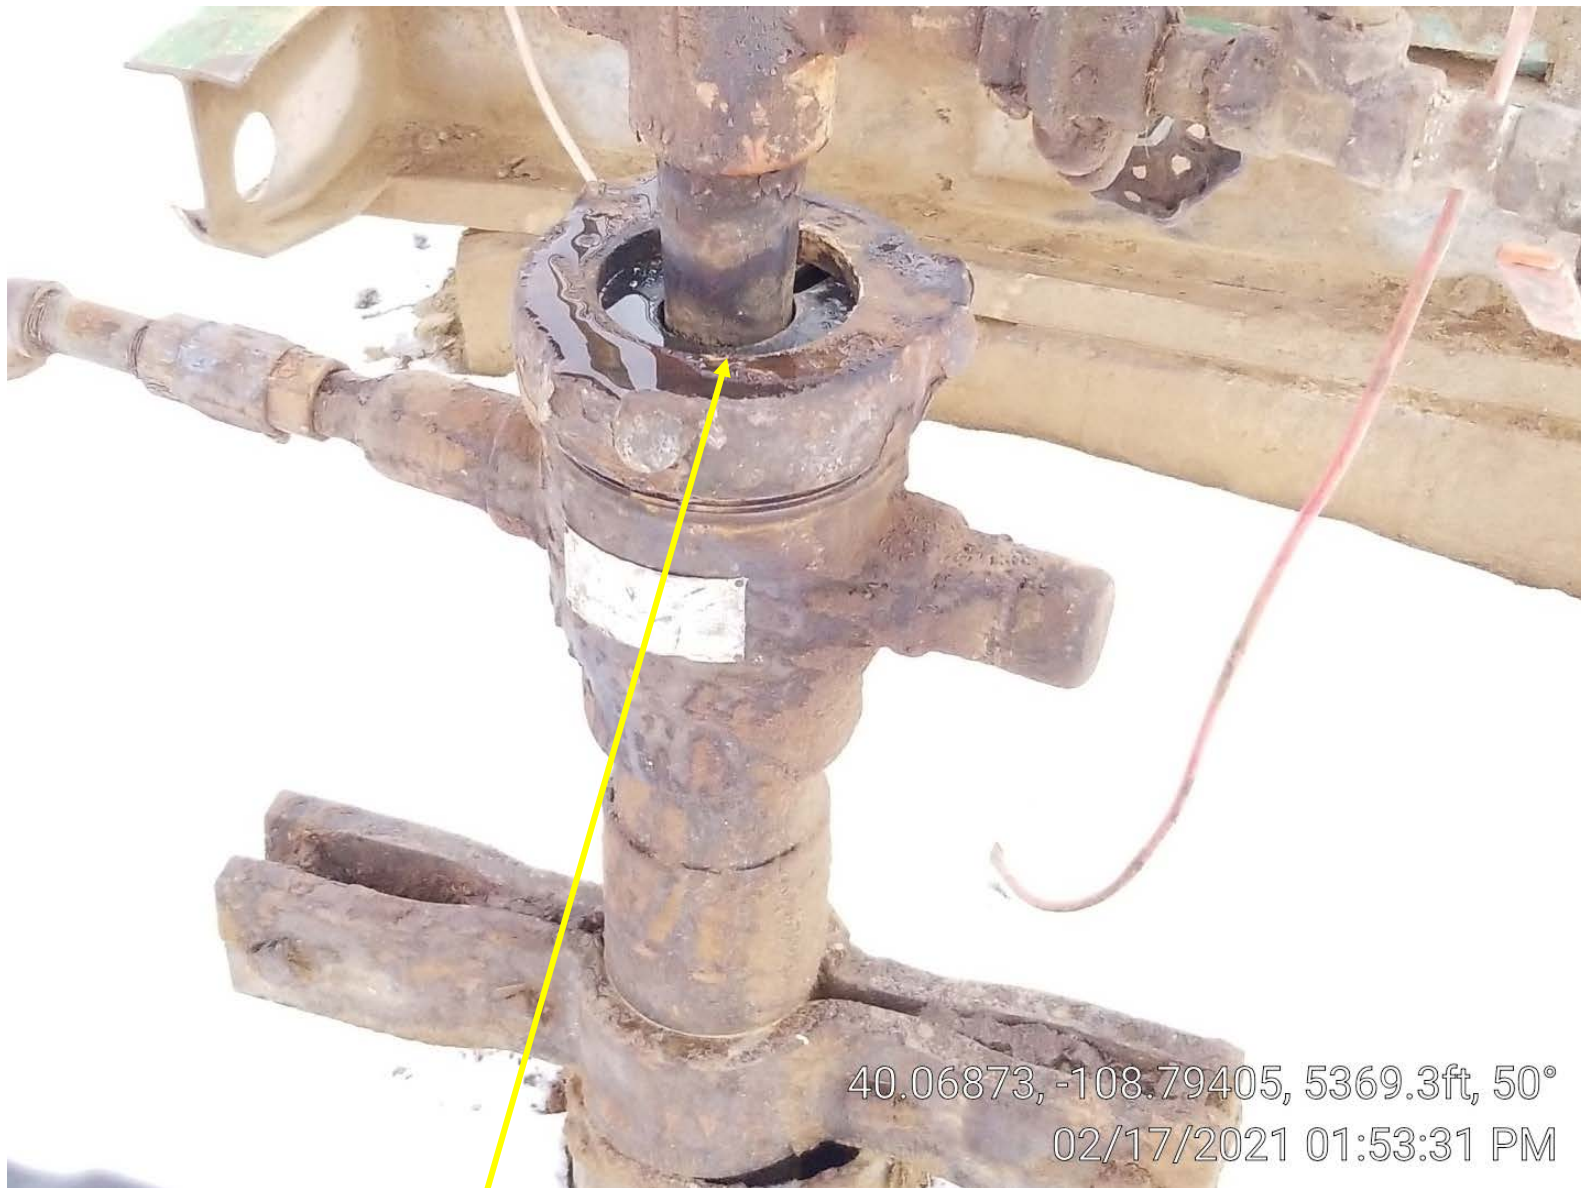
Photo 3. Well gas leak

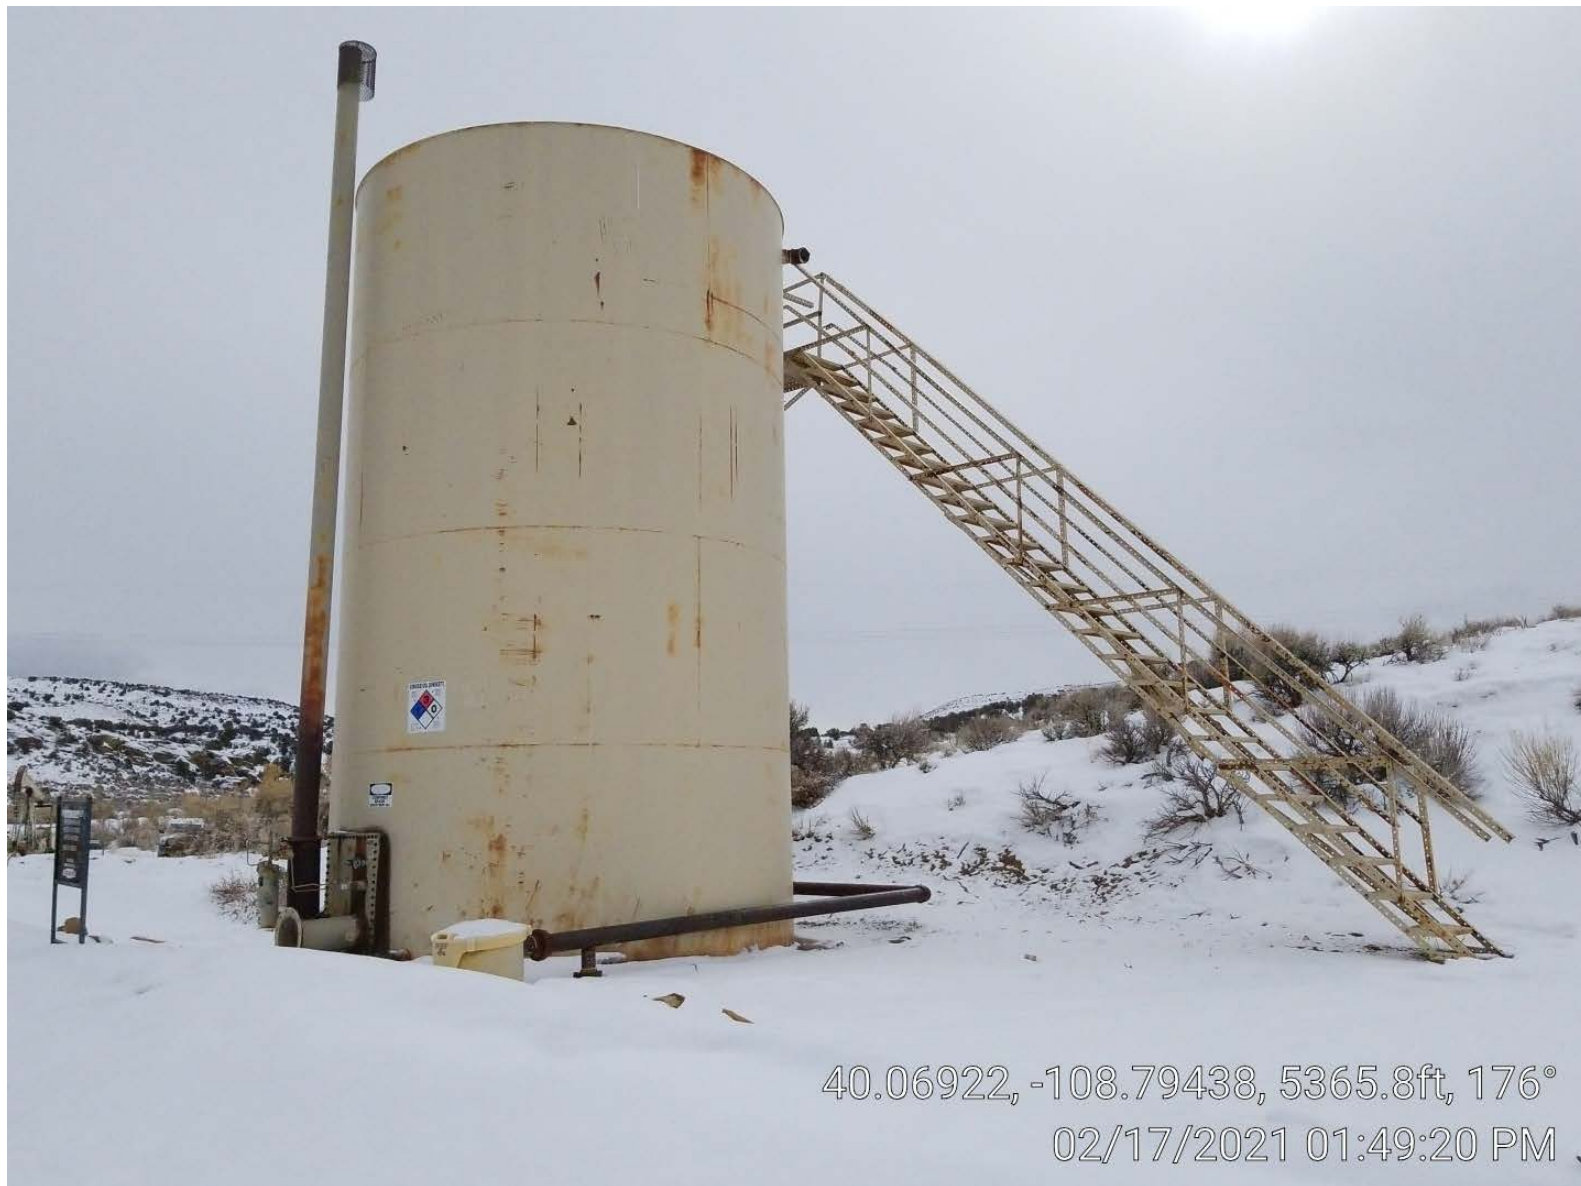
Photo 4. Tank.

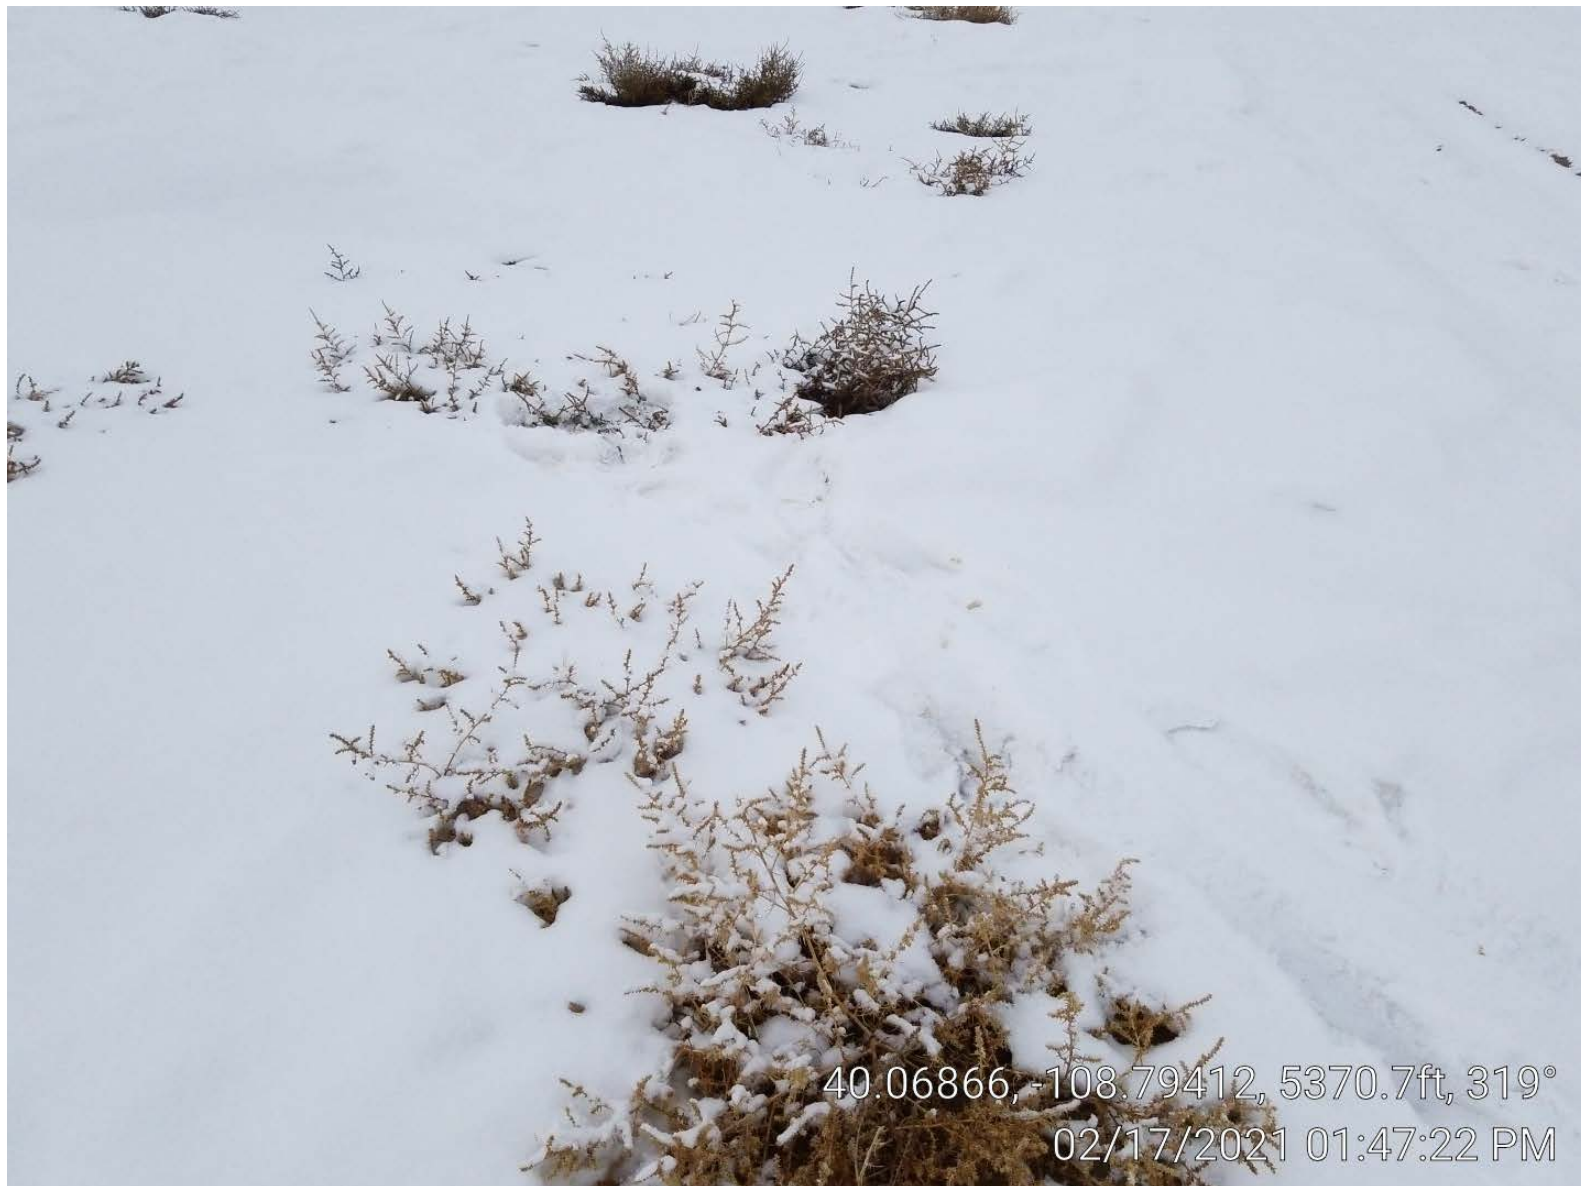
Photo 5. Debris.
