Inspection Photos

2/17/2021

Operator: TEP ROCKY MOUNTAIN LLC - 96850

Location ID: 334601

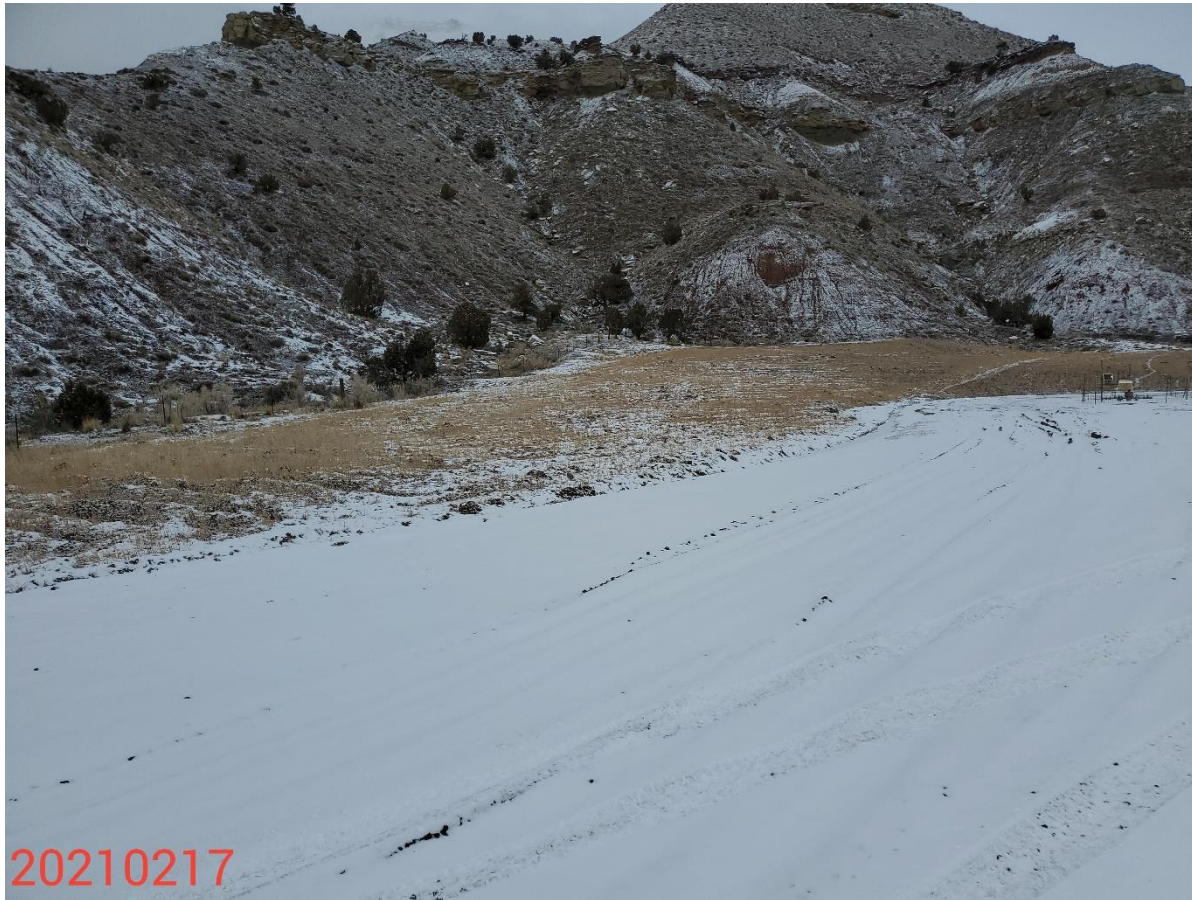
Photo 1: Photo taken from the south end of the Location, facing north. Photos 1-3 provide an overview of the Location from north, northeast to east.

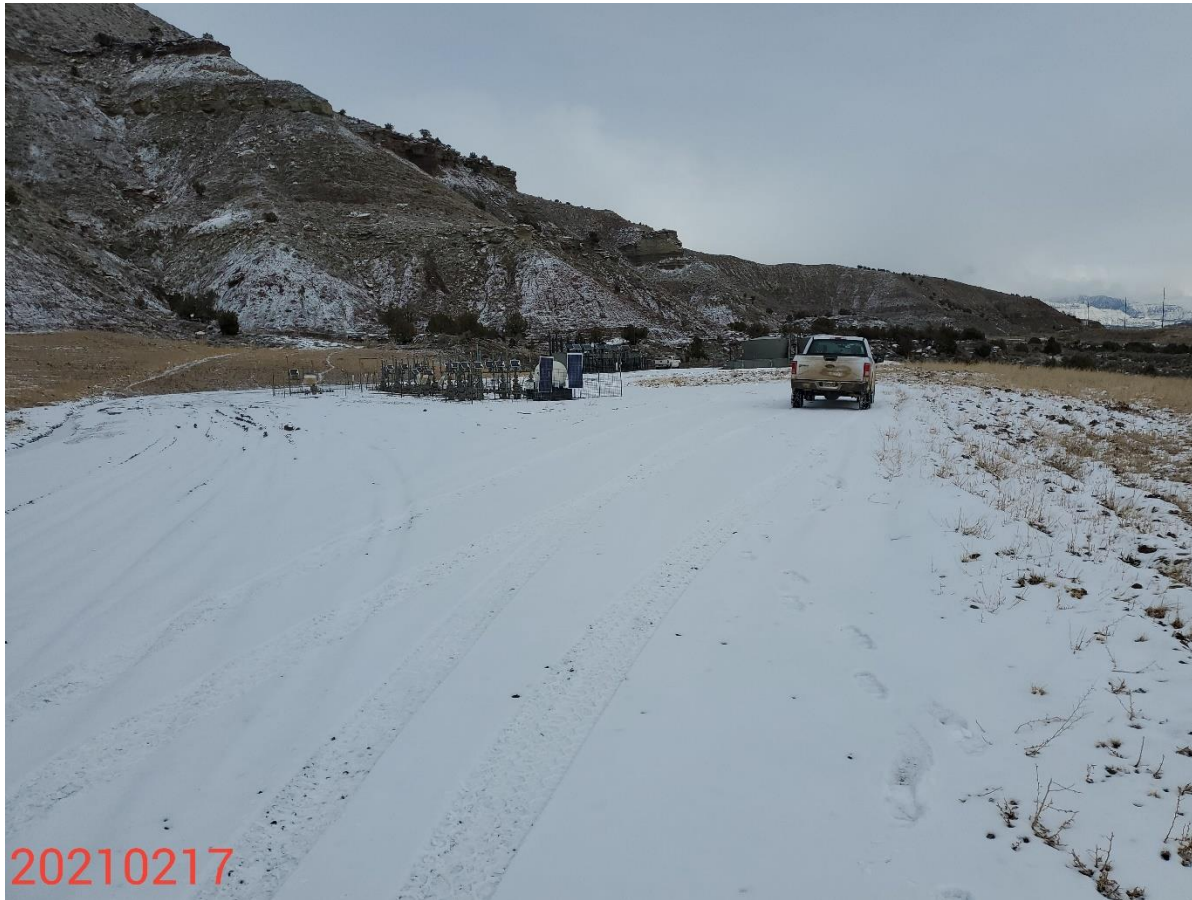
Photo 2: See comments under photo 1.

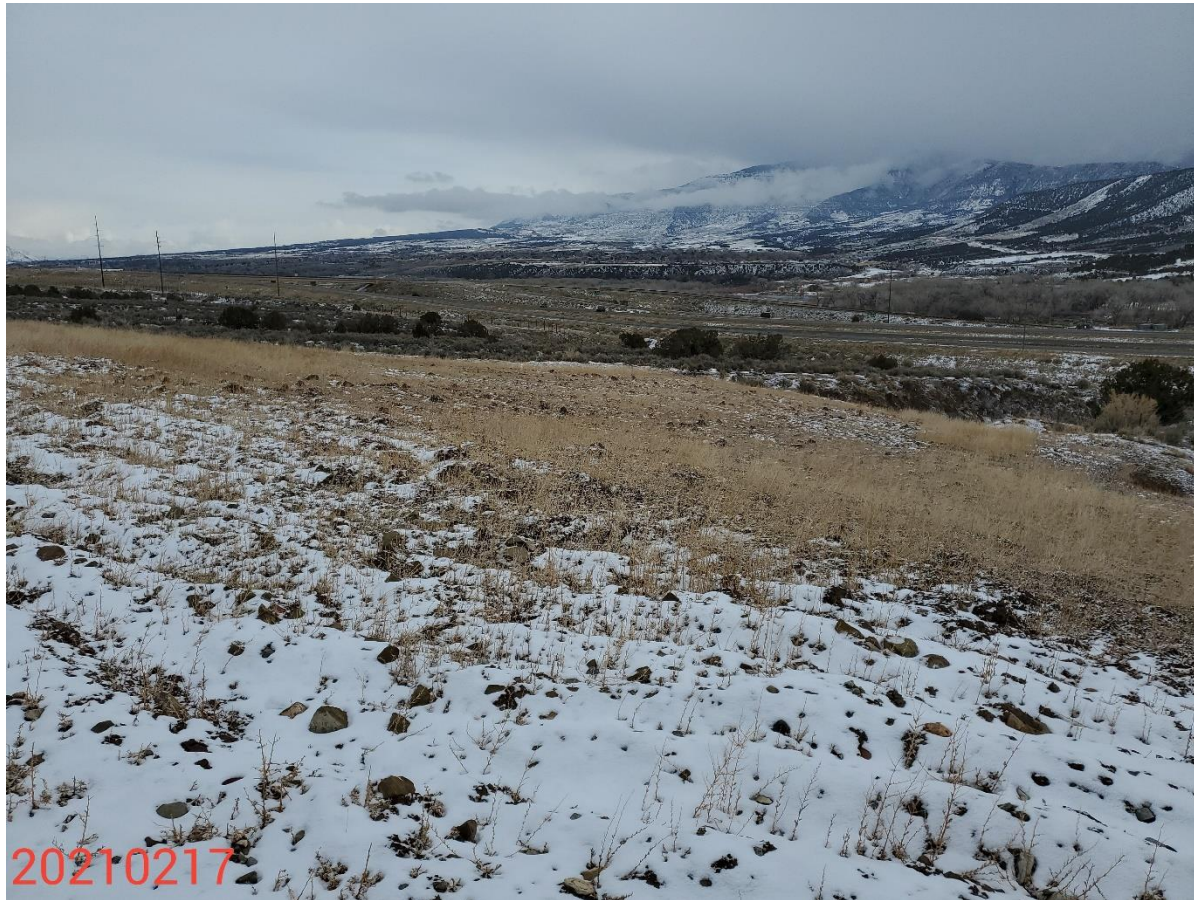
Photo 3: See comments under photo 1.

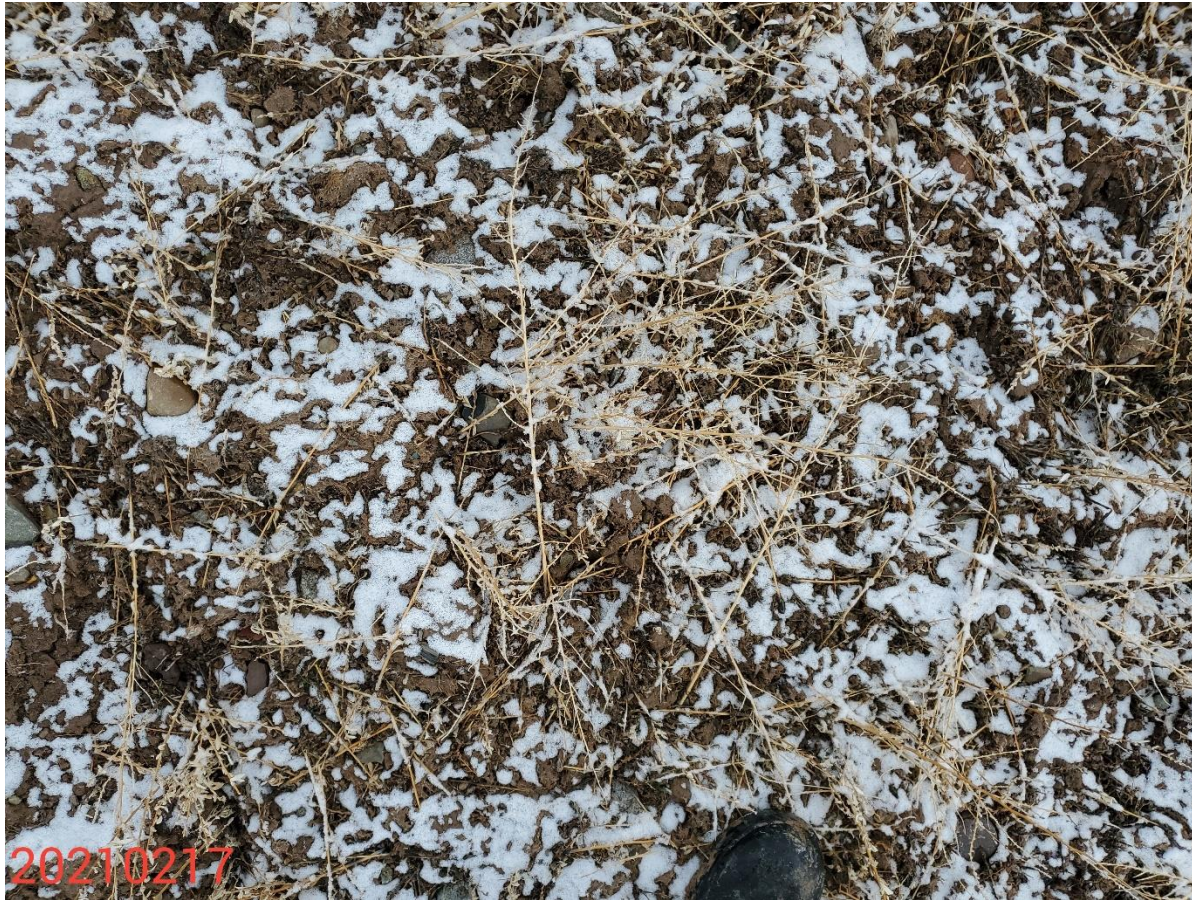
Photo 4: Interim reclamation appears to have been recently conducted on the Location. Photo shows vegetation from last growing season is predominantly undesirable annual weedy plant species; Desirable perennial plant establishment not observed.

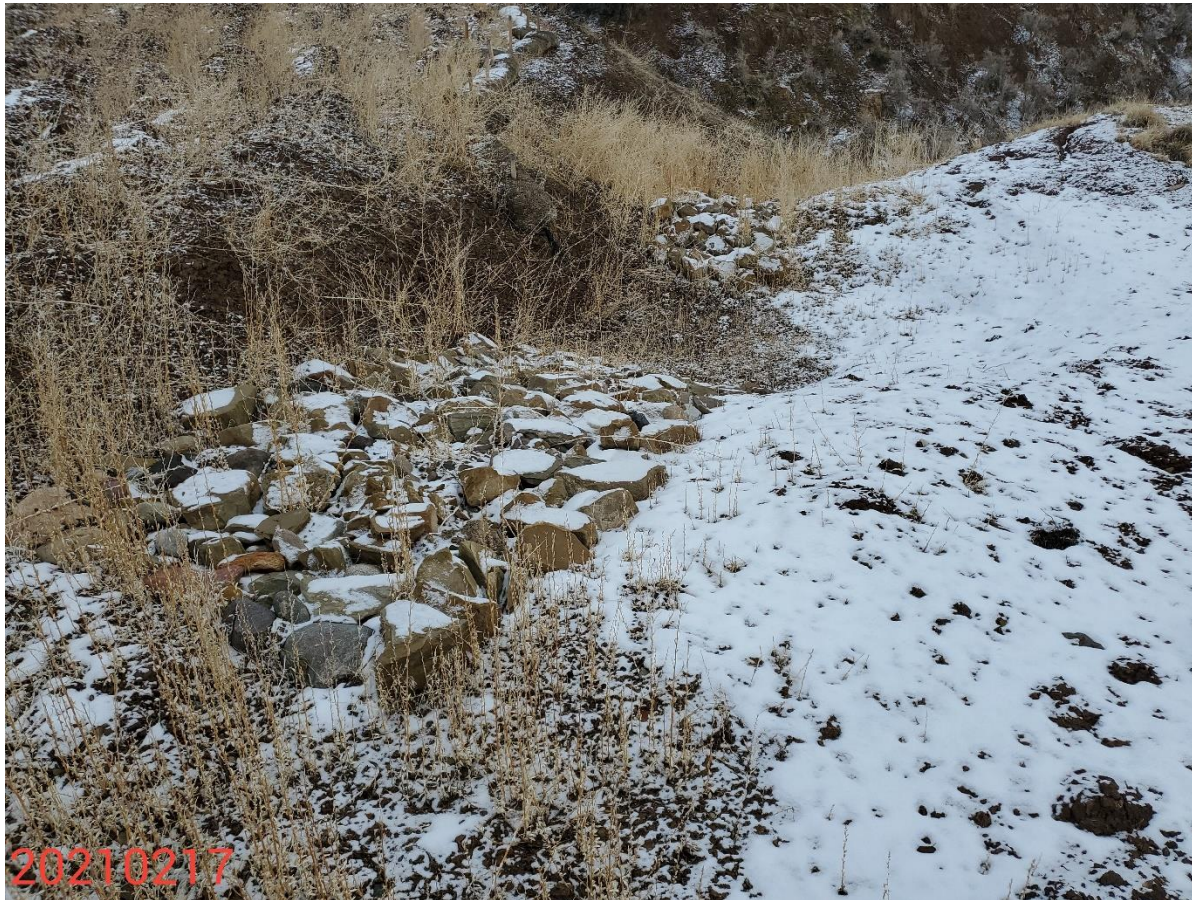
Photo 5: Photo taken from the southeastern interim areas of the Location. Photo shows example of multiple sediment traps installed on the south and eastern ends of the Locaiton.

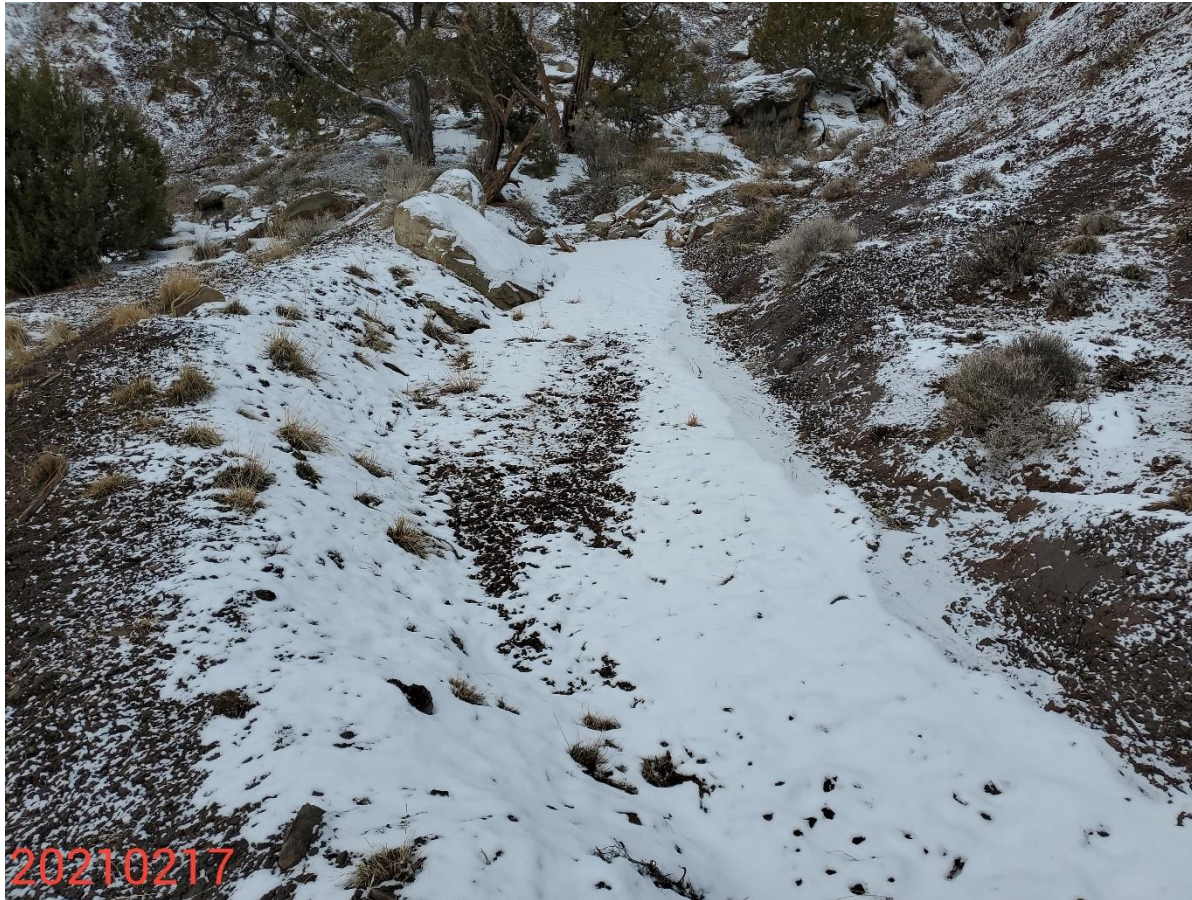
Photo 6: Photo shows perimeter stormwater ditch and berm to manage stormwater runoff.

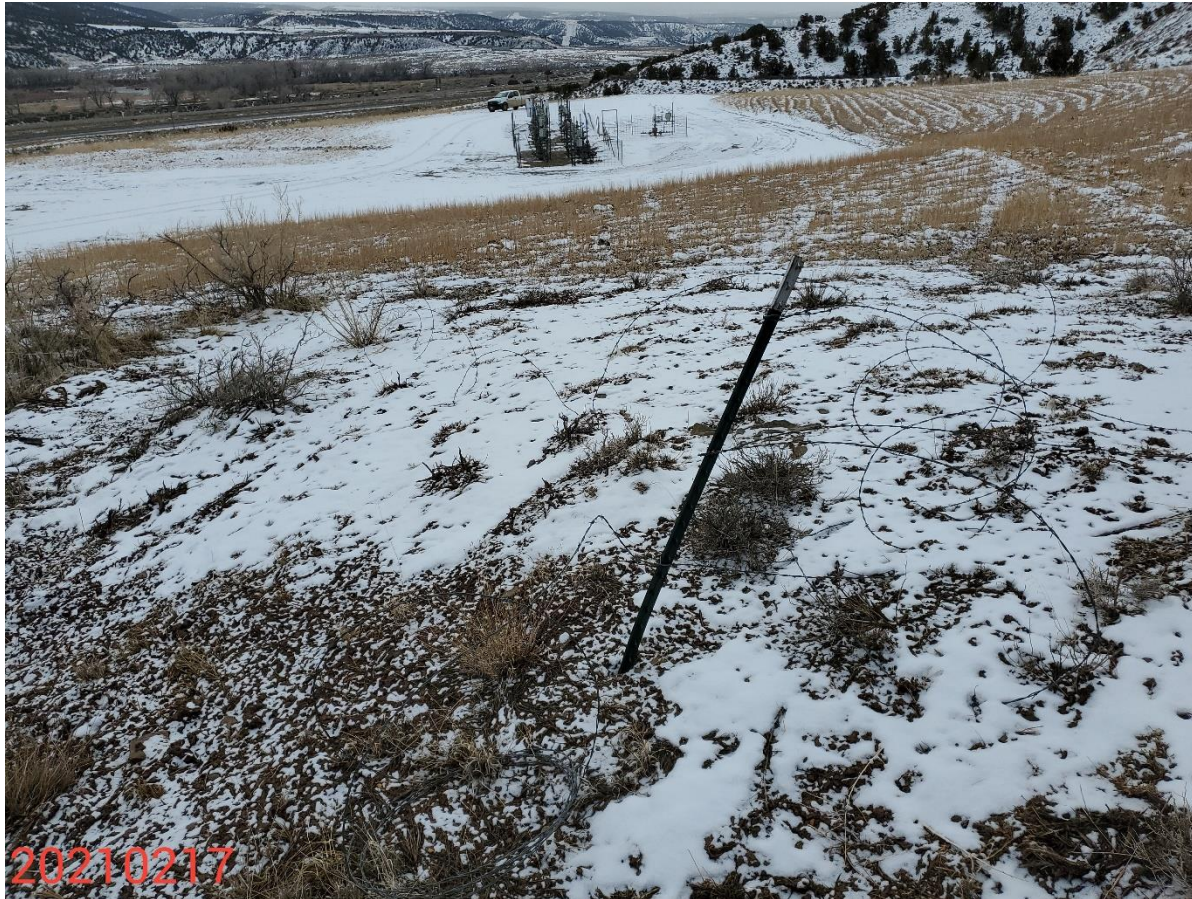
Photo 7: Photo taken from the north end of the Location. Photo shows perimeter fence is in disrepair.

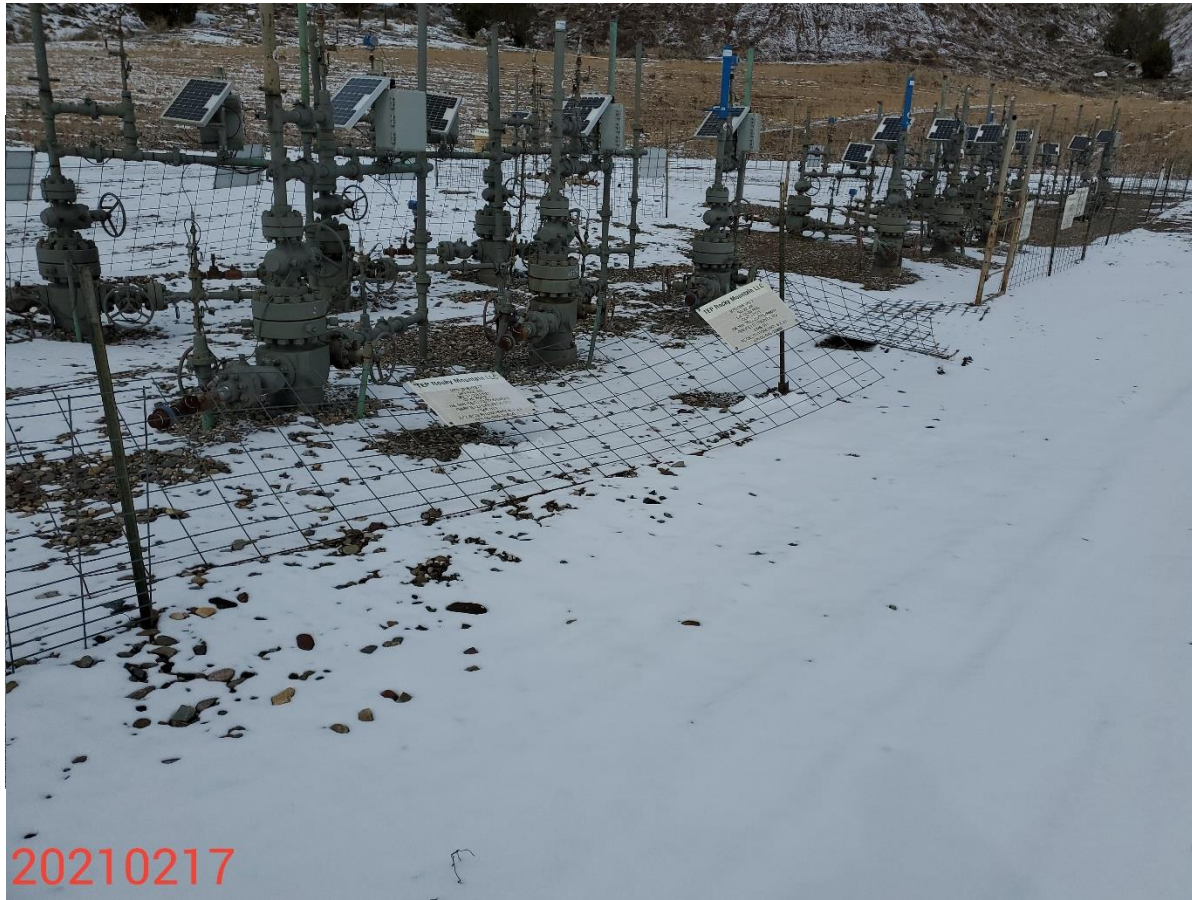
Photo 8: Photo shows fencing panels along wells are in disrepair.
