Inspection Photos

Loc#311534

Operator: Terra

Inspection Number: 692403045

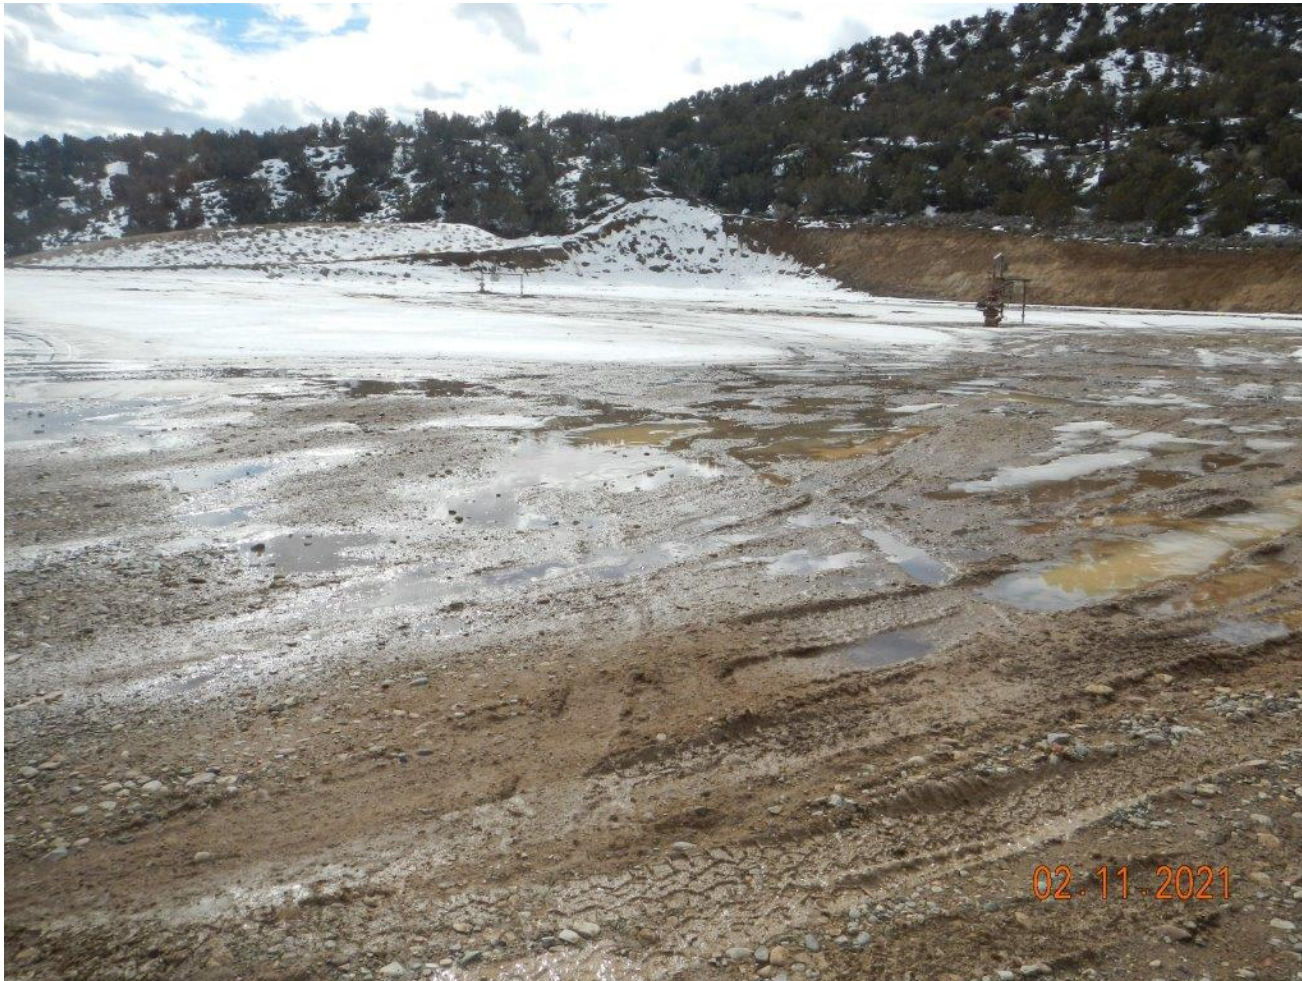
Photo#1:
Overview of Location from entry.

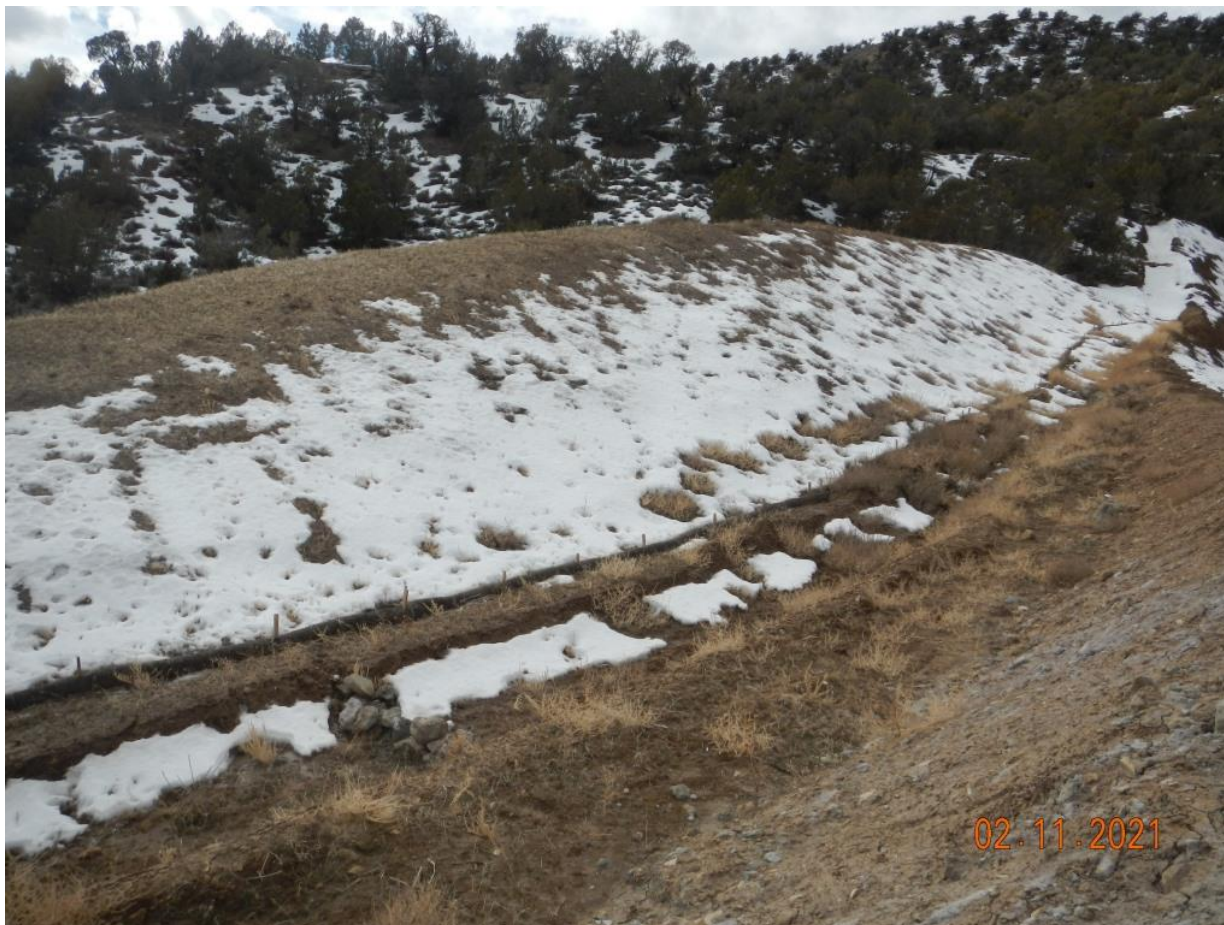
Photo#2:
Topsoil, stockpiled at West side of Location.

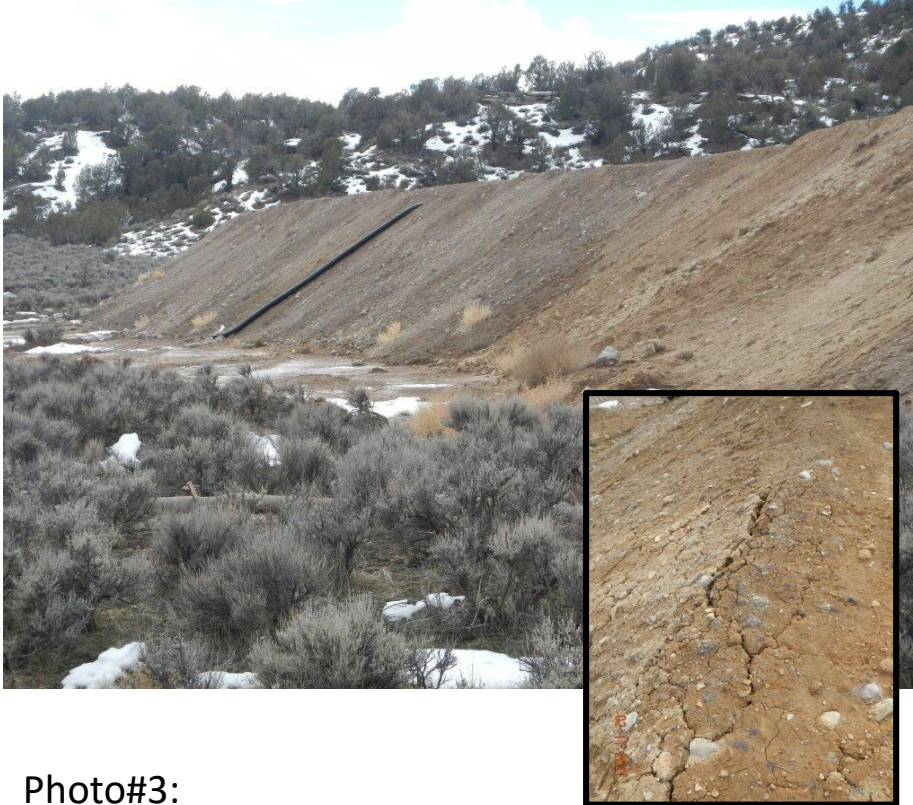
Photo#3:

View along Fill slope from access road. Insert is initiating cracking along top of Fill.

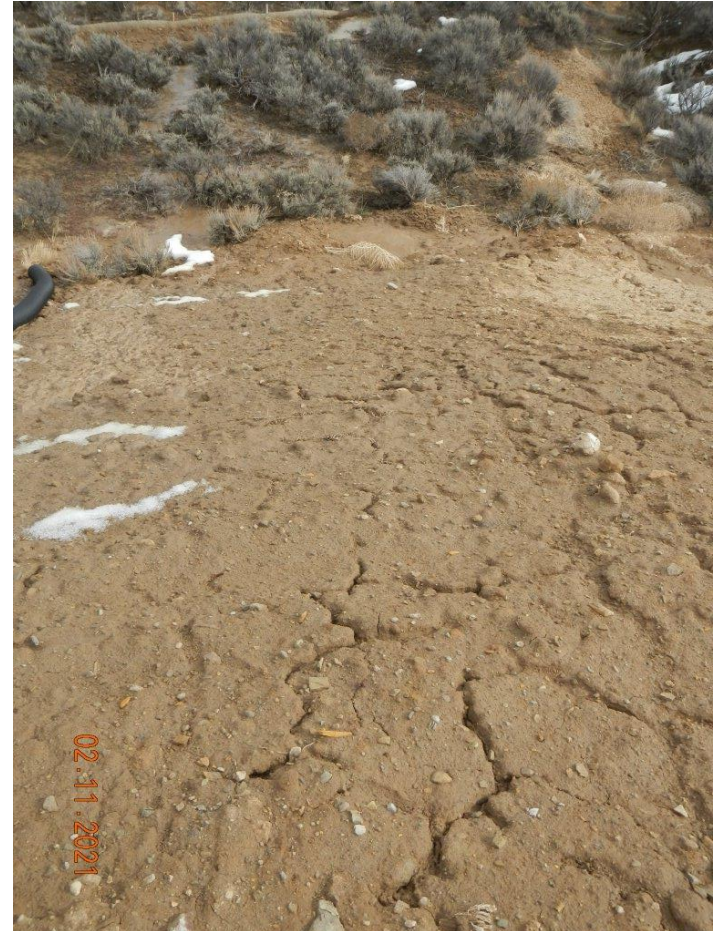
Photo#4:

View from top of Fill down to base. Initiating erosion and sediment migration

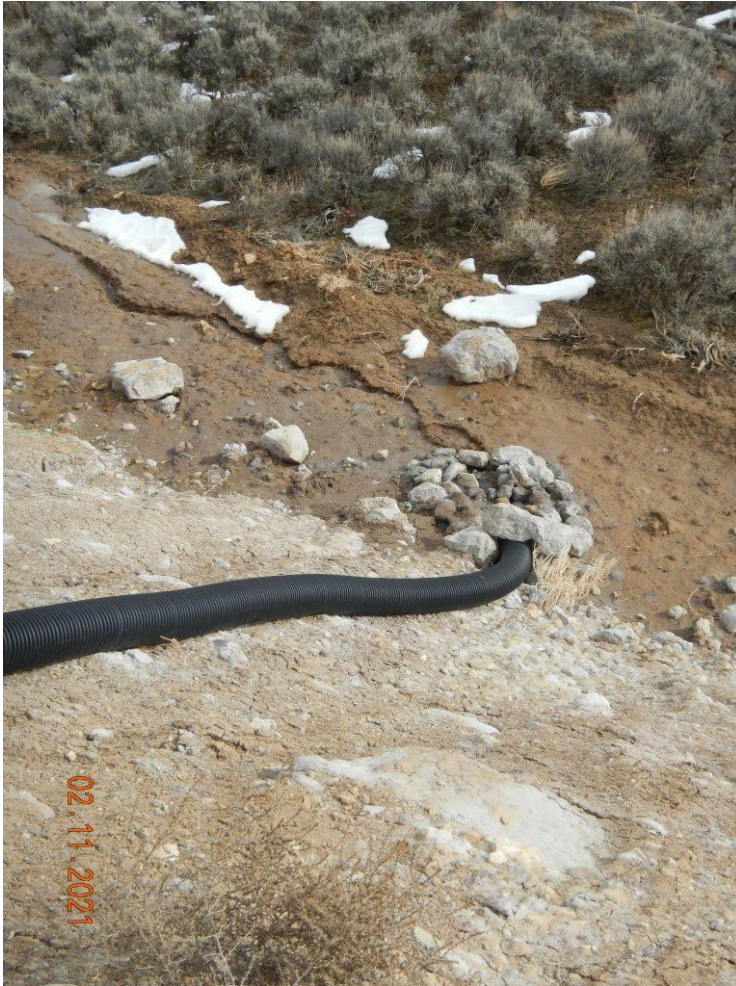
Photo#5:
Flexible drain discharges at base of Fill.

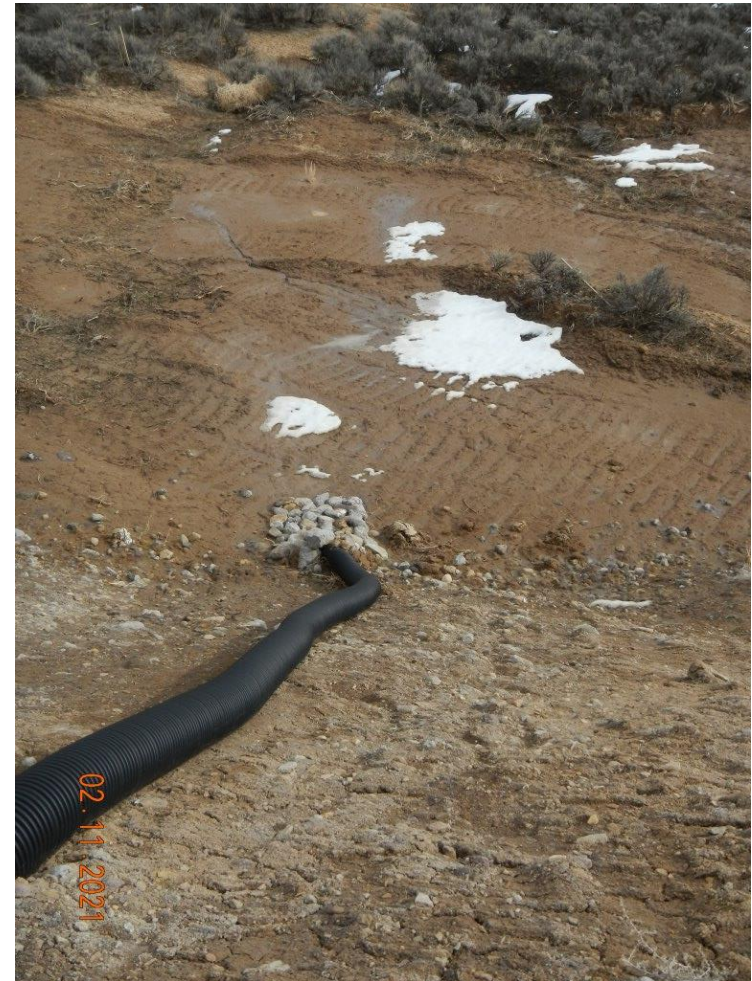
Photo#6:
Flexible drain discharges at base of Fill.

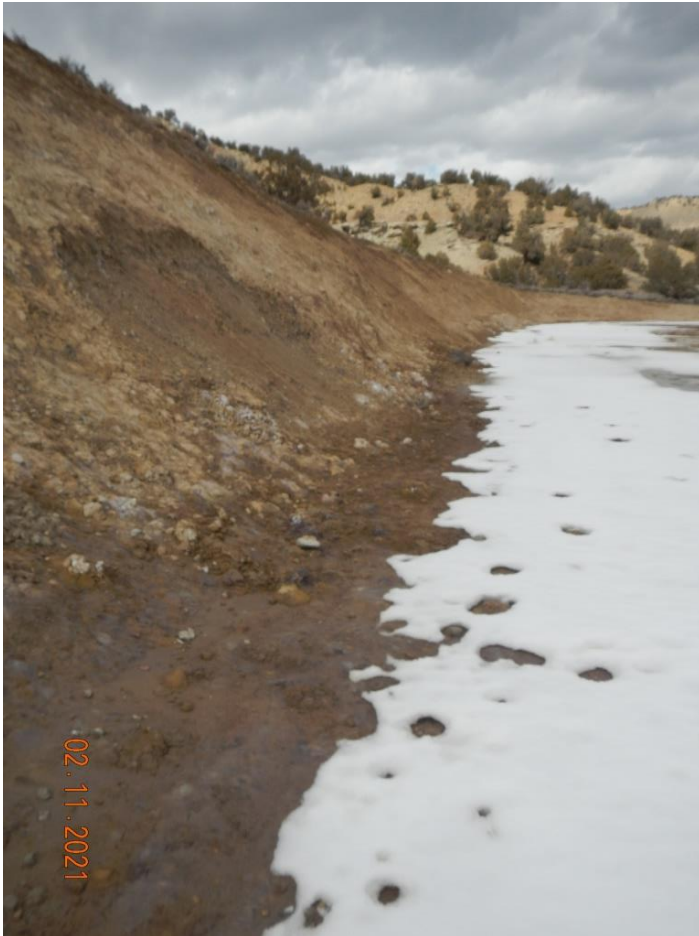
Photo#7:
View along Cut Slope to North.

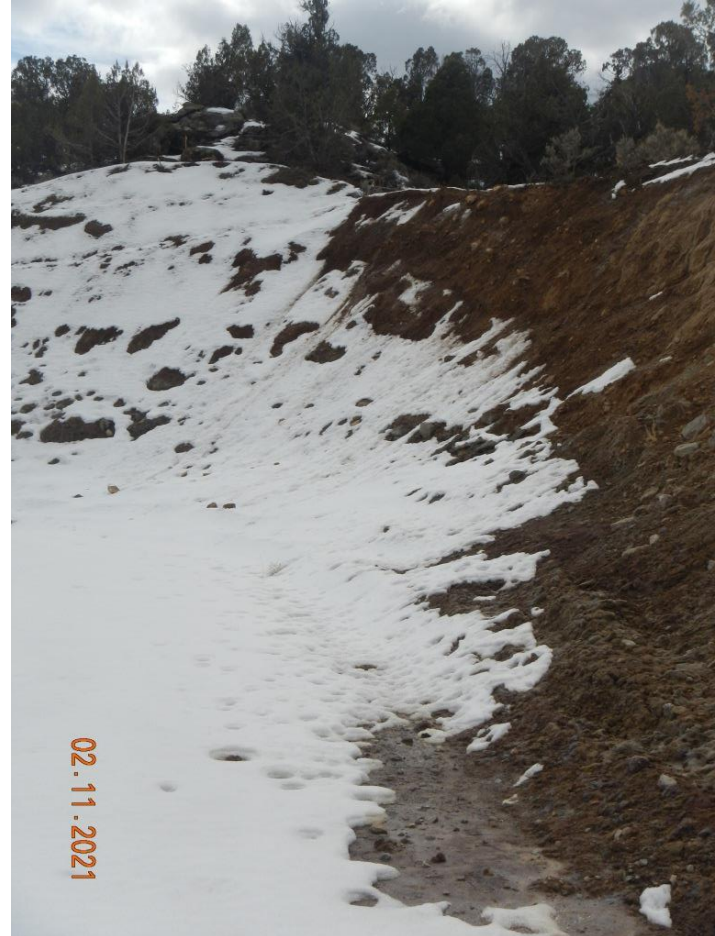
Photo#8:
View along Cut Slope to South.

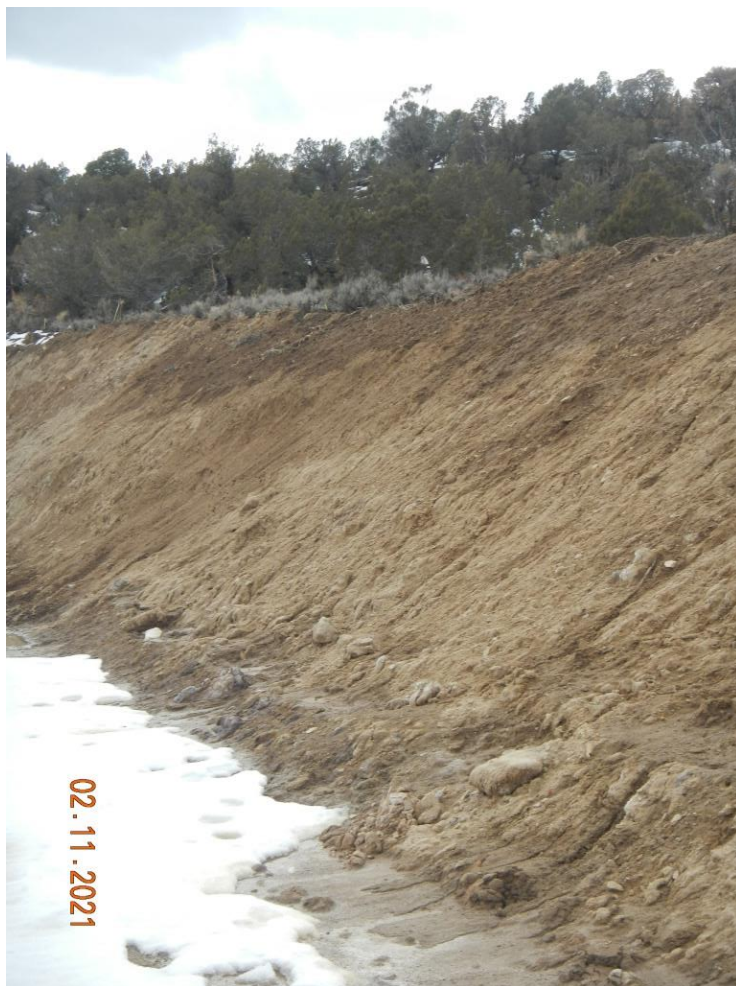
Photo#9:
Northwest portion of Cut Slope.

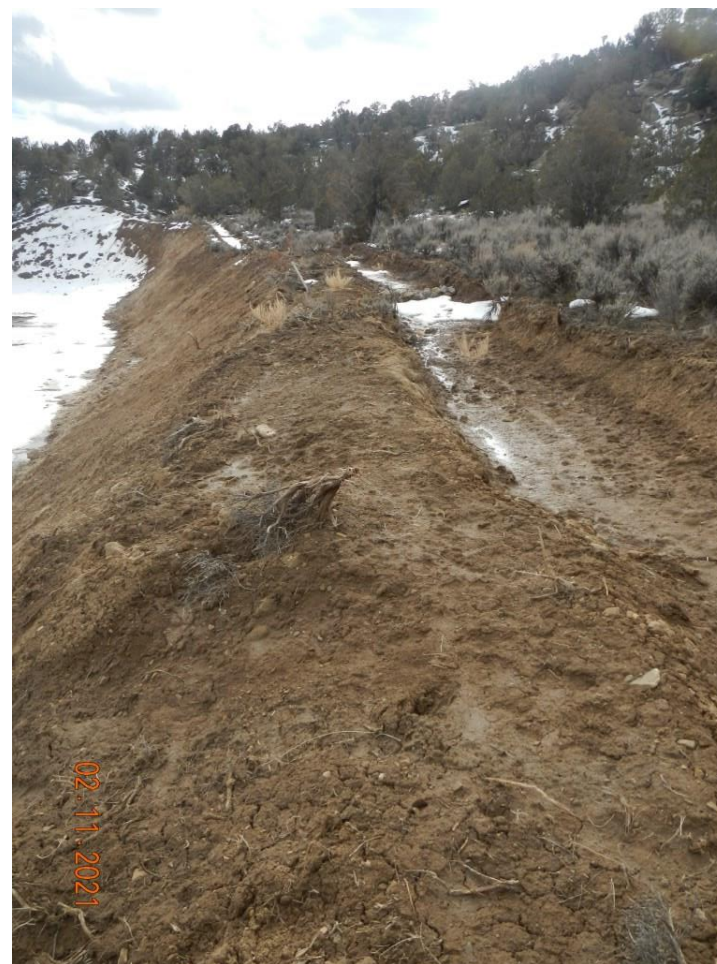
Photo#10:
Diversion BMP installed along top of cut .

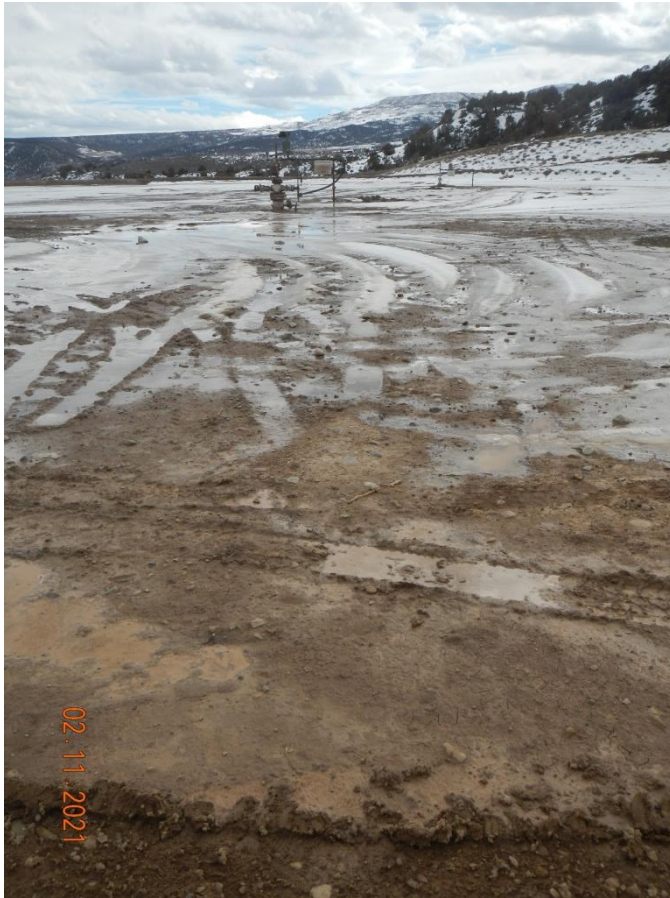
Photo#11:
Ponding, rutting on pad.

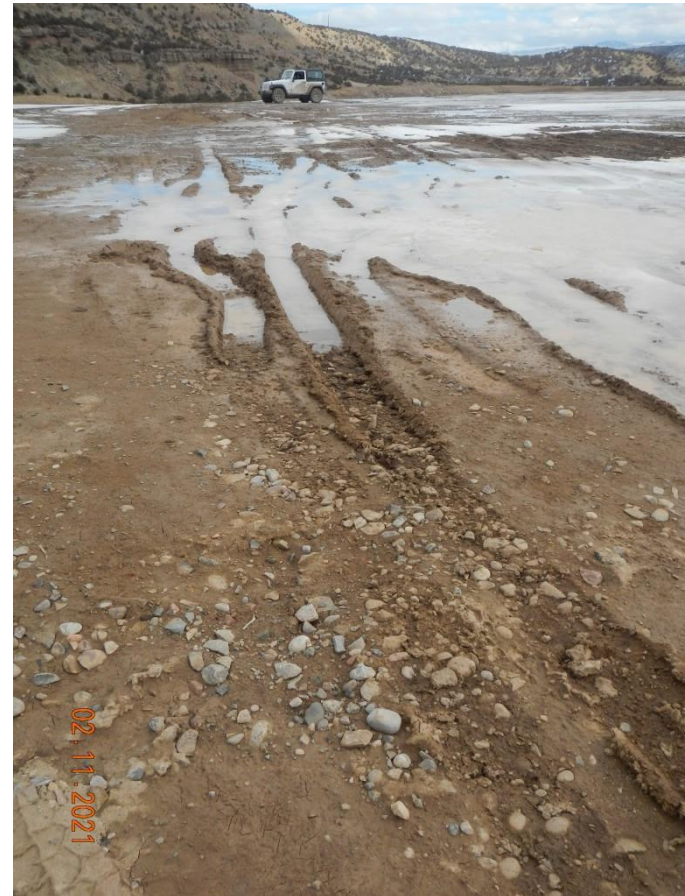
Photo#12:
Ponding, rutting on pad..

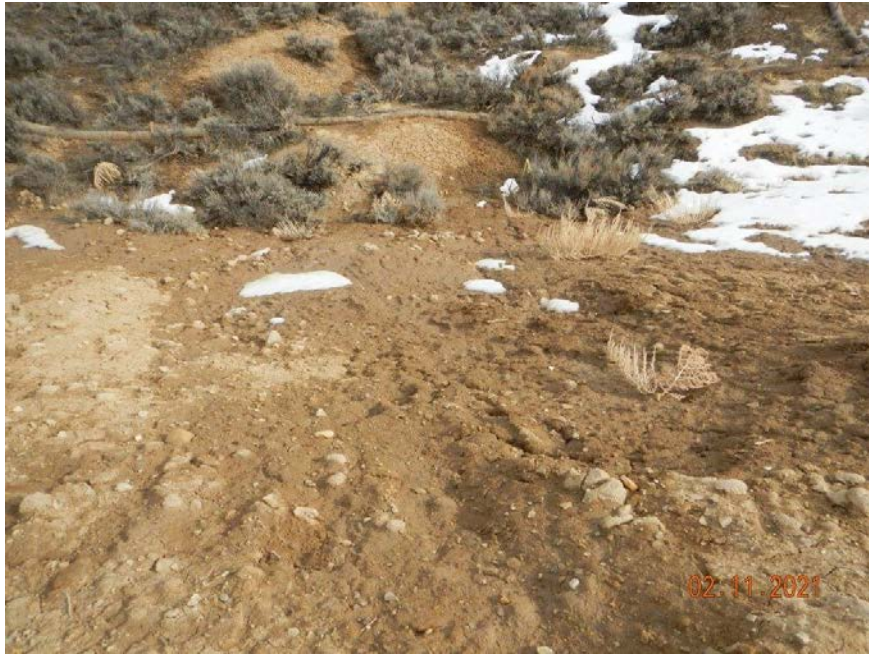
Photo#13:
Fill slope at North side of access road

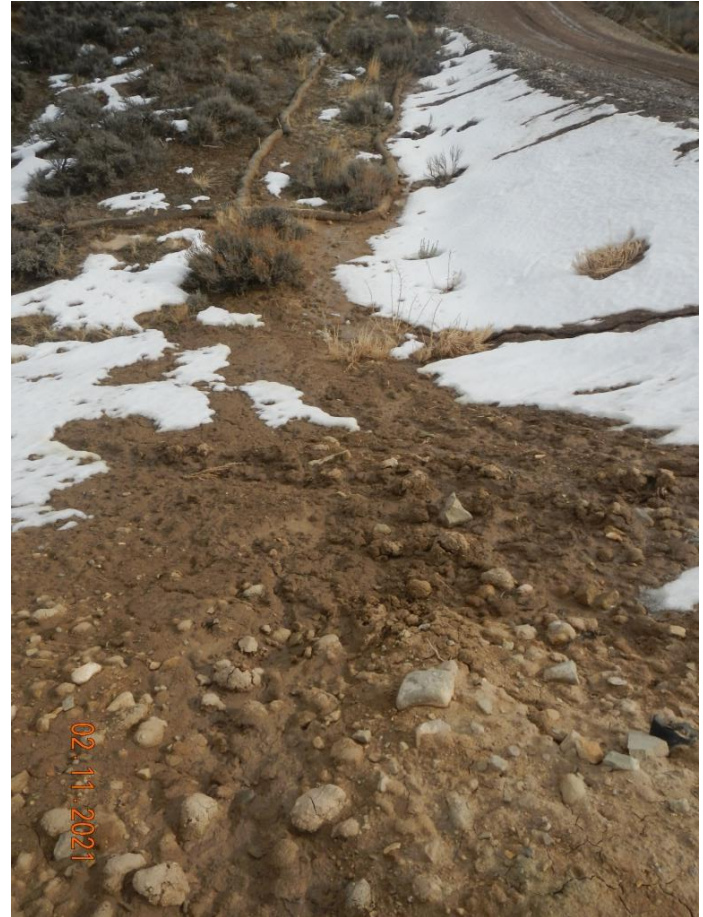
Photo#14:
Fill slope at North side of access road.

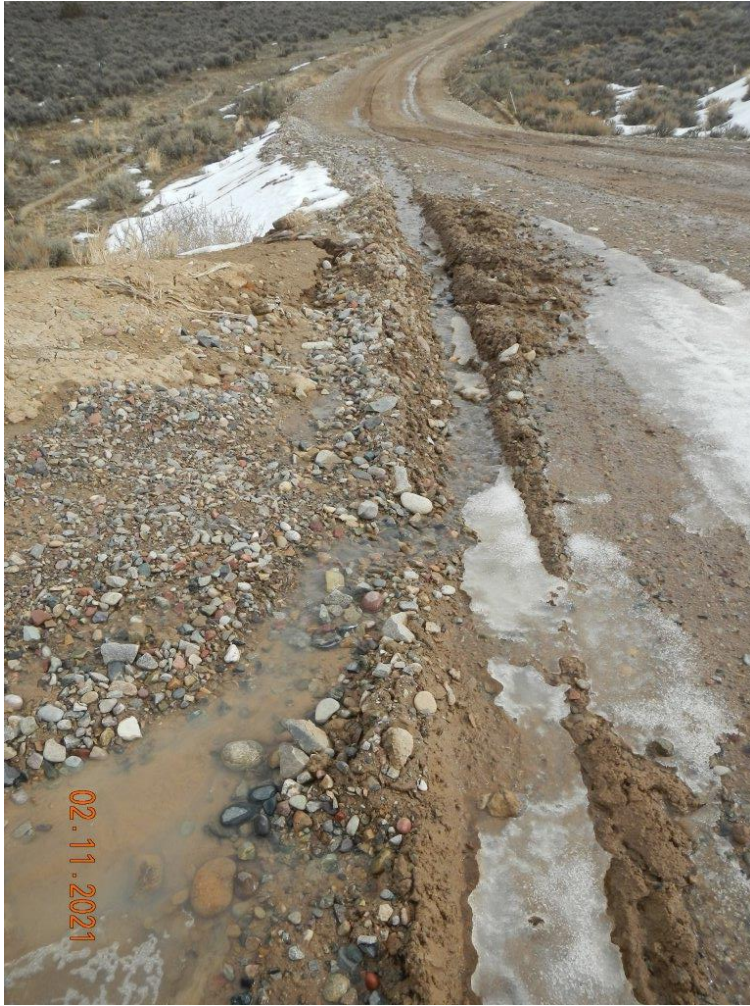
Photo#15:

Stormwater draining along tire rut @ access road North side entry and cutting/eroding off road in Photo#15

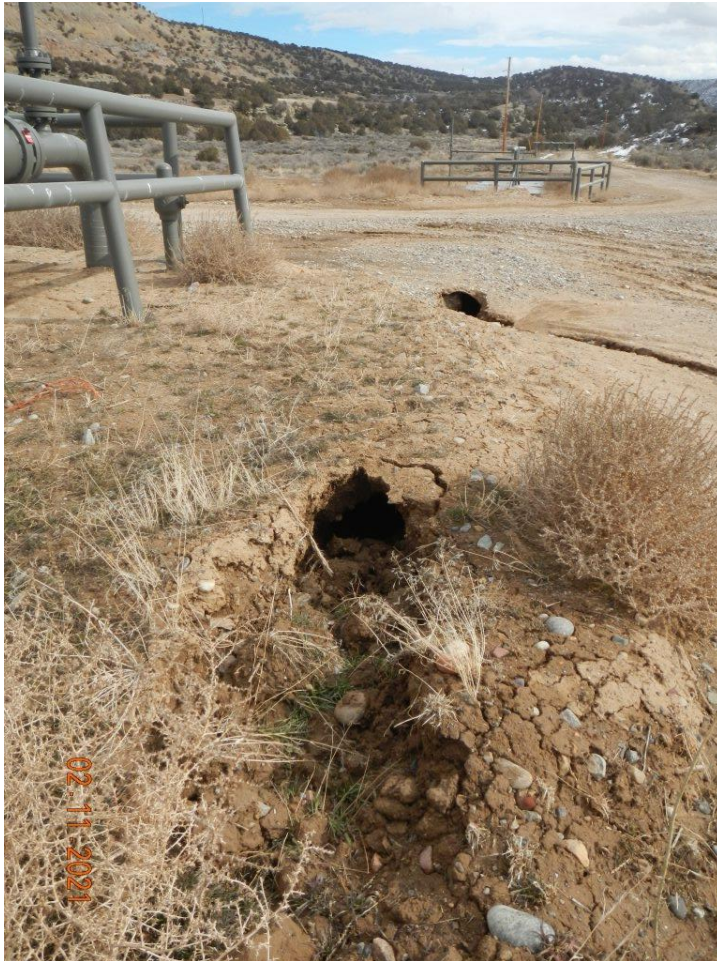
Photo#17:
Erosion concerns at access road intersection with
main lease road.

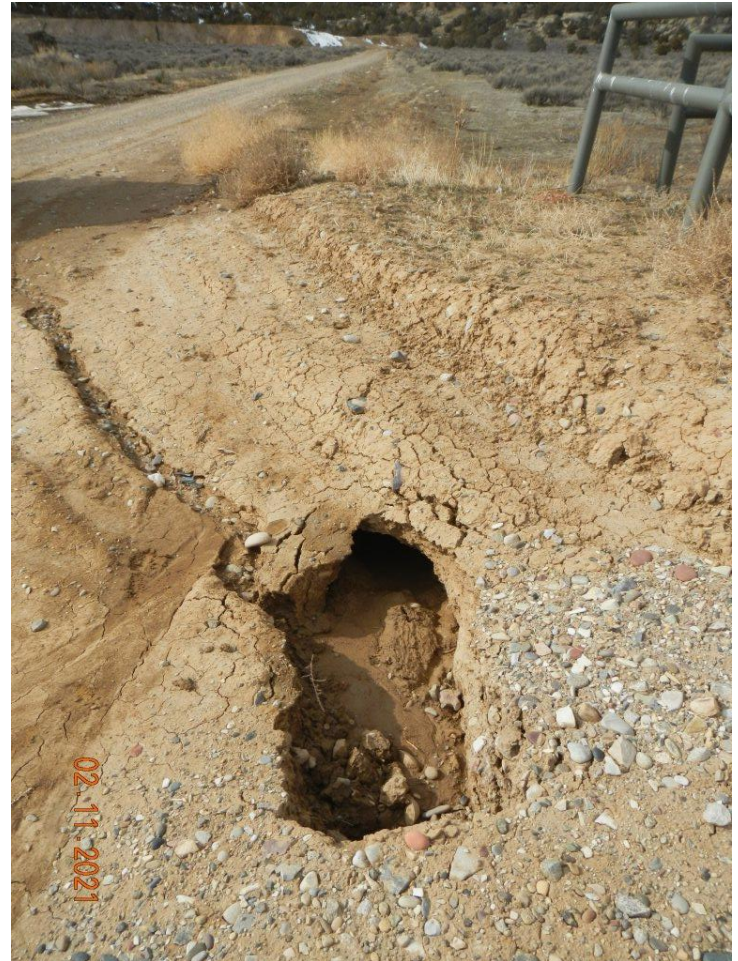
Photo#18:
Erosion concerns at access road intersection
with main lease road.
